AN ARCHAEOLOGICAL WATHING BRIEF

SHELLEYS, HIGH STREET, COOKHAM

BERKSHIRE

AUGUST 2014

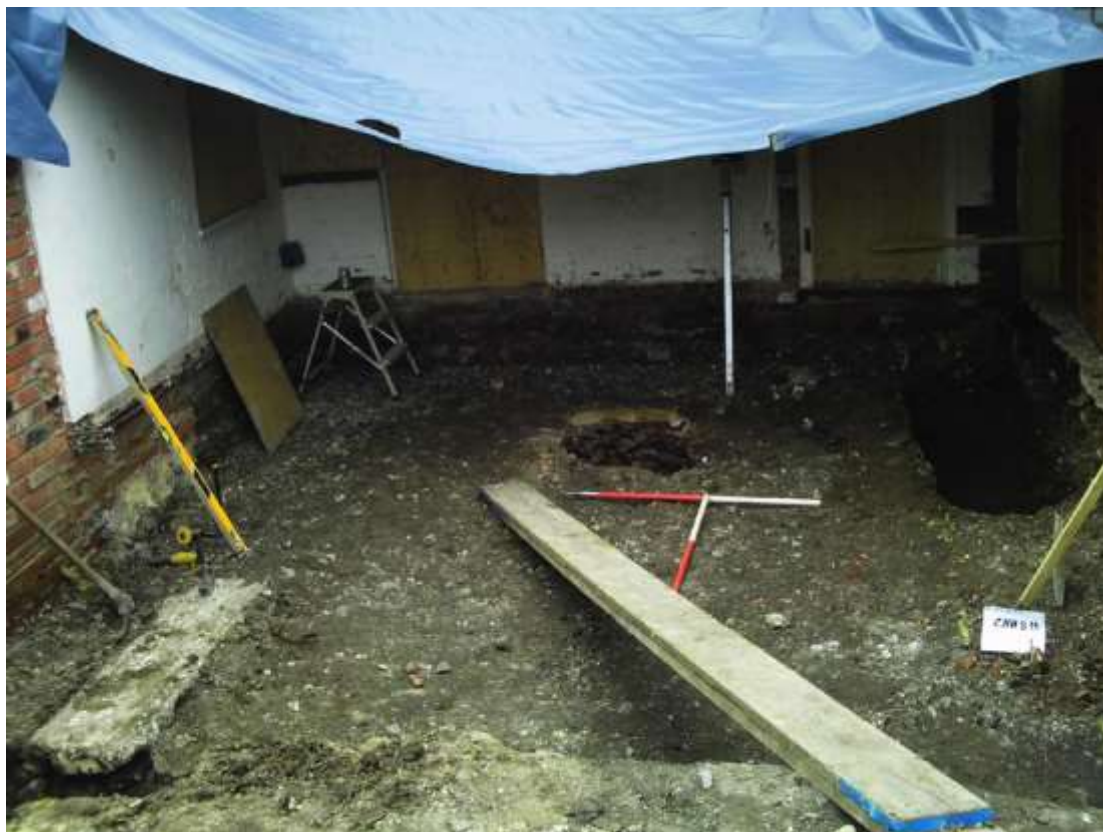
Plate 1: Monitored area, looking south

Prior the excavation of foundation trench for new two-storey extension, the old extension was demolished and concrete slab was removed. Only fragments of concrete foundations from old extension was left *in situ* (Fig. 2a), which cut in to the deposit (103). The entire area of the footprint of new-build was reduced on average by 0.50m (Pl.1).

The excavated footing trench for new extension was 8.65m long in total, 0.60m wide and reached maximum depth 0.90m from the present ground surface.

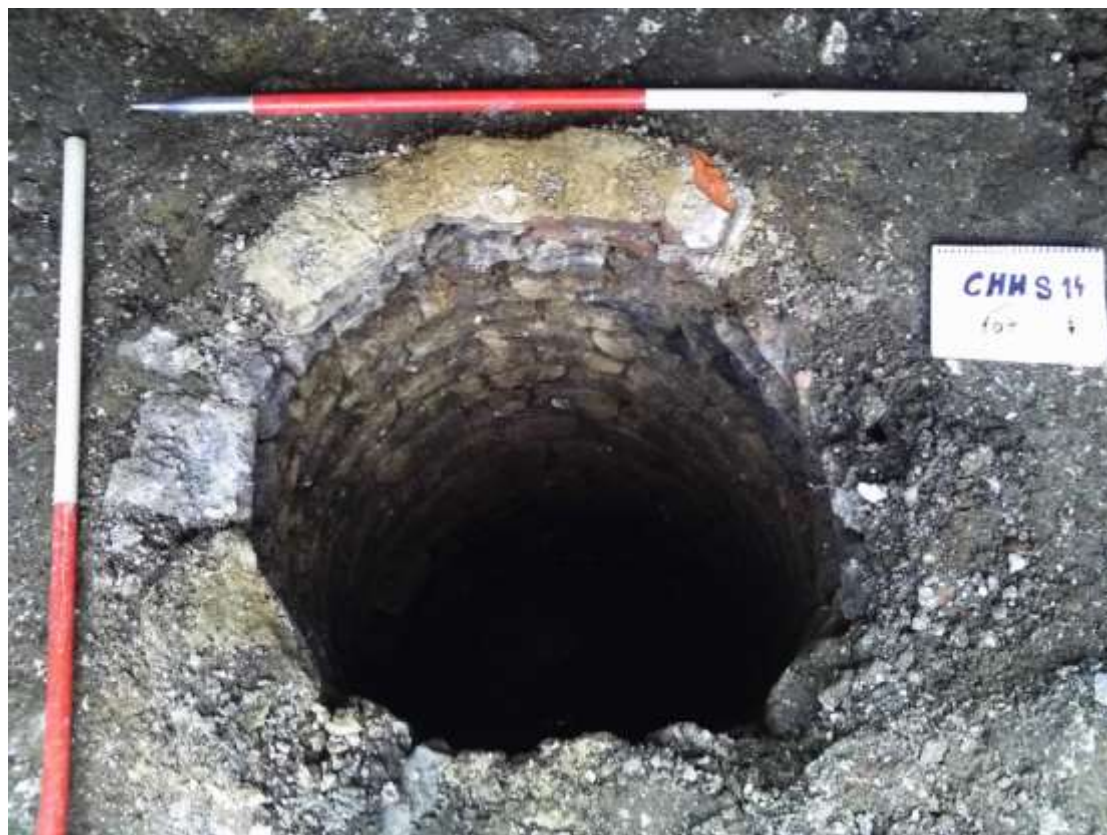
Plate 3: Well 104, looking south

After removal of concrete slab of the old extension, ground workers uncovered a well-preserved well **104**, located in the centre of south part of monitored area (Fig. 2a; Pl. 1). The well was set within circular construction cut 105, which measured 1m in diameter. The internal diameter of well **104** was 0.72m and the thickness of the wall was 0.14m on average as seen on the surface (Fig. 2a, d; Pl. 3). The well was 2.08m deep from the top of preserved masonry down to the silt on the bottom and the water level was at 1.94m. The main structure of well **104** was of roughly squared sandstone built in courses. The upper five courses were built of flints and bricks, which might indicate repairing of the well or that the original above ground part of the well was finished with bricks (Fig. 2d). Stratigraphically the construction cut of well 105 cut into the subsoil (103); however there is possibility that originally the well cut from topsoil (101), which was removed during the construction of the first extension approximately in the mid 20th century.

No dating evidence was recovered from well **104**, although based on the construction style and the fact that wall was still in use in first half of 20th century (based on a neighbour’s oral testimony) the well could be dated to the late post-medieval period.
