JOHN MOORE HERITAGE SERVICES

ARCHAEOLOGICAL WATCHING BRIEF

BOTLEY HILL FARM, TAMWORTH LANE,

HENLEY IN ARDEN, WARWICKSHIRE,

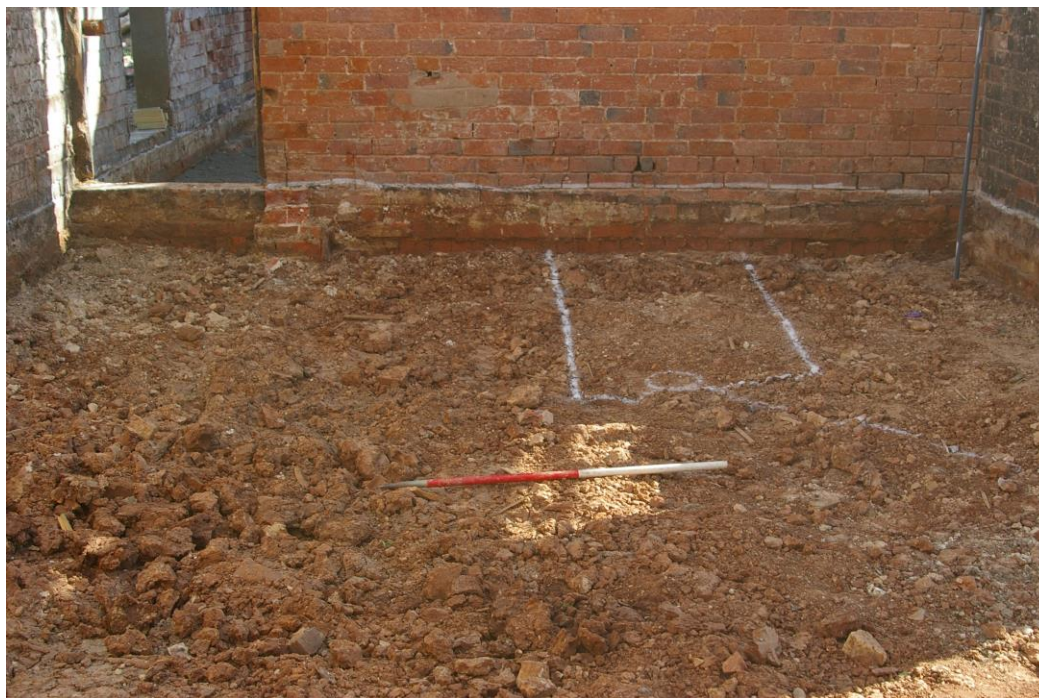
The removal of the floors within the Old Forge and Bull Pens (Plate. 1) in early June 2015, involved excavation of the natural clay (a reddish brown clay) to a depth of 0.4m once the existing floors had been removed. No archaeological features were encountered.

Plate 1. Reduced floor level in Bull Pen looking northeast

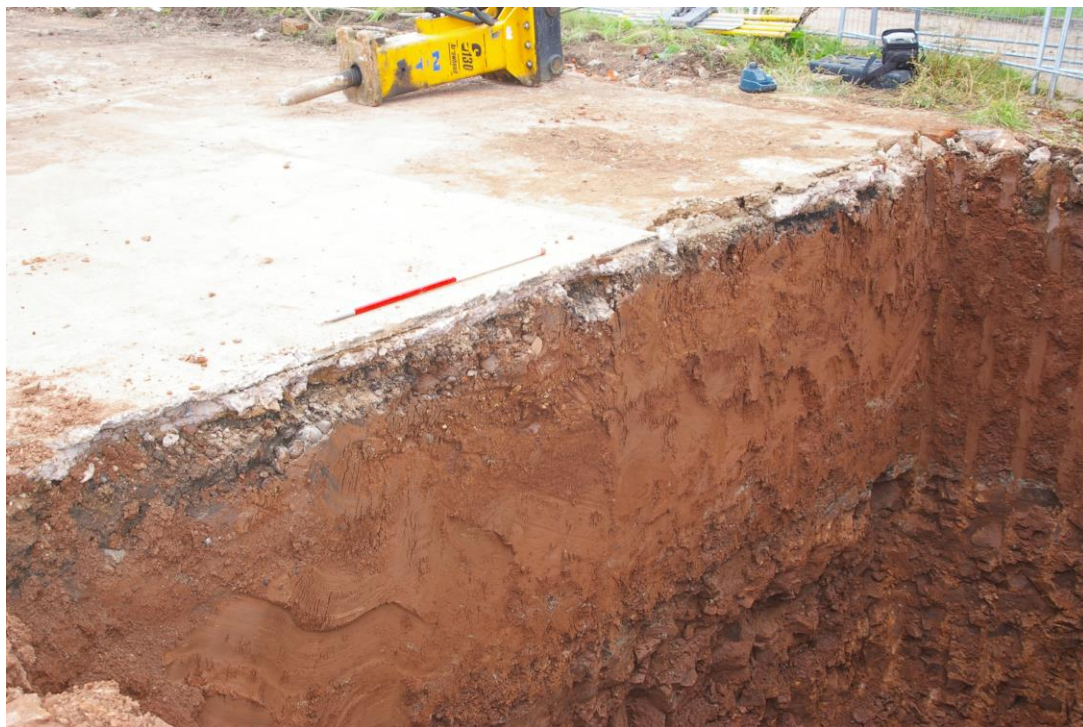
A trench 3.3m wide, 6.7m long and 3.6m deep was excavated within the courtyard area (Fig. 2 & Plate. 2), for a septic tank. The southern 4m extent of the trench comprised a concrete slab floor directly overlying the natural clay with bricks and tile compressed into the upper surface of the natural clay; there was no evidence of any topsoil or subsoil and was devoid of any archaeological features. The natural clay was 1.6m thick and overlay a siltstone bedrock. The southern c.3m extent of the trench had a 0.3m thick layer of a grey / brown silty clay (1001) that contained 19th century brick and tile debris, that overlay the natural clay.

Plate 2. Septic tank trench looking southeast

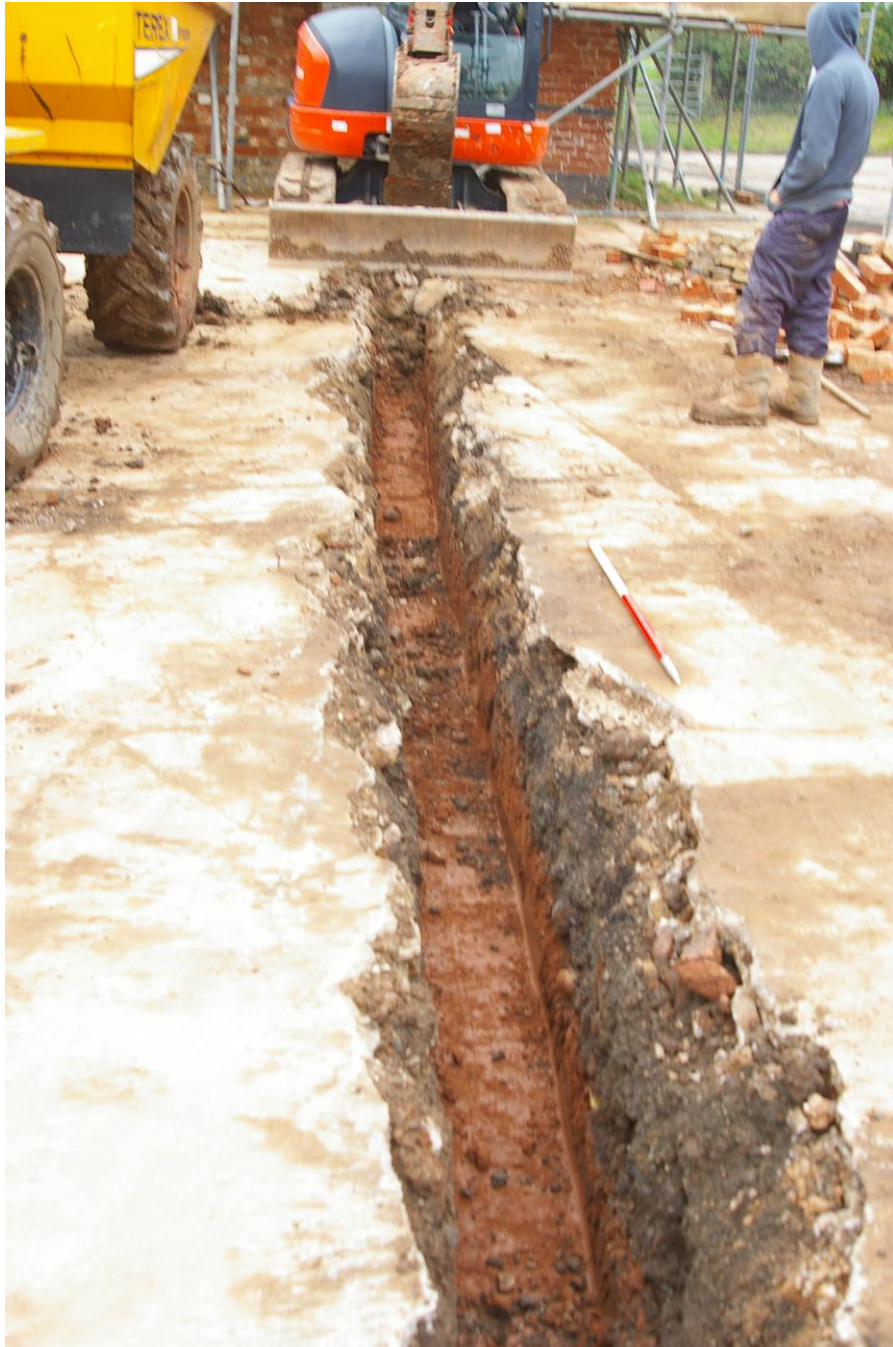
Three service trenches for foul water were monitored; two trenches ran from the Old Forge and Bull Pen building and one trench ran from the old stable building to the central trench containing the septic tank (Fig. 2 & Plate. 3). These trenches were 0.5m wide and ranged in depth from 0.5m – 1.5m. The trenches contained layer (1001), described above, overlying the natural clay. A 0.15m thick layer of clinker (1002) overlay (1001) and extended for 8m east of the Old Forge building and 10m west of the Old Stable building (Fig. 2). Cutting through these layers were the foundation walls from the 20th century barn that was situated within the courtyard of the barn complex and the whole courtyard area was covered with a concrete floor slab.

Plate 3. Trench running from Stable Block to septic tank trench looking southeast

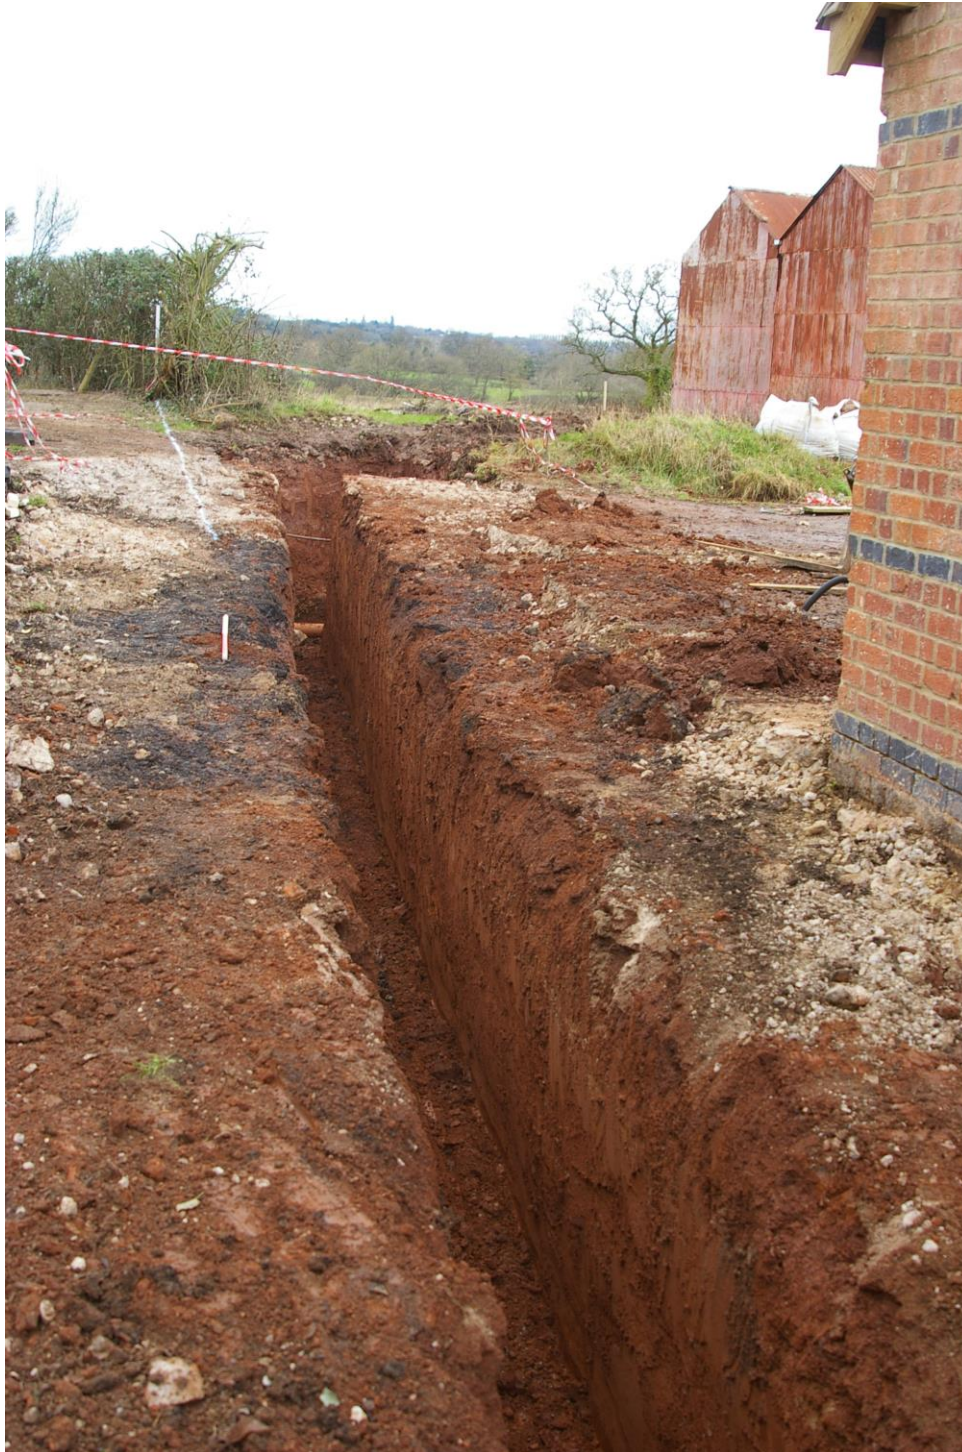
In February 2016 a trench 2m wide, 2.8m long and 2.3m deep was excavated southwest of the Old Forge and Bull Pens building (Fig. 2 & Plate. 4) to expose the existing water pipes to connect to. The trench consisted of concrete floor slab laid directly onto the natural clay. A 0.5m wide and 2.3m deep trench extended from this trench, southeast to link up with the septic tank trench in the courtyard (Fig. 2 & Plate. 4). Again this trench was devoid of any archaeological remains and consisted of concrete floor slab laid directly onto the natural clay.

Plate 4. Trench southwest of Bull Pen looking northwest
