**HERITAGE IMPACT ASSESSMENT**

**OXFORD THAMES FOUR PILLARS HOTEL,**

**SANDFORD-ON-THAMES, OXFORDSHIRE**

**NOVEMBER 2015**

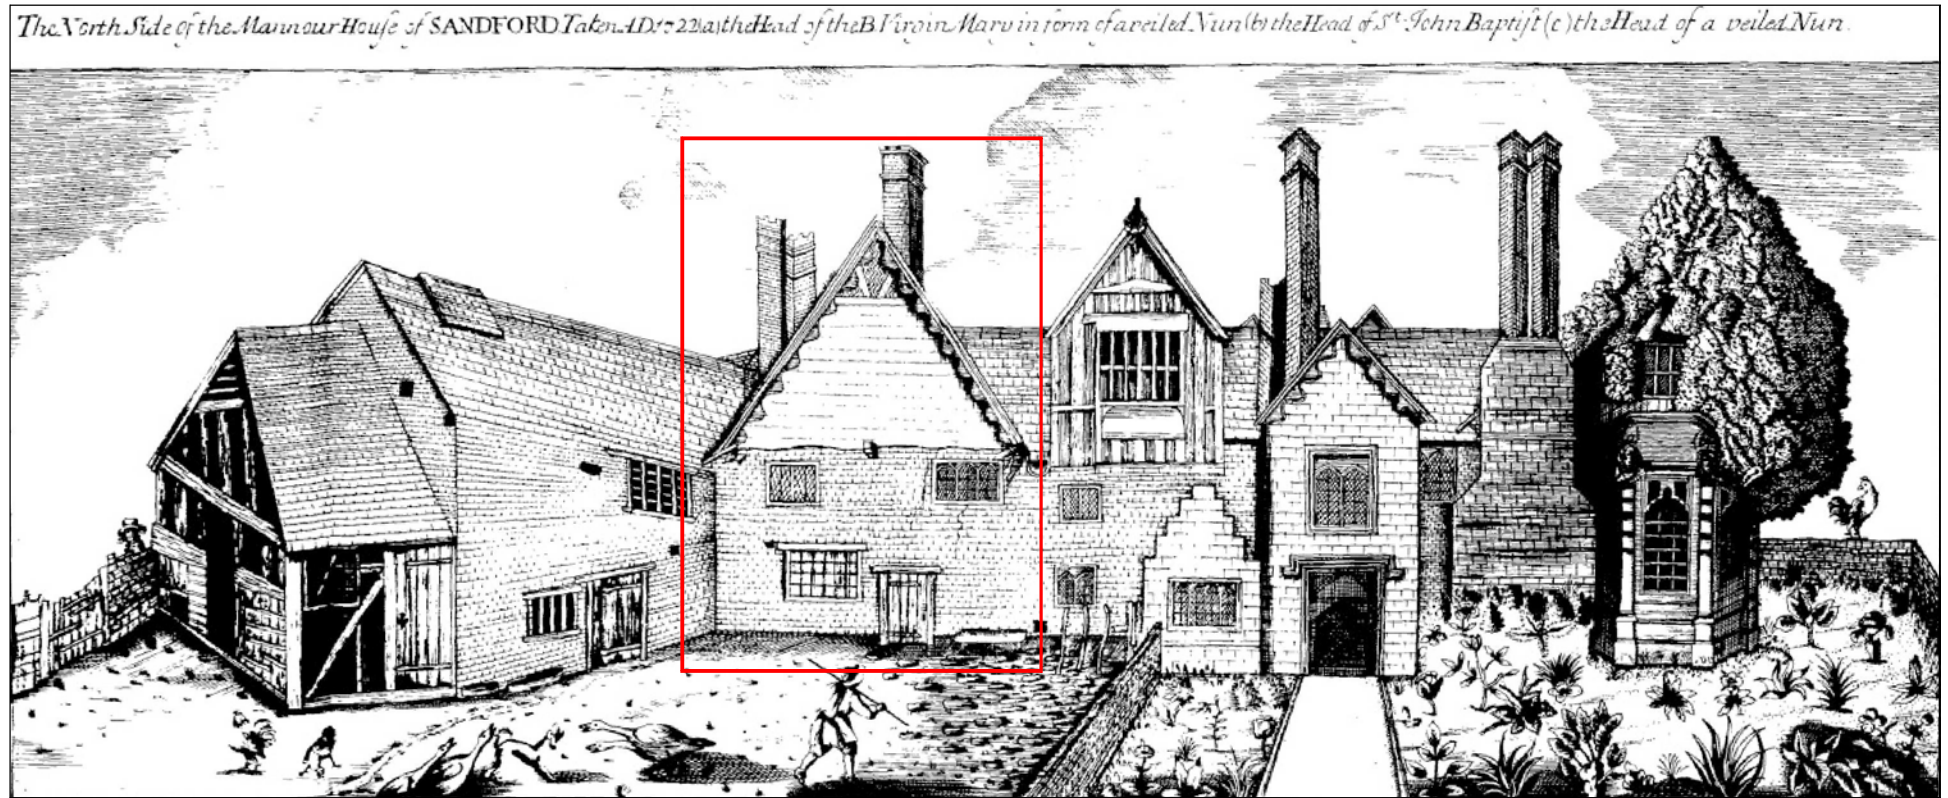
Figure 5: North elevation of Manor House 1722

Gable marked in red survives to present day (see Plate 5)

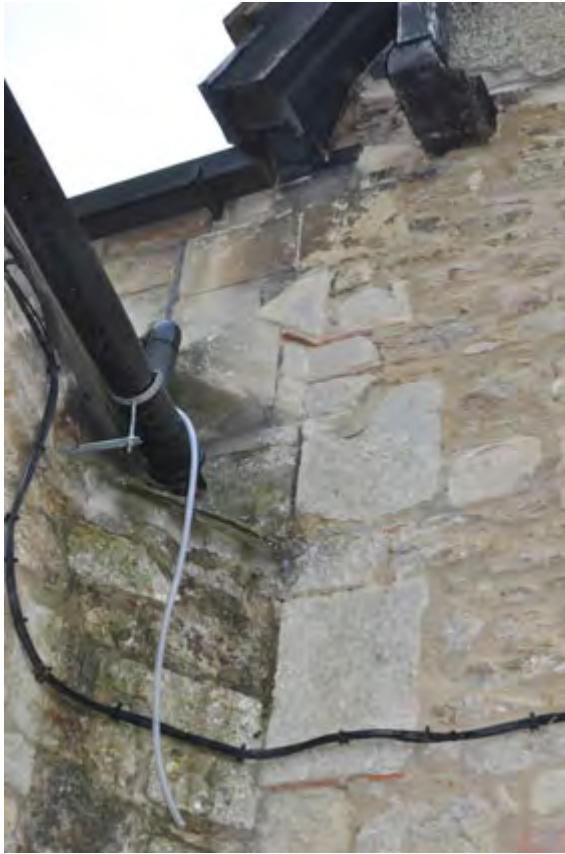
Plate 4: Remains of diagonal buttress on north façade

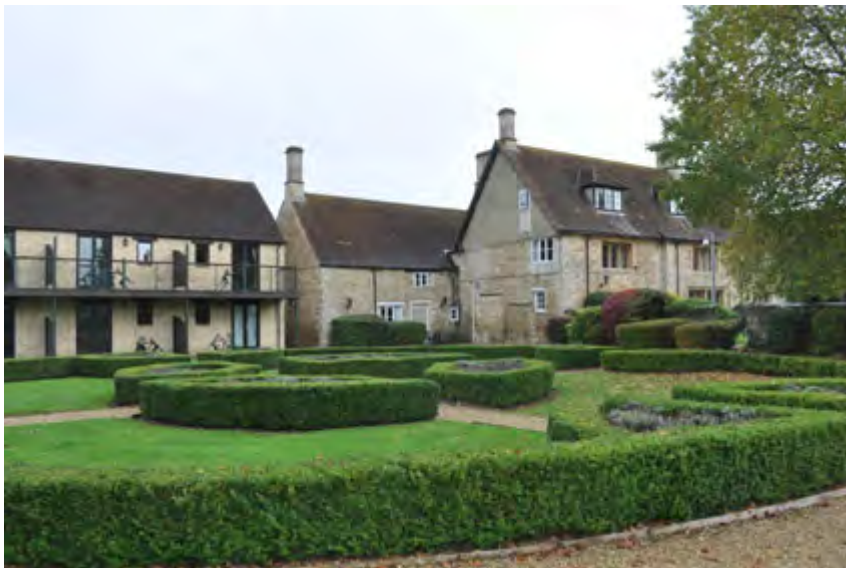
Plate 5: Building from northwest with gable end shown by Hearne 1722

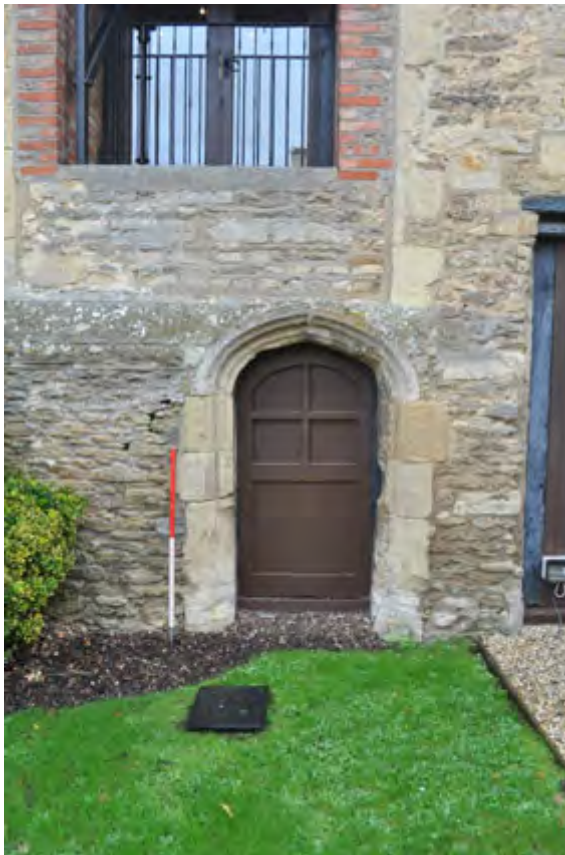
Plate 6: 15<sup>th</sup> century doorway

*medieval building, probably the east end of a chapel. In the north wall a C15 4-centre arched doorway cuts into the 2-course weathering of an earlier plinth, with a mutilated window above. The east gable wall, rising from a low plinth, contains the blocked lower part of a 3-light window with wide central light, possibly C15. A sill-level string returns around a deep buttress to right. Doorways are now blocked and porch is flanked by C20 lean-to structures. The 3-bay building linked to the barn has a small central doorway with a dormer door above, and blocked slit windows. A quoin to left is inscribed WC/1751. Interiors: Barn structure is now cased and not visible. 3-bay building has 2 heavy trusses with curved under-principals and 2 rows of trenched purlins. 2 bays of the loft floor survive. The building is on the site of a preceptory of The Knights Templars, later transferred to The Knights Hospitallers of St. John. (V.C.H. Oxfordshire V, p.268; Buildings of England, Oxfordshire, p.750.)*

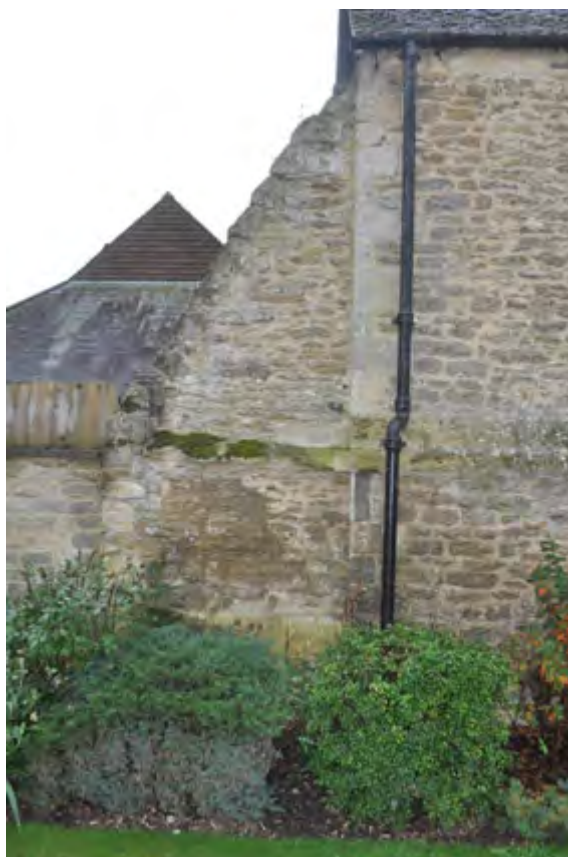
Plate 7: 13<sup>th</sup> century angle buttress
