**ARCHAEOLOGICAL WATCHING BRIEF**

**FORD HOUSE, FORD LANE,  
FRILFORD, OXFORDSHIRE,**

**NGR SU 4446 9723**

**MARCH 2016**

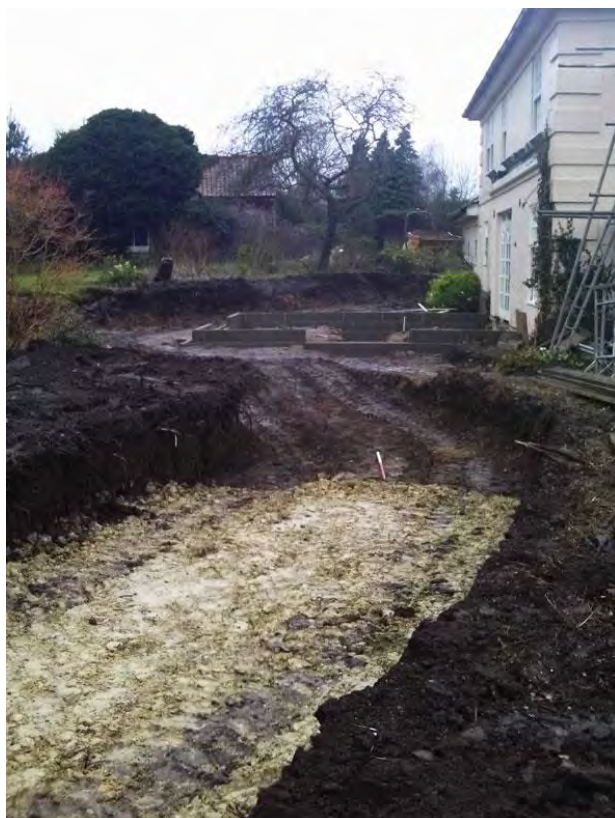
Excavations for the new orangery and the path down to the pool room/gym had already been undertaken prior to the visit by the archaeologist (Plate 1). It was, however, possible to make some observations of the soil horizons observed in the exposed section in the bank to the south of Ford House and in the sections along the pathway.

Plate 1. Excavated driveway/ path to Pool/Gym Room. West view.

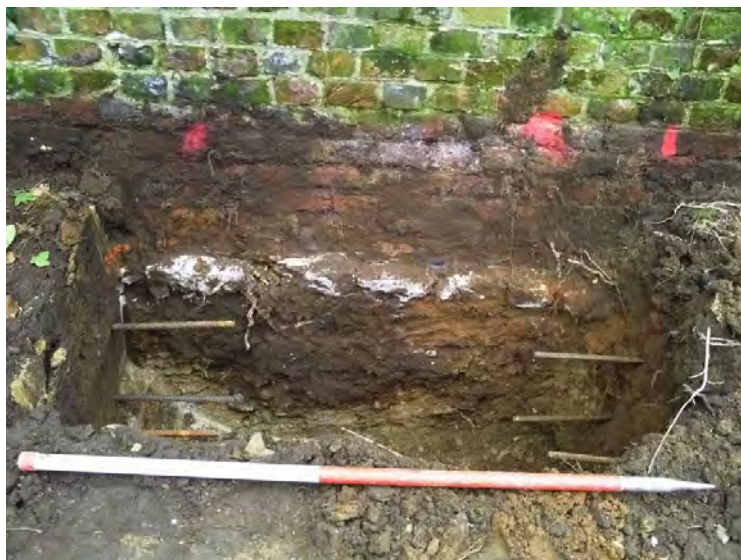
Plate 2. Section 1.

Excavations of the new foundations of wall **9** revealed a layer of white stone laid in a single course into a shallow cut into the top of (4) (Plate 2). Above this there were 12 courses of bricks with an elevation of 0.9m. The revealed cross section of this wall and wall **11** showed that this brick layer did not extend in depth for the entire width of the wall but instead was a facing on the interior of the barn (Plate 3 & 4). This facing was one brick wide and beyond it was a limestone rubble core. Wall **9** was 0.55m wide and was faced on its western face with roughly hewn limestone (Plate 5). Its eastern face was also faced with limestone above the lower brick courses (Plate 6).

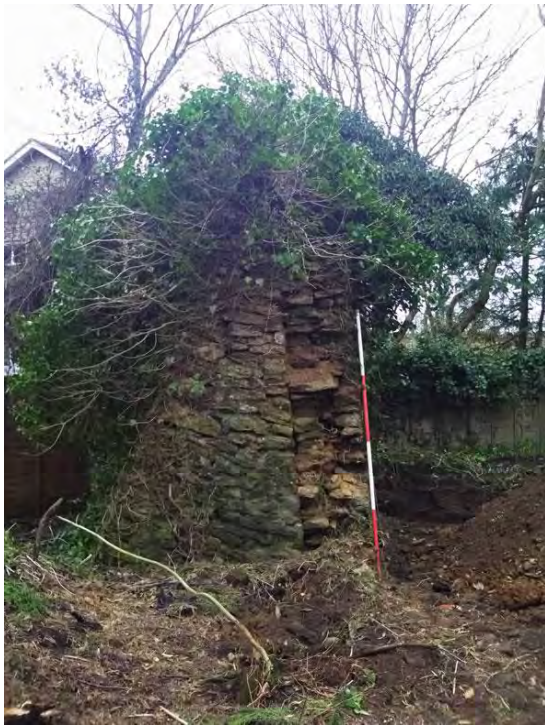
Plate 3. North section of wall 11 and butress. South view

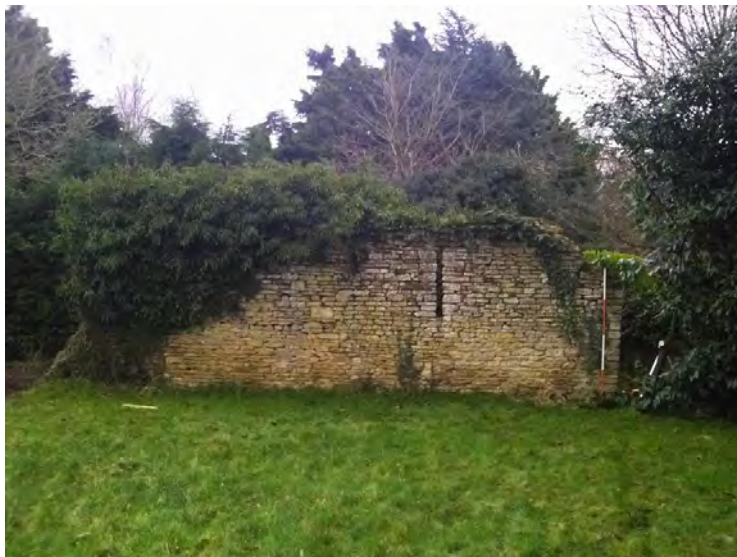
Plate 5. West face of Wall 9.

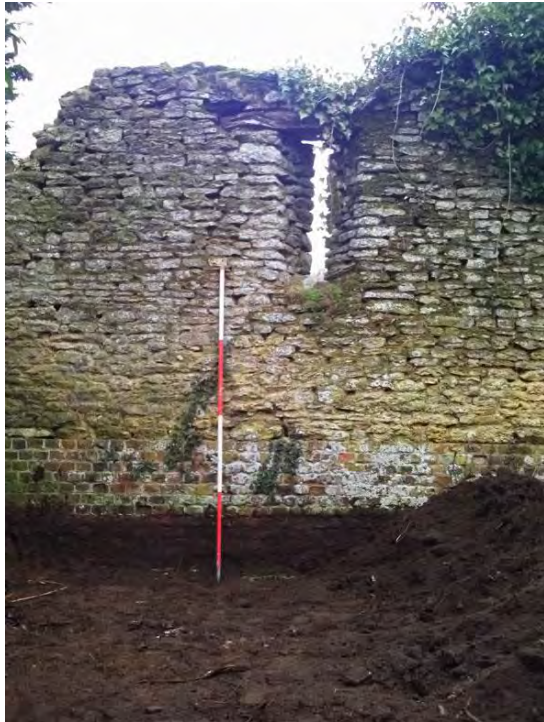
The remains of the wall were 8.9m in length and its elevation on the western face was 2.6m above the present ground level (Plate 2). On the interior of the wall, it survived in elevation to a maximum height of 3m from the bottom of its foundations (Plate 6). The wall featured two arrow slit like openings. The east wall **11** was of similar construction and also featured an arrow slit opening. The eastward tilt of the wall had been secured at some point in the past by the construction of two limestone built buttresses (Plate 3). The surviving height of wall **11** was approximately between 2.7m and 3m above the present ground level. Below ground it extended for 0.45m in section (Fig. 2, section 2, Plate 7). Below ground the foundations to wall **11** only survived for another 1.2m from the north end of the above ground remains (Fig 2. Section 2, Plate 7). There was evidence for a robber cut for this wall, cut 21, and a backfilling with dark brown sandy soil (20). These layer were overlain by a mixed organic sandy topsoil (19).

Plate 6. East face of Wall 9.

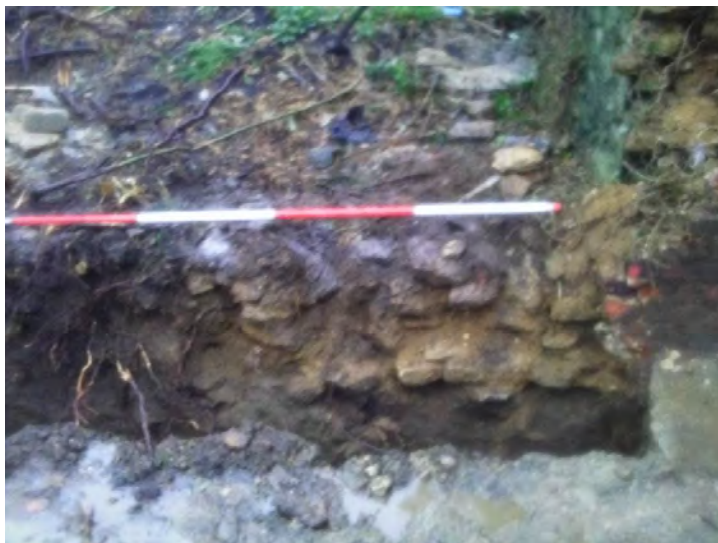
Plate 7. Foundations for wall 11. Section 2.

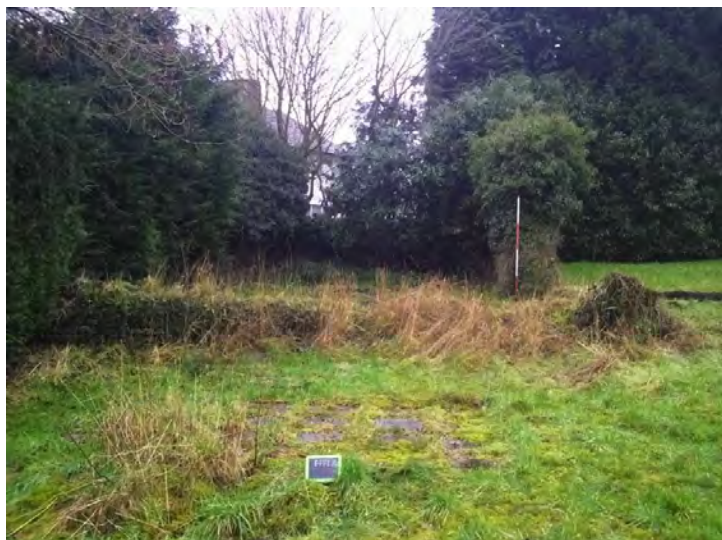
Towards the north area of the barn were the remains of north wall **7** and the continuation of the west wall **17** (Plate 8). These were the low lying remains of brick and stone barn walls. The surviving remains stood about 0.6m high above the ground but obtaining the exact measurements was difficult due to a large amount of plant growth over the walls. Both walls were demolished to the top of the current ground level but this was not observed by the archaeologist as it was carried out between

Plate.8. Barn ruin. View southwards with Wall 7 in the foreground.

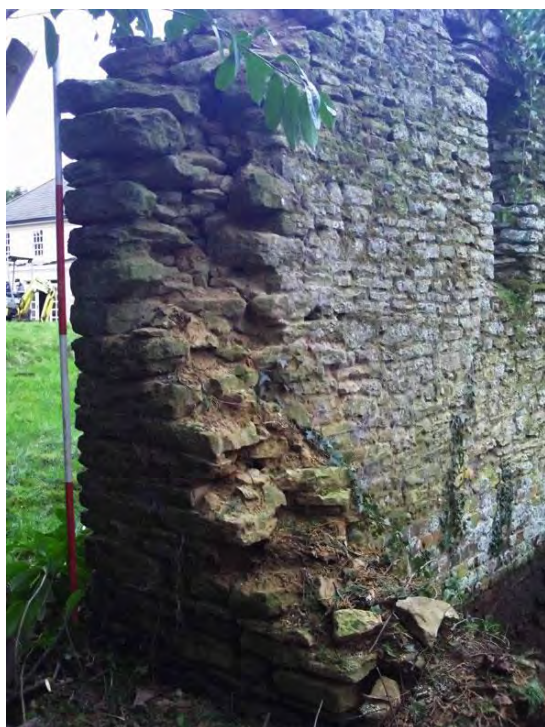
At the south end of the barn the remains of the south wall were noted, wall **13** (Plate 9). The wall joined wall **9** at its southern edge and it was at this point where it survived to its highest elevation at around 1.8m above ground. The wall survived above ground level for about 1.2m before continuing underground for approximately 5m (Plate 9).

Plate 9. Corner of Wall 13 and Wall 9. NW view

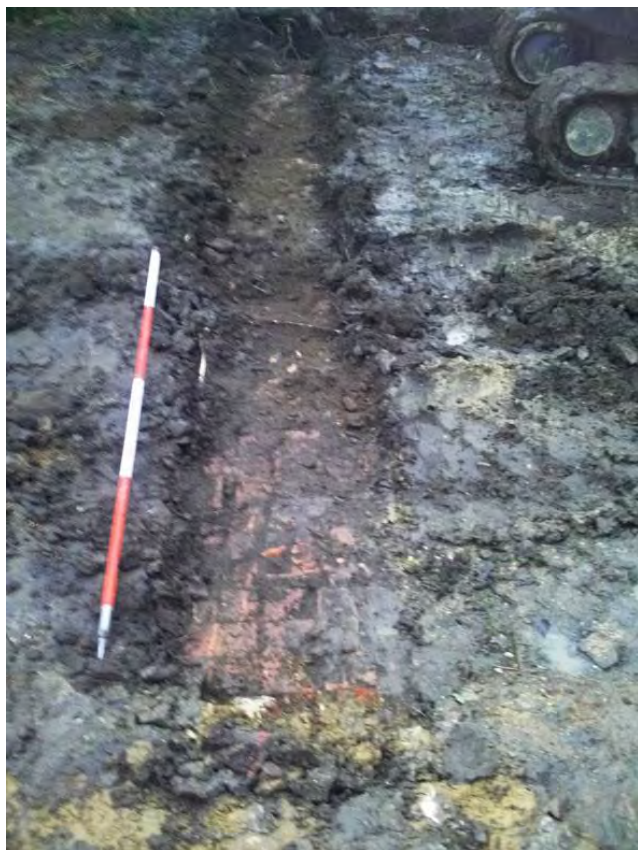
In the north foundation trench to the new build the fragmentary remains of a red brick floor were noted at the west and east ends of the foundation trench. It was made of a single layer of bricks that were imbedded into a layer of dark brown sandy soil (3) and overlain by a soil that was identical in appearance and texture (15). At the east end of the foundation trench the brick floor was identified extending for about two metres towards the west. At the west end of the foundation trench the brick floor extended 1m eastward (Plate 10) and could be identified extending 0.4 south. Towards the north end of the barn, the full extent of the remains of the floor was not revealed by excavation but it was clear that the floor was missing from the central area in the north foundation trench (Plate 10).

Plate 10. Remains of brick floor. View eastwards.
