**BUILDING RECORDING ON  
INTERIOR ALTERATIONS FOR  
ODDINGTON HOUSE, LOWER ODDINGTON  
AND RE-ASSESSMENT OF THE BUILDING PHASES  
OF THE HOUSE  
NGR SP 23326 25903**

*On behalf of  
Daylesford Estate*

**OCTOBER 2015**

# Oddington House

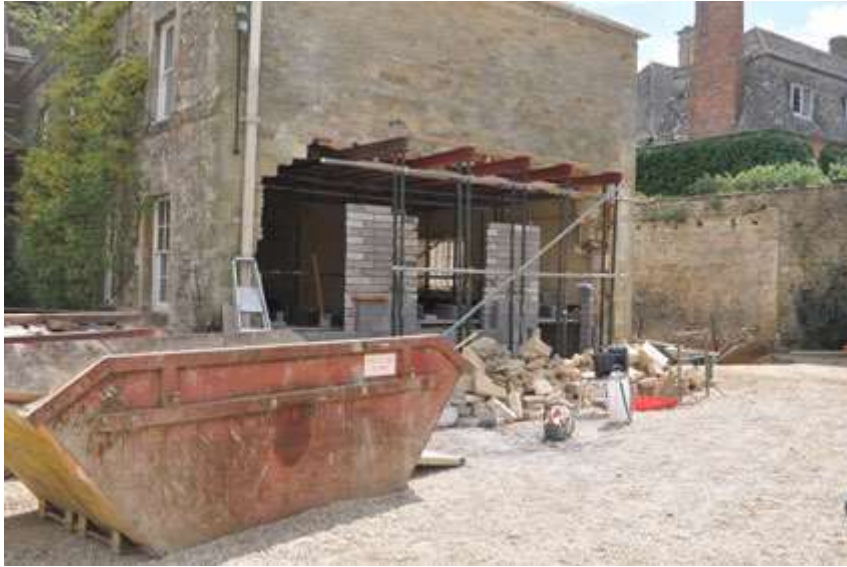
Plate 1: N end of N wing

Oddington House is a limestone structure with a slate roof (plans Figs. 3-6, elevations Figs. 7-8). The Main Range is a three storey structure with a cellar. The building consists of two other component parts called in textual sources the West Wing and North Wing. The West Wing is a two storey structure with a cellar. The North Wing is a two storey structure. Windows are being inserted through the rubble walls in a number of locations in the north and west walls of the north wing (plates 1-3).

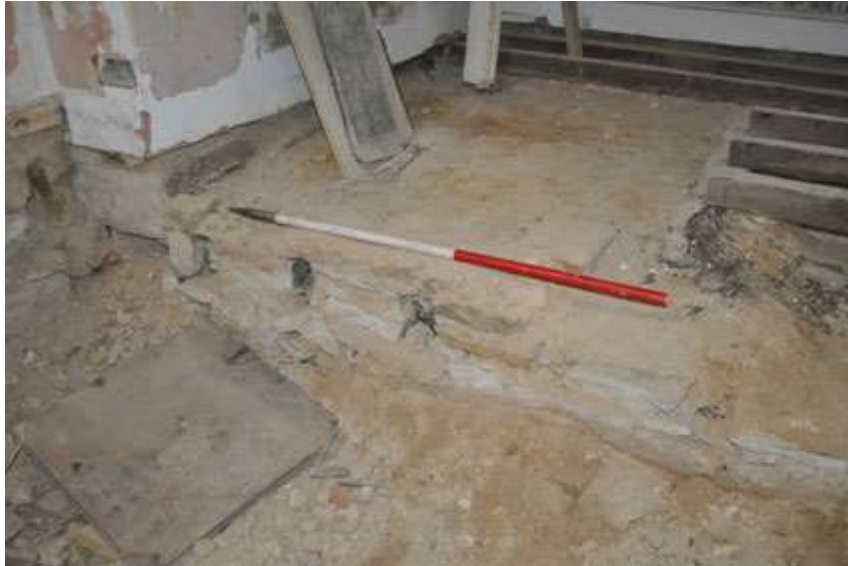
Plate 6: G14 / G15 surviving stone foundation

In rooms G15 and G14 it was apparent that the following observations could be made. The wall between them had been removed when seen and a stone foundation survived in its place (plate 6). There were the remains of timbers indicating an earlier floor suspended over soil layers. The end of the wall on the north side was constructed in brick. On the north side of room G14 there was a gully, which due to its angle may run in line with a former wall line. In the east wall of room G15 there was a butt joint with the quoins being located on the south side (Figs. 3, 9 E9; plate 7). In the southeast corner of room G15 it was apparent that there was a butt joint between the internal brick wall and outside east wall, which internally was also made of brick (plate 8). The butt joint is presumably associated with an earlier and larger doorway. There was also an indication of a timber

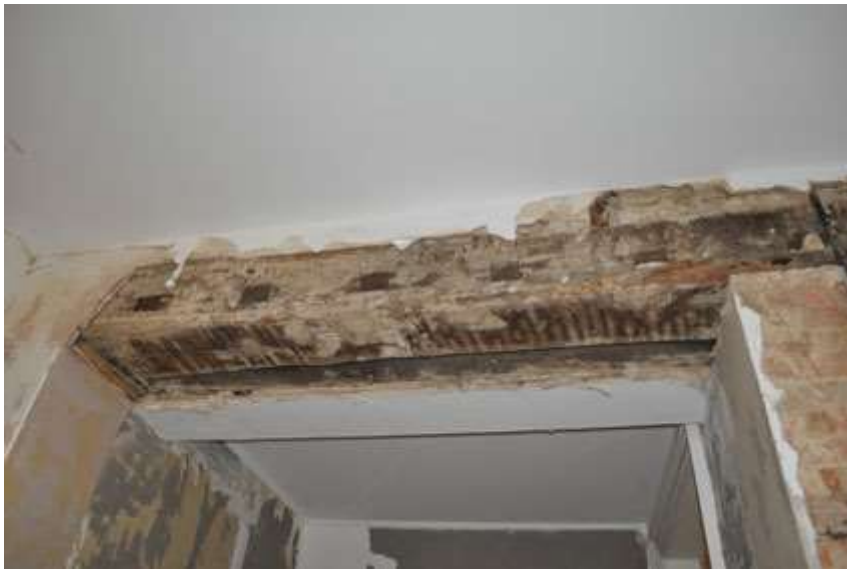
Plate 9: Timber beam supporting wall above G14 / G15

beam in the wall between rooms G14 / G15 which had cut beam supports for a possible earlier floor level (plate 9).

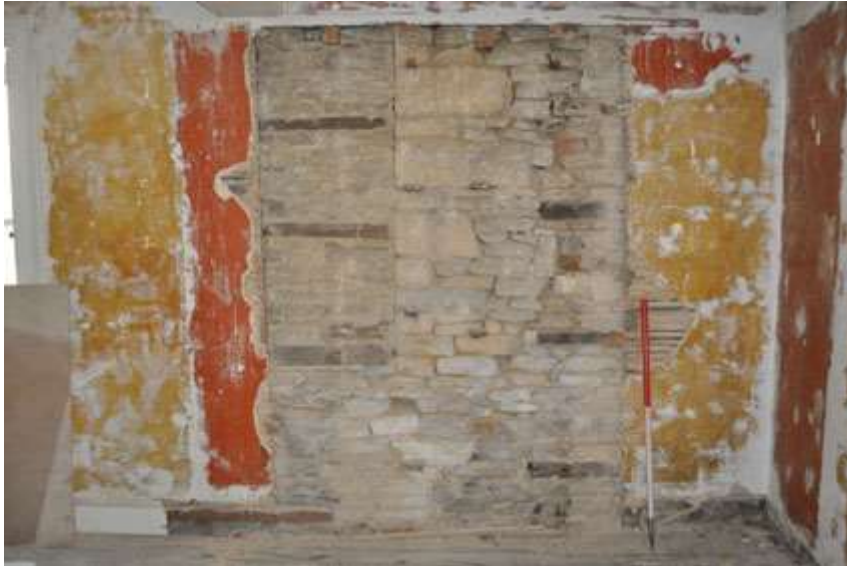
Plate 10: Remains of blocked window in N wall G13

In room G13, where a new window was to be inserted it is apparent that there was already the blocked remains of an earlier window (Figs. 3, 9 E5; plate 10). The window had no visible indication of dating, with tracery or splay. The location of this window means that the window alongside was a later insert.

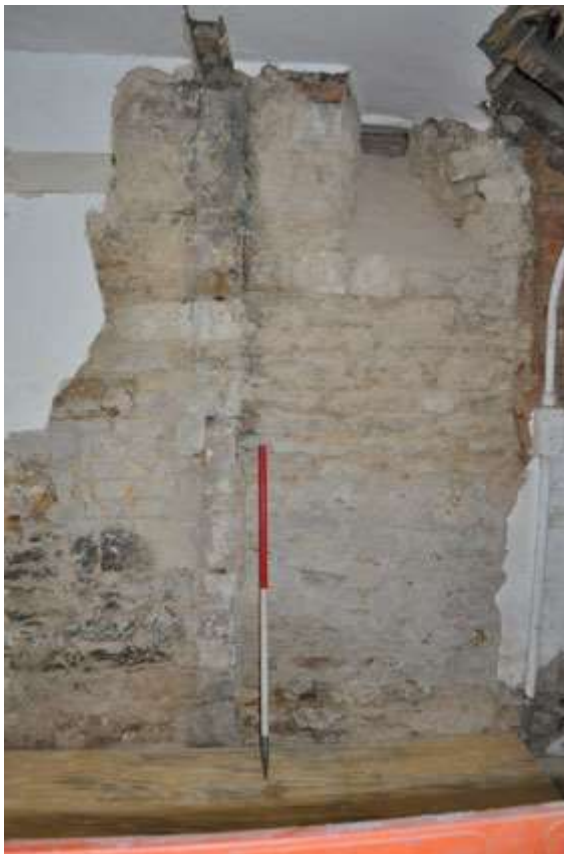
Plate 11: Wall with butt joint G8 / G9

The internal partition between room G8 and the stairwell to the basement G9 was removed as a further window was being inserted into the north façade. The stripping of this wall uncovered the remains of a butt joint with the quoins on the west side of the joint (Figs. 3, 9 E6; plate 11). It is possible that there was an earlier entrance here, perhaps an external entrance to the stairwell providing access to the cellar. The removal of the plaster also indicates that the window alongside was inserted. Plans drawn of the building indicate that the orientation of the north wall of the building, and possibly even the thickness of the

wall alter between this window and the neighbouring window in room G7. This may be significant and shall be discussed later.

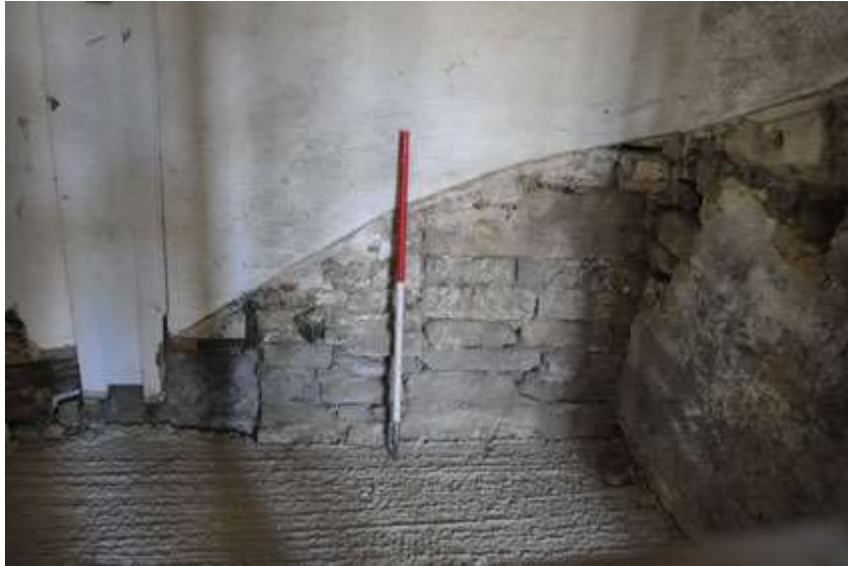
Plate 12: Butt joints G10

Stripping of the stairwell G10 revealed two butt joints (Figs. 3, 9 E8; plate 12). The one was located in the southwest angle, while the other was in the south wall. To the west of room G10 there is a large block of masonry, and one would expect that this originated as a further chimneybreast. The date at which it originated is a bit more obscure as most of its

orientation conforms to the 18<sup>th</sup> century development of the building, however the north wall conforms to the orientation of the front wall.

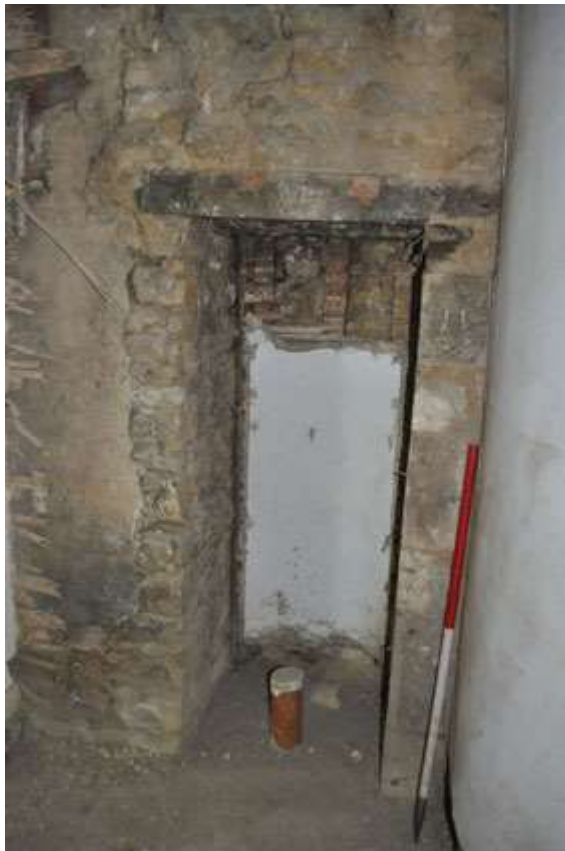
Plate 13: Alcove in room G5

In room G5 there is an alcove set into the masonry between G5 and G10 (Figs. 3, 9 E11; plate 13). The alcove has the appearance of a doorway with timber lintel, but this interpretation is far from assured in that the quoins on the right-hand side are nicely shaped whereas the other side is built of quoins roughly shaped.

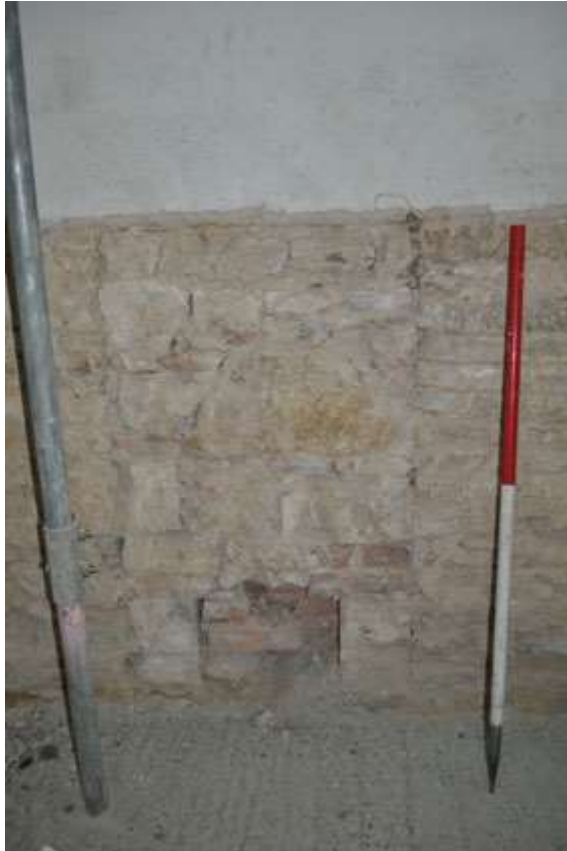
Plate 14: Blocked feature in S wall of G17

In corridor G17 there are indications of two butt joints in the south wall, which has been blocked (Figs. 3, 9 E10; plate 14). This room and room G18 form a splayed trapezoidal shape, and in the north wall of room G18 is the splayed doorway of the 17<sup>th</sup> century door, which Morriss (2012) interpreted as being *in situ*.

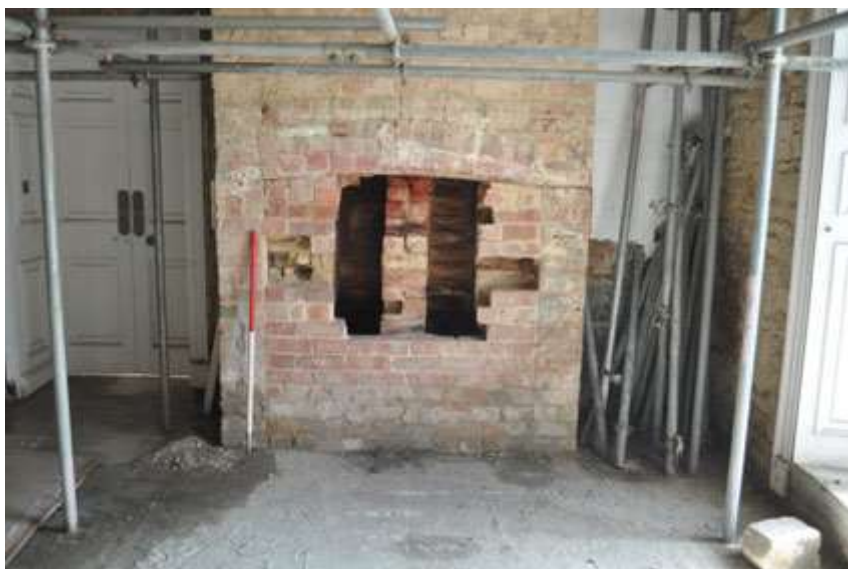
Plate 15: Fireplace and chimneybreast G3

would imply that the rubble wall and the rubble wall with internal brick wall originated as features of two different builds (plate 17). A door had been blocked in the northwest corner of room G4, which had previously provided internal access to the cellar (plate 16). The fireplace in rooms G3 was photographed and partially drawn (Figs. 3, 9 E12; plate 15).

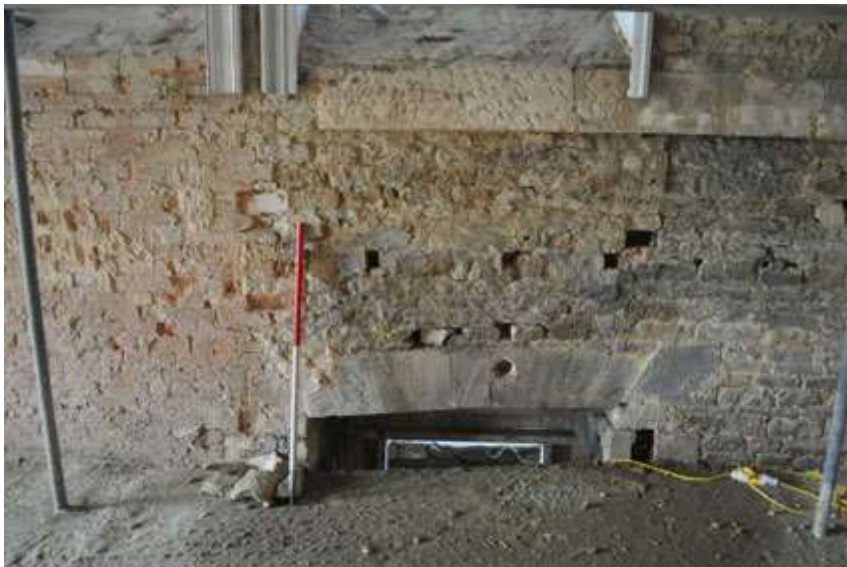
Plate 17: Butt in wall G4

Rooms G4 and G3 are along with G17 and G18 located in the west wing. Of note here is the difference in materials associated with the internal construction of the walls. This

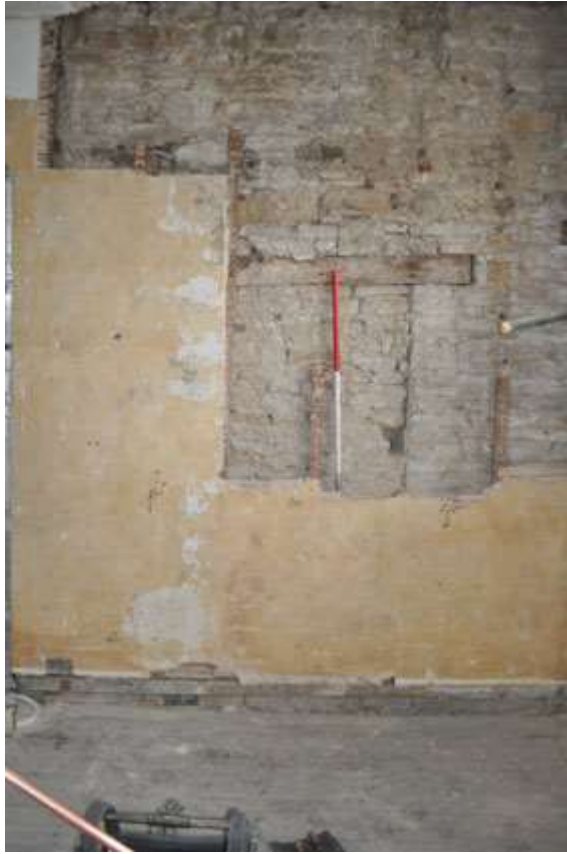
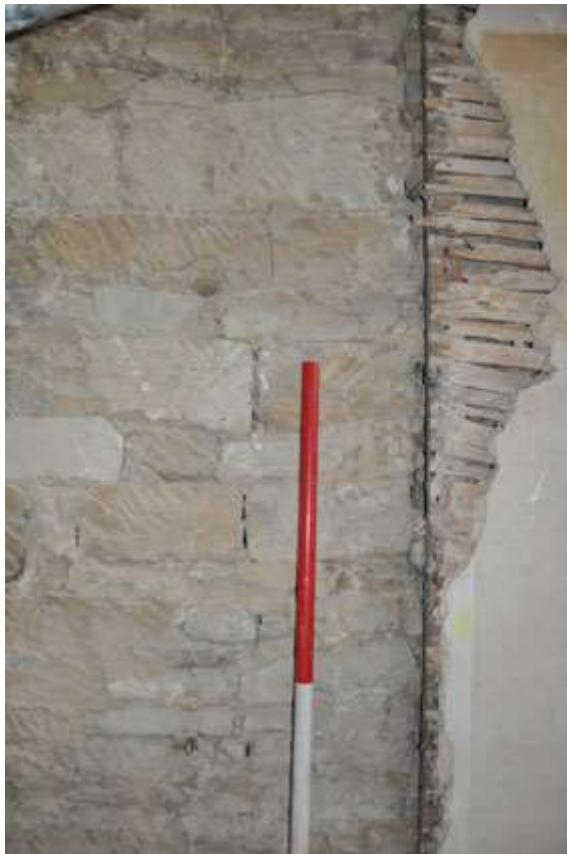
Observations on the first floor included those in room F5, where a blocked doorway was observed with a timber lintel (Figs. 4, 10 E15; plates 21-22). There was a further butt joint observed adjacent in the wall, which may also mean that there was a further door where the new southern development of the building was joined together possibly associated with the change in angle of the wall.

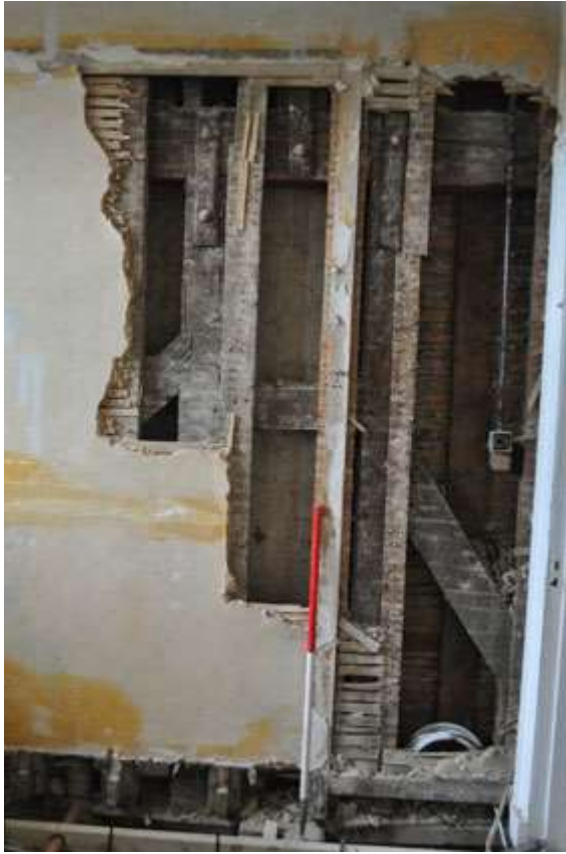
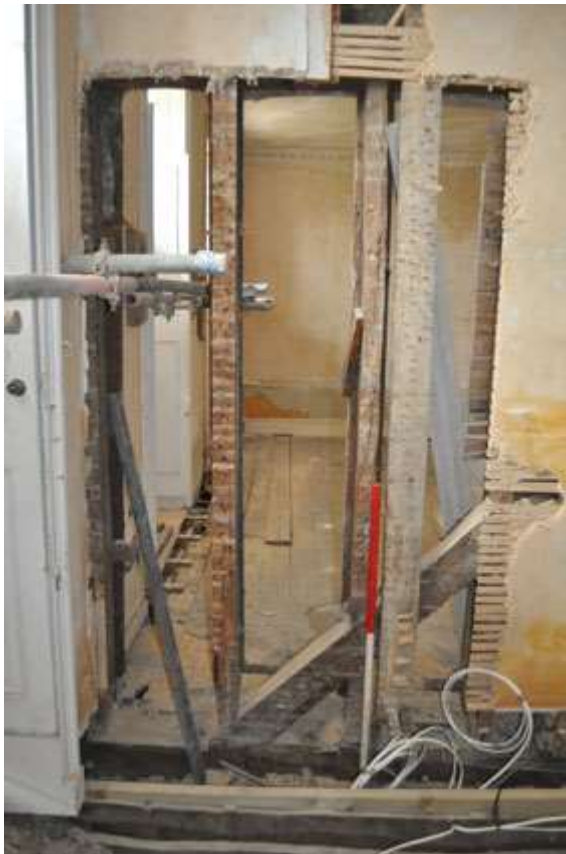
Between rooms F3 and F2 significant timber framing was observed of a traditional nature (Figs. 4, 10 E17; plates 23-24); however, the timbers were clamped together with bolts rather than dowels. This must imply that although this is traditional it is of a probable 18<sup>th</sup> century date.

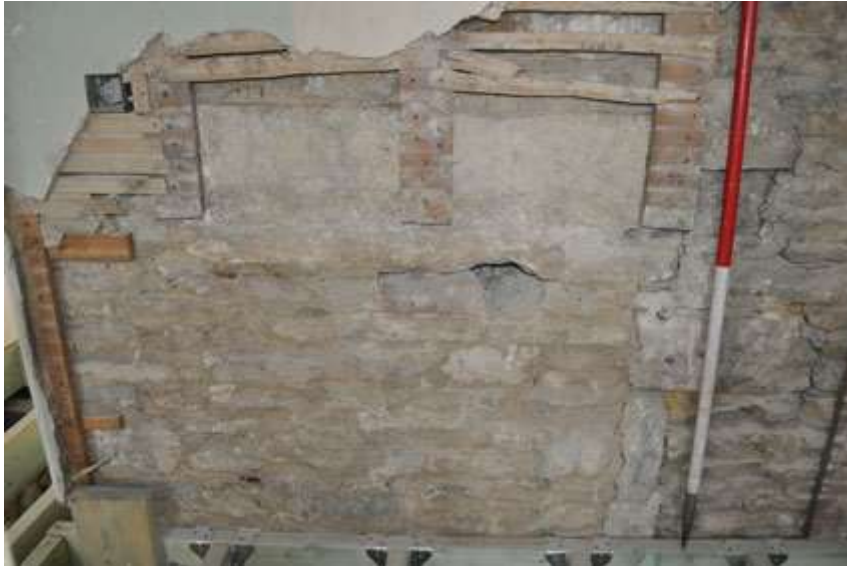
Plate 25: Blocked up fireplace

Rooms F10 and F11 contained the remains of a blocked fireplace in the south wall (Figs. 4, 10 E16; plate 25). The east support for the lintel had been removed as the walls were reworked at a later date. The lintel was originally constructed of a single stone.

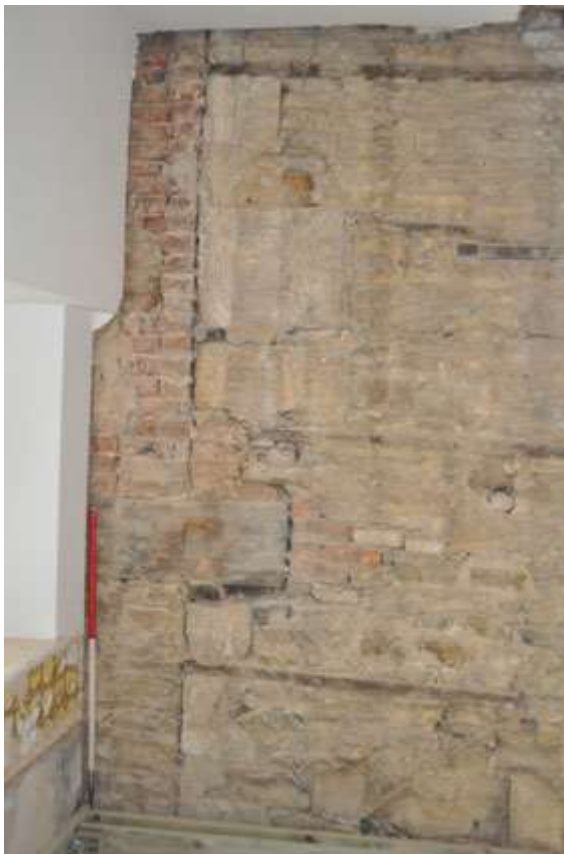
Plate 26: Butt joint in E wall F13

In room F13 there was a butt joint in the east wall (Figs. 4, 10 E18; plate 26), which was a continuation of the feature identified in room G15. The quoins were on the south side and there was a large timber employed to bond the two walls together.

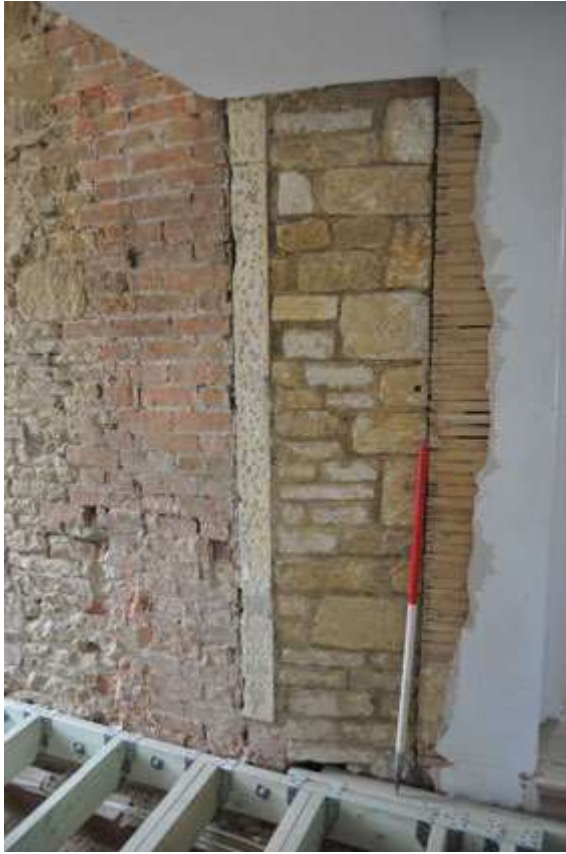
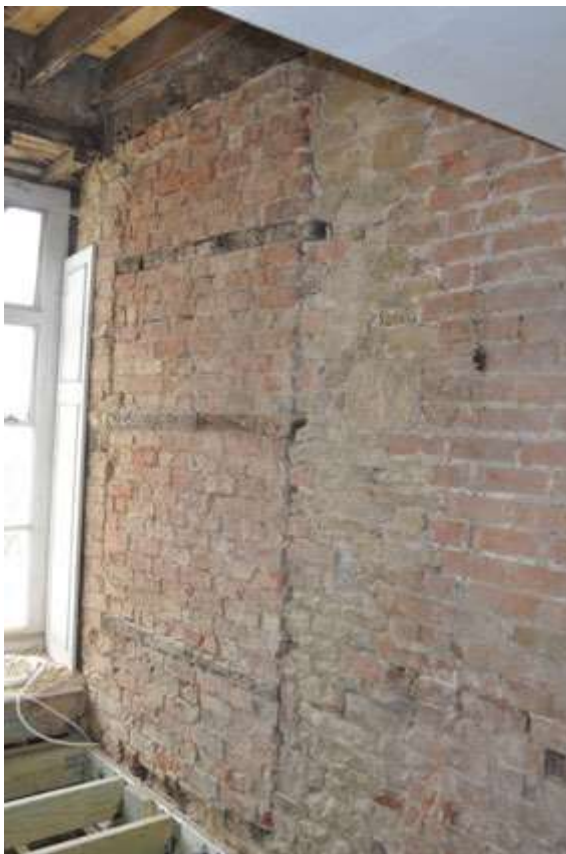
In room F14 the following details were visible (plates 27-28). There was the end of a stone wall, which had probably been truncated. Alongside it was a butt joint with a brick wall,

then part of a stone wall, before there was a large blocked doorway. The doorway had timber tie beams across it.

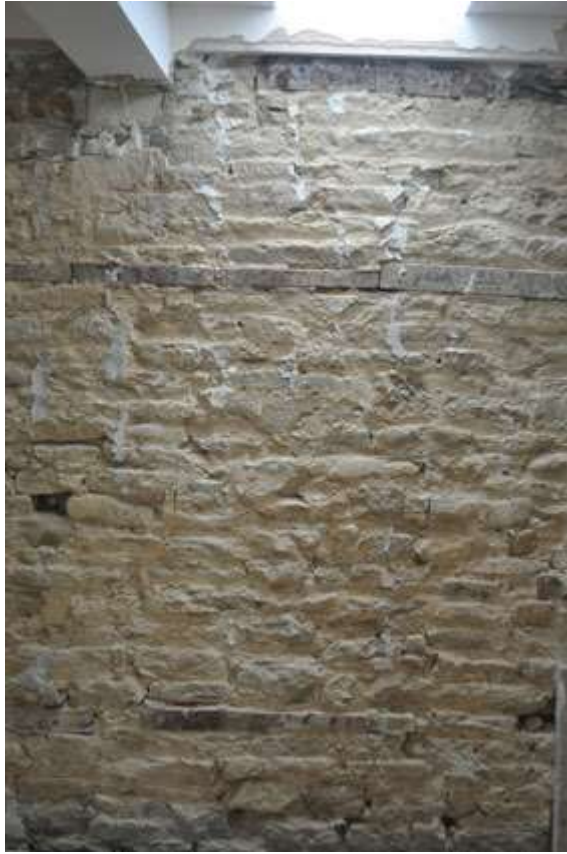
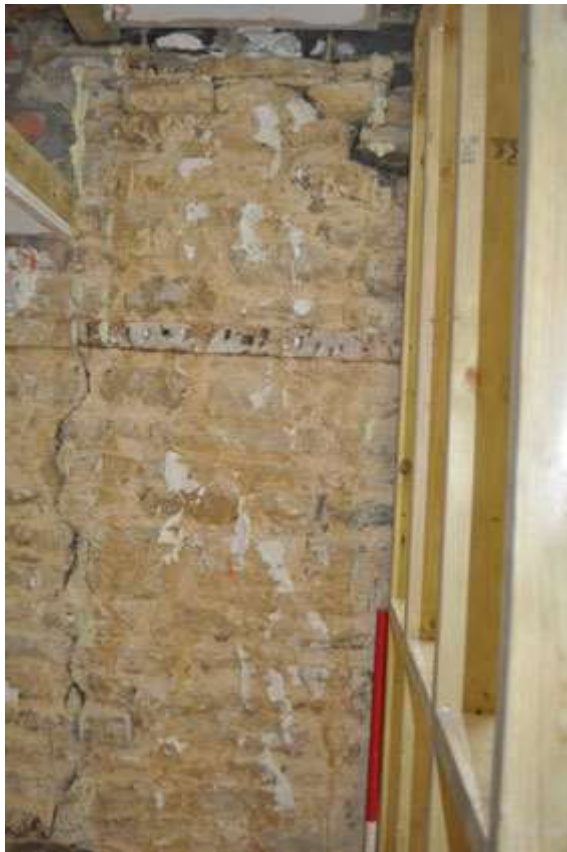
The walls were stripped on the west side of rooms F18, F19, F20, and F21, as two windows were to be inserted in these walls (Figs. 4, 11 E20 & E21; plates 29-30). The wall was constructed of limestone rubble with no physical joints.

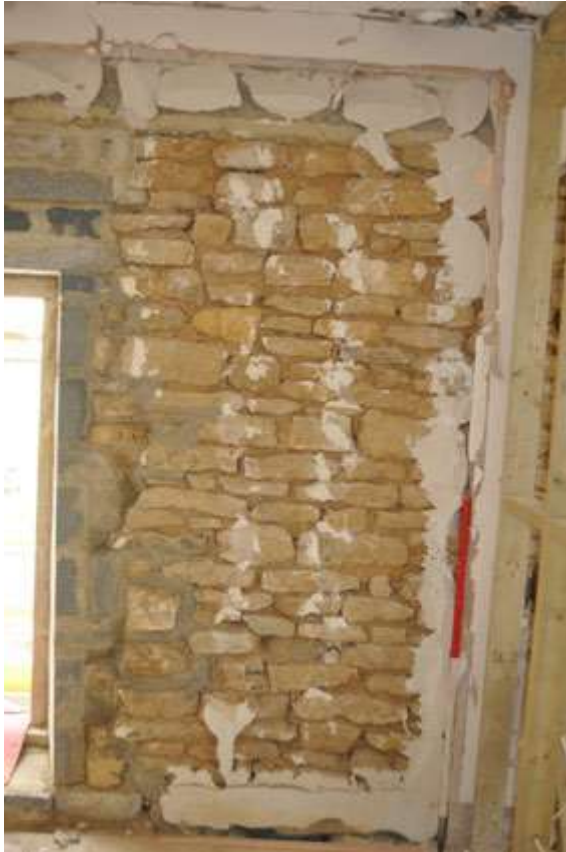
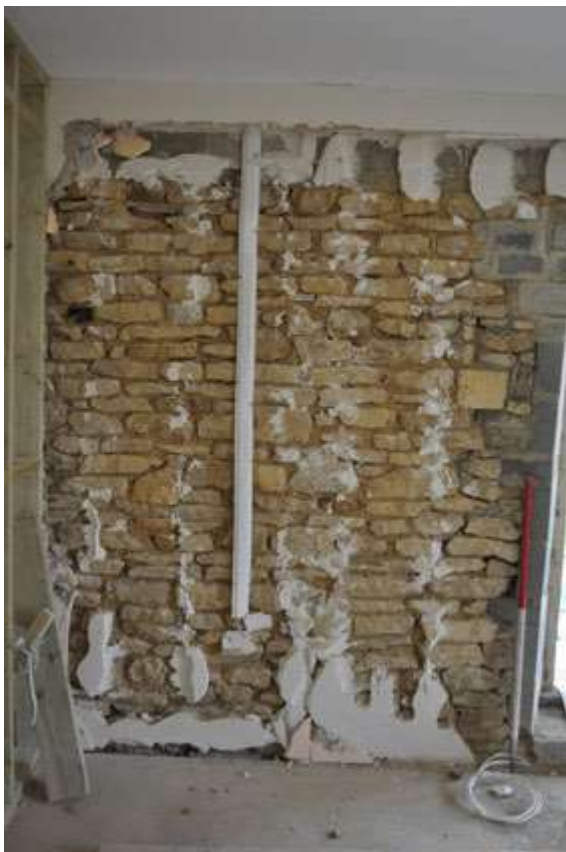
The north wall of room F23 was also stripped (Figs. 4, 10 E19; plates 31-32), but this was not observed before the new window surrounds were inserted.

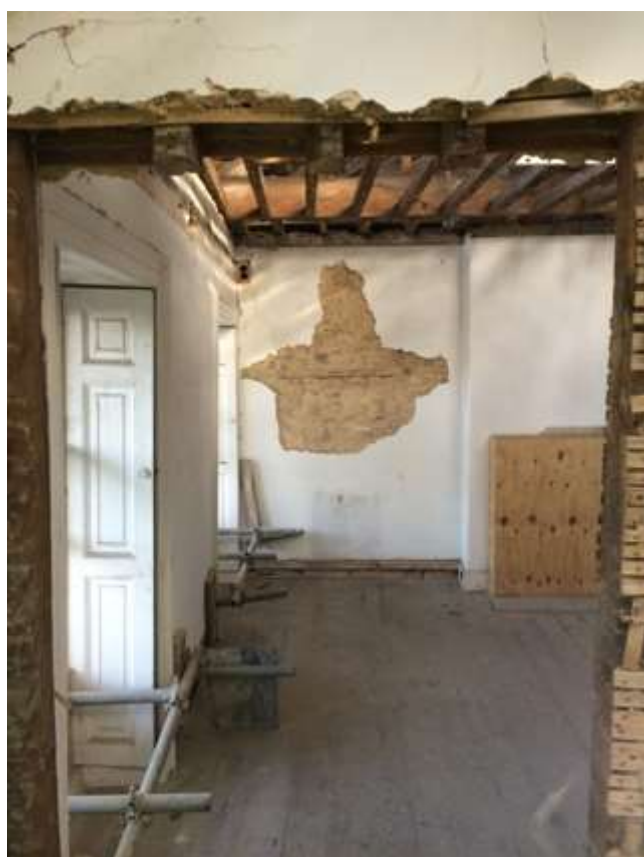
Plate 33: Wall S4

A doorway was to be inserted between the rooms S4 and S5 of the main range (Figs. 5, 11 E22; plate 33). The opening was made before John Moore Heritage Services were notified. An attempt has been made to redraw the walls from photographs taken from the contractor. No construction joints were evident from the photographs or from the architect's inspection. This wall is one of the early rubble walls. A piece of timber approximately 1.5m above the second floor level was noted. This timber was a binder for the wall construction.

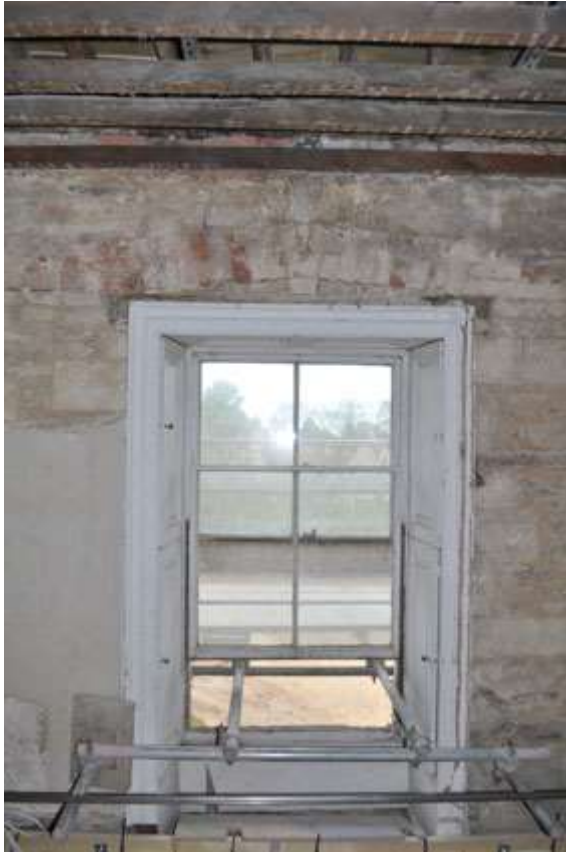
Plate 34: Window *in situ* with brick arch S6

Stone segmental arches were observed over the two windows in the north wall of room S6 (plate 34). This implies that the third storey of the north part of the main range is a later addition to that of the south range. The window in the east wall of room S7 was a later insertion (plate 35).

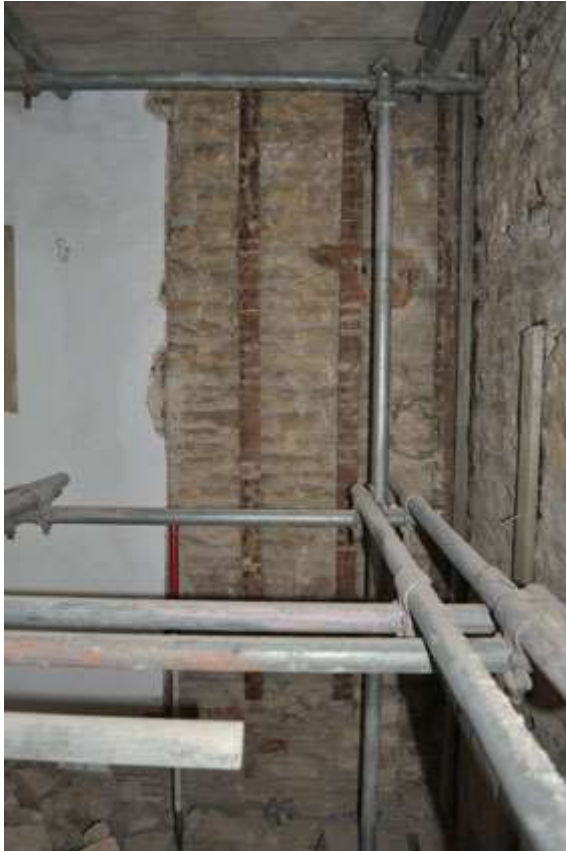
Plate 36: Rubble N wall S8

The rubble N wall of room S8 was recorded where a window was to be inserted (plate 36). In the east wall there is evidence of a butt joint (plate 37). This butt joint appears to indicate that the earlier south part of the main range was a structure of two and a half storeys and that as no real indications of a gable survive that the structure had always been hipped or that the gable was removed or partially removed to bond the wall above.

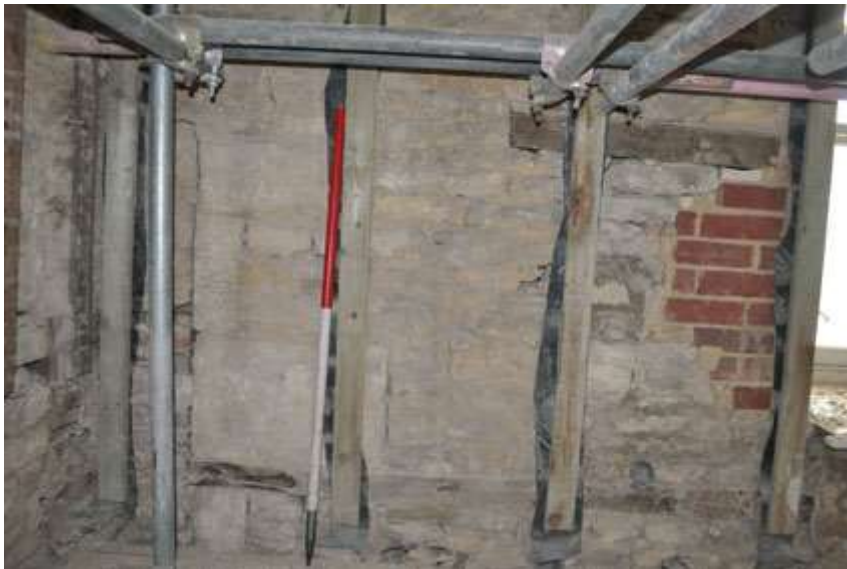
Plate 37: Butt joint in E wall of S8

A number of features were observed in room S8 which included the continuation of the butt joint in the east wall from rooms F13 and G13 below (Figs. 5, 11 E24). The butt joint finished a metre or so above the floor level, thus implying that the earlier 18<sup>th</sup> century

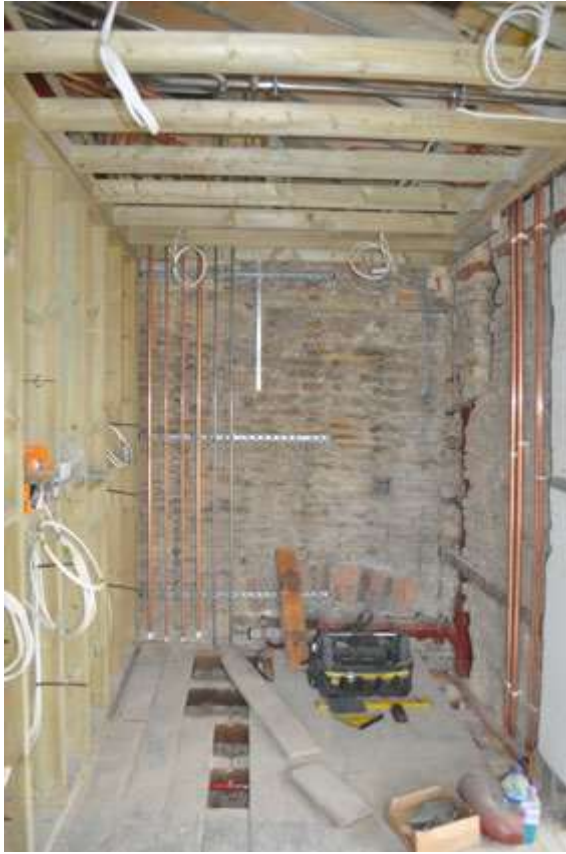
Plate 38: Segmental arch in N wall of S9

Room S9 contains a segmental arch in the north wall, which is probably associated with the larger doors below (plate 38).

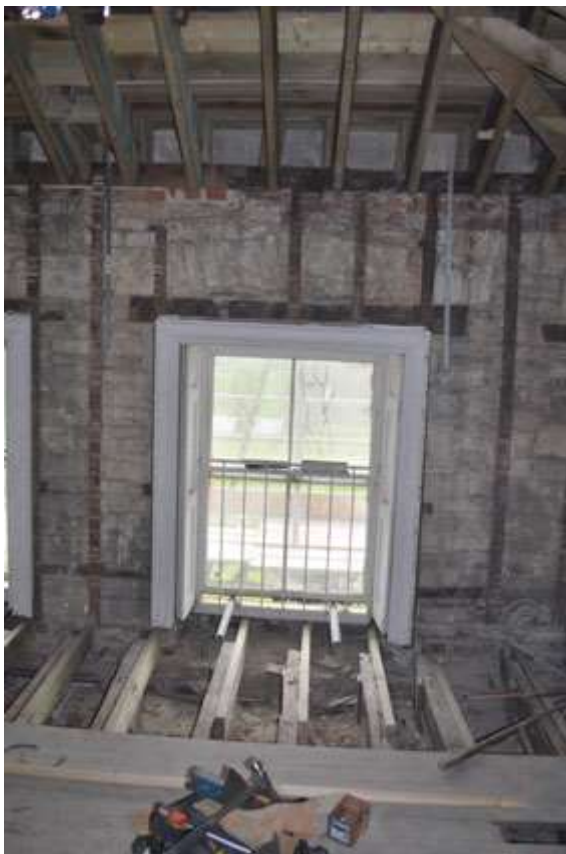
Plate 39: Window S11

Stripping of plaster in room S11 revealed that the second storey sash windows had timber lintels and a limestone segmental arch (plate 39). This construction is different to that on the second floor of the north part of the main range and may indicate that the two parts originate as elements of a different phase of building. There were no clear indications that these windows had been inserted. The wall that was located between rooms S11 and S12 was a timber framed structure with indications of traditional design (plate 40).

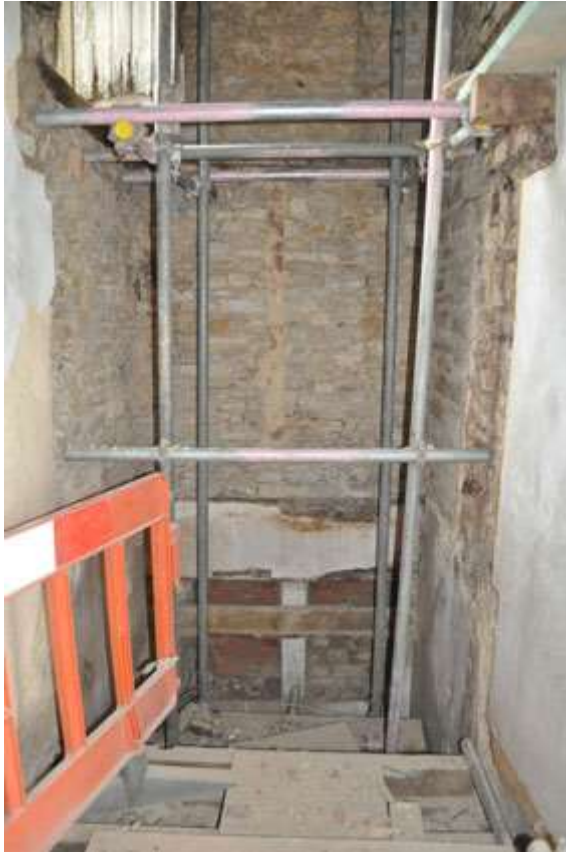
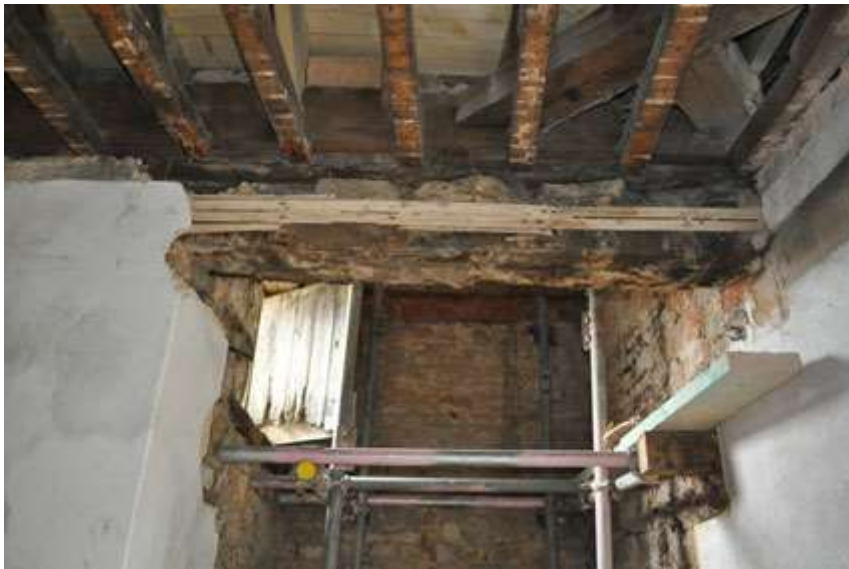
A final point to note concerns room S3 in the northwest corner of the second floor. Here it was apparent that the tower like structure had no wall blocking it from the room (plates 43-44). This was not recognisably the case at lower levels and thus it can be assumed that the tower was created when the second storey was created on the north side of the building.

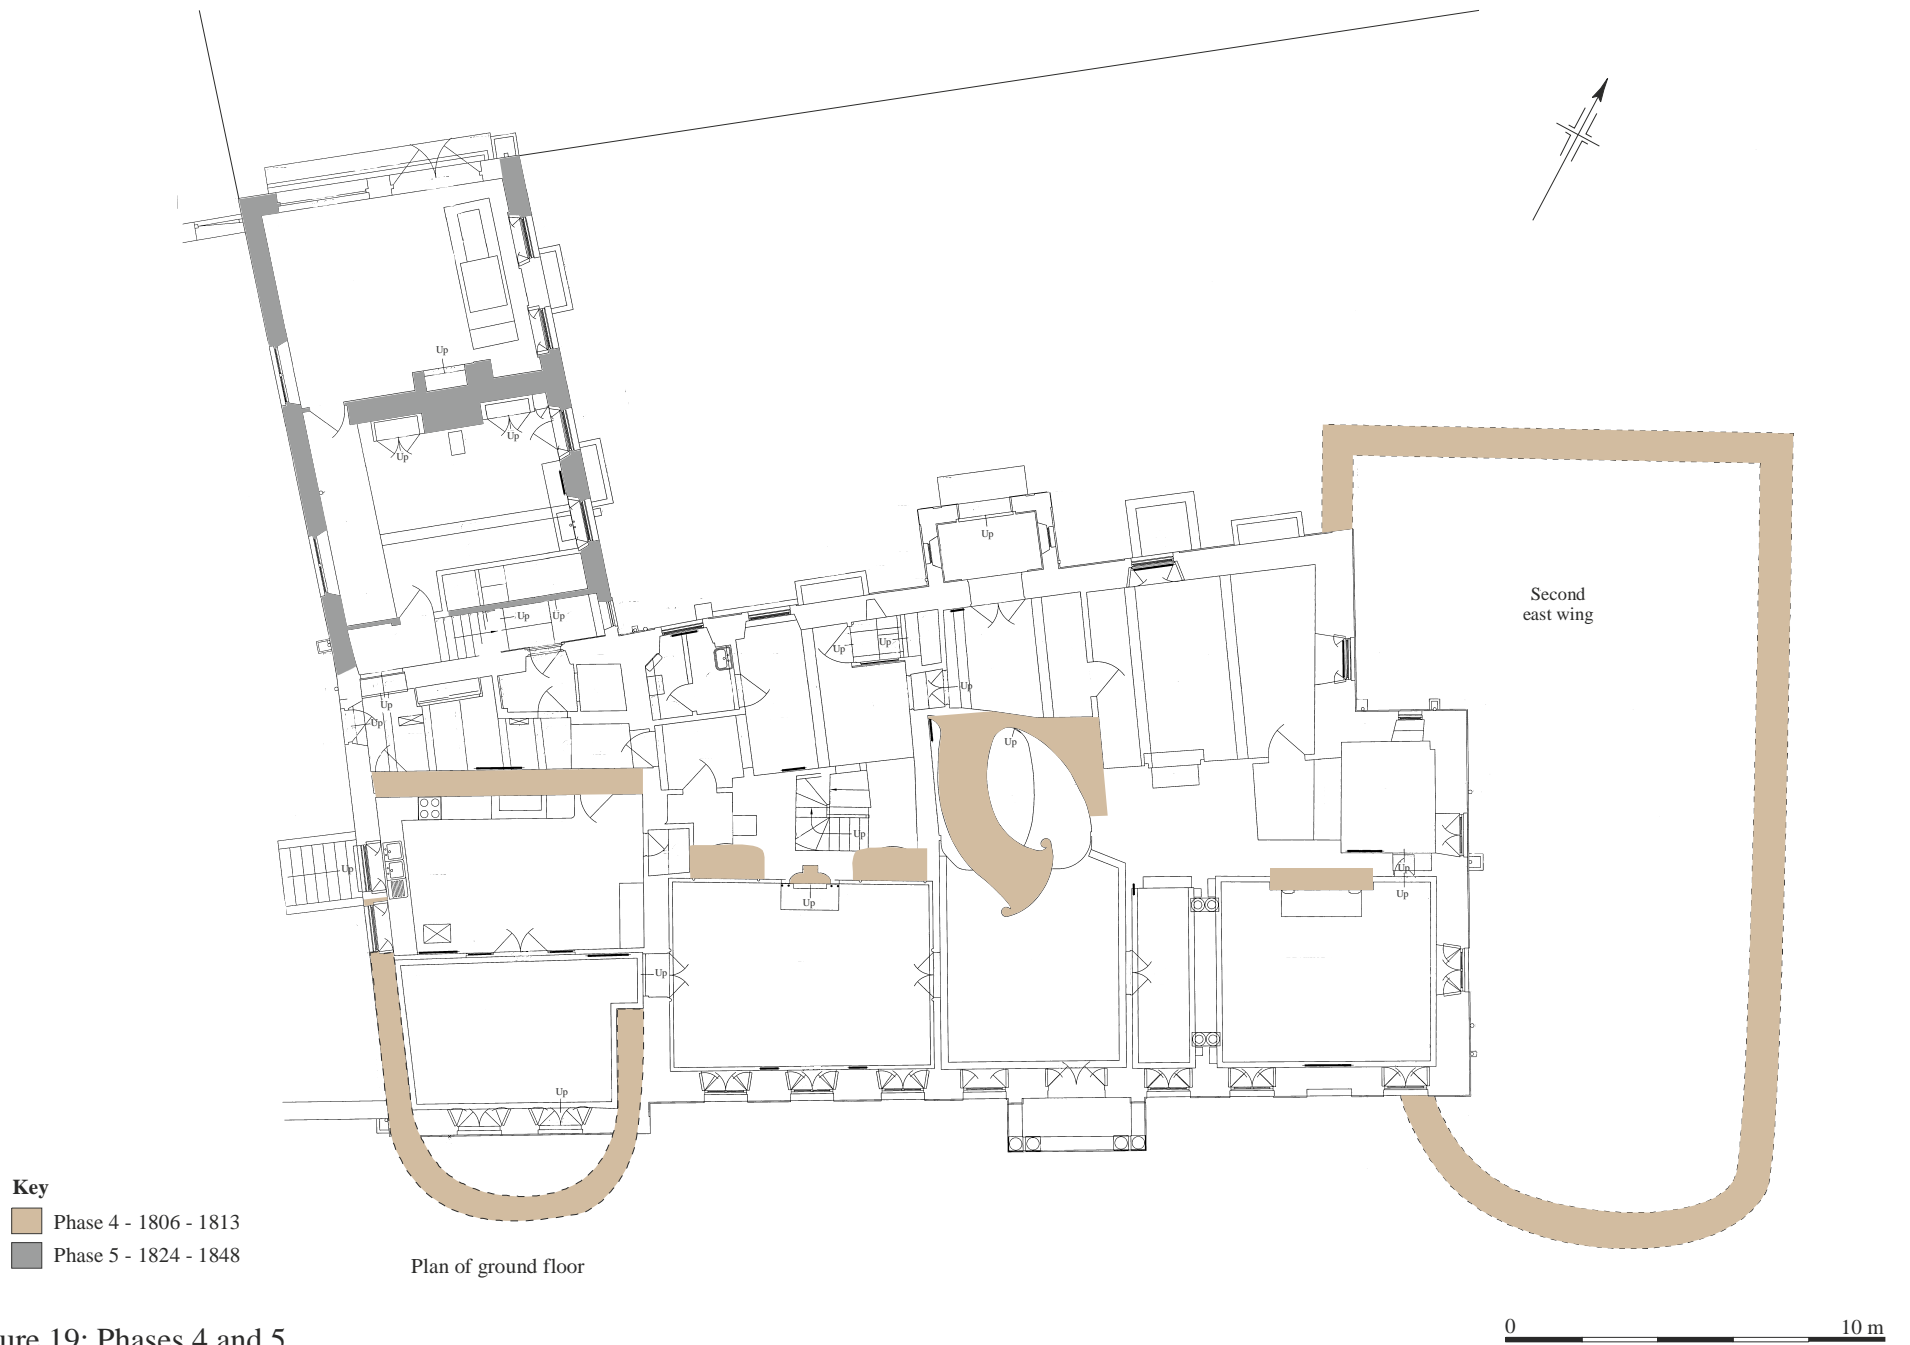
Morriss (2012) assumed that the service court to the north of the house was fully developed with buildings linking together, which included the north wing and a structure on the north side of the courtyard that linked this to the stable block. The Inclosure Map of 1787 shows no sign of these buildings as existing, and neither does the Bryant map of 1824. The map of 1787 does plot the course of the north and west walls of these structures, but we have no reason to consider that these are anything other than boundary walls, the line of which the later structures followed. It is thus safe to assume that the north wing, the stable block and the building that linked to both and lay on the north side of the courtyard were constructed at a date from 1824 to 1848, as they occur on the sale catalogue plan of the latter date. These structures are thus considered to be phase 5 of the Oddington House development (Figs. 19-20).
