HERITAGE (BUILDING) IMPACT ASSESSMENT

AND JUSTIFICATION

SCHOOL COTTAGE, LONDON END,

PRIORS HARDWICK, WARWICKSHIRE

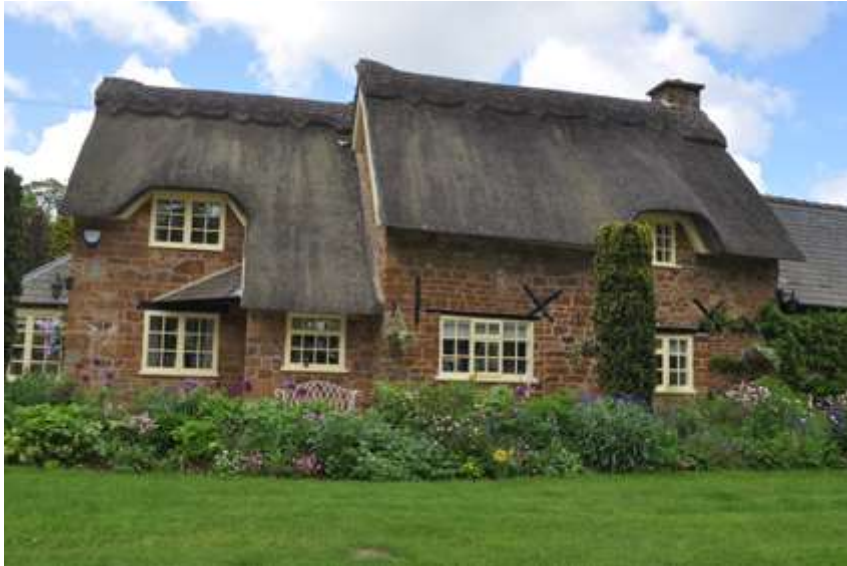
Plate 1: Front façade

The front façade of the building consists of five bays, all containing wooden framed windows that appear to be replacement windows (plate 1). All but the second bay ground floor window has a timber lintel. The first bay and fourth bay of the façade have a ground floor window and first floor window, with central mullion. The first floor windows have an eyebrow dormer. The second bay, which is part of the porch, has only a ground floor window, with extended thatch roof. The third and fifth bay consists of a single ground floor window, of which the first has two mullions. On the west side of both the third and fourth bay ground floor windows is a metal X-shape attachment used to identify movement in the wall. The building has a staggered wall line with the third and fourth bay in the fore, then the second and fifth bay set back, and the first bay set back from the second bay. There is a conservatory on the east end.

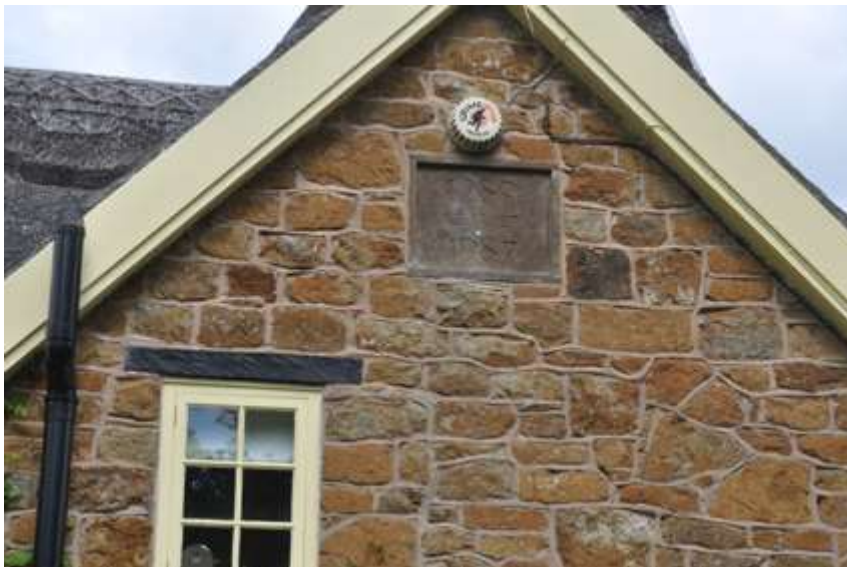
Plate 2: Plaque with dates

The main east elevation contains three parts with the south one set well back and consisting of the kitchen door into the garden. The central part is the main east gable end and consists of a ground floor bay window / conservatory with a pitched slate roof and a small off-set first floor window. In the apex of the roof is a stone plaque reading “1289 RE-BUILT 1987” (plate 2). The north part of the elevation is set back from the gable end and contains the front door within the porch in a lean-to structure. In the courtyard, in the central part of the ‘U’, there is a further east facing wall which is of stone, and extends only slightly beyond the northern part of the main east façade.

Phase 3 consists of the further extensions on the building. The extensions are all dated to after 1939 as they are not depicted on the latest Ordnance Survey map examined. The plaque on the east wall indicates a rebuild in 1987; however, the pro-map does not show these extensions perhaps indicating that they are even later. The extensions consist of the

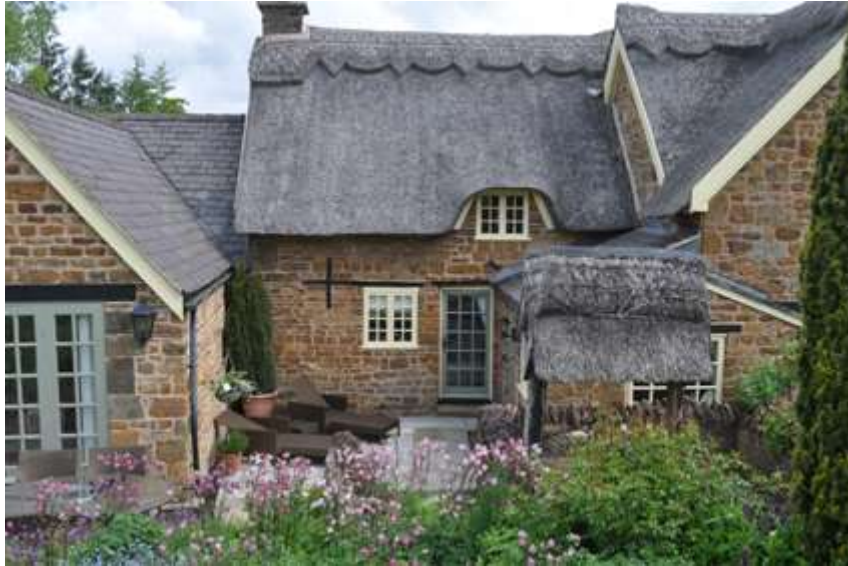
Plate 3: Courtyard at rear

The rear elevation is in four parts with two gable ends, one lateral wall, and a bay or conservatory at the east end. The central part of the structure is of two and a half storeys, being the lateral wall of a rectangular component (plate 3). On the ground floor there is a glass panel door and a single mullion, both with timber lintels. On the first floor is a single mullioned window with an eyelid dormer. To the west of the second bay is a metal cross feature, similar to the features on the front façade. To the east is a one and a half storey

gable end, with a lean-to structure on the side. On the ground floor there are two windows, and a single window on the first floor. The gable end to the west of the rear elevation contains patio doors.

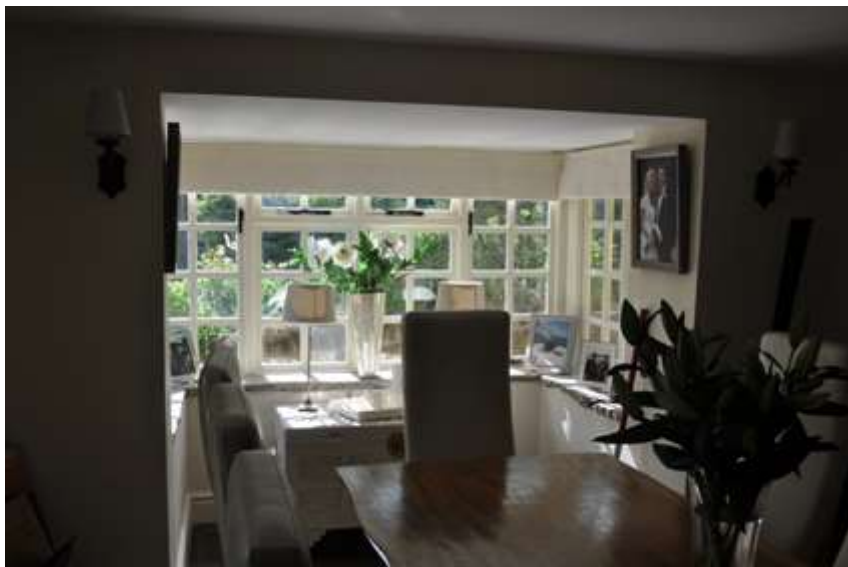
Plate 4: Dining room

The dining room (G2) is rectangular with two windows, the first is a small window in the north wall and the second a bay window / conservatory in the east wall (plate 4). There is a ceiling beam running from the north to south which continues in to the kitchen (G3). The doorway to the kitchen is in the south wall. The adjoining wall between the dining room and the kitchen is 0.14m thick.

The current proposal is for the removal of the adjoining wall between the dining room (G2) and kitchen (G3) and the placing of a single pillar and lintel to support the *in-situ* chamfered timber beams (Fig. 3).

The proposed alterations are likely to have a limited impact on the structure. The material that the wall is made of is not known, although the width of the wall 0.14m would indicate that it is not of stone, but probably a single wall of brick. The rest of the building shows no indication of the structure containing timber framing and it is probably the case with the rebuilds of 1987 that none exists here.

The wall is only load bearing in that it supports the ceiling beams, and a stud wall above running adjacent to it, there is no wall directly above in the bedroom (F2). There will be an effect on the historical space of the cottage, but this has already been altered with further alterations to the structure. The east rectangle has no chimney and consideration has to be given as to whether it was a cattle byre or similar.

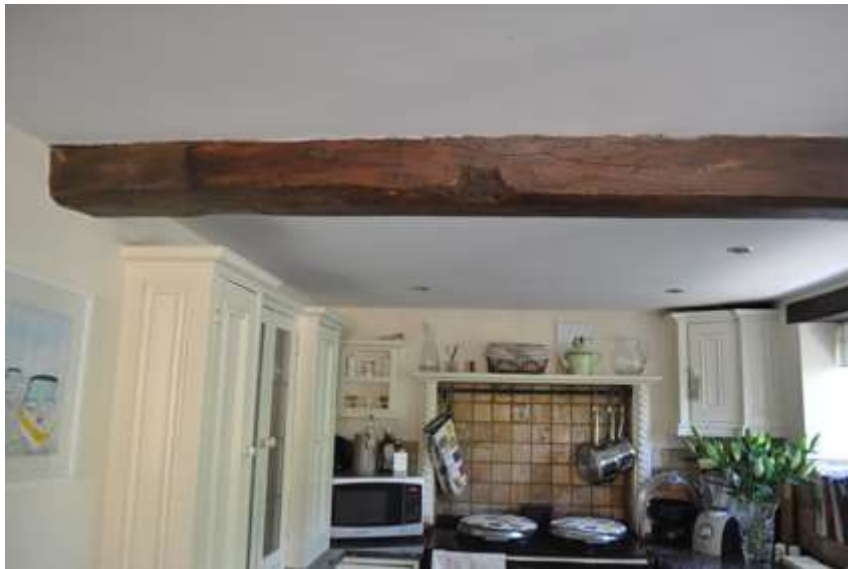
Plate 5: Ceiling beam in kitchen

The kitchen (G3) is an L-shaped room which is of a modern design with a timber ceiling beam running north to south (plate 5). This is a continuation or in line with the ceiling beam in the dining room (G2) and has a predominant notch in the middle on the west side of the beam. Another beam is presumably a steel joist supporting a stone wall above. The south wall is staggered, with the east part further north than the west end. There are 2 windows in the east part and one in the west end. There is a fourth window and external door in the west wall. There is an additional external door in the south part of the east wall.

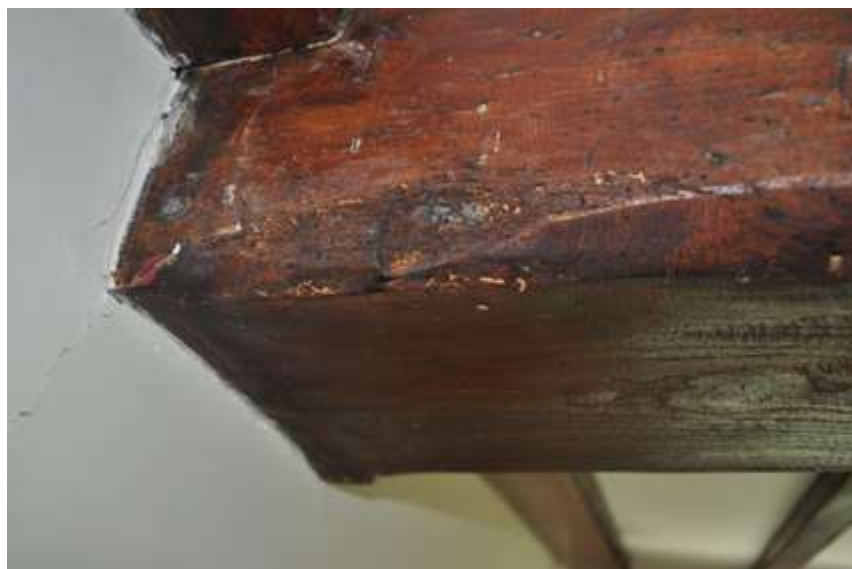
Plate 7: Chamfered ceiling beam, west end

The west door from the porch (G1) leads into the living room (G4), which is rectangular in shape, with a small west spur (G5). The north wall has 2 windows with a butt of a former wall between and the south wall has an external door and window. All the windows have seating beneath. In the southeast corner is a dog-leg stair case leading to the first floor which has a timber post in the internal corner of the staircase (plate 6). The west wall has a large fireplace with a wooden lintel, with opening alongside to G5. There is a main ceiling beam running east to west with chamfer and stops and joists running north to south. At the west end of the ceiling beam there are two stops and addition slots in the centre of the beam (plate 7).

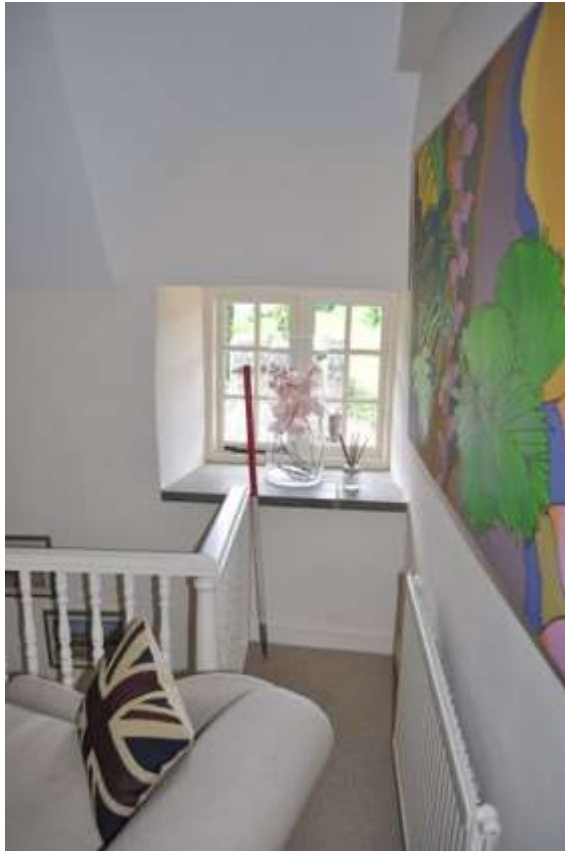
Plate 8: Window in first floor hallway

The first floor is accessed via the stairs in the living room (G4). The landing (F1a) is T-shaped with a window in the south wall (plate 8) and doors in the west and north walls. The east part of the hallway (F1b) is accessed through an archway with two low steps (plate 9) and leads into the bedroom 1 (F2) through a door on the south side.

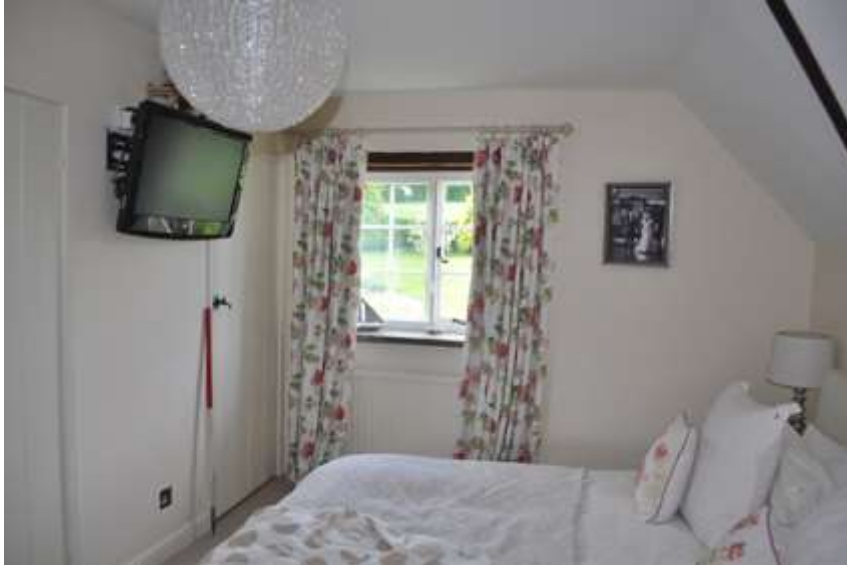
Plate 10: Window in south wall of bedroom 1

Bedroom 1 (F2) has a single window in the north and south walls (plate 10). The south part of the east wall is a studded wall and overlies the adjoining wall of the dining room (G2) and the kitchen (G3). Within the studded wall there are 2 panel doors, the north door leads into an en-suite (F3) and the south door leads into a cupboard. The en-suite (F3) is of modern design with a window in the east wall (plate 11).

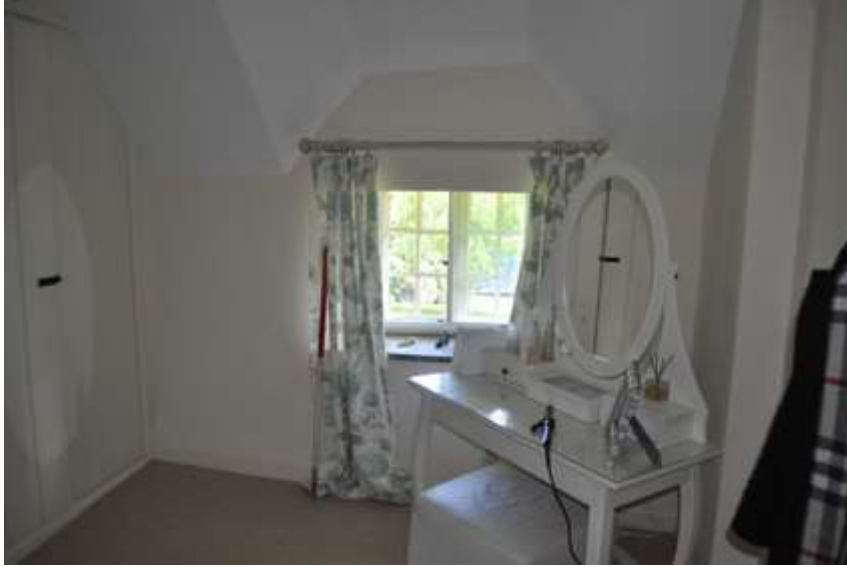
Plate 12: Window in north wall of bedroom 2

The door on the west side leads into bedroom 2 (F5) which has a single window in the north wall (plate 12) and an alcove in the west wall (plate 13). There are built-in wardrobes in the north-west corner with panel doors and the main door into the room is also a panel door (plate 14).
