**ARCHAEOLOGICAL WATCHING BRIEF**  
**AT**  
**BICESTER COMMUNITY HOSPITAL,**  
**KINGS END, BICESTER, OXFORDSHIRE OX26 6DU**

**NGR SP 579 223**

**APRIL 2016**

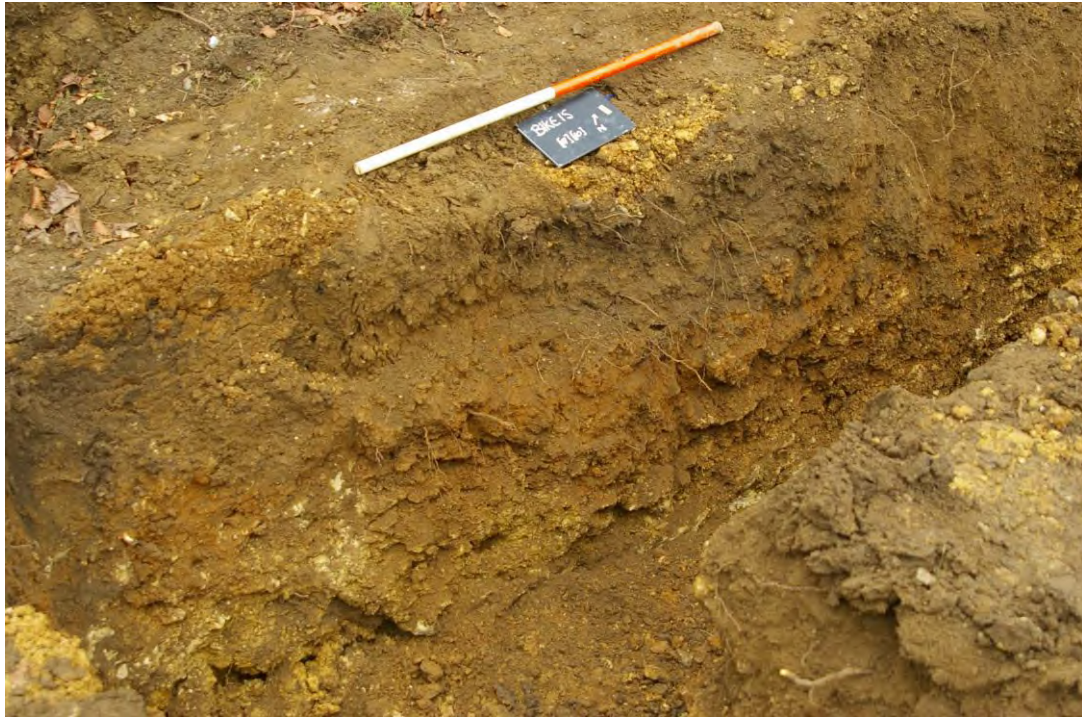
Plate 1. Ditches 7 and 10 looking northwest

Ditch 07 (Plate 1) was orientated northwest / southeast, 0.85m wide, 2m long and 0.3m deep with moderately sloping sides and a concave base. It contained a single fill of a reddish brown silty clay (08) that was devoid of artefacts.

Ditch 10 (Plate 1) was orientated northeast / southwest, 1.9m wide, 0.8m long and 0.6m deep with moderately sloping sides and a flat base. It contained a single fill of a reddish brown silty clay (11) that was devoid of artefacts.

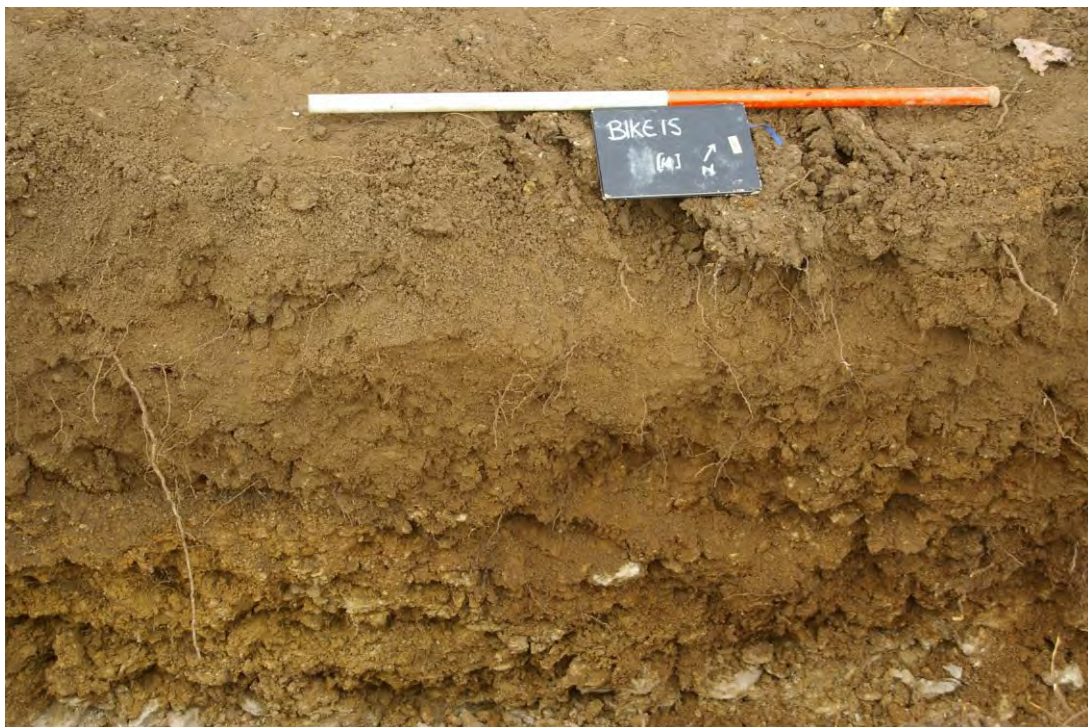
Plate 2. Ditch 14 looking northwest

Ditch 14 (Plate 2) was orientated northeast / southwest, 1.8m wide, 0.8m long and 0.6m deep with moderately sloping sides and a flat base. It contained a single fill of a reddish brown silty clay (15) that was devoid of artefacts. This ditch was the same as ditch 10 situated c.9m away to the west-northwest.
