JOHN MOORE HERITAGE SERVICES

**ARCHAEOLOGICAL EVALUATION AND
WATCHING BRIEF**

**THE MALT BARN, 96 CHURCH WAY,
IFFLEY, OXFORD**

MARCH 2016

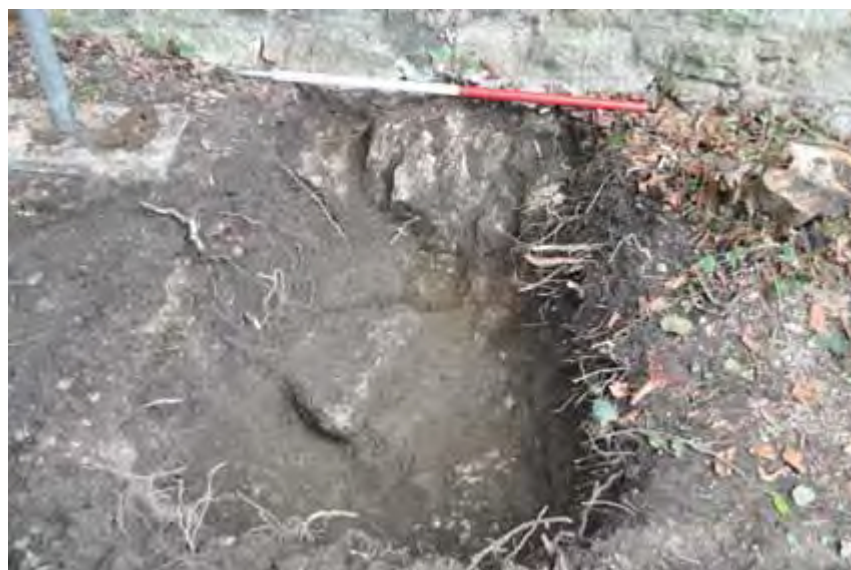
Plate 1: Wall 3 and buttress foundation 4

In TP1 the remains of two stones 4, were set over the top of the lower layer of limestone cobbling (6). Context 4 extended out from the building some 0.6m and survived to a depth of 0.13m (Fig. 6 S.2). The feature would appear to be the possible remains of a buttress that was constructed against the earlier rubble wall 2. Though there is the possibility that the foundation of this buttress was placed in a cut through the upper cobbled layer (5), this is inconclusive. Layer (5) was a compact dark grey green sand clay with charcoal inclusions which was 0.08m deep. The deposit also had limestone fragments and bunter pebbles laid to form a hard surface.

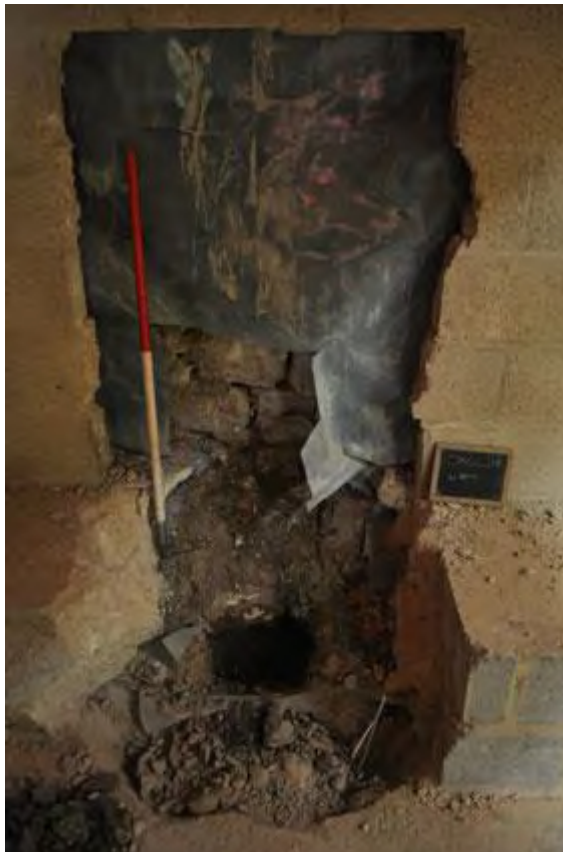
Plate 2: East wall wider foundation 45

Truncating deposit (27) was linear foundation cut 46 of which the width was not determined. Sat within the cut was masonry wall 45 (see Test Pit 5 on Fig. 2) a

limestone rubble structure that was 0.17m deep, and which had a considerably wider dimension than the wall above (plate 2).

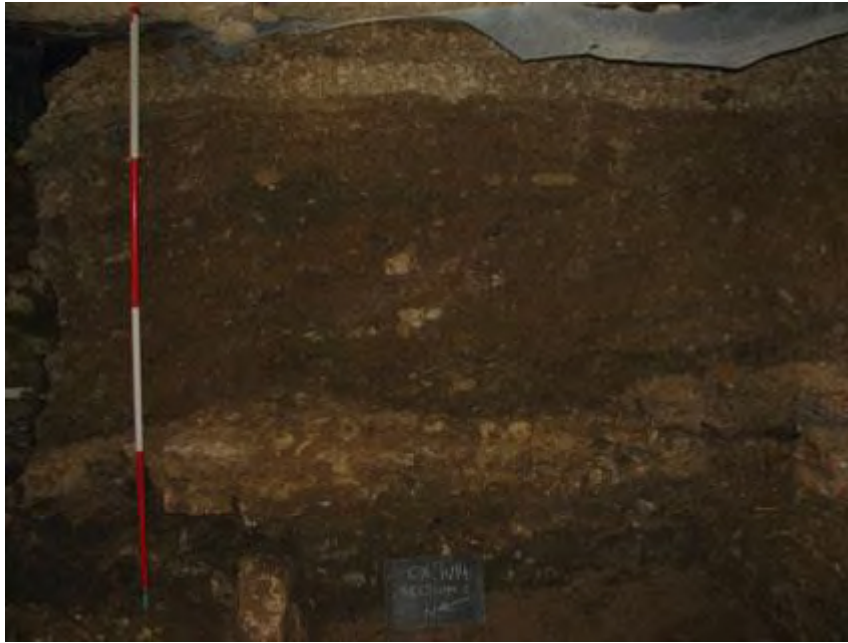
Plate 3: Section showing wall 72 and wall 68

Truncating deposit (71) was foundation cut 77 that had vertical sides and a flat base and is orientated east to west. This was for limestone masonry wall 72 of rubble blocks 300mm x 200mm x 100mm, which were randomly coursed (Fig. 5 S.3). This represented the possible remains of a wall 0.6m wide and 0.4m deep orientated east to west. The structure was bonded with light grey yellow sand.

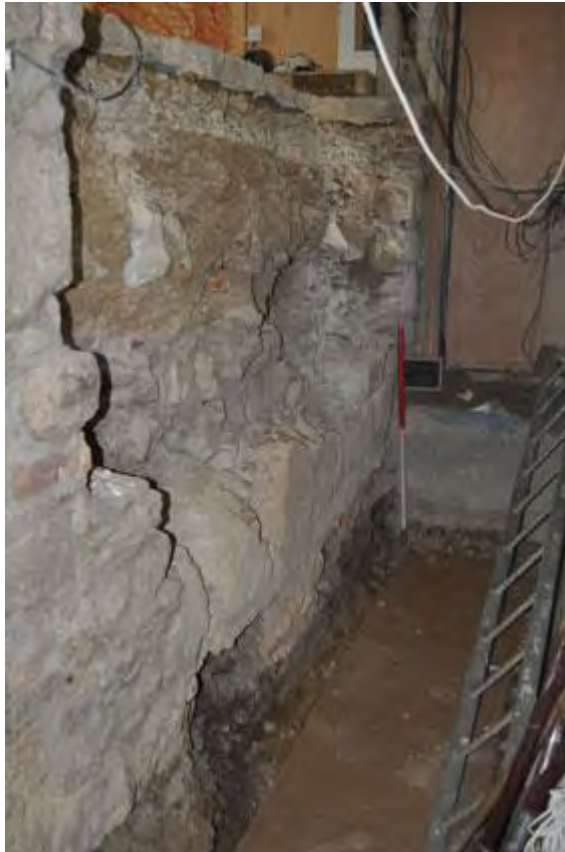
Plate 4: Wall 48 (to left) and wall 72 (below central), with wall 22

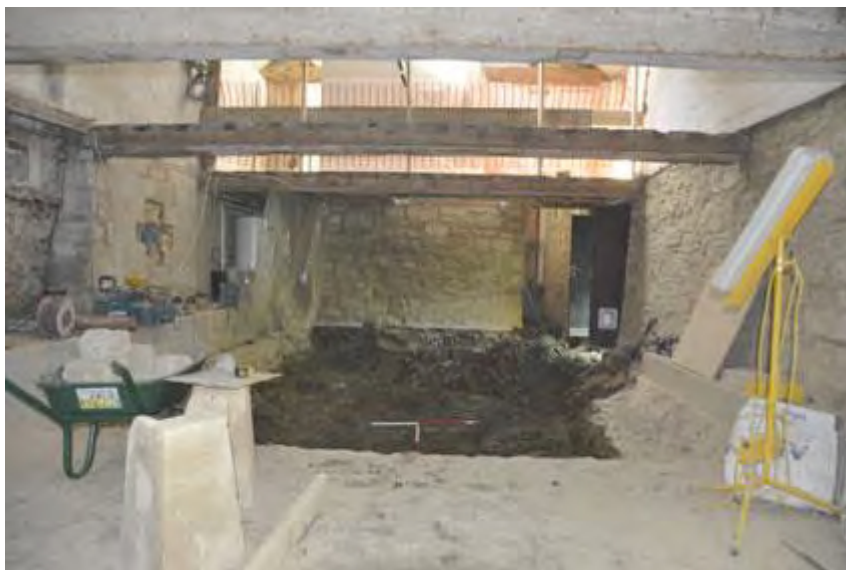
Plate 5: Wall 48/76 at the south end of north part of the barn

Also truncating this deposit (20/71) was foundation cut 49 a linear feature possibly 0.5m across (perhaps slightly more) with vertical sides and a flat base. The masonry wall associated with this foundation cut was numbered 48 and 76. Masonry wall 48 was a limestone rubble wall approximately 4m to 4.5m long. Limestone masonry wall 76 is a rubble structure with blocks averaging 300mm x 200mm x 80mm, which are randomly coursed and have a light yellow grey sand. The wall survived at this time to 0.9m high. This wall was in a key location as it marked the location where the two main units of the structure joined together. The wall had a later pipe cut 43 running underneath it and it is possible from this that it may have been reworked and in some cases rebuilt at a later date. However, due to the depth of the cut of the wall it would imply that this wall was cut 0.4m approximately into the black grey horizon.

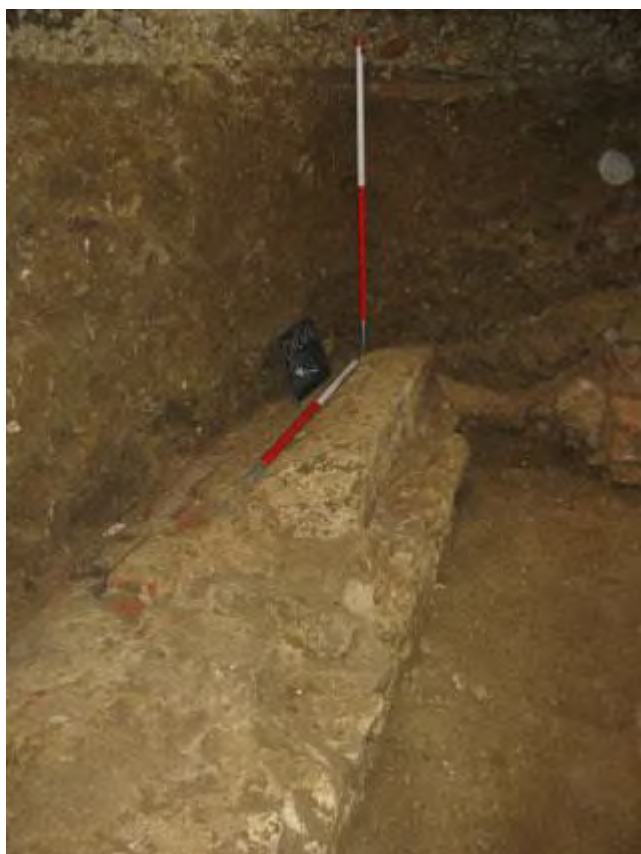
Plate 6: Wall 68

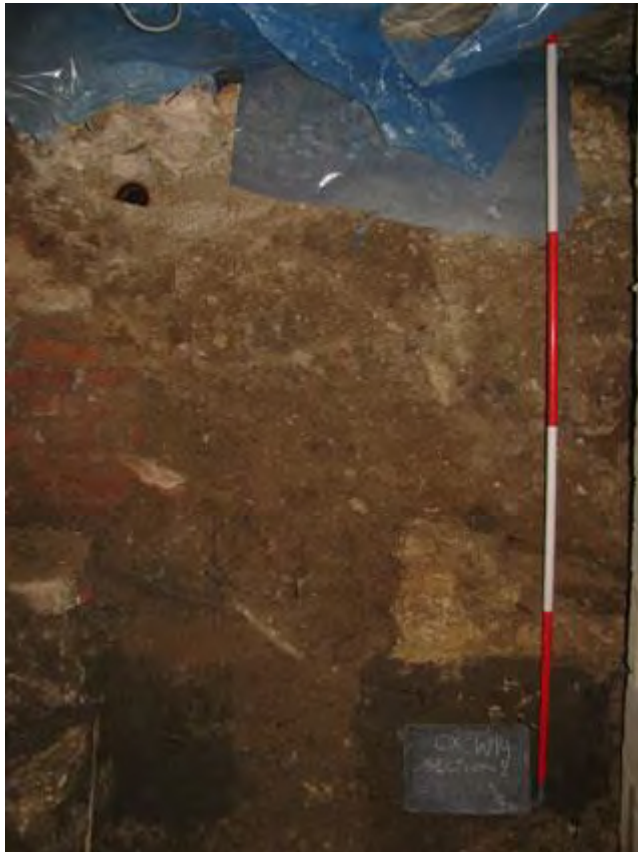
Plate 7: Wall 68 and wall 75

Also cutting deposit 66 was linear cut 80 which was assumed to have a dimension of 3.1m by 0.7m and was orientated north to south. Sat within the cut was limestone masonry wall 68 containing rubble stone in lower courses and squared blocks in the upper courses that average 300mm x 200mm x 100mm (Fig. 5 S.3, S.5, S.6). Brick components in the wall measured 220mm x 100mm x 60mm. The wall was bonded by light grey yellow mortar. The remains of the wall were 3.1m long, by 0.7m wide and 0.4m high. The depth of the brick here, would suggest an 18th century date, however, it is possible that this may simply represent repair and reworking of the limestone wall.

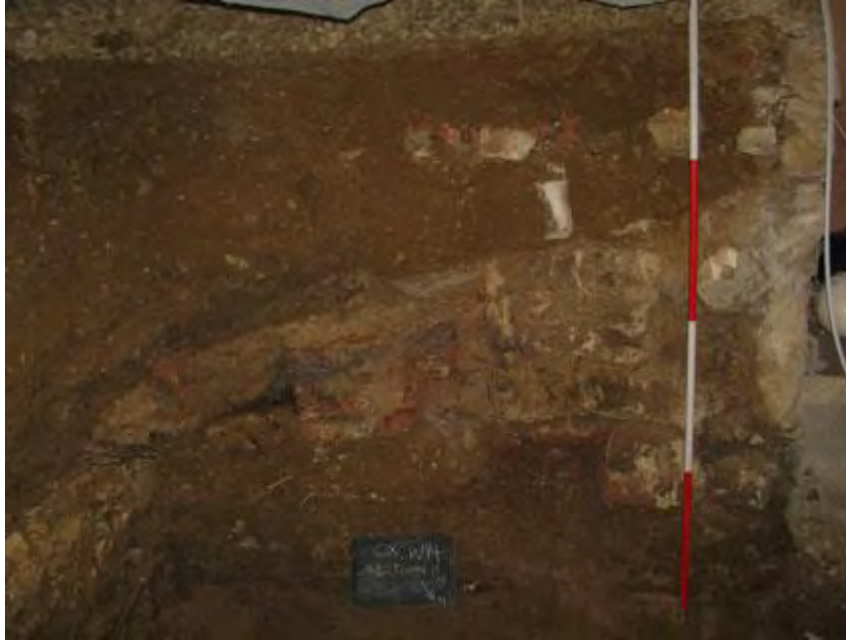
Plate 8: Kiln 69 and wall 22

On the east side of wall 22/60 was the remains of what was undoubtedly the Malt Furnace or Kiln. This structure was probably in use from the 15th or 16th century to the 18th century as defined in textual sources. It is likely that wall 22/60 may be part of this structure. Other features would include wall 68 and 70 and the brick structure 69. Linear cut 83 is treated as a feature with vertical sides and a flat base, which measured 0.4-0.5m long and was 0.22m deep. This was for limestone masonry wall 70 containing rubble blocks 700mm x 300mm or 500mm x 400mm approximately (Fig. 5 S.4). The wall is coursed and bonded by a light grey yellow silt sand. The wall has a height of 0.9m. This wall is possibly a stub wall or internal wall associated with the kiln, but could also be an indication of the original breadth of wall 22/60 with this wall being narrowed with later re-workings.

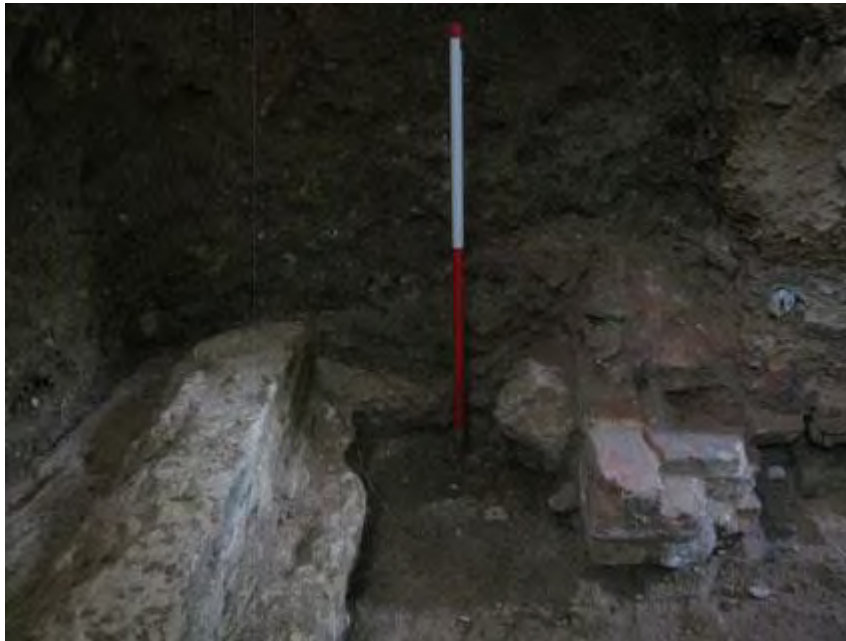
Plate 9: Kiln 69

Cut 84 of an unknown shape but probably rectangular with vertical sides and a flat base truncated deposit 66 but was butted up to wall 70. The cut was filled by a brick built masonry structure 69 (Fig. 5 S.4, S.6) that contained bricks measuring 220mm by 100mm by 60mm. (Bricks of a depth of 38-44mm were recovered from the site, which indicated the possibility of bricks on the site from the 15th to the 17th centuries). The structure had regular courses and a central void. The mortar was a mid-grey silt sand. The structure as identified measured 0.6m long and 0.35m wide, and had a height of 0.3m. From what was left of the kiln it was not possible to define exactly how the kiln was arranged and where the chimney would have been located, though walls 20/60, 48/76, 68 and 70 appear to have formed a rectangular space 3m by 1.5m, and that 68 and 69 contained some of the brick structure. 69 being vaulted could be part of an entrance to the furnace.

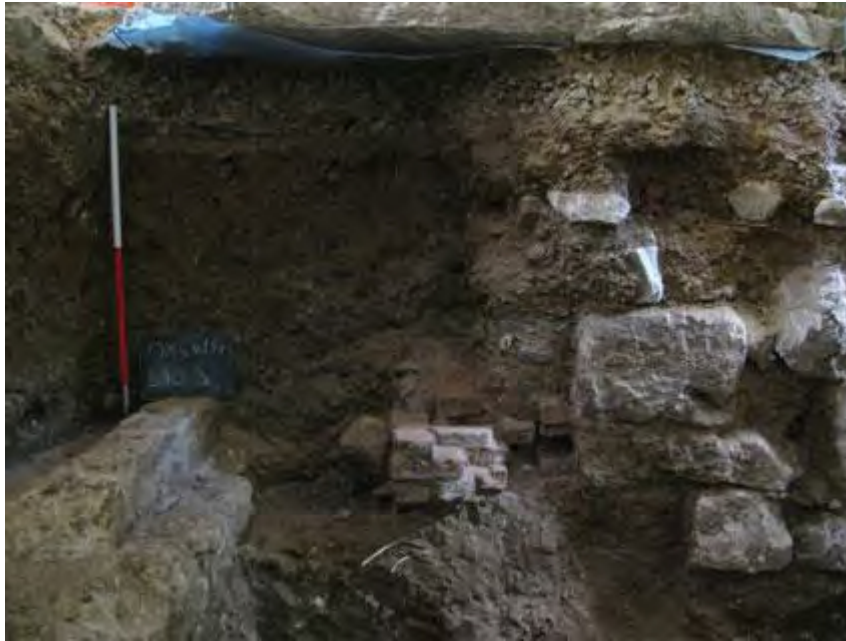
Plate 10: Kiln 69 and wall 70

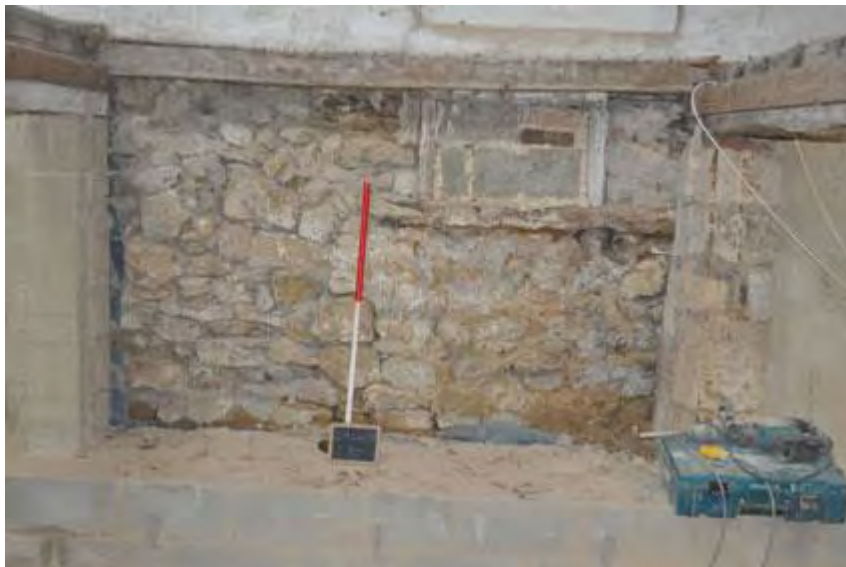
Plate 11: Part of wall 18

Cut 19 was associated with the demolition of the upper part of wall 45 and the rebuild of wall 18. Masonry wall 18 was constructed of limestone rubble roughly squared and which was orientated north to south (Fig. 7 S.8). The wall was bonded with a grey mortar and which contained a number of timber windows that had been blocked up.

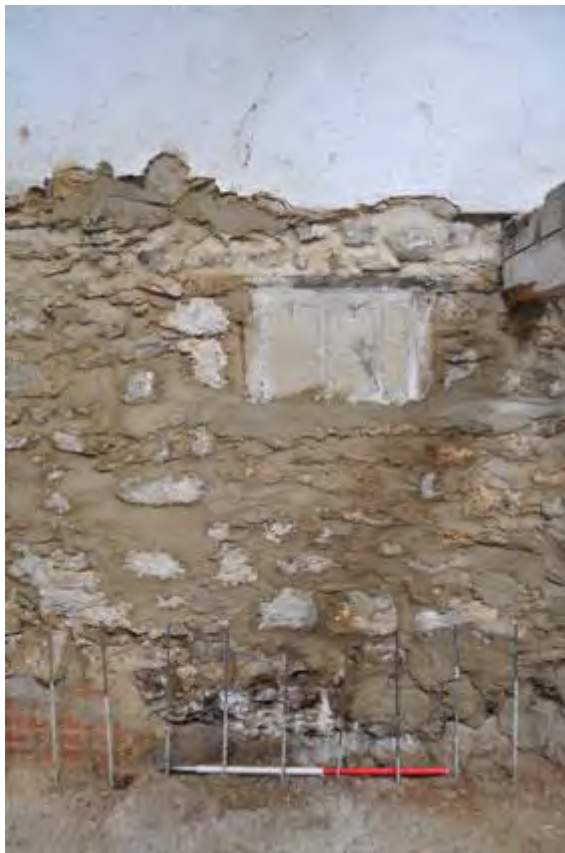
Plate 13: Part of wall 18 (with collapsed foundation)

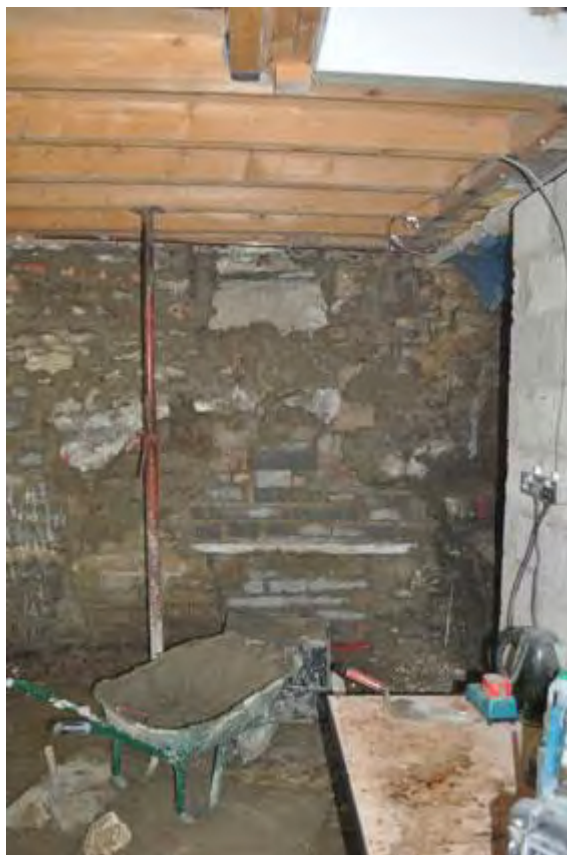
Plate 14: Part of wall 18 (after collapse) with wall 48/76 removed (on right)

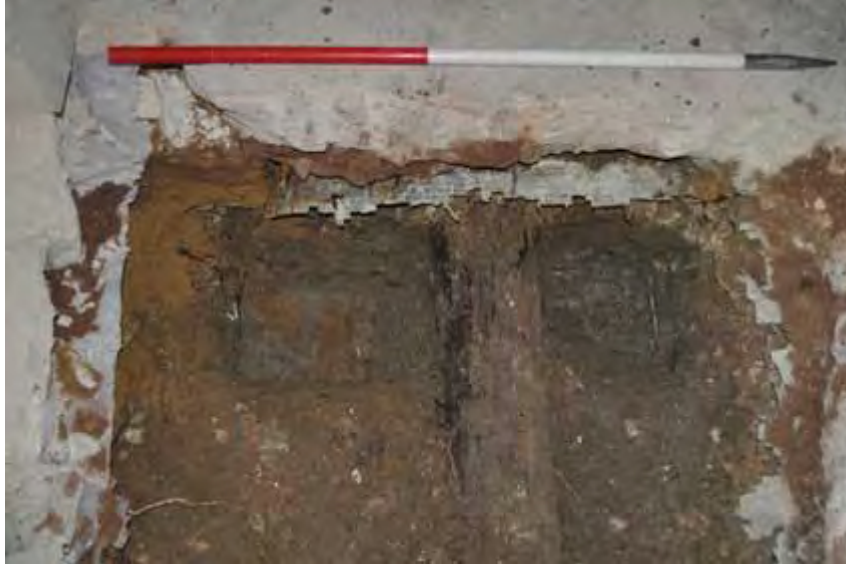
Plate 15: Timber 13 with clay packing (14)

The red earthenware pottery sherd recovered from context (14) is of interest in that it indicates that it was used as part of some type of industrial process. The pottery was a type of brown slipped vessel, but concreted onto the outside of this was a dried out grey liquid clay. The deposit was not created after breakage as the concretion did not lie over the broken section. The question is what this liquid clay would be used for. One possibility is that it was created as a slip deposit in pottery, but as yet we have no evidence for pottery in this area to which this could be associated with. A further possibility is that the liquid clay was used to paint other things. In Vietnam it is known that clay was sometimes used as a wood preservative; it appears to work through the following process. The clay is used to cover and seal the timber, thus retaining a high moisture layer in the wood and halting decomposition within.

Set within this upper clay layer was a timber 13 (Fig. 4), a sill beam running horizontally and on a similar alignment as the axis of the building. The timber had a rectangular section (box halved) which measured 1600mm x 700mm. There were darker stains on the timber. This timber beam is presumably all that survived of a series of beams that supported a plank timber floor.
