JOHN MOORE HERITAGE SERVICES

HISTORIC BUILDING ASSESSMENT

THE MALT BARN, 96 CHURCH WAY

IFFLEY, OXFORD

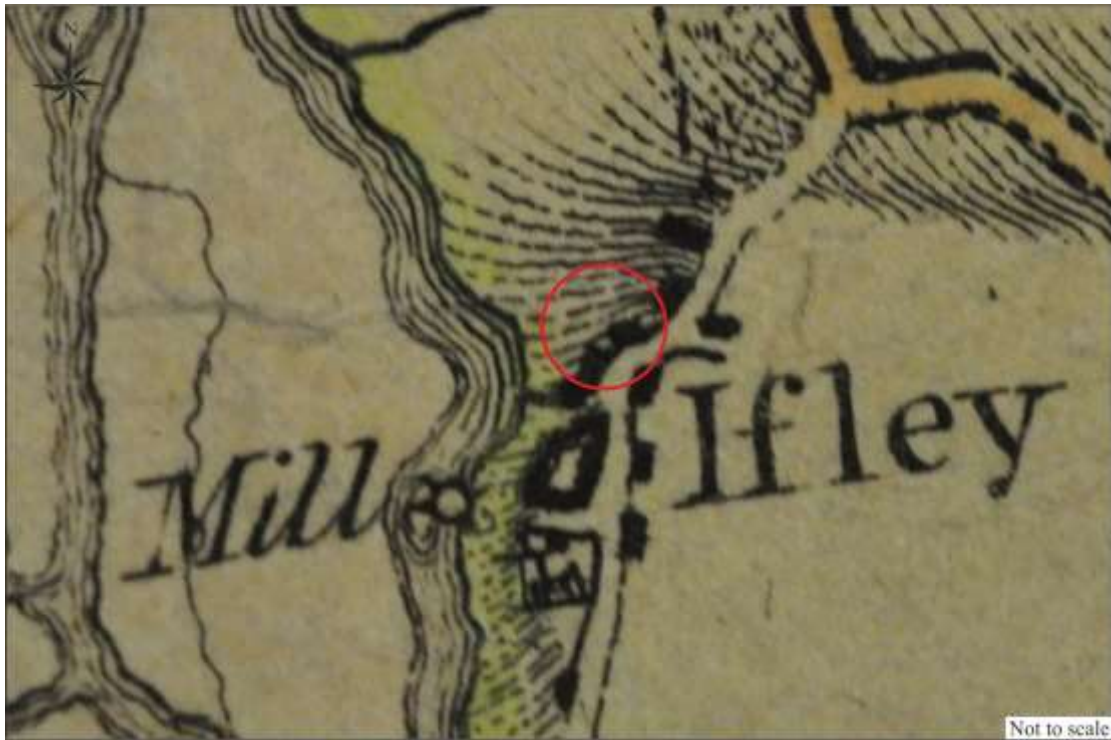
Figure 2 Jefferys' Map of 1767 (CP/103/M/1)

Two maps of Iffley exist for the 18th century. Jefferys' map of 1766-7 (OHC CP/103/M/1) shows buildings in the general area, but nothing that could be positively identified as the location of the Malt Barn (Fig. 2). The other map is Davis of Lewknor's map of 1797 (OHC CH.XX/2), however, here the accuracy of the map at Iffley is a problem and there appears to be a confused road system (Fig. 3). The earliest 19th century map of Iffley is that of Bryant dated 1824 (OHC P345/M/1), which does show a structure in the area of the Malt Barn as a building generally orientated north to south stepped back behind the street frontage (Fig. 4).

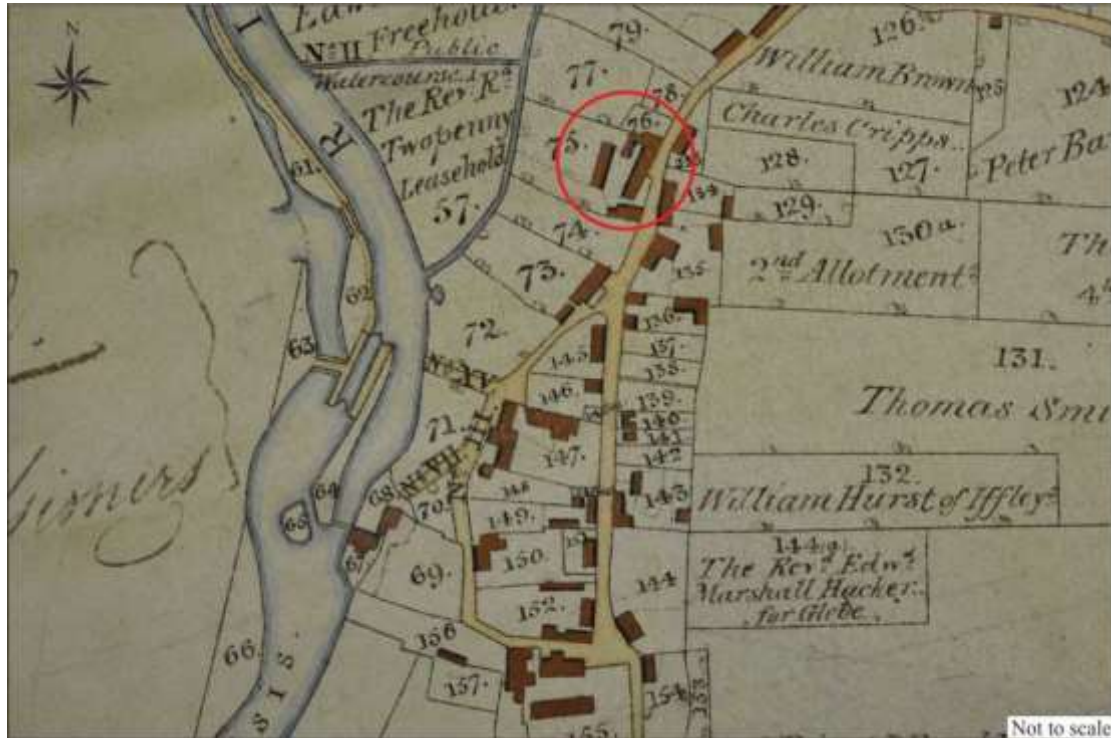
Figure 5 Inclosure Map of c 1830 (QS/D/A/vol E)

The Inclosure Award map of c 1830 (OHC QS/D/A/vol E) produces further details reported by the VCH and stated that plot 75 was held by William Brown; it is listed as a house, garden, malthouse, stable and close (Fig. 5). The adjacent plot 76 is listed as 3 cottages held by Edward King. This implies that the Brown family held the malthouse complex, when it was used as a chapel. The inference here is that the building was not the malting shed at this time, but may simply have been the stables. Rivermead and Malthouse Cottage are probably

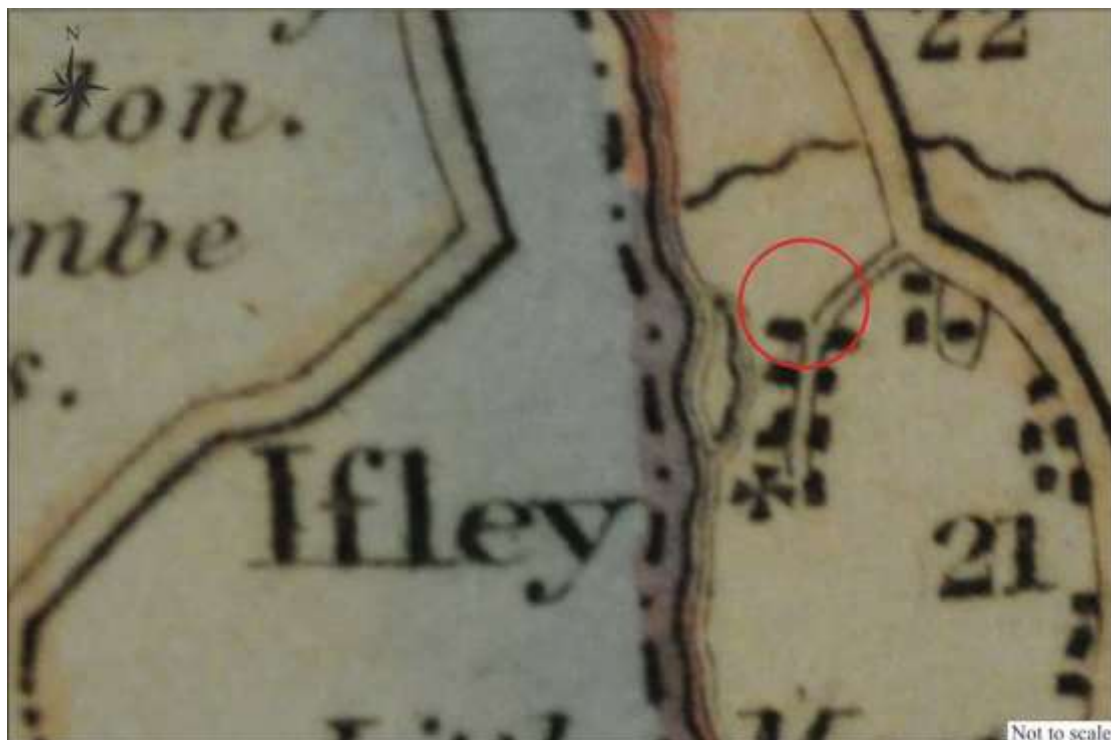
Figure 6 Greenwood's Map of 1832 (CH.XLVII/1)

located on early workers' accommodation for the malting. The information from the early 19th century is that the site was used as the location of a tannery and slaughter house, and that this was altered to that of a chapel (c 1810-35), being sub-let from the Brown family. The Greenwood map of Oxfordshire dated 1832 (OHC CH.XLVII/1) is not detailed enough to be of any significant use (Fig. 6).

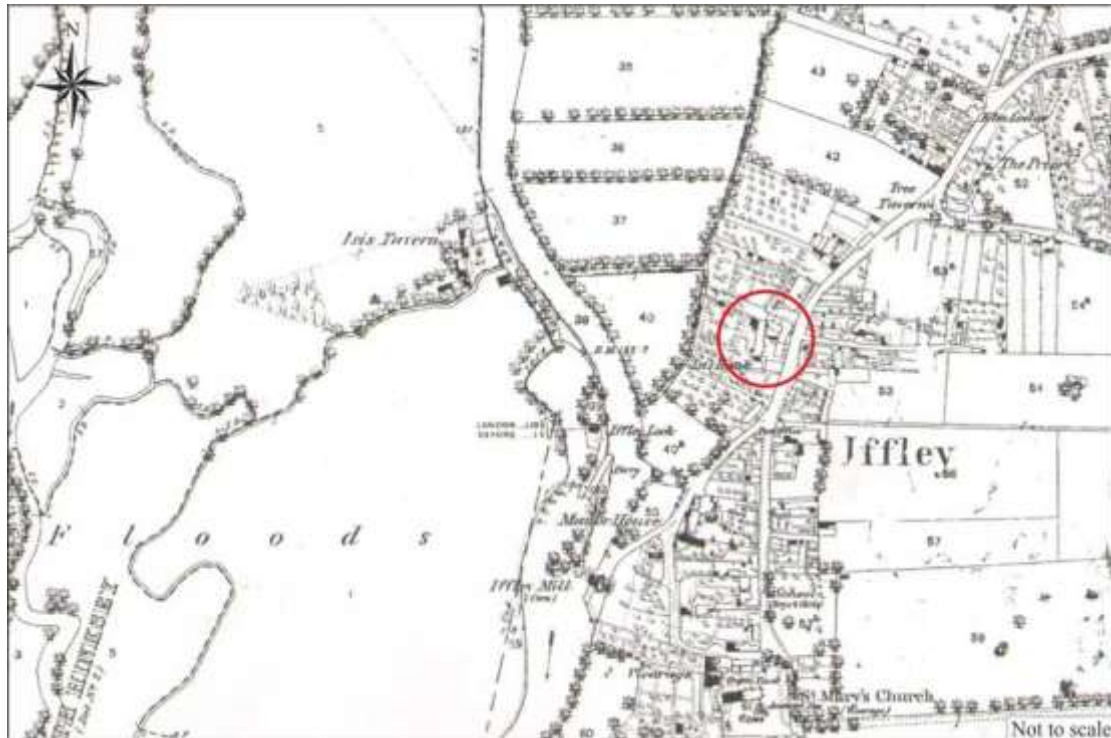
Figure 7 First Edition Ordnance Survey 1: 2,500 dated 1875 (Oxon sheet XXXIX.7)

Edition of 1875 (Oxon sheet XXXIX.7) shows the Rivermead, Malthouse Cottage, Malt House (also known as Isis Bank) and Malt Barn complex much in the same plan as it is today (Fig. 7). There are a number of alterations evident that include two extensions on the west side and a further one on the south side. The Second Edition of 1899 (Oxon sheet XXXIX.7) shows the same basic plan (Fig. 8). The Third Edition of 1921 (Oxon sheet XXXIX.7) shows the building plan as being similar, but marks the south extension of the structure as though it was an orangery or greenhouse (Fig. 9).

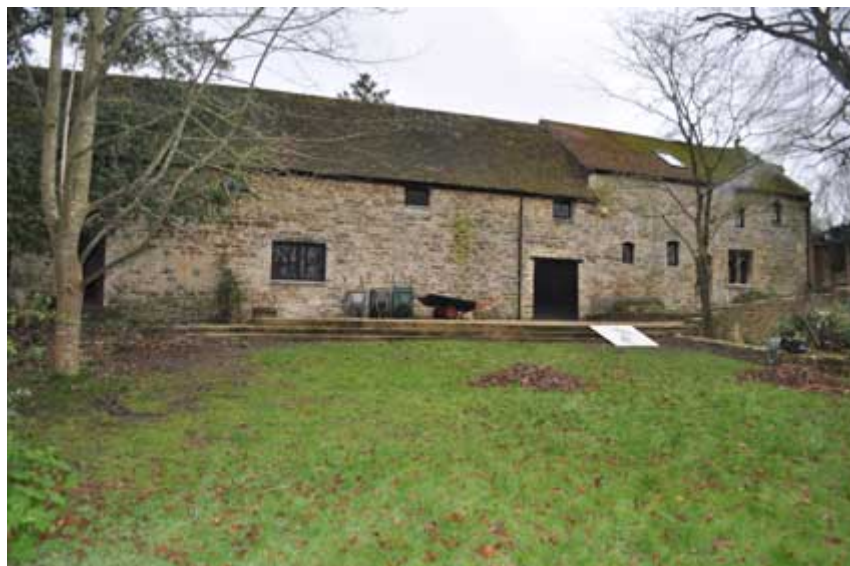
Plate 1 West façade

The main façade of the building is the west façade (fig. 12, plate 1), which faces away from Church Way. This façade has two component parts on the south side; there is a limestone wall, with slightly raised eaves to the rest of the building. This is separated from the rest of the building by a butt joint, which runs from about 0.5m above ground level to the eaves. Centrally in the south part of the wall there are indications of a statue inserted into a niche. One wonders who this statue is meant to be, it is likely to be of a tomb showing a man in priestly orders. To the right of this there is a reset late medieval or Tudor tracery window, while above this there is a smaller lancet window and to the right of the upper window there is a further small lancet window. To the left of the statue there are two further small windows with segmental arches. The roof above this is of concrete plain tile (to be replaced with clay) and has one roof light inserted.

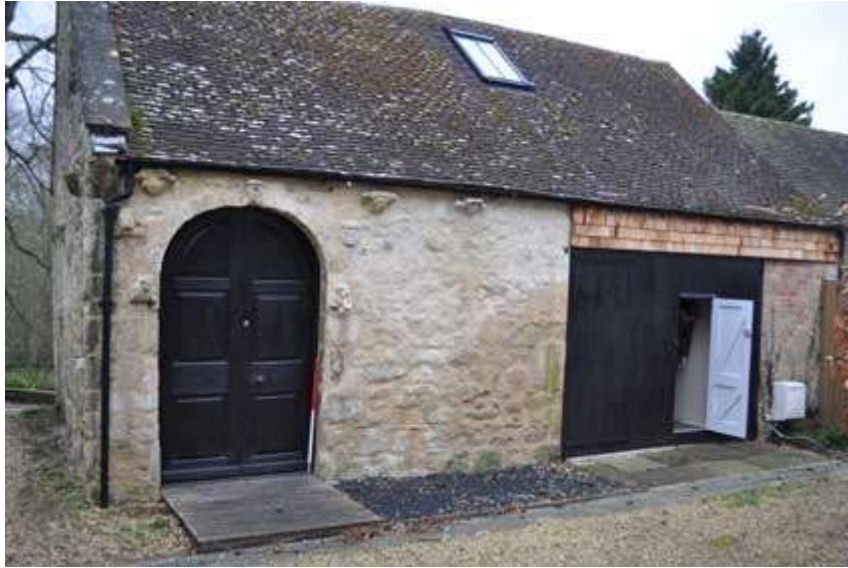
Plate 2 Part of the east façade

The south part of the east façade is a mixed bag (plate 2). On the right hand side there are modern double plank doors, which now act as the main entrance to the property. To the right of these is a modern brick wall and above the door is timber shingle. The wall

on the left hand side is of limestone with a round headed arch at its south end, which has a series of weathered sculptural pieces set around it with four weathered corbels above. This appears to have a modern round headed double door. The roof above this is of concrete plain tile (to be replaced with clay).

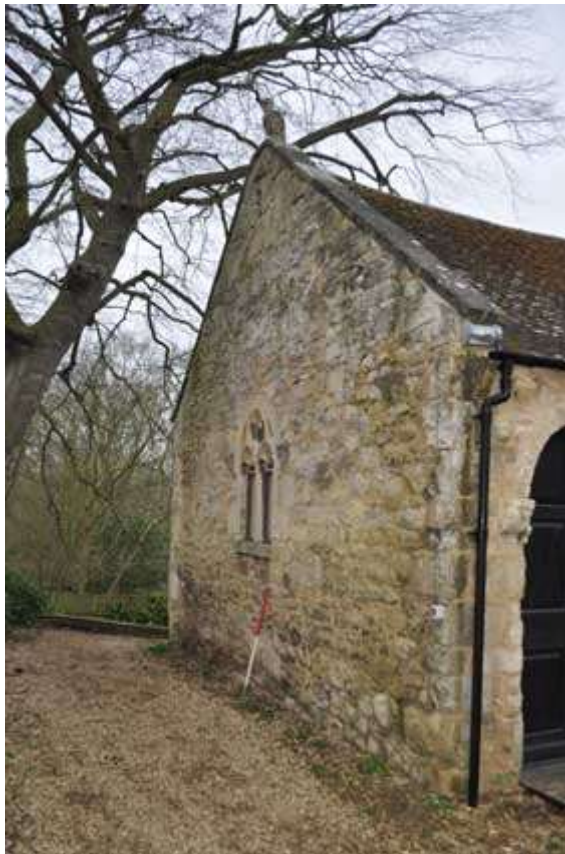
Plate 3 South gable end

The south gable is all of limestone with a medieval tracery window inserted (plate 3). The gable has a pediment onto which a finial is attached, a sculptured bird reused. In the gable wall there are three inserted pieces of sculpture, some of these may be from tombstones and one is the volute from an Ionic classical piece.

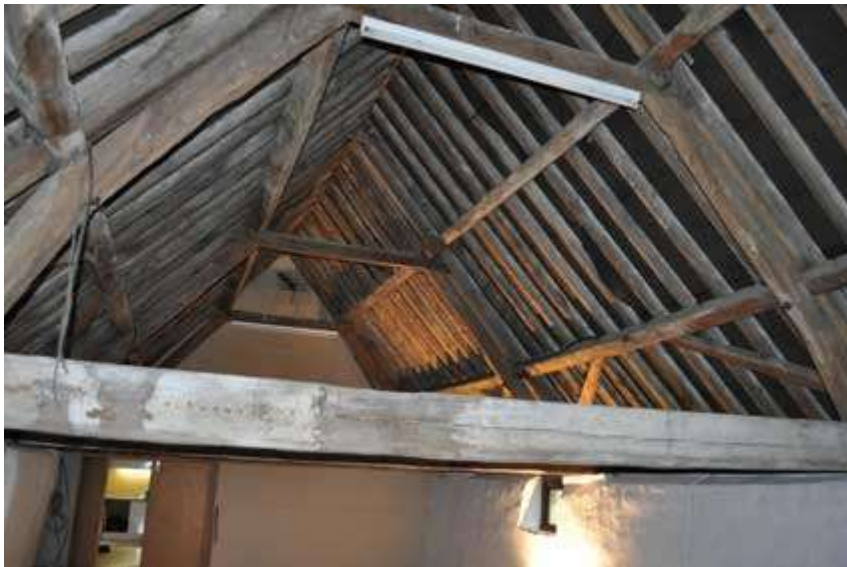
Plate 7 Baltic pine roof

The stairs lead up into the loft of the north part of the building (fig. 11 R5). Here there is a large space that has been sub-divided by a modern artificial wall towards its southern end. The main part of this area is open to the rafters and perkins and there are a number of exposed trusses (plate 7). The trusses have a collar beam supported on a

timber which is not a full cruck-blade, but is half of one, invariably described as a brace or perhaps an inner principal rafter, that runs to the underside of the collar beam. The scarfed perkins are joined by timber pegs, with the inner and outer principal rafters trapped together with wrought iron bolts with cleated-over iron sheet and iron pins (Steane and Ayres 2002). Baltic pine is known to have been widely available in London and the east of England in the mid-18th century. However, this technique has been noted as being used elsewhere as at Greenwich Naval Hospital dated 1690 and Sheephouse Farm at Warleigh near Bath where a late 17th century date is suggested. The north wall of the main loft contains a different truss with a tie-beam set on a stone wall, containing a collar beam, two queen struts, with interrupted collar beams and princess struts. There is weatherboarding visible in this area. Steane and Ayres (2002) mention a fine painted inscription of matchboard, which is no longer extant. The roof was relaid in the latter part of the 20th century.

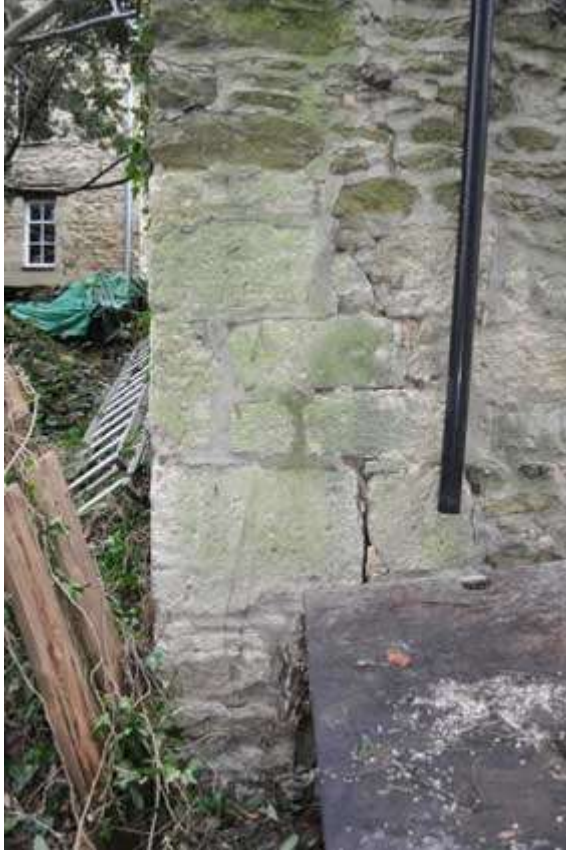
Plate 8 No indication of vertical butt, but three bandings of stone

Consideration of the surviving walls shows no sign of there being butt joints near each of the end walls, see plates 8 and 9. Plate 8 shows the northwest corner: what is evident is that there are indications of three different builds, one with rubble stone at the base, an area of ashlar limestone centrally, and then an upper layer of rubble stone, with each group of distinct stones running out beyond the location in which the butt should occur. Plate 9 shows the south end of the barn with no butt joint.

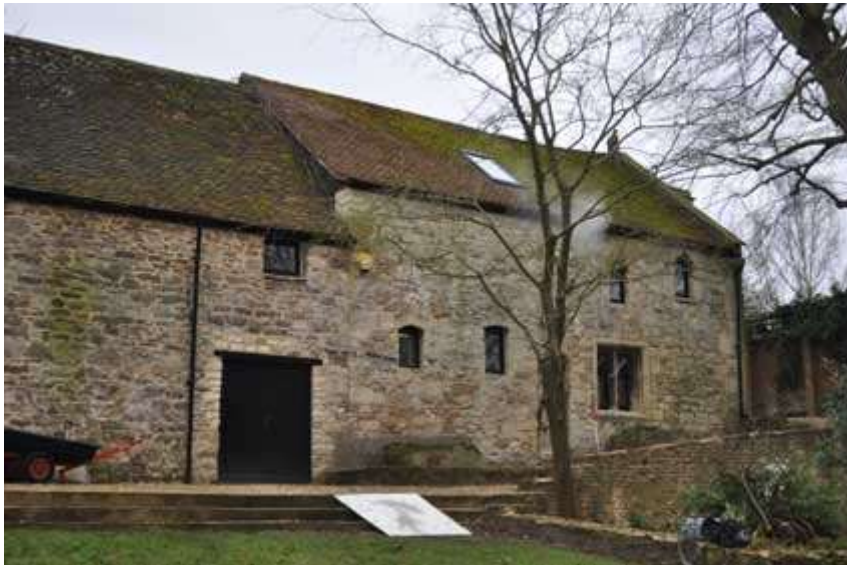
Plate 9 No indication of butt joint at the south end

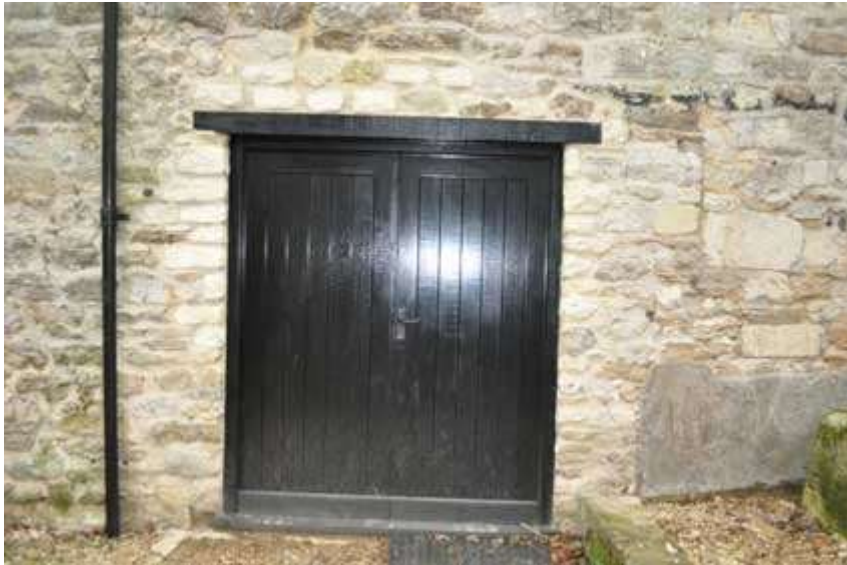
Plate 10 Area of staggered butt joint on the right hand side, above an area with no butt

Plate 10 shows the central part of the wall where the central component joins that of

the north unit, which consists of the barn proper. The lower part of the wall here may be part of a dwarf wall foundation. This again implies that the earliest structure was a long rectangular building for which the earliest openings are not known. It is thus the case that Steane & Ayres phase A would appear to be the earliest phase 1.

There are indications in the location where the southern and northern units join together that rebuilding work has occurred. Here there is a staggered butt joint shown on plate 10 and 11. What these features imply is that there have been a number of rebuilds onto the original foundations. It may also be an indication that one of the structural units was built wholly in stone prior to the other and that one of them possibly had timber components on a dwarf wall. The shape of this butt joint implies that there were three phases to the structure in stone. The northern unit was raised in stone possibly with some original timber superstructure (Phase 2); then the southern unit was raised in stone (Phase 3), and subsequently an additional stone build was made of the northern barn (Phase 4).
