JOHN MOORE HERITAGE SERVICES

ARCHAEOLOGICAL WATCHING BRIEF
AT
THE MANOR HOUSE, CHURCH STREET,
GREAT SHEFFORD, HUNGERFORD, BERKSHIRE

NOVEMBER 2016

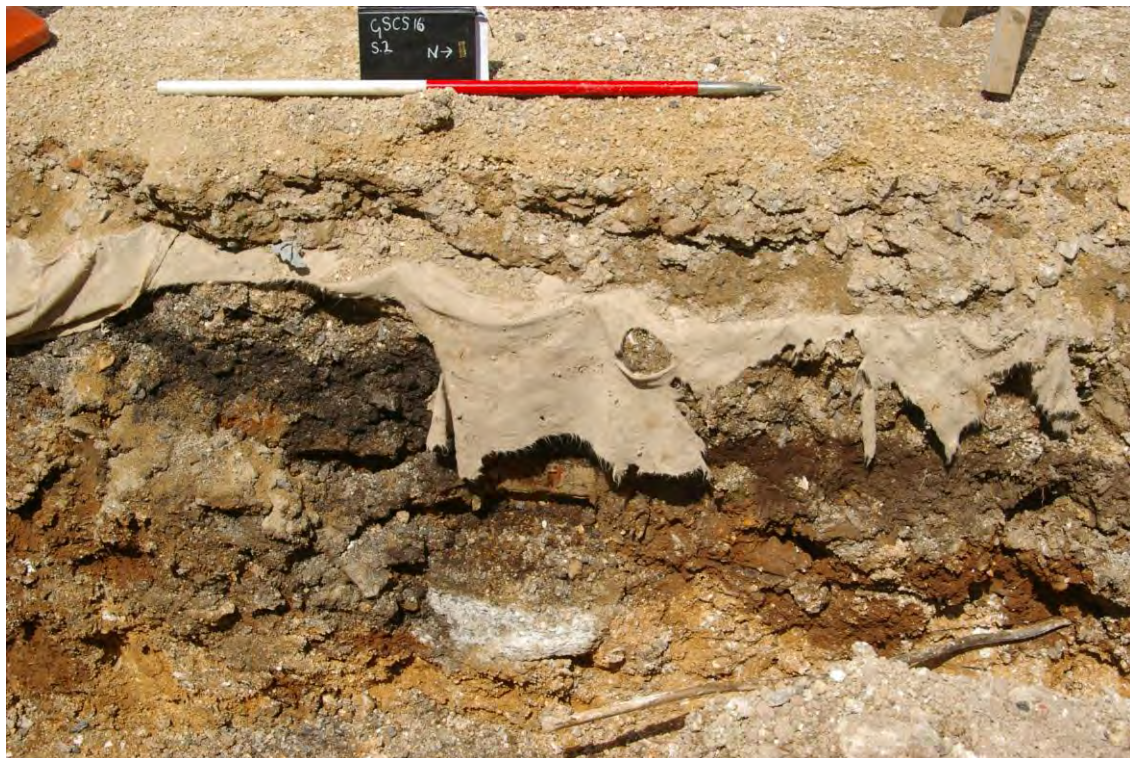
The first phase of work involving the 7m x 15m machine strip of the garage footprint (Fig. 1) revealed a 0.3m thick layer of disturbed ground overlying the natural chalk (01). The disturbed ground layer (02), was a grey brown silty sand (02) with frequent amounts of chalk and building debris together with plastic sacks laid upon the interface with the chalk and clay and the disturbed ground (Plate 1).

Plate 1. Disturbed layer (02) in foundation trench

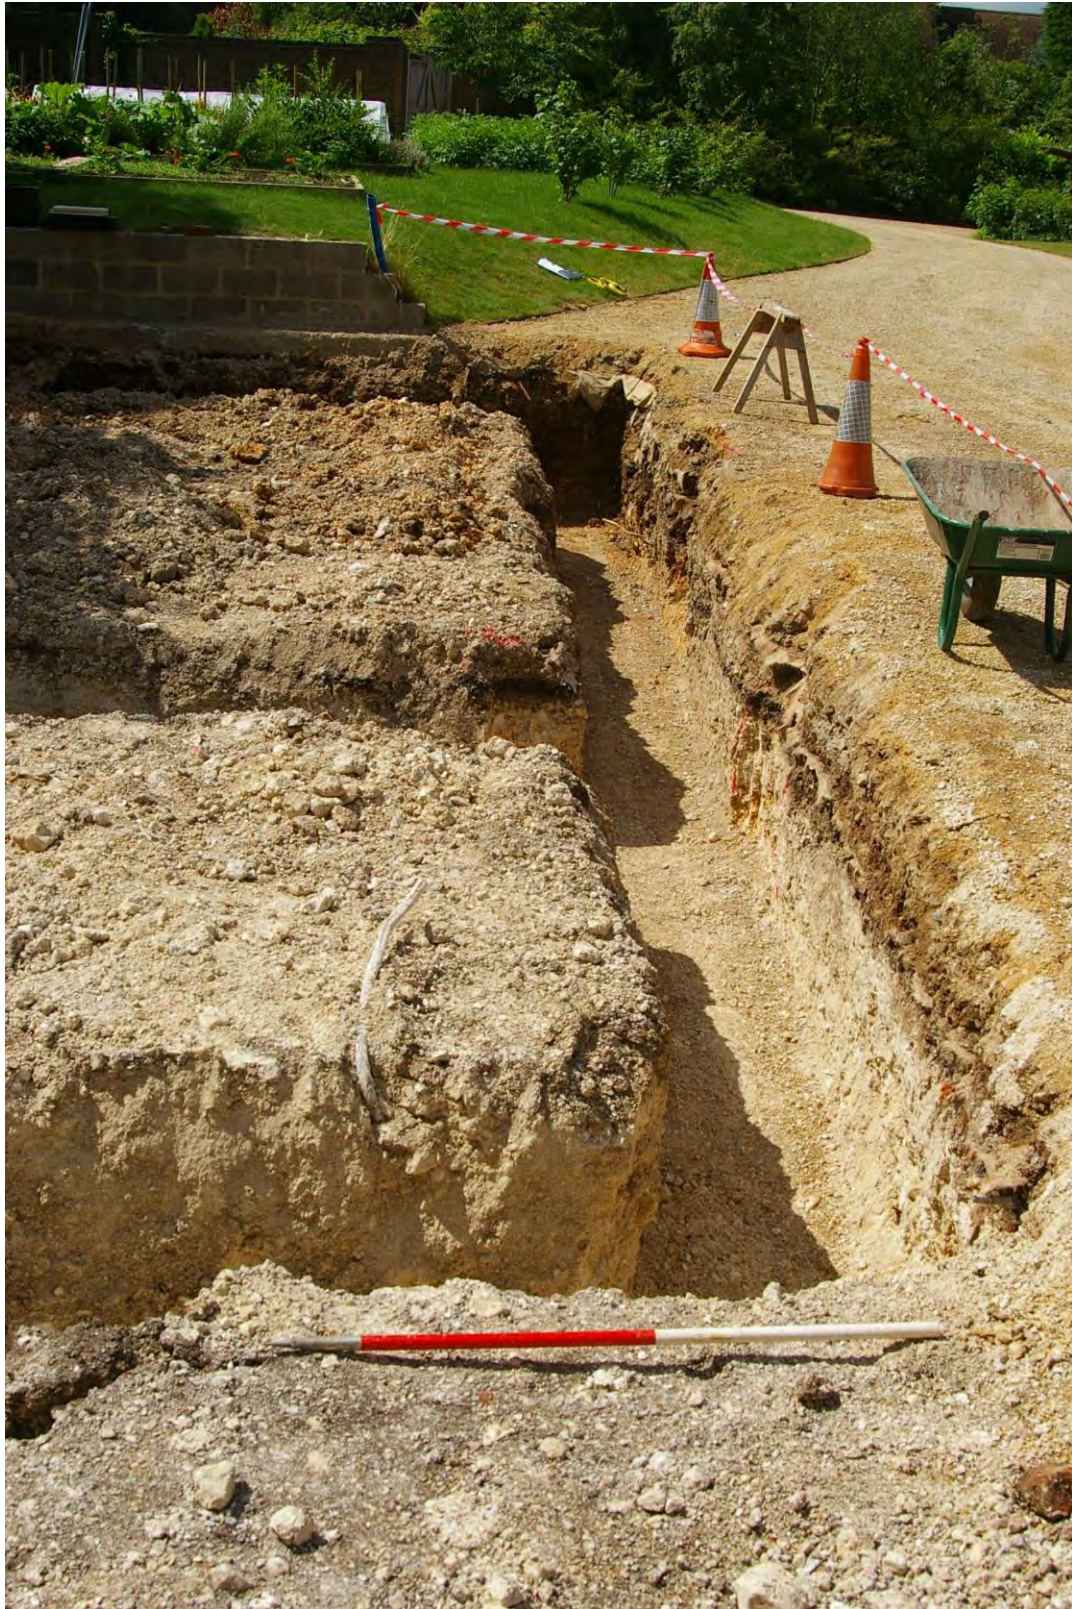
The second phase of work involving the monitoring the excavation of the foundation trench along the northern extent of the trench (Fig. 1 & Plate. 2). The trench was 0.8m – 1.6m wide and 1.2m deep and consisted of the disturbed ground layer (02) overlying the natural chalk and clay (01). The depth of the disturbed ground layer increased to 1m deep along the north-western extent of the trench (Fig. 1 and Plate 2).

Plate 2. General shot of foundation trench looking west
