JOHN MOORE HERITAGE SERVICES

**ARCHAEOLOGICAL OBSERVATION,  
INVESTIGATION, RECORDING, ANALYSIS AND  
PUBLICATION OF WORKS**

**LAND R/O 1 KELMARSH ROAD,  
CLIPSTON, NORTHAMPTONSHIRE LE16 9RX**

**DECEMBER 2016**

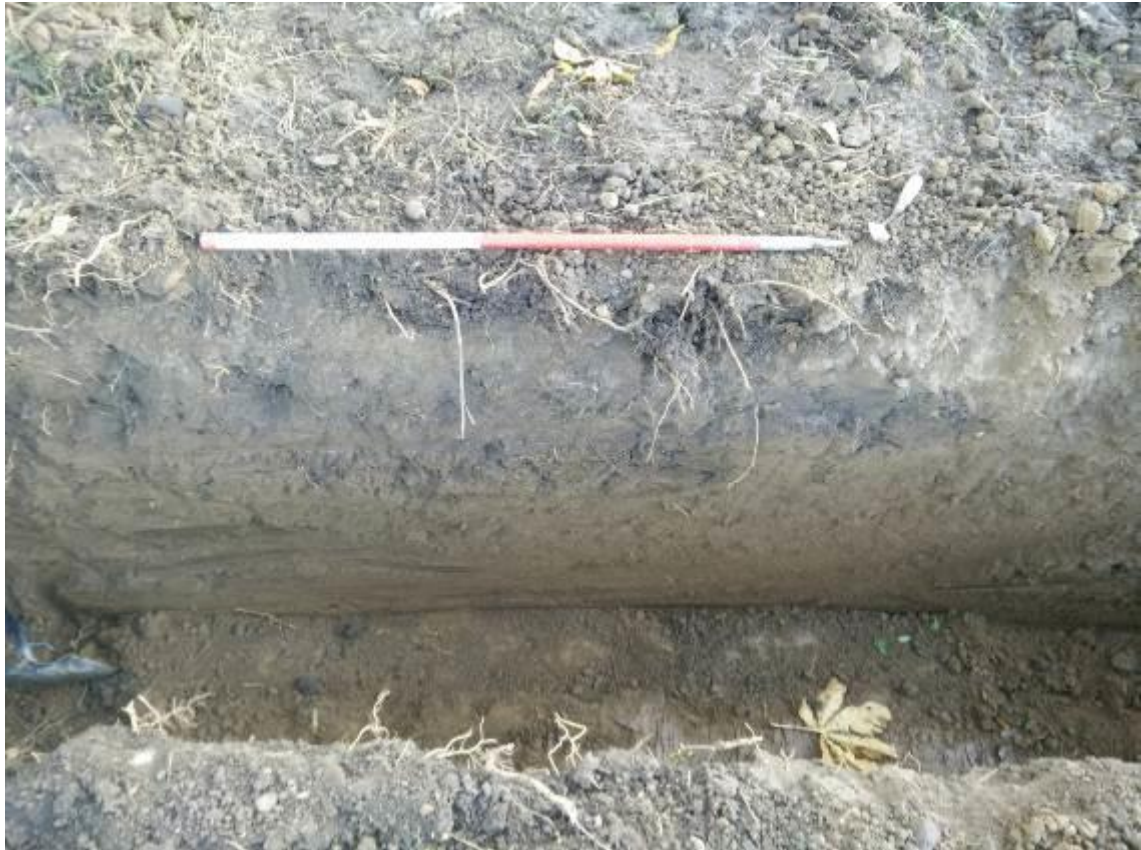
Trench 1, house footprint (Fig. 2 and Plate 1): The 260mm thick topsoil (01), was of a mid to dark brown clayey silt, friable in consistency with modern rubble occasionally observed throughout. The 280mm thick subsoil (02), was of a mid greyish brown silty clay, friable but firm, with 10-15% charcoal inclusions throughout and common lenses of mid to late 19<sup>th</sup> century and early 20<sup>th</sup> century agricultural refuse. These items were observed in section as well as in the spoil. The natural (03), or sterile soil was of a mid-yellowish brown silty clay, compact with occasional sub-rounded flints <40mm in diameter. There were two cuts observed, 04 and 06, both associated with 19<sup>th</sup> century ceramic field drains noted emptying into the adjacent drainage ditch to the NW of site.

Plate 1. Representative section of foundation trench facing SE (house).

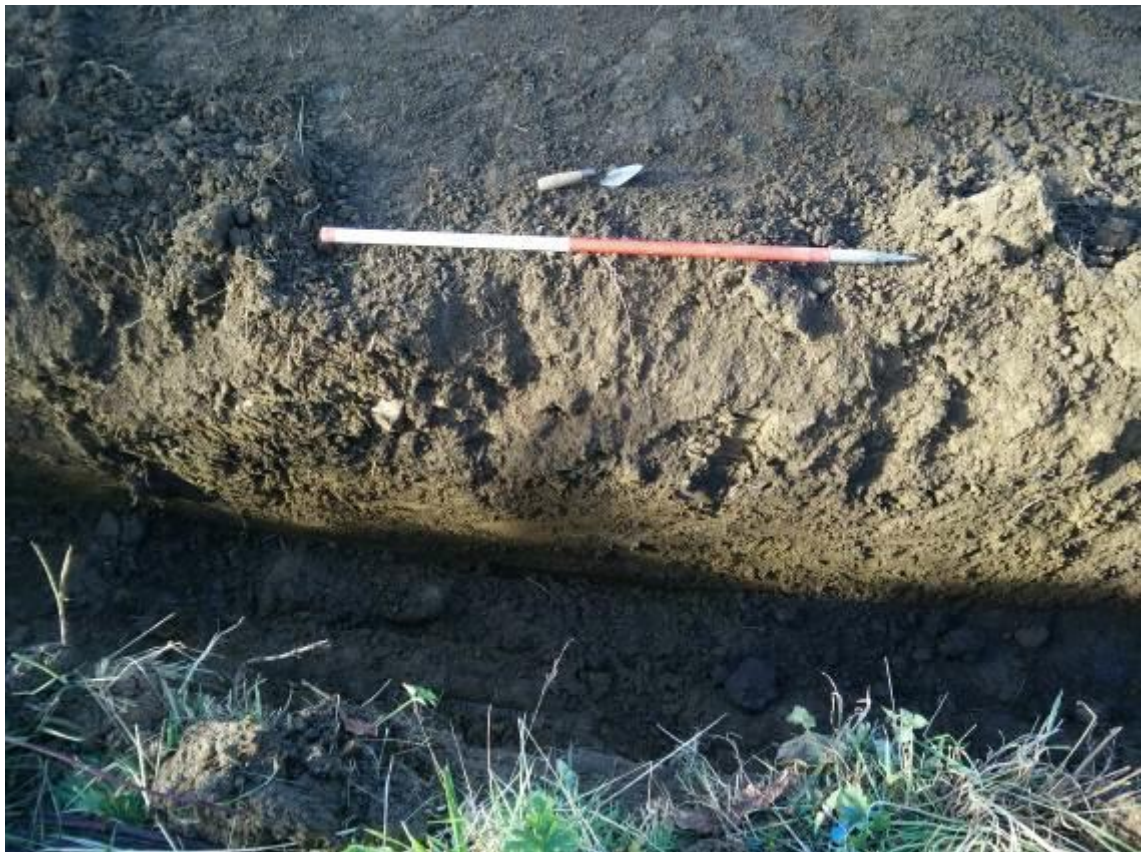
Trench 2 garage footprint (Fig. 2 and Plate 2): The 300mm thick topsoil (08), was of a mid to dark brown clayey silt, friable in consistency with modern rubble occasionally observed throughout. The 410mm thick subsoil (09), was of a mid greyish brown silty clay, friable but firm, with 10-15% charcoal inclusions throughout with common inclusions of mid to late 19<sup>th</sup> century and early 20<sup>th</sup> century brick and tile. The natural (10), or sterile soil was of a mid-yellowish brown silty clay, compact with occasional sub-rounded flints <40mm in diameter.

Plate 2. Representative section of foundation trench facing W-NW (garage).

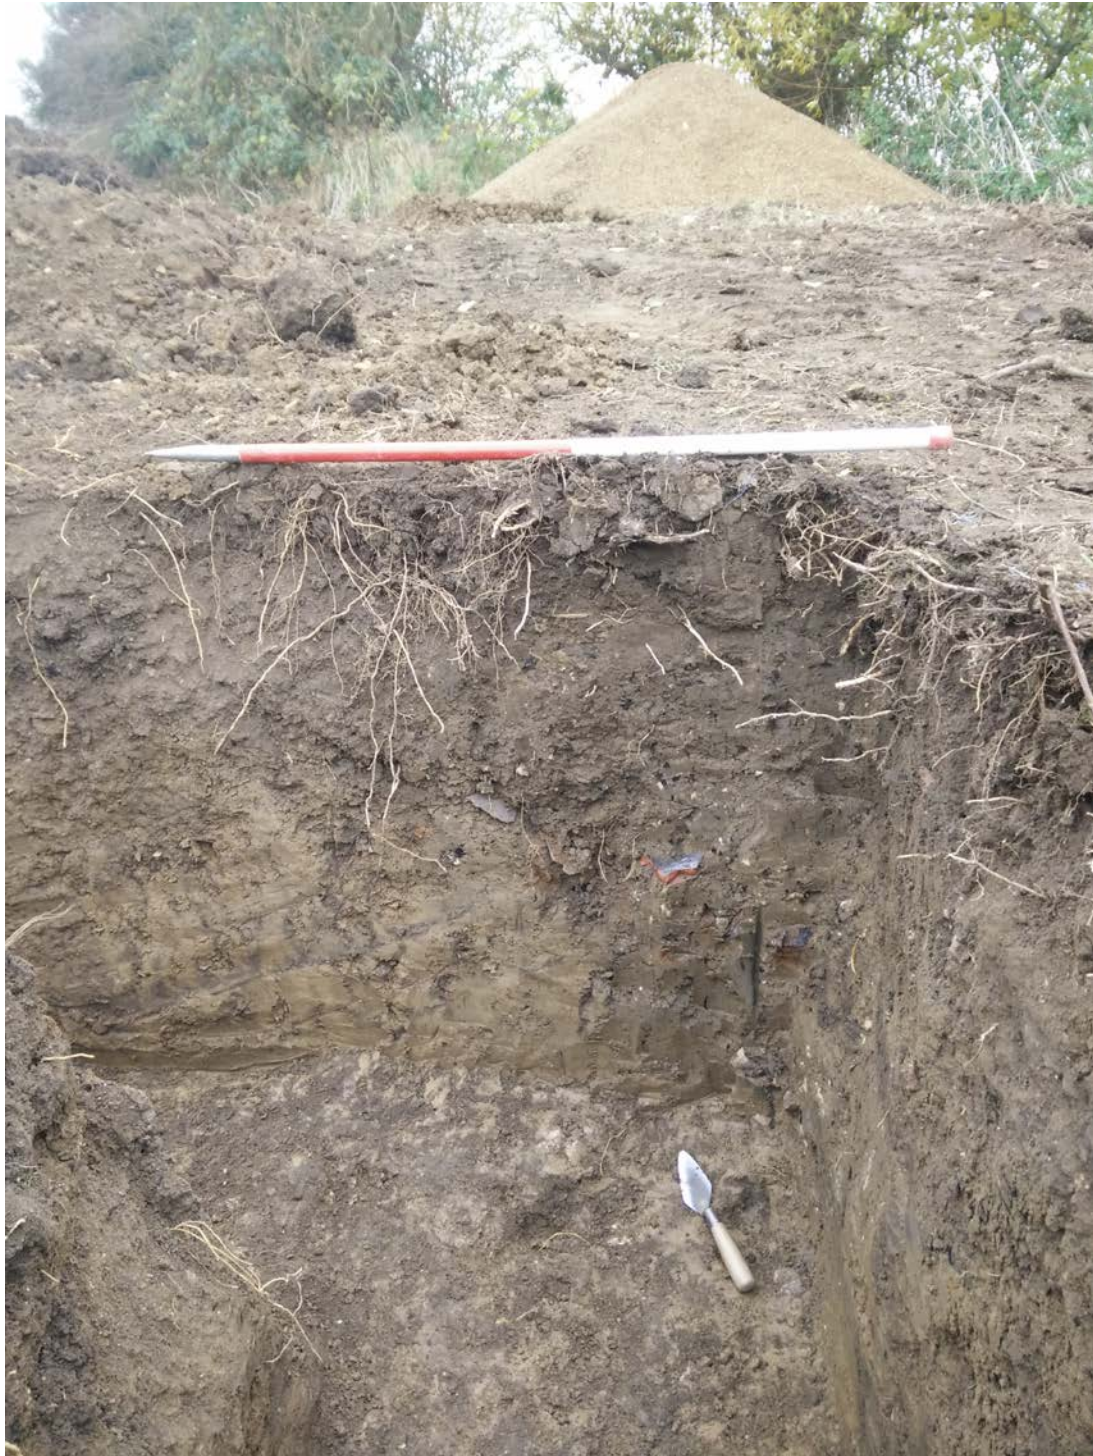
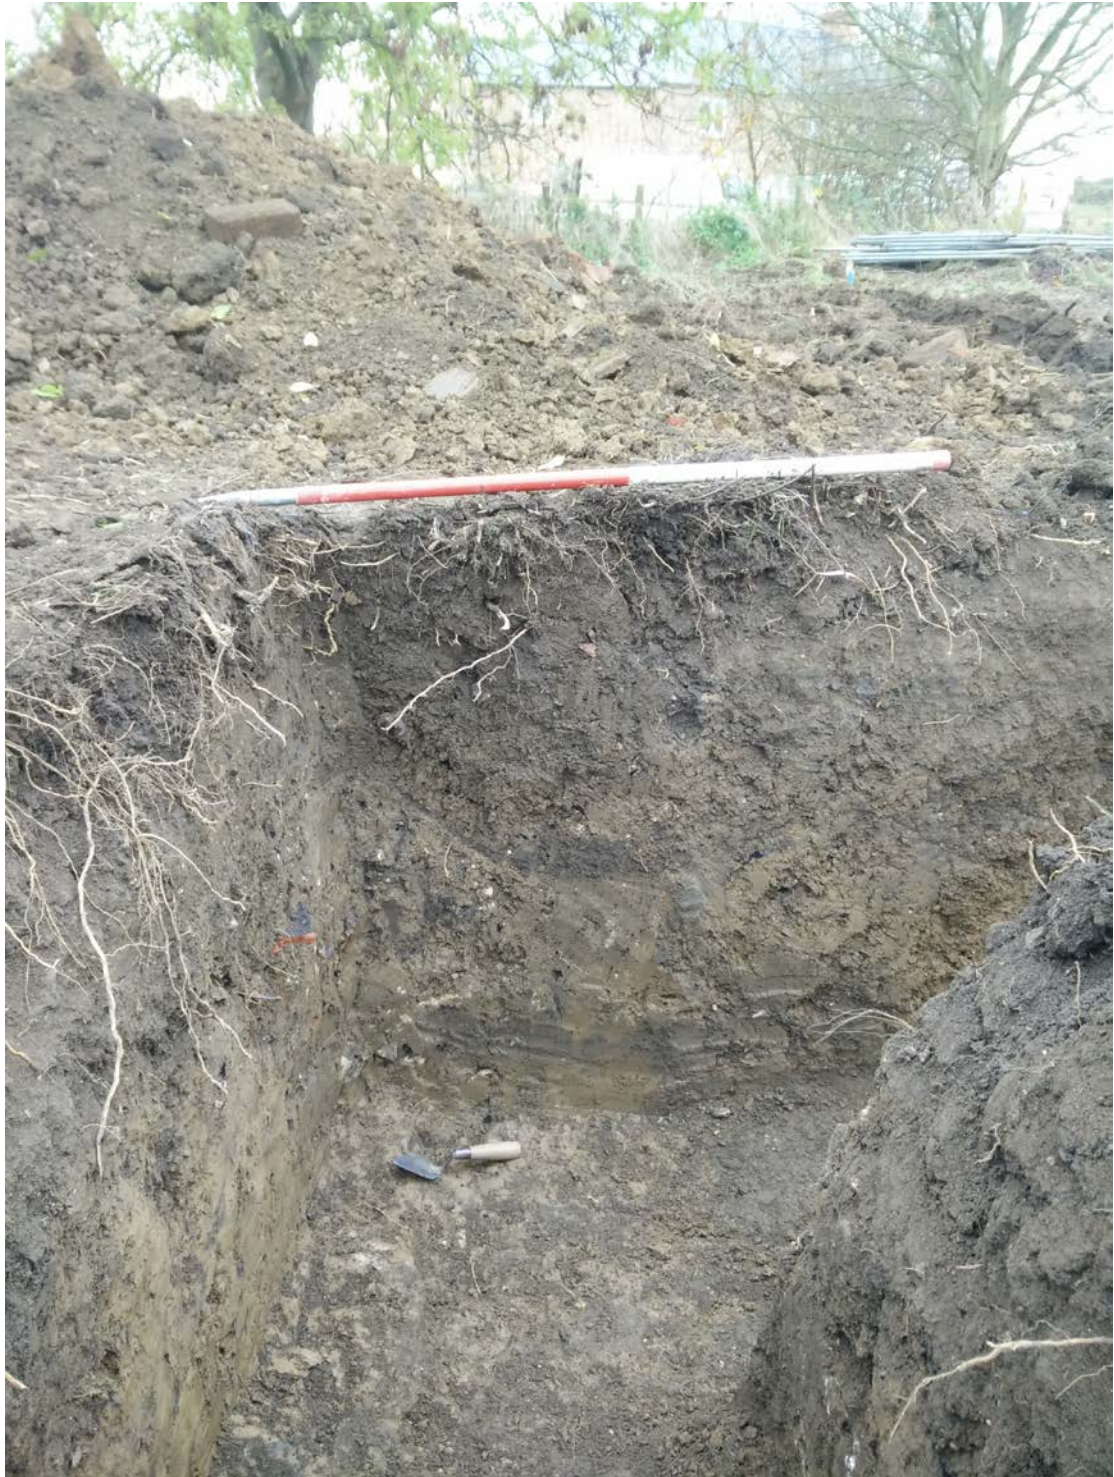
Section 3

Description linear, Not fully exposed, partly outside L.O.E., Field drain cut

Description Mid yellowish brown  
slaty clay, ~~with~~ 19th c. rubble  
(fill of field drain)
