ARCHAEOLOGICAL WATCHING BRIEF

ST JOSEPH'S COLLEGE,

UPPER REDLANDS ROAD, READING,

MAY 2016

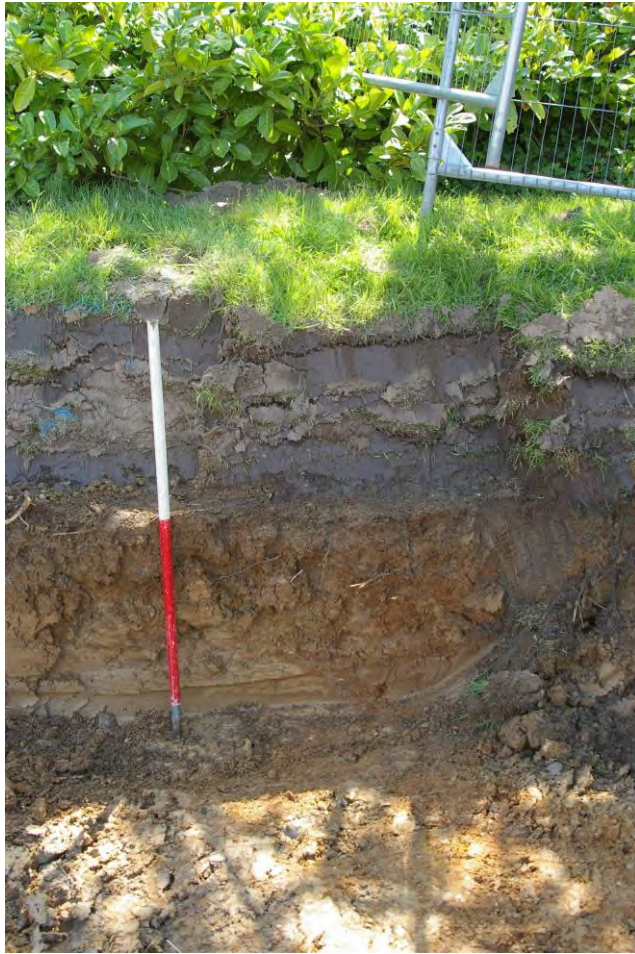
There were no archaeological features present cutting into the natural clay (04) where it was encountered in MUGA 1. The southwestern extent of the site was relatively undisturbed with the turf / topsoil (01) overlying subsoil (03) that overlay the natural clay and sands (04). Further east and south a layer of modern made ground (02) increasing in thickness to the northeast from 0.2m to over 1m thick.

Plate 1. Section 1 looking southwest

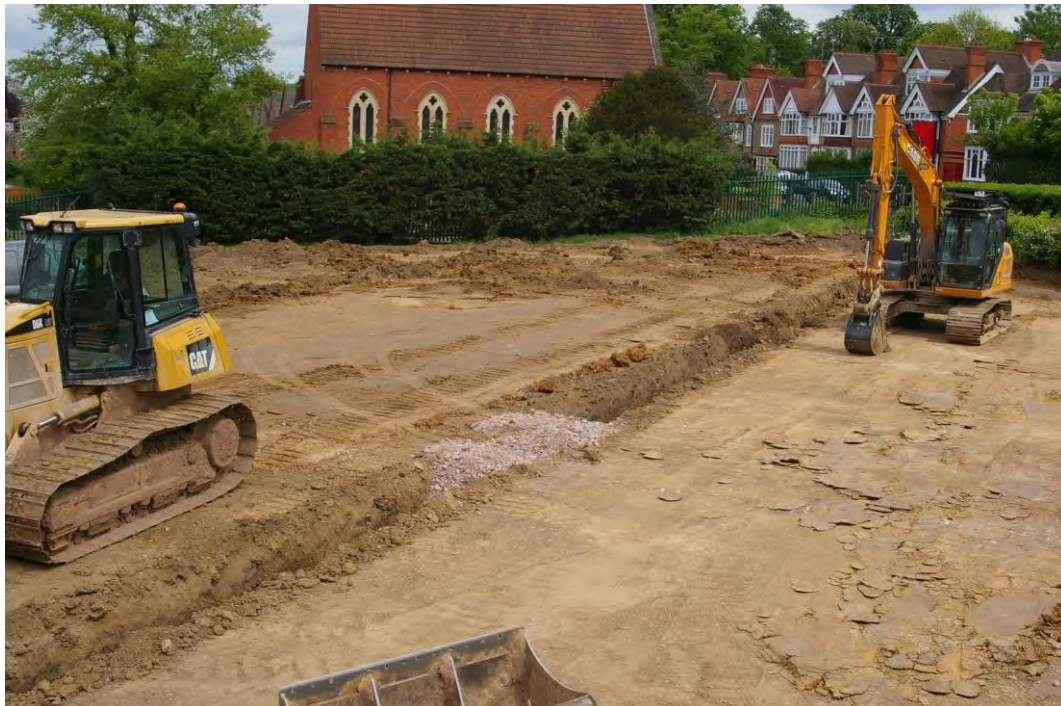
Plate 2. General view of site looking southeast
