JOHN MOORE HERITAGE SERVICES

ARCHAEOLOGICAL WATCHING BRIEF

ST BLAISE, MILTON,

APRIL 2017

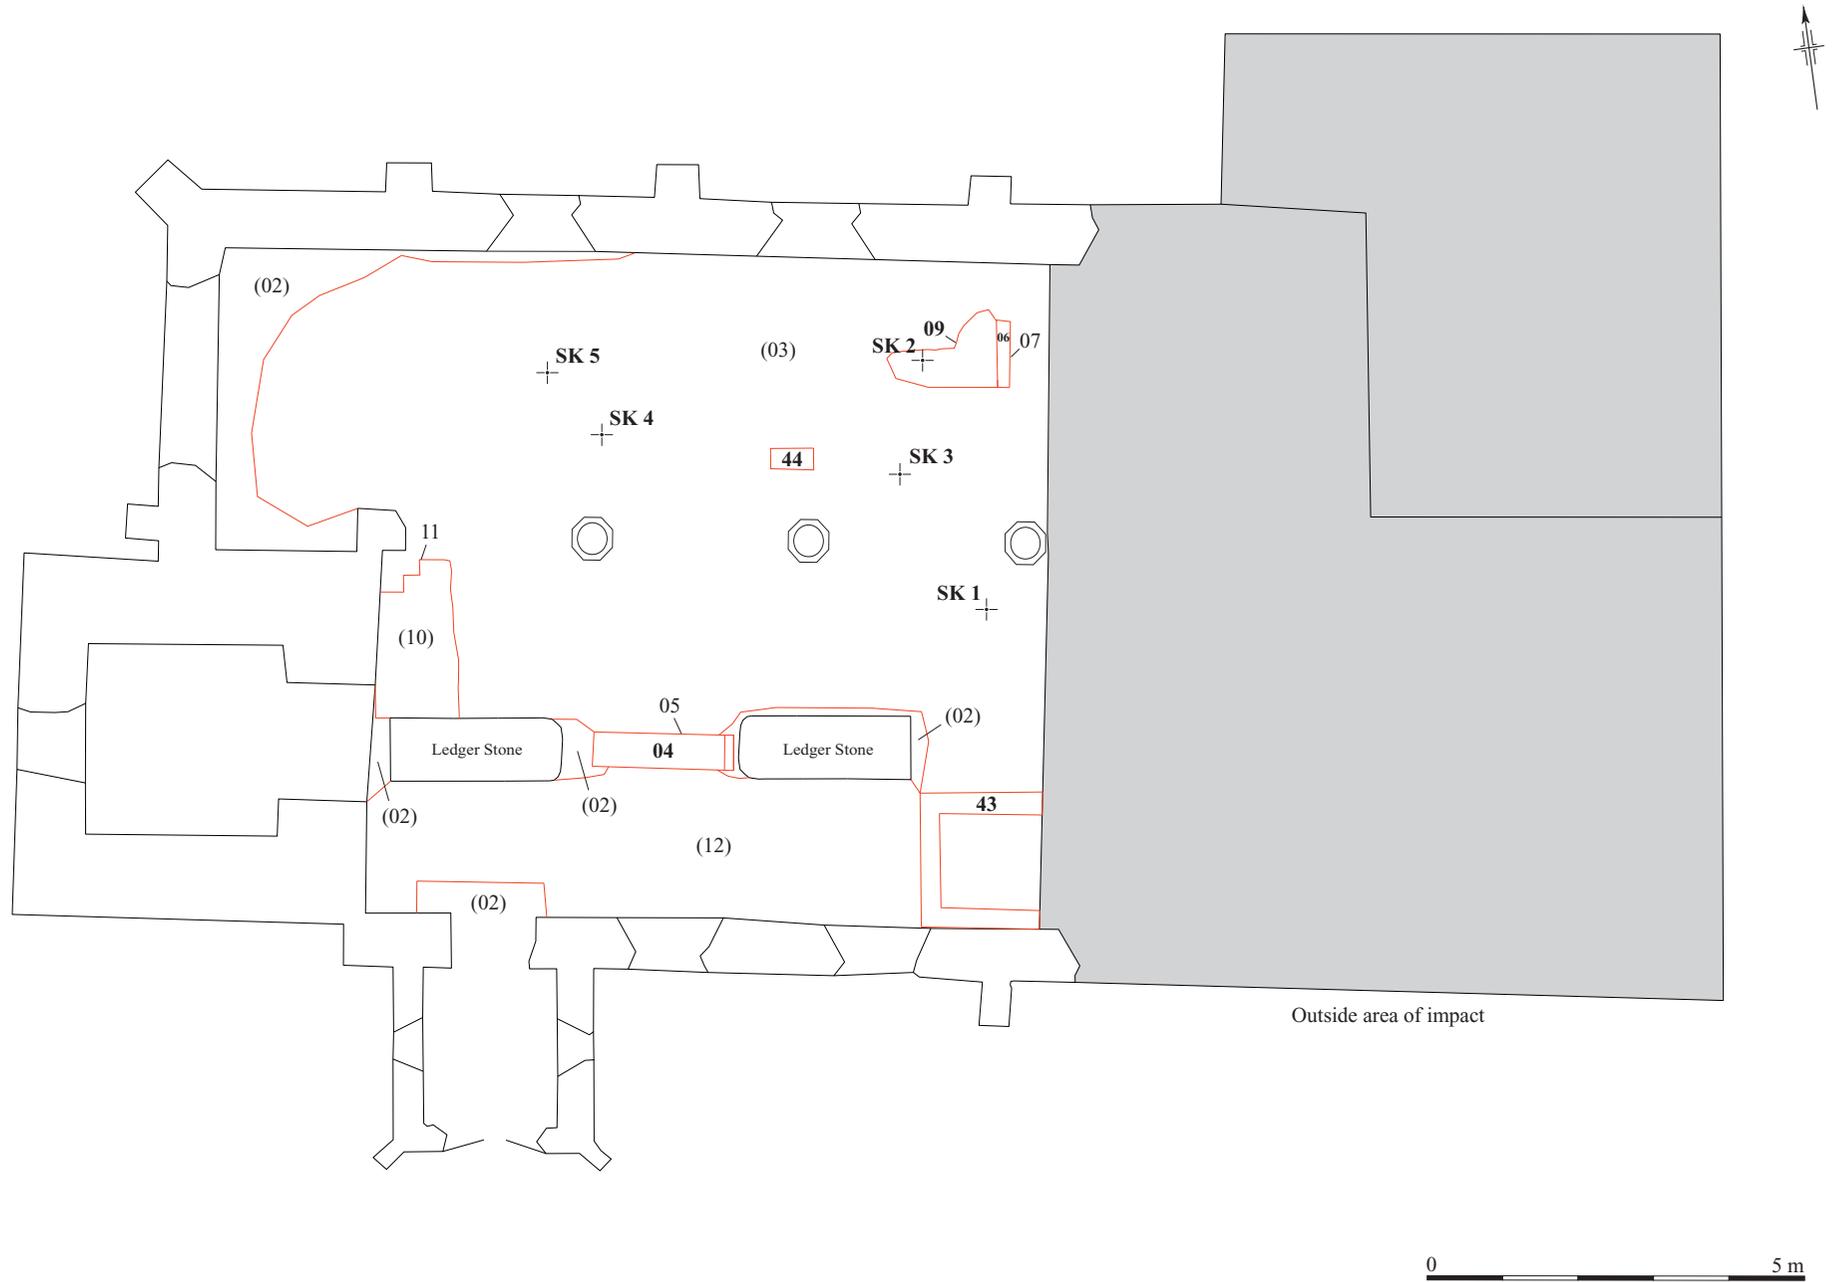
Figure 2: Post excavation plan of interior floor surface

There were 12 contexts identified during the floor removal and levelling activities within the church. Of these, four archaeological features were identified; a crypt, **04**, was of mid-19th century construction based on the non-regulated brick dimensions and the technically perfect appearance of the bricks (Hammond 1990: 31). Crypt **04** was in foundation cut 05, the remnants of a section of foundation wall **06** with its foundation cut 07 and the negative evidence of a previous architectural element 11 from earlier phases of the church's layout, and a possible disturbed grave **09**.

A sub-circular possible disturbed grave **09** or charnel pit was found in the eastern portion of the north aisle. The grave was filled by a loose, mid-brown grey silty loam deposit (08) and measured 1.8m long by 0.7m wide (it was not excavated so there is no thickness). This deposit contained a large amount of human remains, though these appeared to have been badly disturbed (possibly redeposited). This feature was truncated by the remnants of a previous foundation wall **06** in foundation cut 07, which was exposed 0.7m long and 0.2m wide running in an N-S alignment. It was made of worked stone similar to those observed used in the foundation. Approximately 2.5m SW from **06**, a portion of a substantial stone, **44**, was uncovered 0.3m long by 0.2m wide, which could be part of the original north foundation wall of the structure prior to either North Aisle extensions in the 19th century.

An angular negative feature 11, was exposed in the nave abutting the bell tower. Only an area 1m long by 0.5m wide was exposed (abutting the NW corner of the bell tower). It was not excavated therefore further characterisation was not possible.

A recessed masonry feature **43**, was exposed in the nave abutting the subterranean wall between the chancel and the nave, leading to the main crypt. This recessed feature **43** had been fully excavated by the time an archaeologist was contacted to attend the monitoring of the interior area, therefore contextual and artefactual information is not available. It was apparent that steps down in a spiralling manner were part of the original entrance design, but had been removed. Only the shadow of the steps could be seen in the upper point of contact with the chancel wall and the lower point of contact on the recessed flooring 1m below the surface. The structural element measured 2m long by 2m wide and reached 1.1m in depth, abutting the SE corner of the nave which appeared to have been a bricked up entrance into the extant and still used crypt under the chancel.

The first phase of work involved the removal of the extant floor surface within the interior of the nave and north aisle. The area impacted was approximately 9m wide and 11.5m long (see Figure 2).

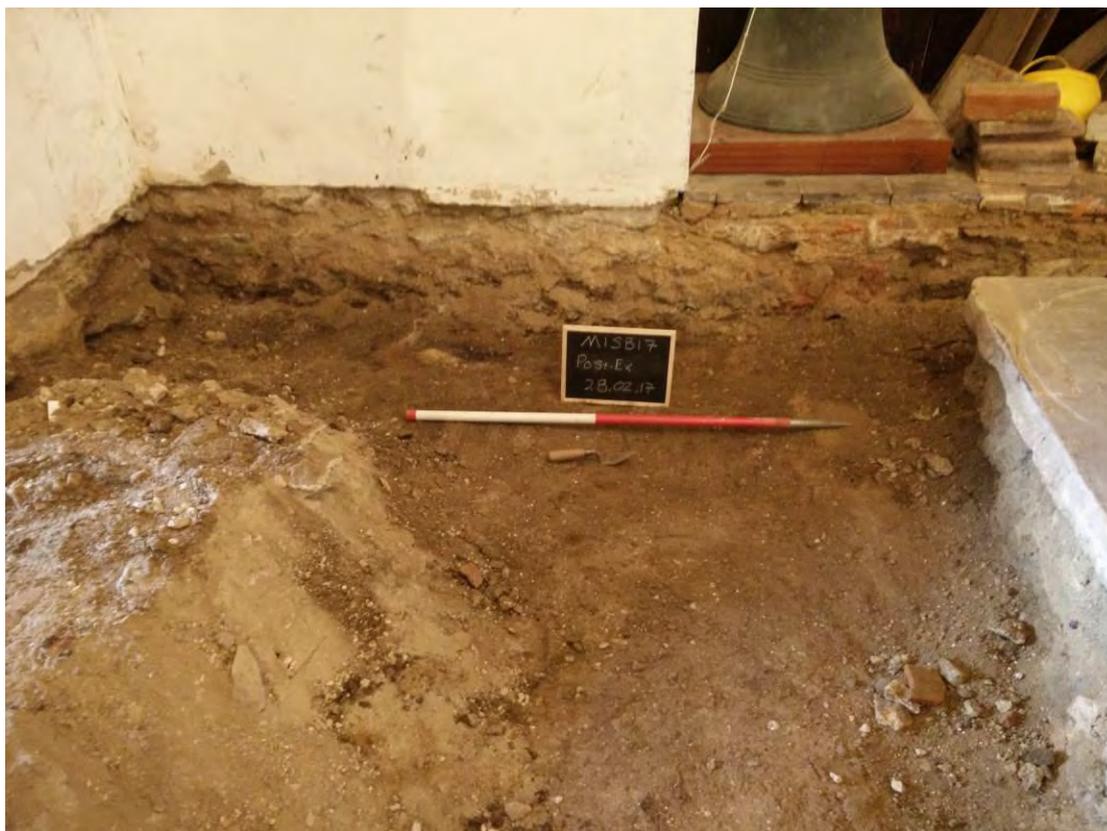
Plate 1: Limit of excavation in SW corner on the interior floor surface facing west. Located with the entrance to the south, bell tower to the west and ledger stone to north. Looking west.

This was followed by the excavation of a very shallow foundation to level the area for the new flooring and services for the building. The trenches were excavated down to a maximum depth of 0.32m below the floor surface in the south west corner (Plate 1). Four archaeological features were identified in the second phase of work; a crypt of 19th century construction, two cuts from previous architectural elements from earlier phases of the church, and a possible disturbed grave. The only finds were unstratified human remains within the surface deposit in the NE section of the church. These were all disarticulated and were redeposited and reburied *in situ*.

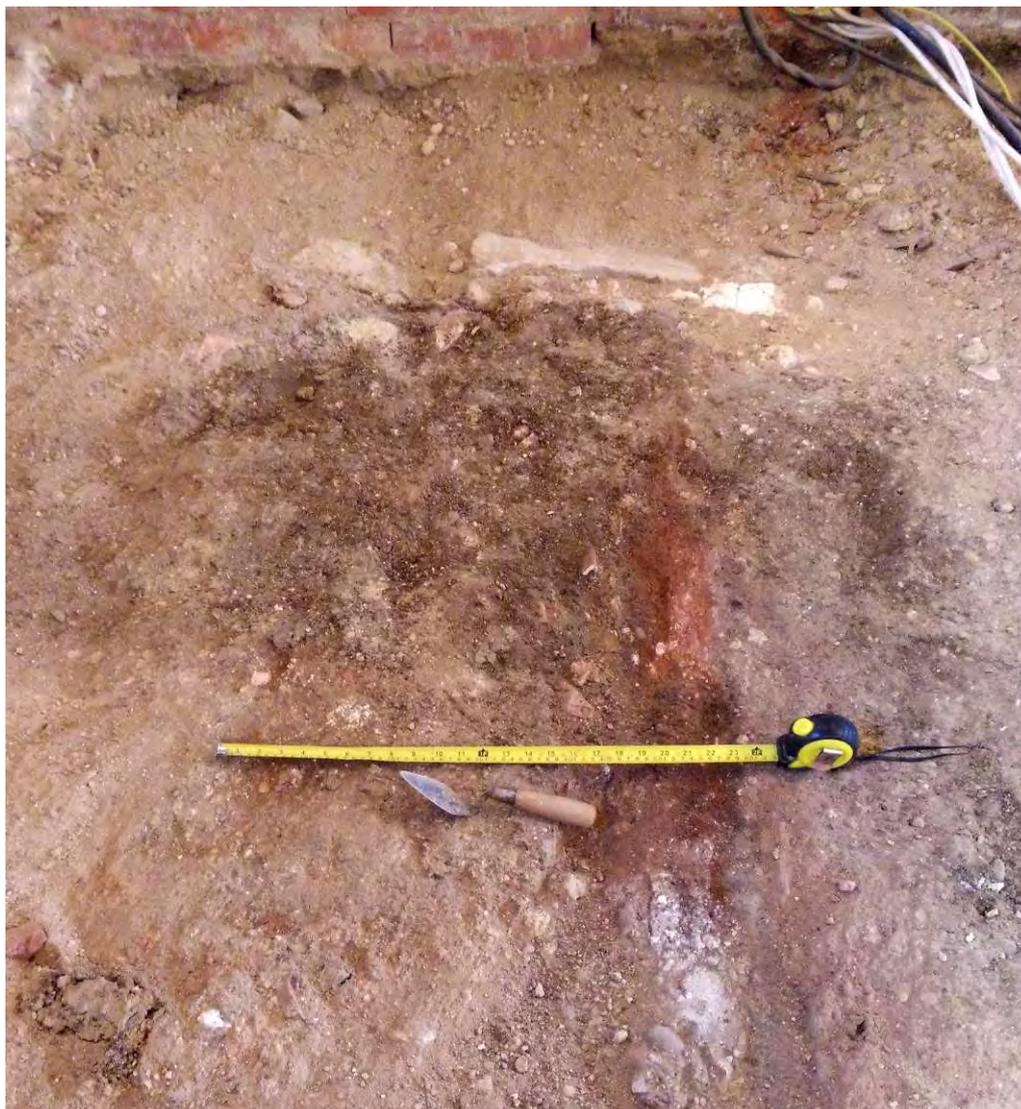
Plate 2: Possible grave 09 shown here to have remains of timber and plaster debris over top, abutted by the stone foundation wall 06. Looking east.

The finds were limited to the structural elements which remained *in situ*, such as the crypt, **04**, and the possible remains of the earlier North Aisle foundation, **06**. Additionally, the fill (08) of possible grave 09 was observed to contain what appeared to be timber and plaster debris (see Plate 2).

The stone foundation, **06**, and the timber and plaster debris in fill (08) of possible grave 09 were likely remains from the original north aisle extension from c.1817, which was demolished in the mid-19th century.

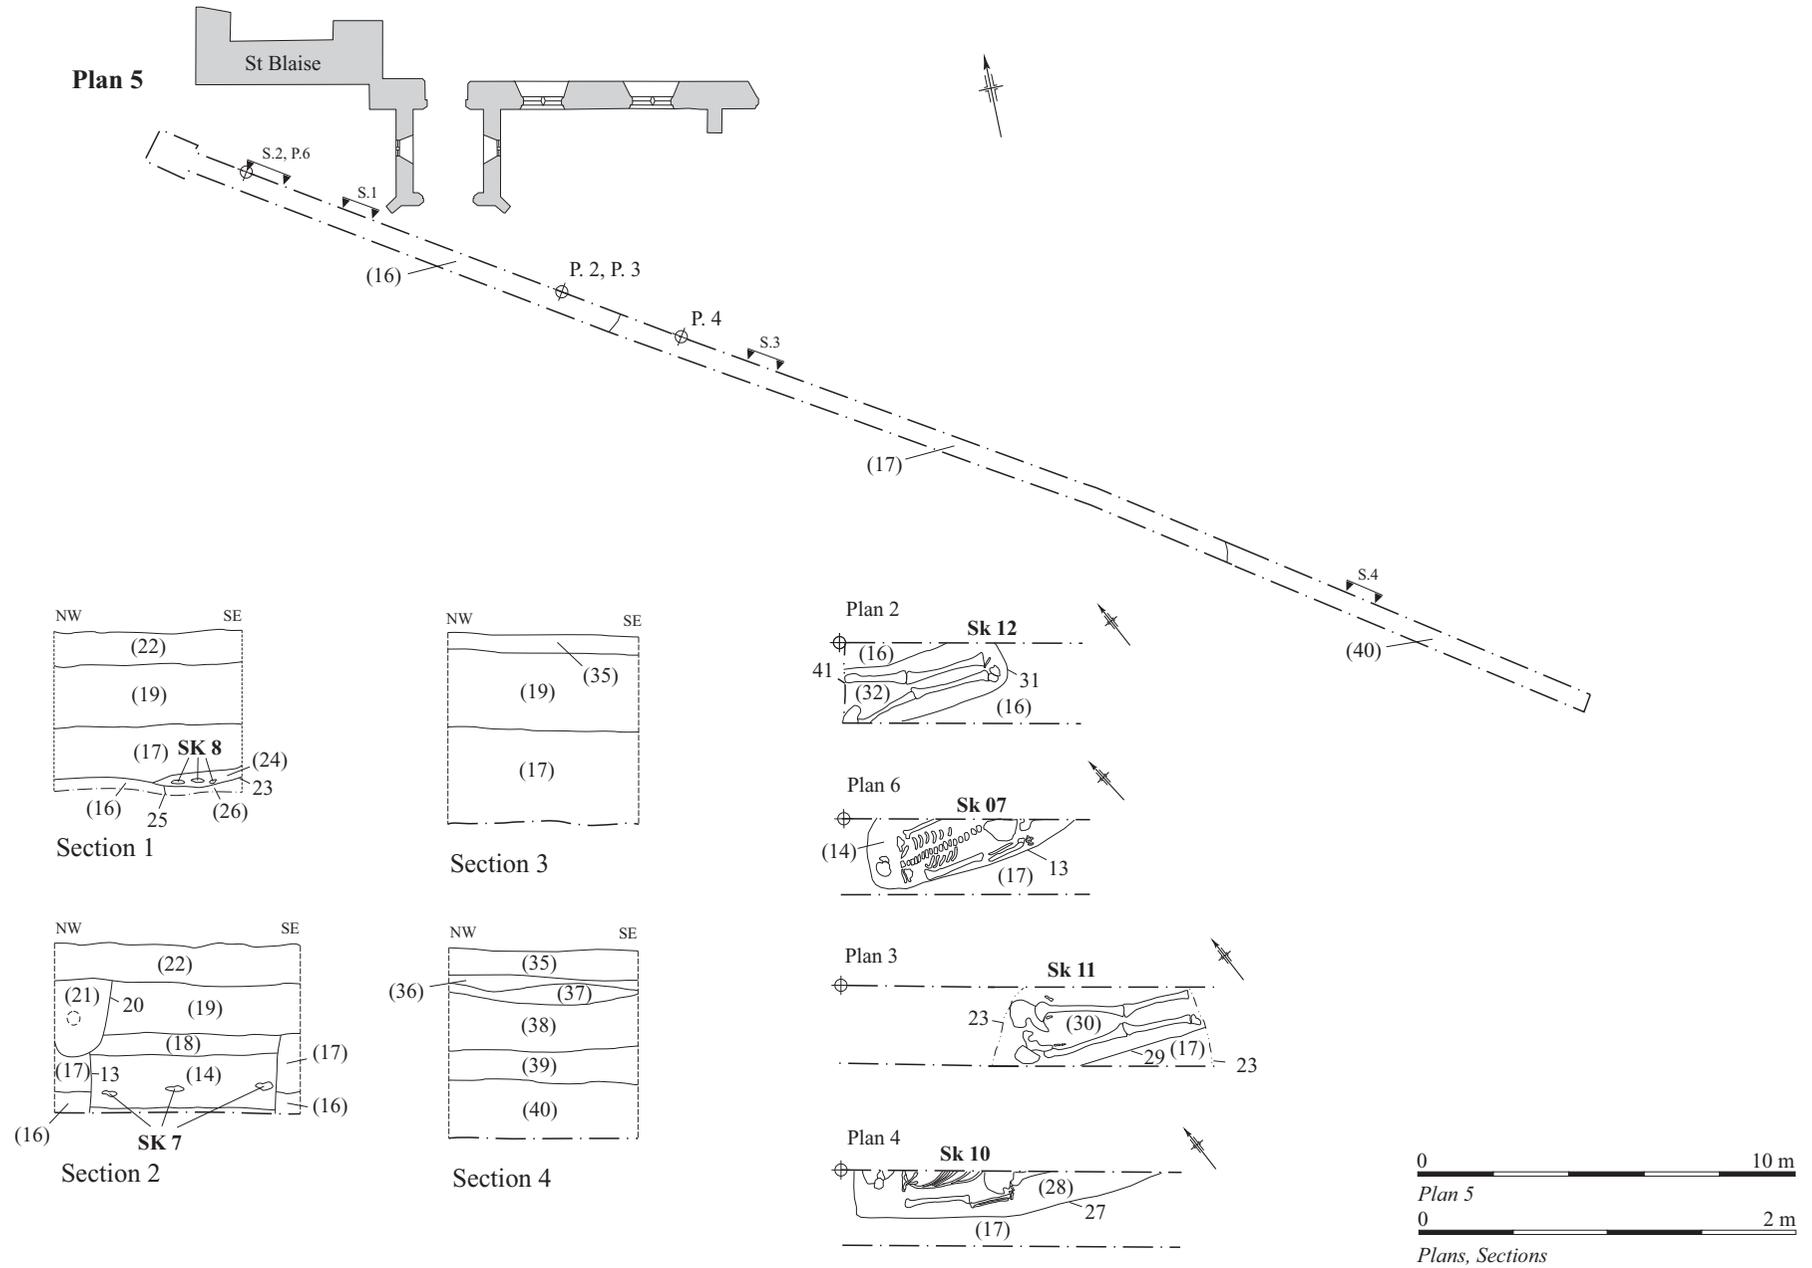
Figure 3: Service trench plans and sections

The lowest observed deposit in the service trench was (16) a compact mid reddish brown fine gravel with a maximum excavated depth of 0.1m. This deposit extended beyond and below the limit of excavation (l.o.e) and was interpreted as the geological horizon. This was truncated by two grave cuts; 25 and 31. Grave 25 was located 5m from the north western end of the trench. The cut measured 0.4m in length by 0.45m in width, extending beyond the l.o.e. to the north; the grave was filled by **sk08** which was heavily truncated from the lower upper body down and (26) a friable dark greyish brown silty loam (Fig. 3, Section 1). The grave had been heavily truncated by 23, a

later gas pipe trench. This cut was 0.40m in depth >0.35m in width and ran the length of the excavation. The cut extended beyond the l.o.e. to the north. 1m in length and 0.50m in width; the grave was filled by **sk12**, which was moderately well preserved and (32) a firm mid brownish grey silty clay (Fig. 3, Plan 2; Plate 3). The cut had been heavily truncated, resulting in the removal of the upper body of **sk12**. It is likely that the grave had been truncated by a later grave cut, although no cut was visible in plan or section; this was recorded as 41, with fill (42) indistinguishable from (17). This was overlain by (17) a firm dark brownish grey silty clay that extended beyond and below the l.o.e. with a maximum thickness of 0.33m; a layer of reworked subsoil.

Graveyard soil (17) was truncated by three grave cuts: 13, 27 and 29. Within the trench grave 13 was 1m in length and 0.45m in width, extending beyond the l.o.e. to the northeast; the grave was filled by **sk07**, which was well preserved and seen to be complete within the area exposed (Fig. 3, Plan 6, Section 2; Plate 4). The presence of iron nails and coffin handle mounts provided evidence for a coffin (15), which was overlain by fill (14) a friable dark greyish brown silty loam. Grave 27 was 1.6m in length and 0.3m in width, extending beyond the l.o.e. to the north; the grave was filled by **sk10** (Fig. 3, Plan 4; Plate 5), which was well preserved and seen to be complete within the area exposed and (28) a firm dark brownish grey silty clay. Grave 29 was 1.1m in length by 0.40m in width and also extended beyond the l.o.e. to the north; the grave was filled by **sk11**, which was well preserved, and (30) a firm dark greyish brown silty clay (Fig. 3, Plan 3; Plate 6). The grave was truncated by 23, a later gas pipe trench (this was the same gas trench that had truncated **sk08**), which had resulted in the removal of the upper body and feet of **sk11**.

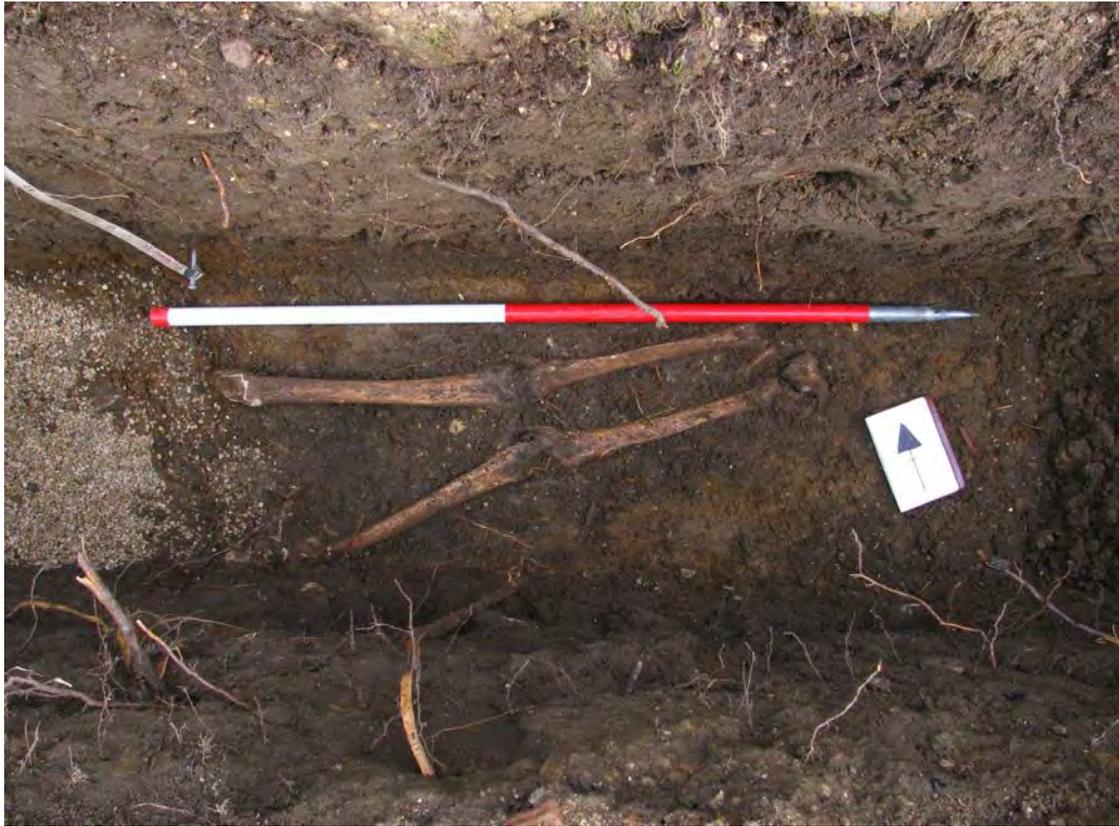
Plate 3: Skeleton 12 within grave cut 31, showing truncation to upper body.

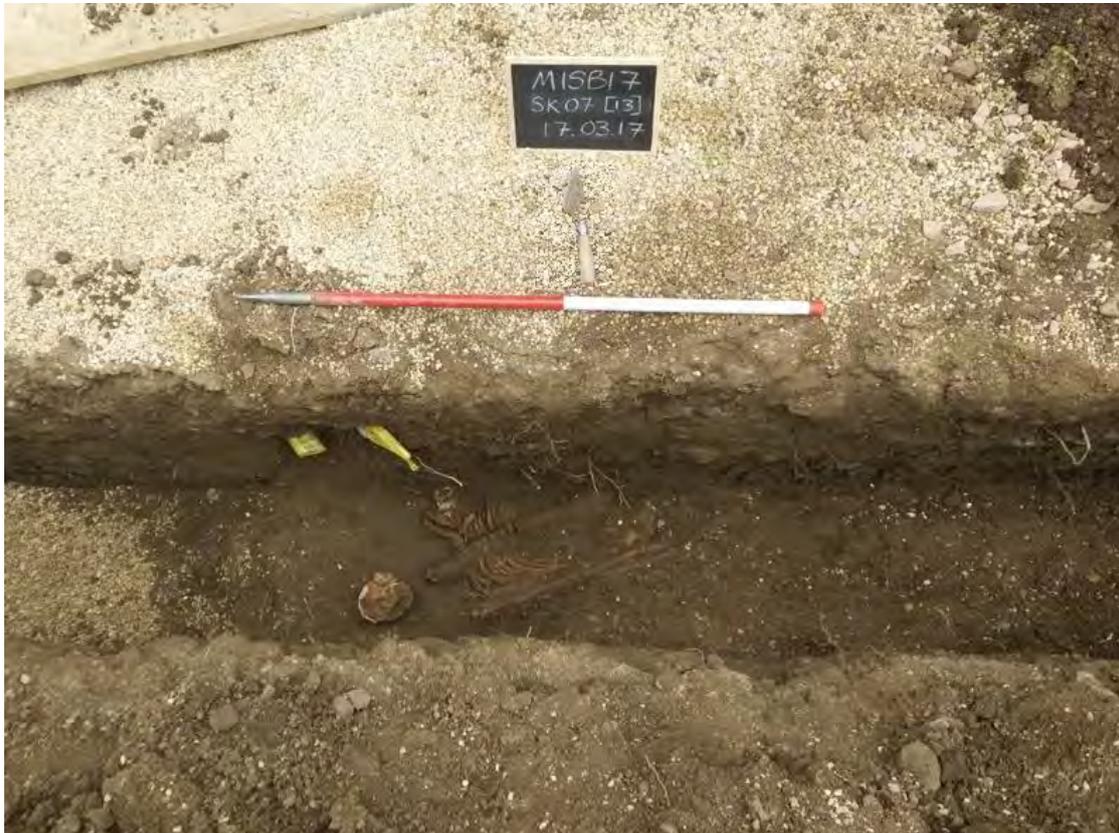
Plate 4: Skeleton 07 within grave cut 13.

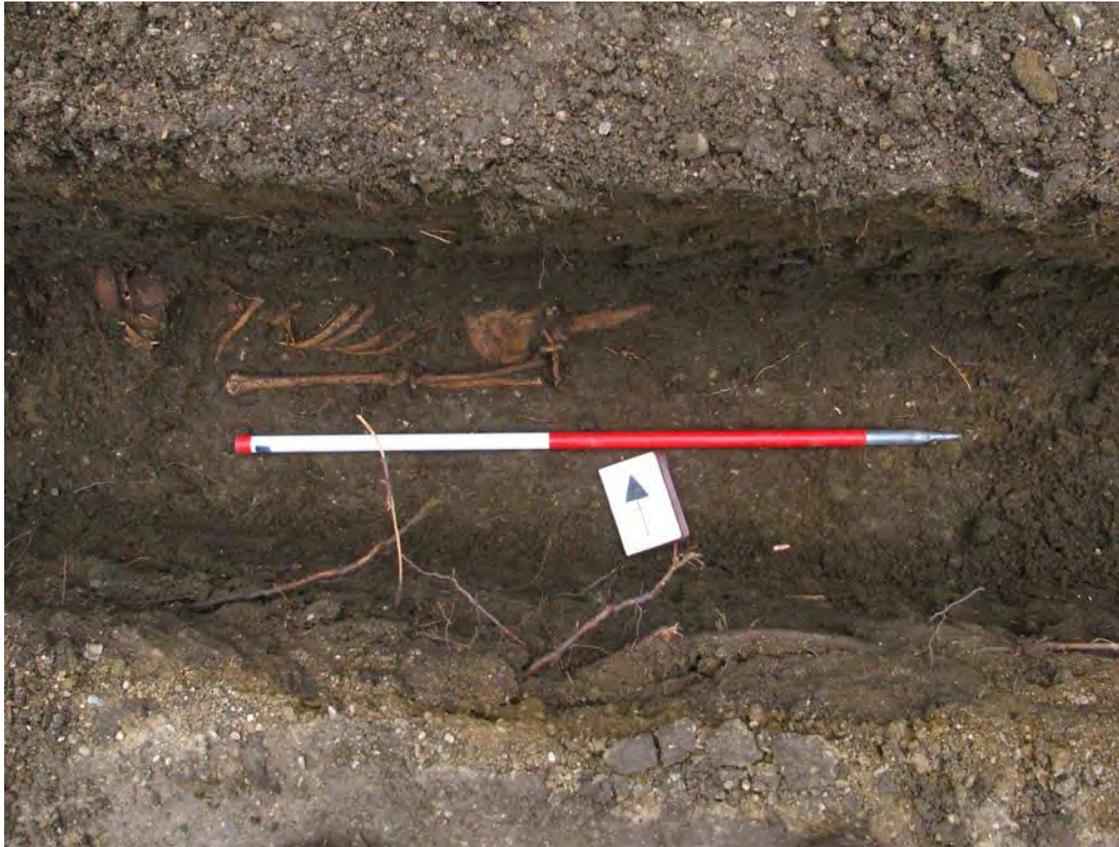
Plate 5: Skeleton 10 within grave cut 27.

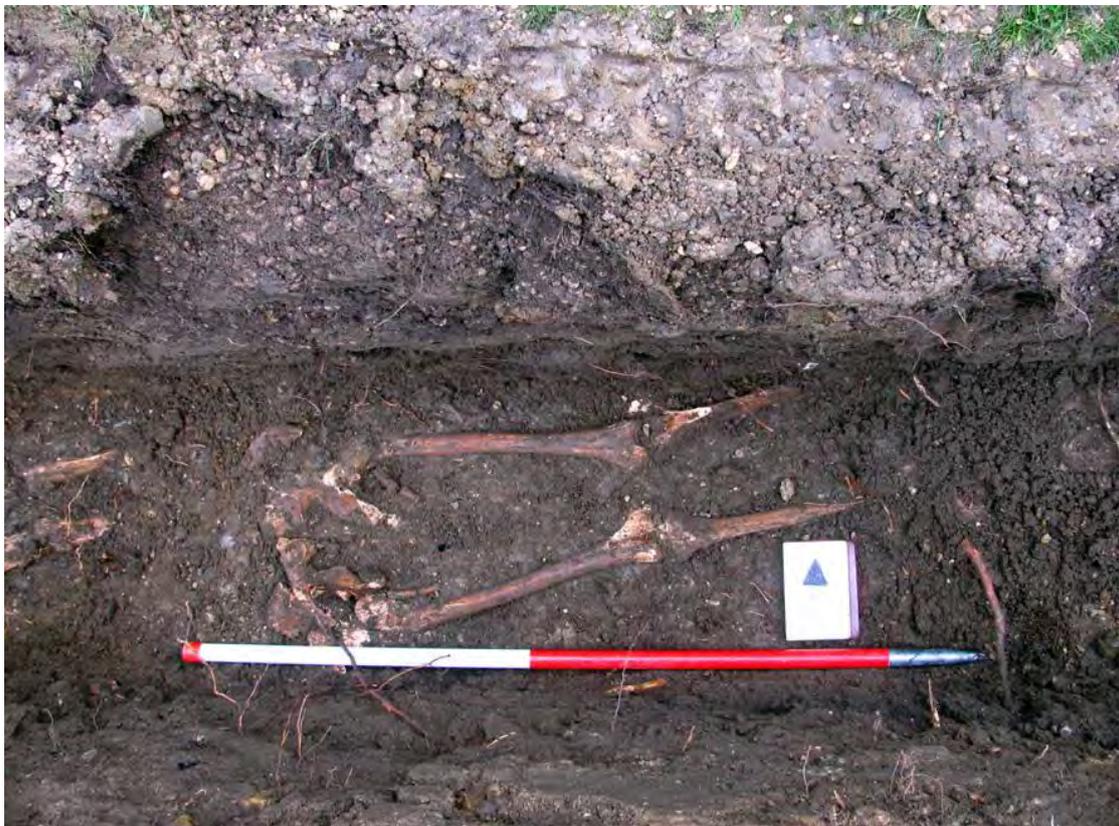
Plate 6: Skeleton 11 within grave cut 29, showing truncation to upper body.

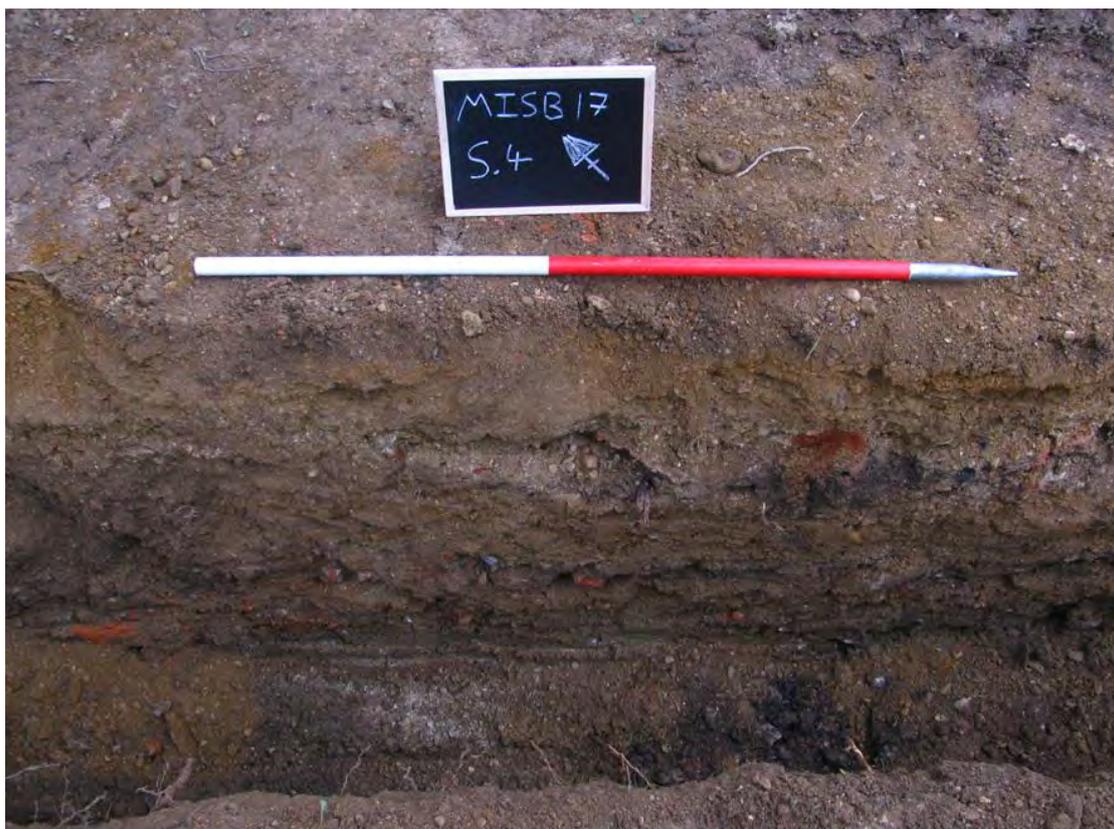
Plate 7: Section 4, showing gravel levelling layers (36) to (40). Looking north east.

At the south eastern end of the trench (19) was overlain by a series of gravelly deposits (Plate 7). These were visible in the trench for a length of 12.5m, increasing in thickness toward the south easterly limit of excavation. The lowest of these was (40) a compact mid brownish yellow sandy gravel 0.3m in thickness containing moderate, poorly sorted fragments of brick and angular limestone; a brick recovered from this deposit measured 230mm x 110mm x 67mm and appeared to be of late 19th century date. This deposit extended below and beyond the l.o.e. and was overlain by (39), a compact mid yellowish grey sandy gravel 0.21m in thickness that contained occasional fragments of brick and tile. This was overlain by (38) a compact mid brownish yellow sandy gravel, 0.32m in thickness which in turn was overlain by (37) a discreet deposit of friable dark greyish brown clayey silt, 1.2m in length, >0.35m in width with a depth of 0.12m. This deposit extended beyond the l.o.e. to the north. The last deposit in the sequence was (36) a compact light greyish yellow fine gravel, 5m in length, >0.45m in width and 0.11m in thickness.

Two possible explanations can be proposed to account for the gravel deposits recorded at the south eastern end of the service trench.

Historically the eastern side of the graveyard formed part of the grounds of the adjacent rectory, and is depicted as such on the First Edition Ordnance Survey map of 1875 (by the second edition of 1899 the current boundary of the graveyard has been established). It is therefore possible that the gravel layers seen in the trench are associated with this change in use, representing levelling layers deposited in order to raise the ground level of the former rectory grounds to that of the graveyard.

The alternative is that these layers represent evidence of the ‘church pond’ mentioned briefly by Davenport in her 1927 history of the village and described as follows: ‘*A few people remember the Church Pond, it being eventually filled in and included in*

the Churchyard'. This pond appears on the 1875 OS map and is located immediately to the south west of the footpath. The gravels may therefore represent a series of infilling and levelling deposits associated with the former pond.
