ARCHAEOLOGICAL WATCHING BRIEF

LAND ADJACENT TO 7 BEAUMONT CLOSE,

MAIDENHEAD, BERKSHIRE SL6 3XN

FEBRUARY 2016

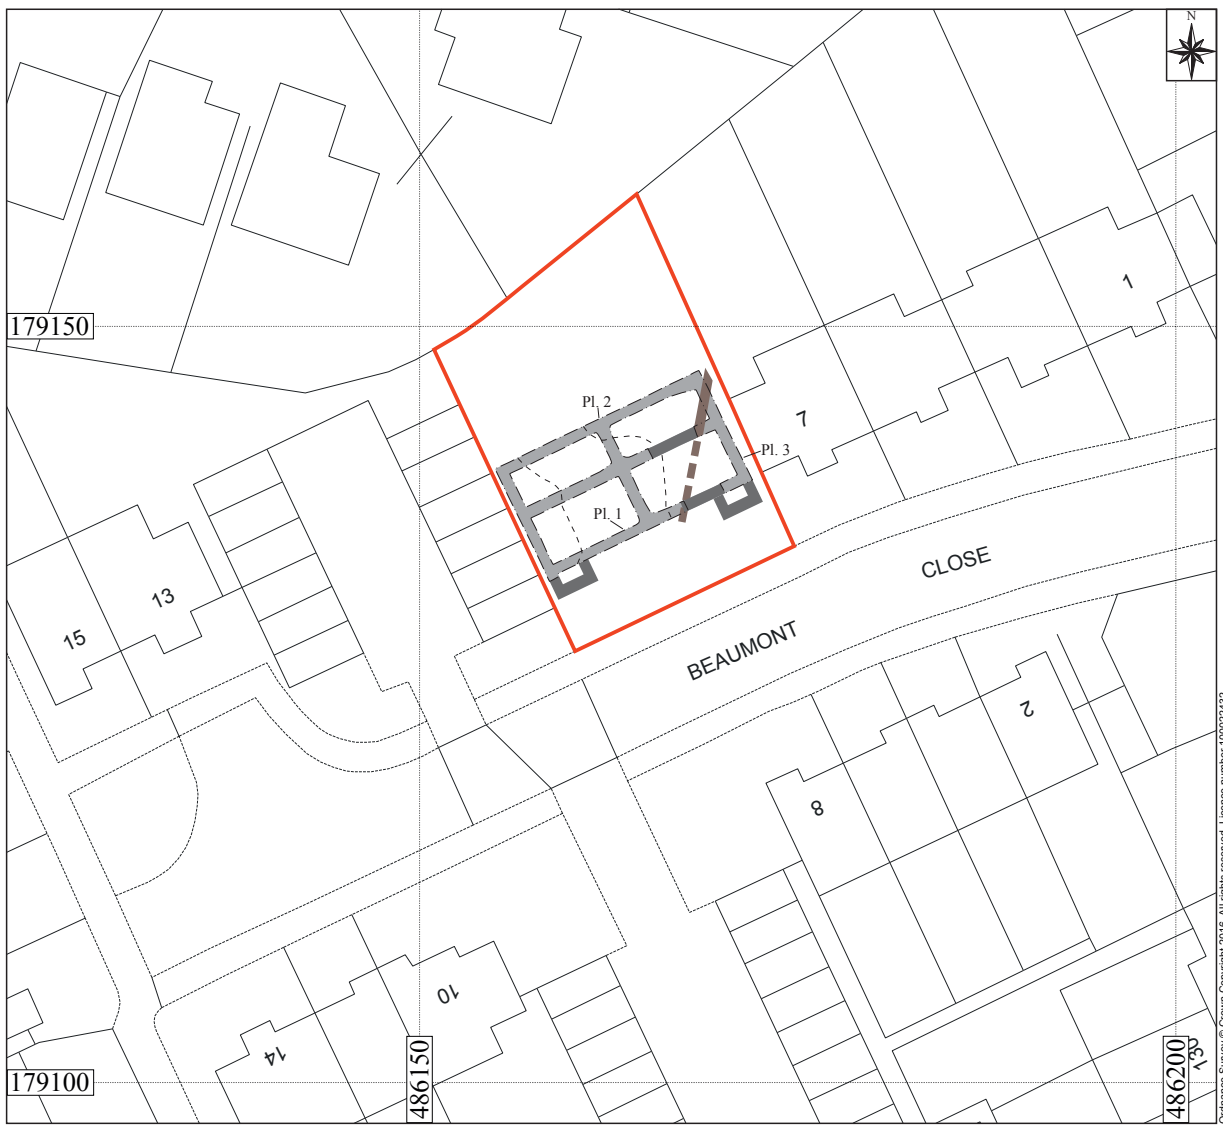
Figure 1: Site location

Key Site boundary Monitored area Not monitored area
 Foot of natural chalk ridge Sewer pipe

56.50 m of foundation trenches were monitored. They were 0.70 m wide and varied in depth from 1 m to 1.57 m from the present ground surface (Fig. 1).

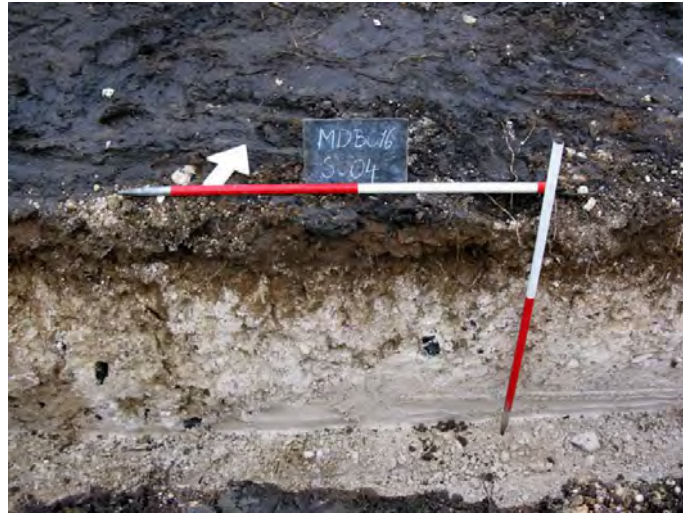
Plate 1: Representative section of SSE foundation trench, looking NNW

Four successive layers and a sewerage pipe were presented within the monitored foundation trenches. The lowest deposit encountered within the foundation trenches was 0.06 to 0.66 m thick (as excavated) natural chalk with a high percentage of flints (103), interpreted as bedrock geology (Pl. 1 & 2). It formed a natural ridge in the central area of the site (Fig. 1). Deposit (103) was overlaid by 0.20 to >1.37 m thick deposit of mid reddish brown sandy silt with a moderate amount of flints (102), interpreted as superficial natural deposit (Pl. 1, 2 & 3). Deposit (102) was cut by 20th century sewerage construction cut located in the east portion of the monitored area (Fig. 1), and overlaid by 0.08 m thick deposit of light pinkish grey sandy gravel (106) encountered as the southeast corner of monitored area (Pl. 3). The uppermost deposit within the monitored area was layer of 0.18 m thick dark grey loam (101), which

represented a topsoil (Pl. 1, 2 & 3). The topsoil contained 20th century rubbish and fragments of bricks.
