**AN ARCHAEOLOGICAL EVALUATION AT  
WINTERHILL FARM, WINTER HILL,  
COOKHAM, BERKSHIRE**

**(NGR SU 8757 8625)**

**MARCH 2015**

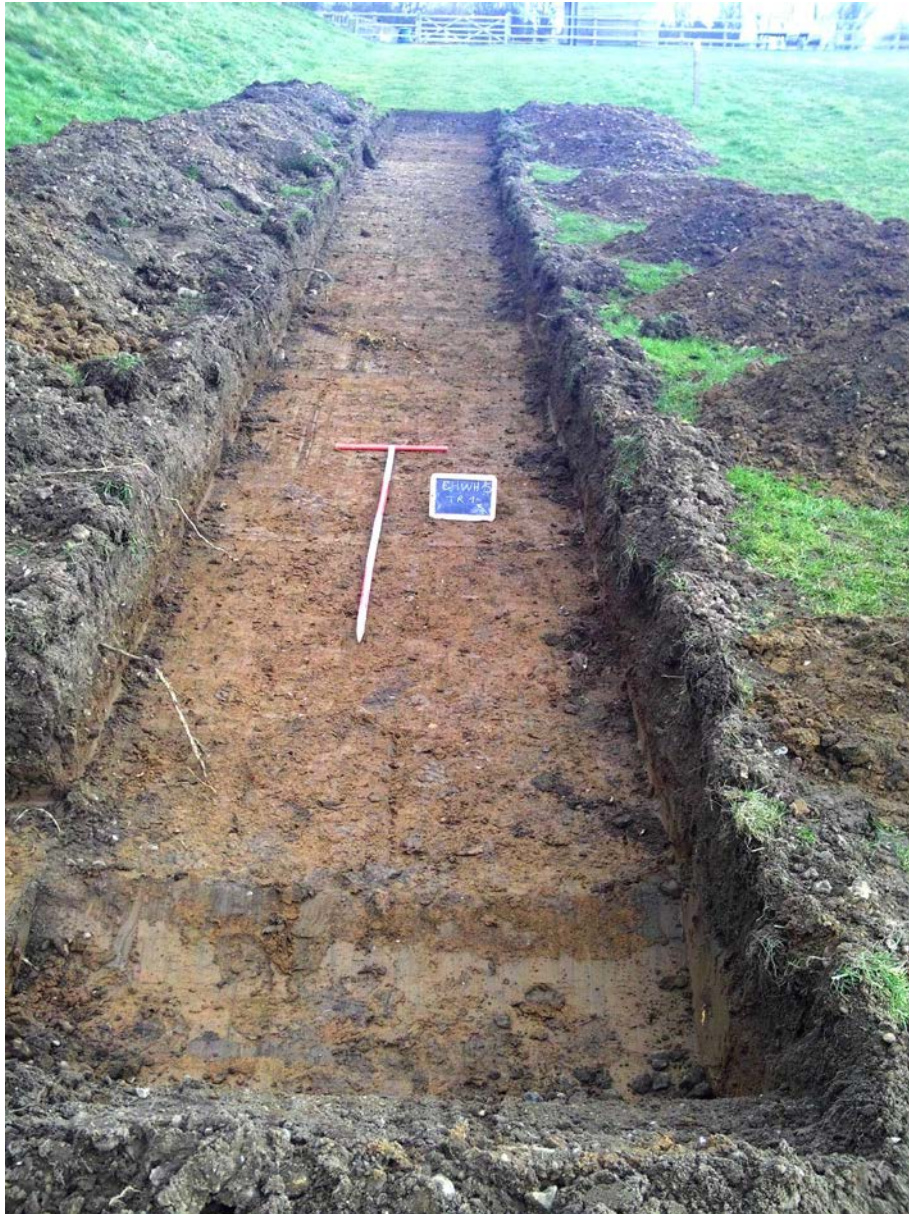
The geological horizon (1/02 and 1/03) was encountered at a general depth of 0.3m (71.98m OD, NE end, 70.36m OD SW end) and consisted of loose pebble gravel (1/02) to the north-east of the trench, sharply changing to moderately compact mid brown silt towards the south-west end of the trench.

The geological horizon (1/02, 1/03) was overlain by a deposit (1/01) of loose, mid grey silty sand with 60% poorly sorted sub angular flint gravels, generally 0.26m thick.

Layer (1/01) was cut by two land-drains, generally filled with re-deposited geology. Modern brick and tile was noted within these features. No finds were noted from deposit (1/01) although it is likely to represent a ploughed soil of post-medieval/modern date.

Sealing the land-drains and overlaying (1/01) was the current turf and topsoil (1/04), 0.12m thick.

Trench 1. View to north-east.
