The George Inn
Dorchester-on-Thames
South Oxfordshire District

Historic Building Assessment

May 2010

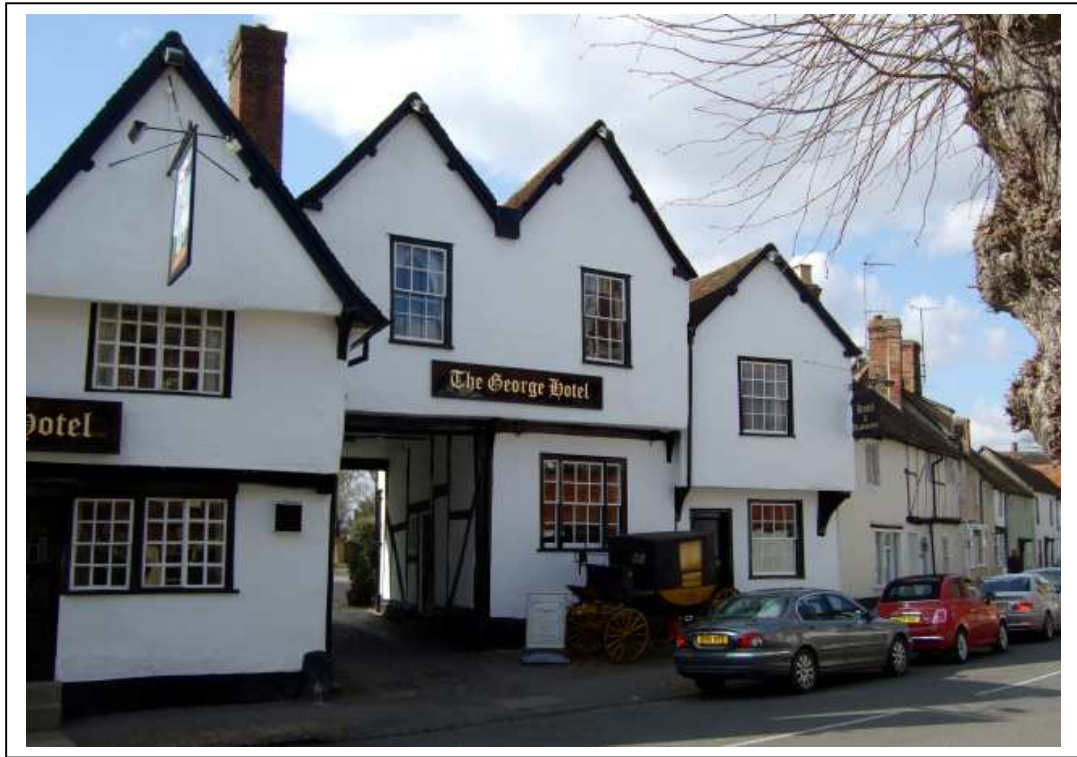
Fig. 3: The first room north of the George Inn entrance and the second room on the right in the adjoining 'shop'

- 3.2.1 Of the two rooms north of the entrance one occupies the outer room of the medieval inn, and the other is in the adjacent building to the north. The side walls of the entrance passage have exposed medieval timber framing of large posts and braces, but almost none of this is now visible inside the north rooms.

- 3.2.2 The *first room* off the passage has a modern door and renewed windows, and a curious modern fireplace made up of older materials. The west wall of the room appears to be a modern partition, and beyond this is a store room reached from the yard through a renewed door, perhaps originally of 18th-cent. date. This store room has in the rear north-west corner a large post which is likely to be the outer corner of the medieval frame (following across from the diagonal line of the medieval rear wall).

- 3.2.4 The *second room* is now reached from the first through modern double door, though it also has a door to the street from when it was a separate premises. In the party wall there is one timber post next the double door and some modern stonework beneath it, but no other indication of framing. This room has a window and a former door to the street, and a door at the back to the passage. At the end of the room next the back door is a cupboard. The cupboard and back doors are both modern fire doors in an older, 19th-cent. frame. Both rooms have solid floors that may be concrete.

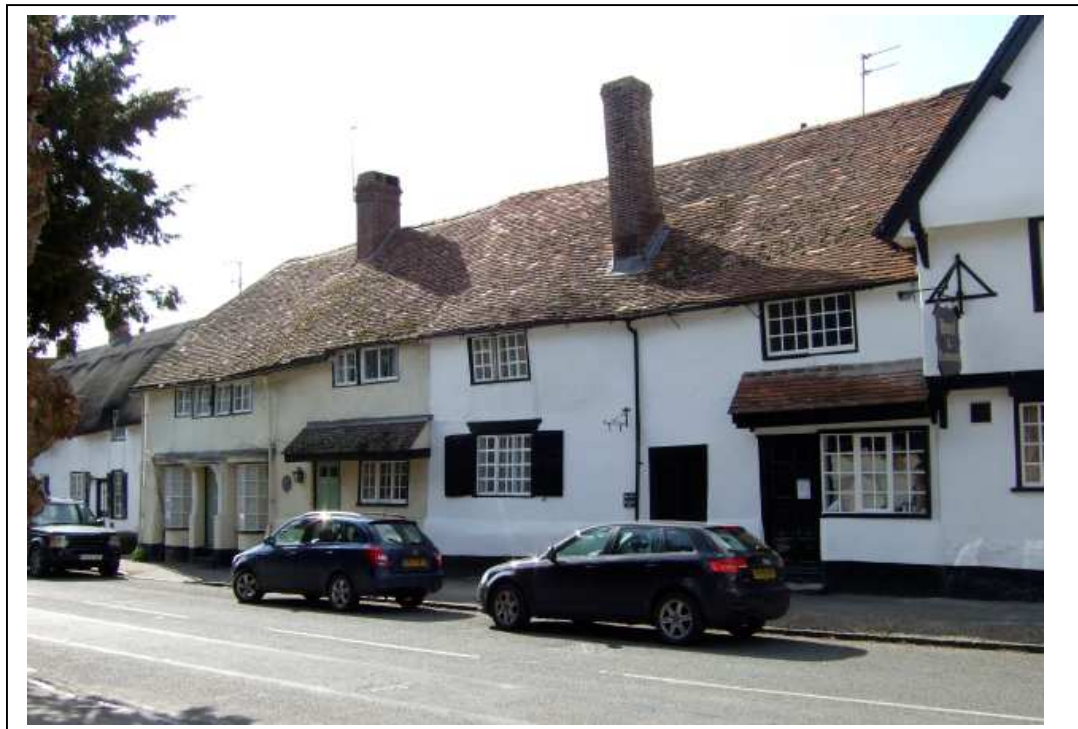
Fig. 4: The row of cottages south of the George Inn
(No. 25 is on the right, with a notice on the door)

- 3.3.1 As described above, the cottage is certainly part of a pair with No. 23, and possibly once formed a longer row. It was formerly a small shop, and has its own front door beside the door to the brick-paved passage that divides the cottages. The front is timber-framed on an offset plinth and the rear has two brick gables (one for No. 23, one for 25) that indicate a rebuilding at the back part in the late 18th or early 19th century.
