BUILDING RECORDING

THE STABLE BLOCK, MANOR FARM,

CHURCH STREET, HAMPSTEAD NORREYS,

WEST BERKSHIRE

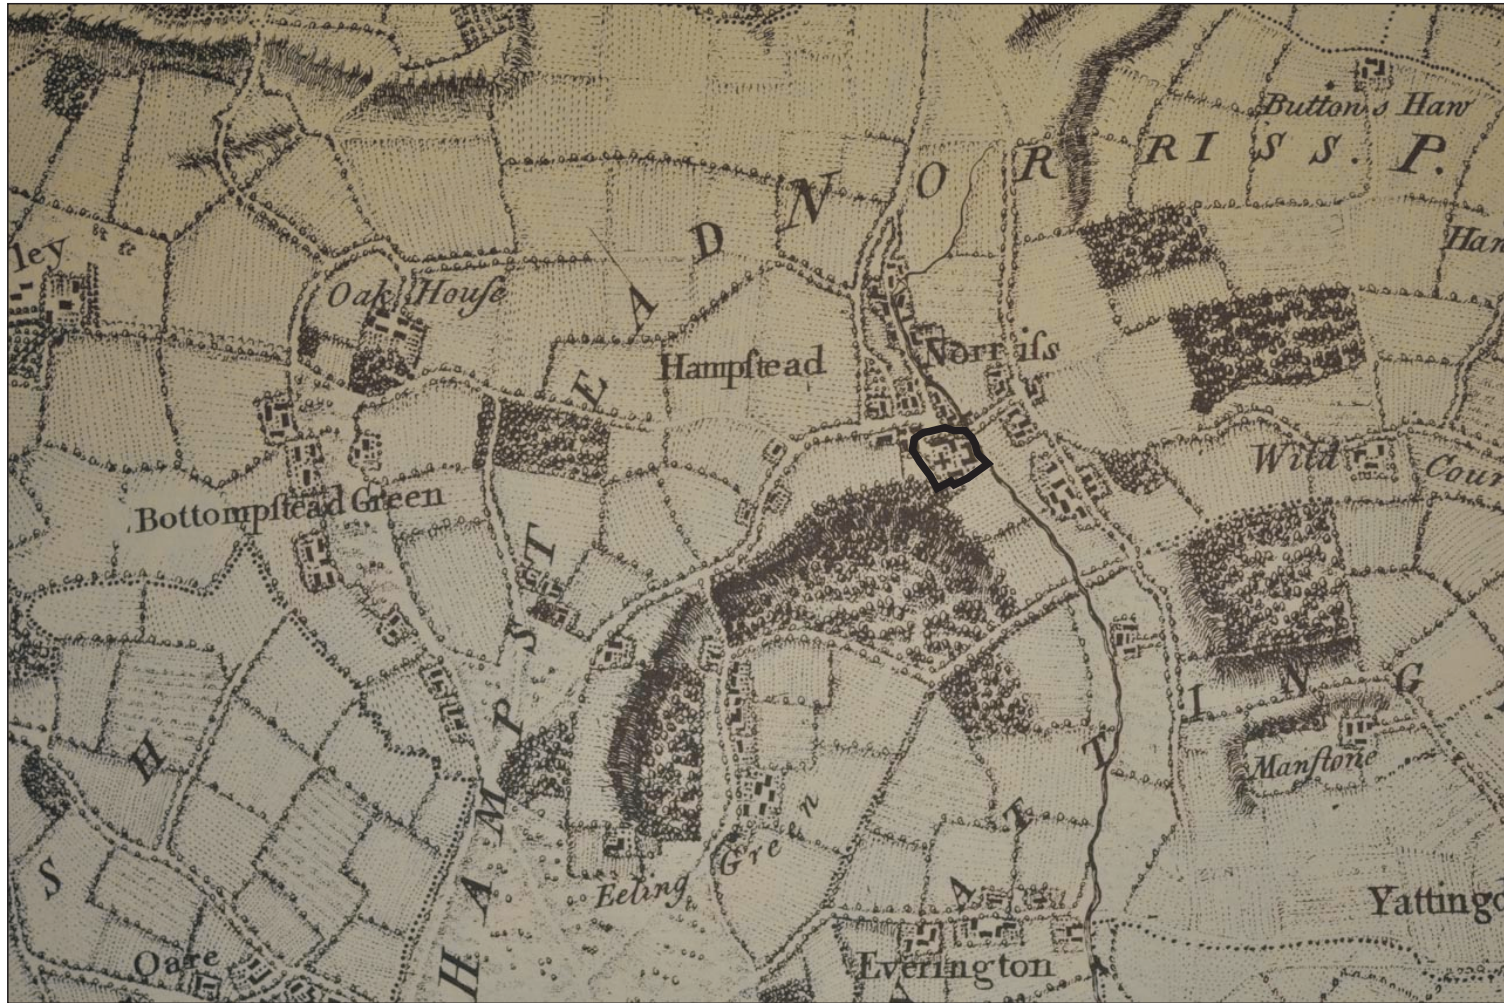
Figure 2. Rocque's map of 1761 showing the Manor Farm complex, with a winged building depicted to the east of the Manor

- 2.2.7 Rocque's map of 1761 (figure 2) shows a square building to the northeast of the church in the village of Hampstead Norreys. The great threshing barn of the 16th century is shown to the south of the church, while adjacent to this to the east there is a large building shown with two wings. No other structures are shown on the map between it and the Pangbourne Brook. It could feasibly be argued that part of this structure represents the L-shape configuration of the stable block, with a now missing wing to the south, presumably south of the evaluation carried out by John Moore Heritage Services. If this is the stable block then the map would indicate that the structure is earlier than had previously been thought.

by Thomas Baldwin, which uses a chequered design of blue and red brick. It is apparent that buildings of the earlier 17th century use English bond predominantly not Flemish, for example West Woodhay House of 1635 (Tyack, Bradley et al. 2010, plates 43, 44). It was noted earlier that Rocque's map of 1761 shows a two-winged structure to the east of the manor house. If this building is that which is represented then it is highly likely that a series of phases were made in the earlier part of the 18th century.

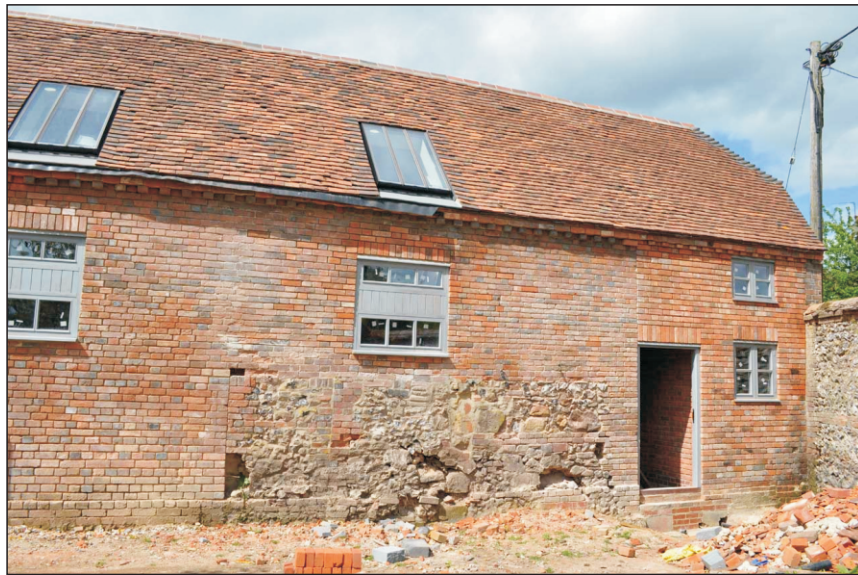
Plate 1. The rubble and brick wall of the Phase 1 building.

there is evidence of an earlier rubble and brick wall, either part of an earlier building or a garden wall. To the right of the north butt there is a door with flat head, blocked features occur to the right of this.

- 4.1.1 The rubble and brick wall on the northeast side of range B may represent the remains of a substantially older structure or equally plausibly the remains of a wall similar to the one butting up to the east side of the stables. This has to be considered as phase 1 (elevations 4 and 5, fig 4, plate 1).

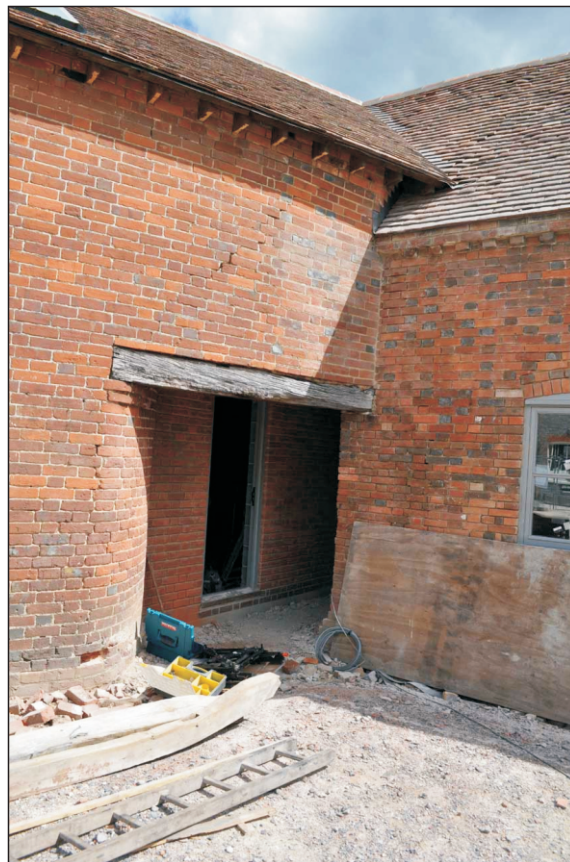
Plate 2. View of Phase 3 front elevation 4

- 3.4.1 The west façade of range B (elevation 4, fig 4; plate 2) can be divided into two component parts as there is a butt joint in the middle of the wall. Each component part has a similar design in that they have a central doorway with segmental arches and stable doors. There are windows located to the east and west of these doors on the ground floor with segmental arches. In both cases above the doors and the right hand windows further windows are set into the upper storey. In one case the roof is flush and in the northerly one a dormer roof is apparent. There is a brick corbel line that runs under the eaves of the building. The positions of the corbels suggest that the southeast part of this range is the older brick component.

- 4.1.4 The northwest unit of range B was added to that of the southeast unit. It is apparent internally that this gable once had a hipped roof at its northwest end. This suggests that the east range of the L-shaped building was completed first. This event if the Rocque map is correct also had to occur in the earlier part of the 18th century. This is interpreted as phase 3 (elevations 4 and 5, fig 4).

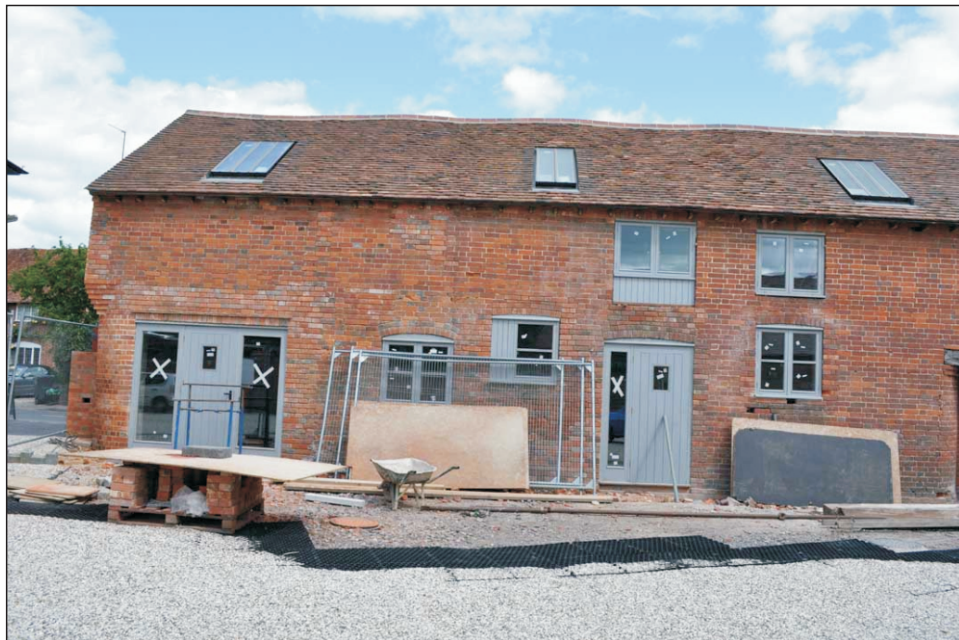
Plate 3. South elevation of Range A (Elevation 1)

- 3.2.1 The south wall of the north range indicates that this structure is a two-storey building (elevation 1, fig 4). The brickwork is Flemish bond, with mainly red bricks and with occasional blue bricks in some places used end on to create a chequer pattern although this is not universally applied over the extent of the wall. The west end has a lower storey with a rounded corner with a corner projection for the upper storey. A brick moulding can be observed above this. A door and window have been placed into the wall on the ground floor at the west end, with a large wooden lintel. A small opening or window light can be observed to the right (east) of this in line with the upper part of the door lintel. Below this are the remains of a blocked window with a segmental arch. In the central part of the façade is a stable door with segmental arched head. Either side on the ground floor are the remains of two windows with segmental arches and four lights. Above the door are the remains of a loft door; while above the right window are the **remains of a further window**.

Both of these features extend to the roofline. At the east end of the south façade there is an opening with a wooden lintel. The wall curves from the west into this opening. A possible butt can be identified above the lintel.

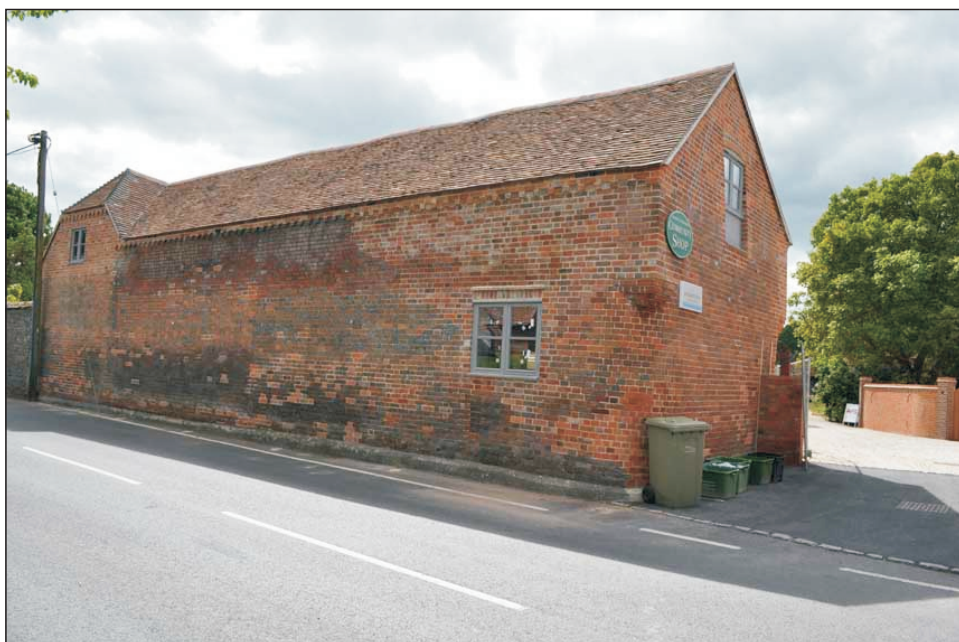
Plate 4. North elevation of Range A (elevation 3)

- 3.2.3 The north wall façade (elevation 3, fig 4) consists largely of a blank wall with a mixture of red and blue bricks that are largely un-patterned. There is a plinth along the base of the wall with the west end of the wall being part of a rounded corner. The first floor corner projects. In the west end of the wall are the remains of a window light with a flat lintel. There is a butt joint underneath this suggesting that this may have been the location of an earlier door. A brick corbel line runs underneath the roof eaves. The east end of the wall forms a hipped gable with a corbel line inserted into the gable. There is potentially a join in the wall where the gable meets the north wall of range A.
