A Record of Stables
at
FORD'S FARM, HIGH STREET
EWELME, OXFORDSHIRE

K A Rodwell
for
JOHN MOORE HERITAGE SERVICES

May 2007

A RECORD OF STABLES AT FORDS FARM, EWELME, OXON

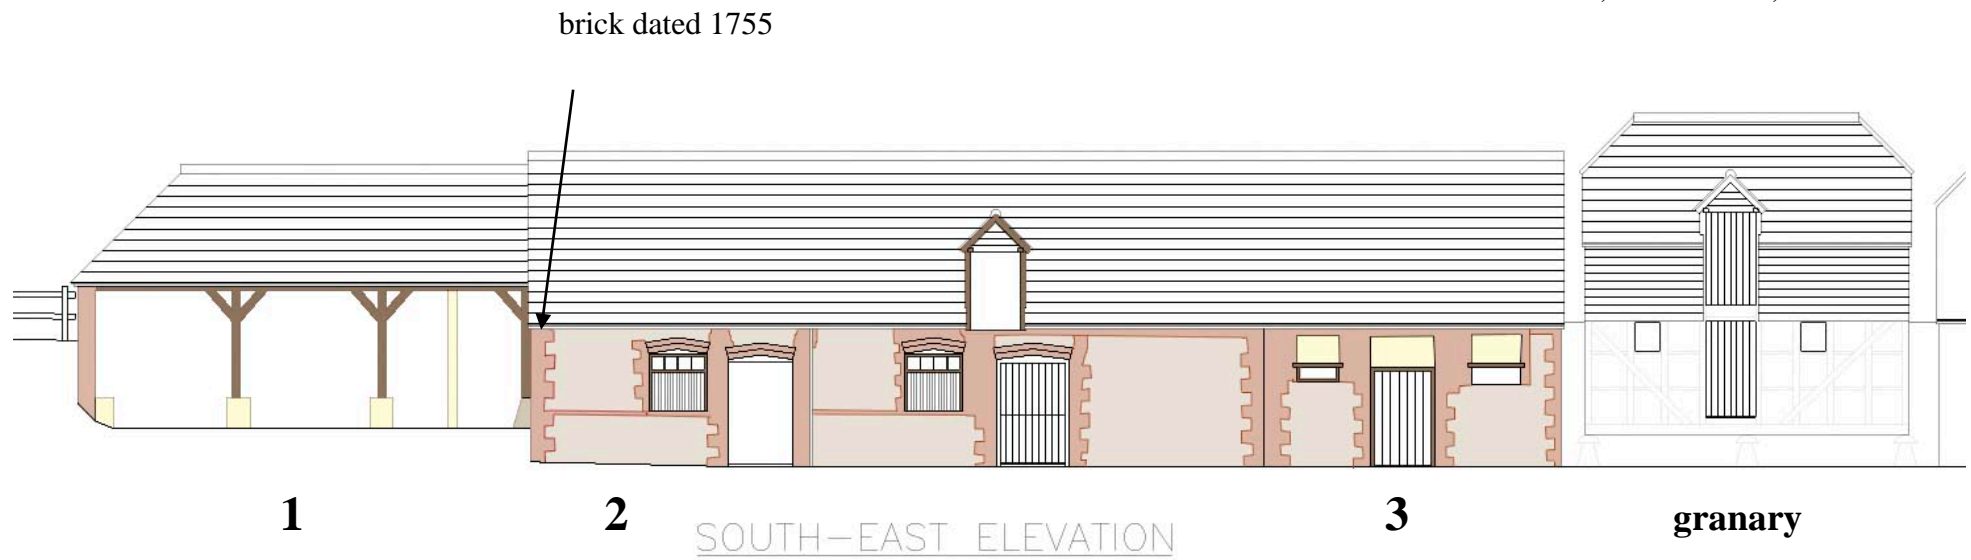
Fig 2 Elevations & sections

Locations shown on Fig 1

The buildings occupy the western side of the farmyard, which forms a separate enclosure to the south-west of the house, and are cut into the bank alongside the road. The principal elevation faces south-east and the range is composed of three distinct units. Plans are shown on Fig 1; sections and elevations on Fig 2.

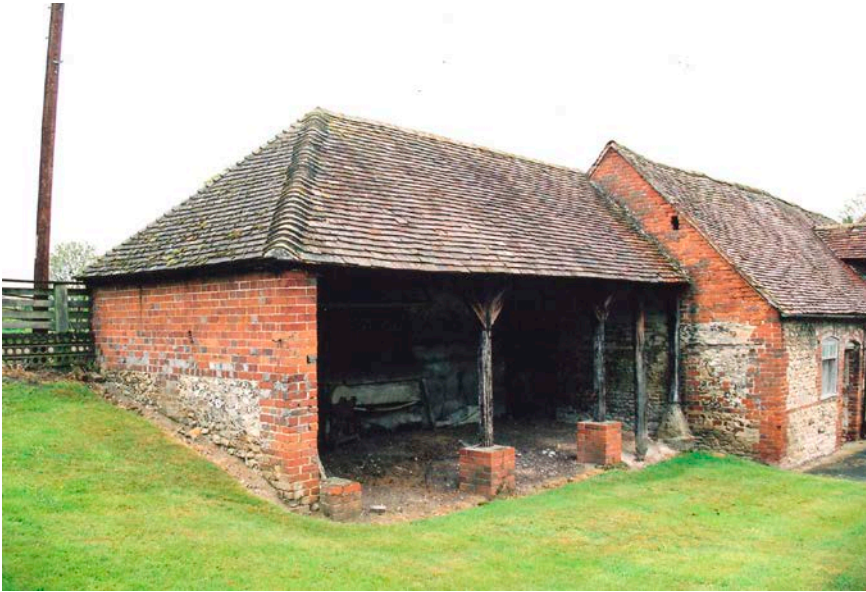
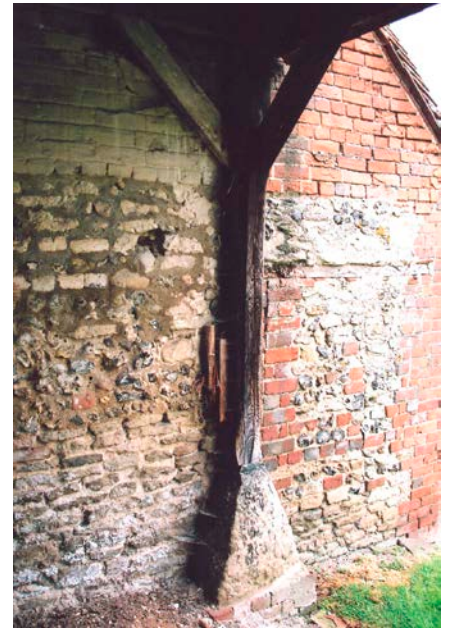
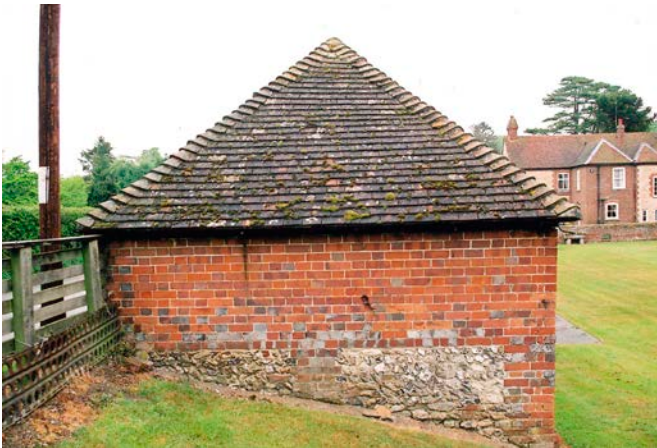
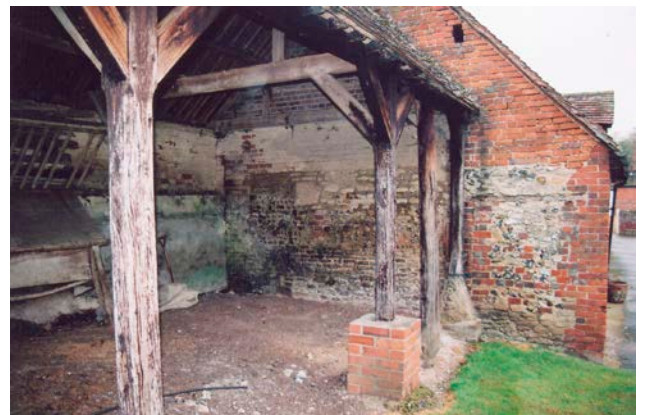
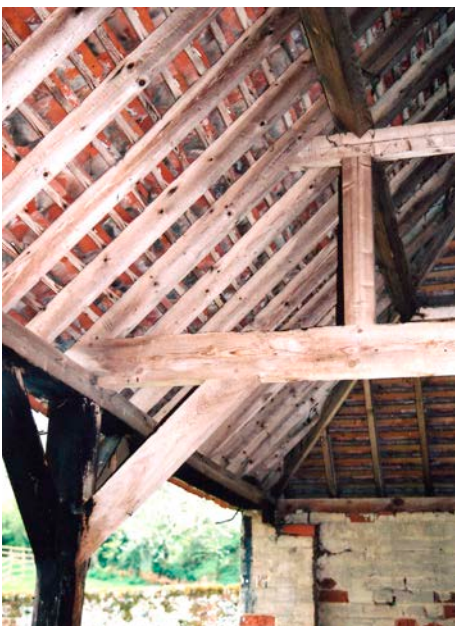
Fig 3 Building 1

South-east elevation

Detail of post with original base

Post with replacement base

Interior looking south-west

Detail of roof truss

South-west elevation

1 (*Figs 3-4*) At the south-west end is an open-fronted shed three bays long with brick walls in Flemish bond on a flint rubble base and a hipped tiled roof. It is an addition to the main part of the range, narrower and with a separate roofline. At the front the roof is carried on three substantial posts (a fourth is missing) with chamfered edges and pegged straight braces to the wall plate and tie beams. At the northern end an original pyramidal stone base block survives raised on two courses of bricks; the other posts are set on replacement brick piers. The three roof trusses are of pegged pine construction with carpenters' marks; they have straight collars, queen posts and a clasped edge-set purlin. The internal walls have an offset c.1.5m above floor level and along the back wall the bottom rail of a slatted hayrack is lodged on this. The top rail is secured to the tie beams by struts. Set below is a feeding trough formed of three wide elm boards supported at intervals on a framework of posts and short rails let into the wall; a cat hole is cut in the front board. There is a sloped boarded lid in two sections hinged at the top. This structure only survives in the southern half of the building.

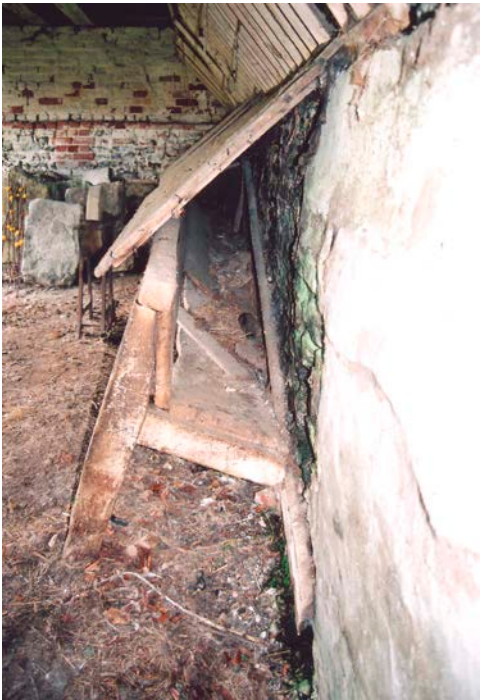
Fig 4 Building 1

Manger and hayrack interior

Section: scale is 1m

View from the north

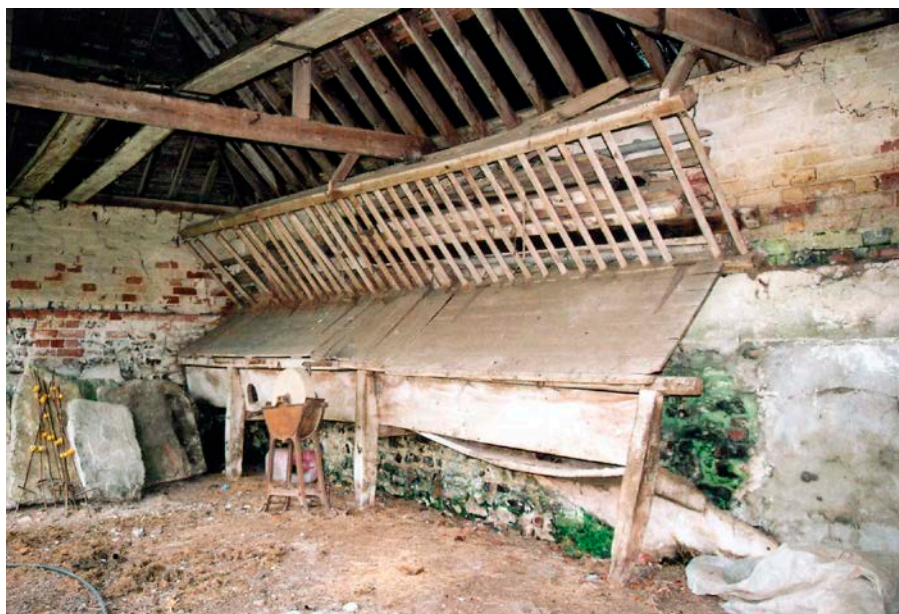
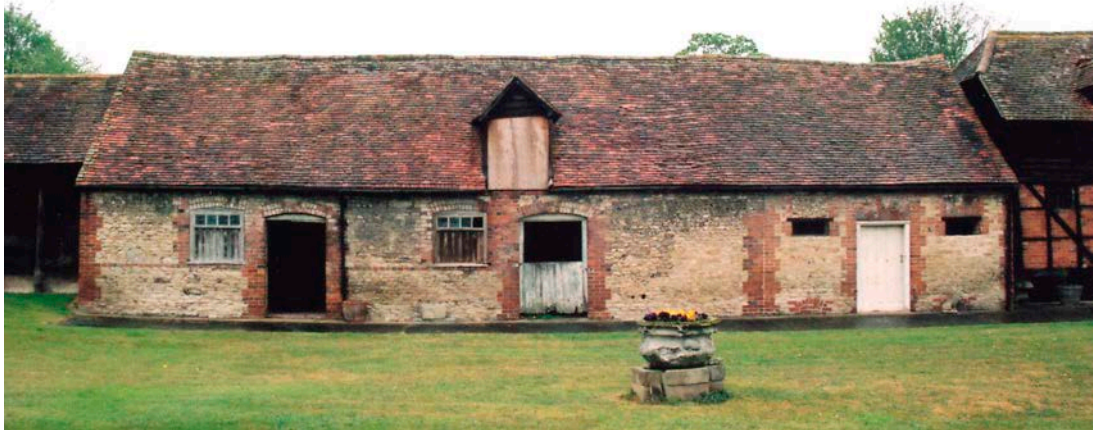
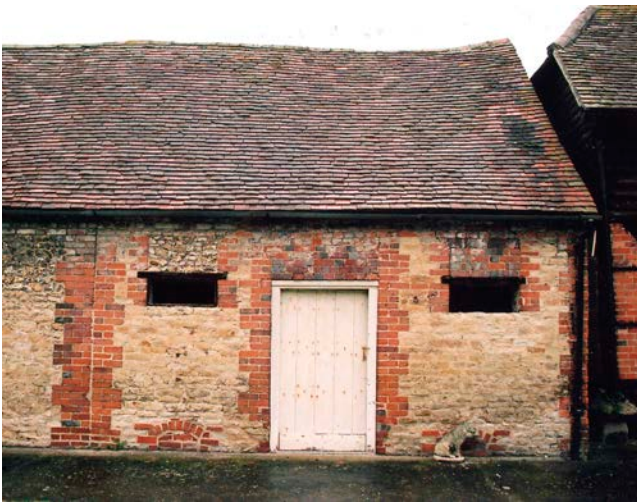
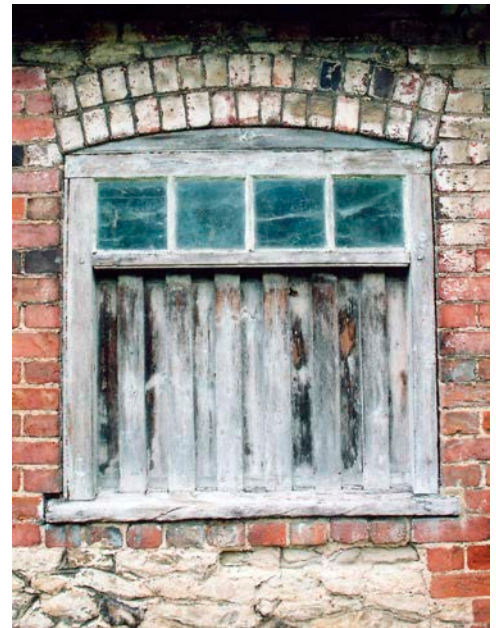
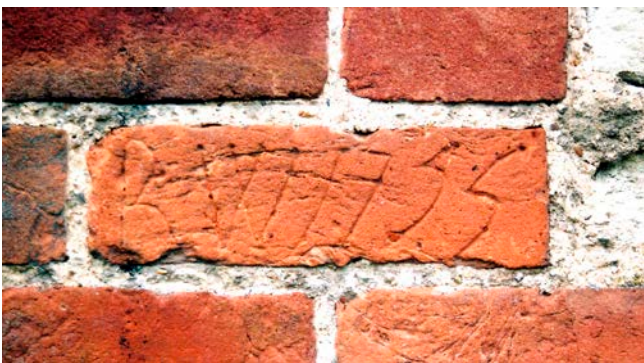
Fig 5 Buildings 2 & 3 (clockwise)

South east elevation

Window detail building 2

Road elevation from south

Dated brick [B]W 1755

Building 3 detail with reduced door and window openings

2 (*Figs 5-6*) In the centre of the range is a stable block built of mixed rubble with brick dressings and a peg-tiled roof. The principal elevation has two doors and two

windows, all with segmentally arched heads and there is a gabled and weatherboarded loading door set into the roof at eaves level. The windows have frames of pegged construction with glazed top-lights and slatted shutters (formerly hinged internally) below. One of the bricks in the quoin at the south-west end has an incised inscription [R or B]W 1755. This building was originally free-standing and a blocked window can be seen in the south-west elevation, which has a brick-built gable in English bond. This was matched by another in the north-east elevation (both visible internally) now covered by building 3; the straight joint where two brick quoins meet can be seen on the main elevation.

3 (*Figs 5, 7*) This building is butted against 2 and is built of the same materials. It has a central door flanked by unglazed slit windows which have been reduced from larger openings defined by their brick jambs. The door has also been dropped from its original position and originally had a threshold raised 0.3m above ground level. Flanking the door at ground level are two blocked openings with low arched heads outlined in brick. There is now only a narrow gap between the north-east end wall and the adjoining timber-framed granary but two blocked windows, the larger centrally placed, the smaller in the gable, indicate that it was originally free-standing.

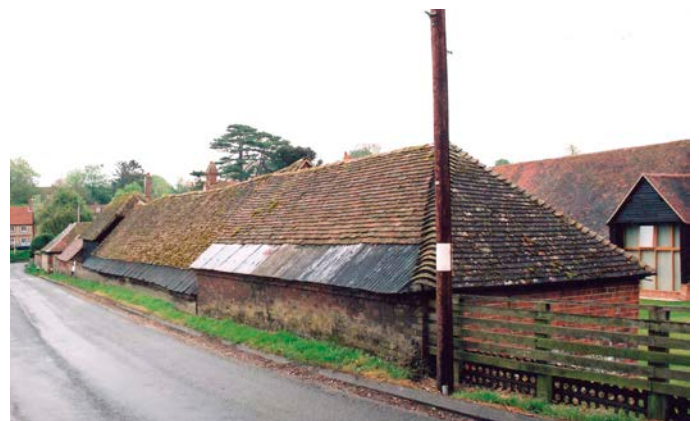
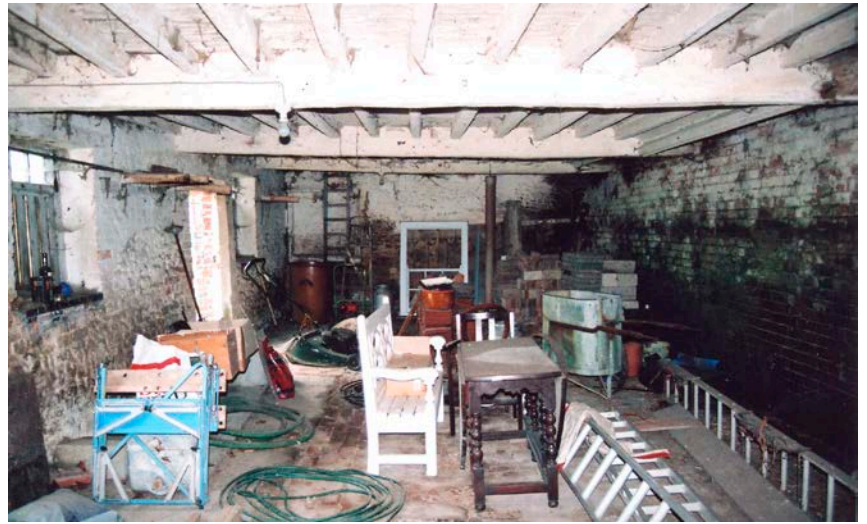
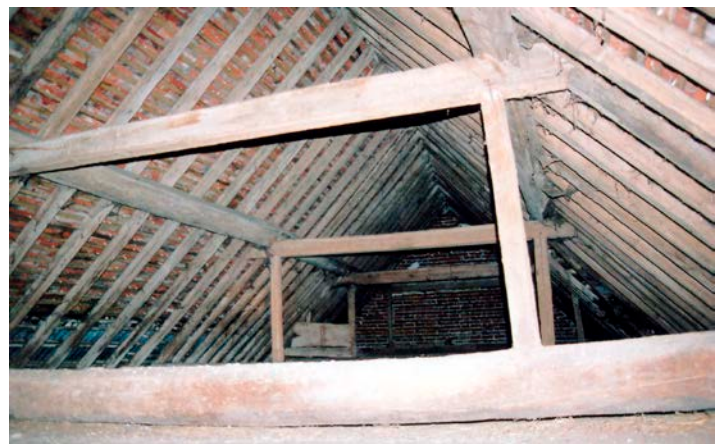
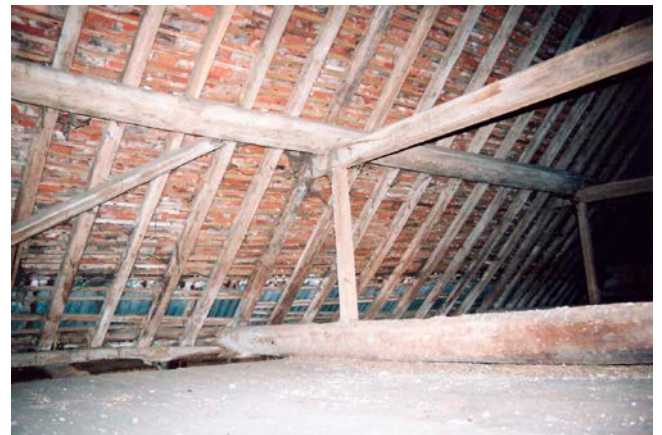
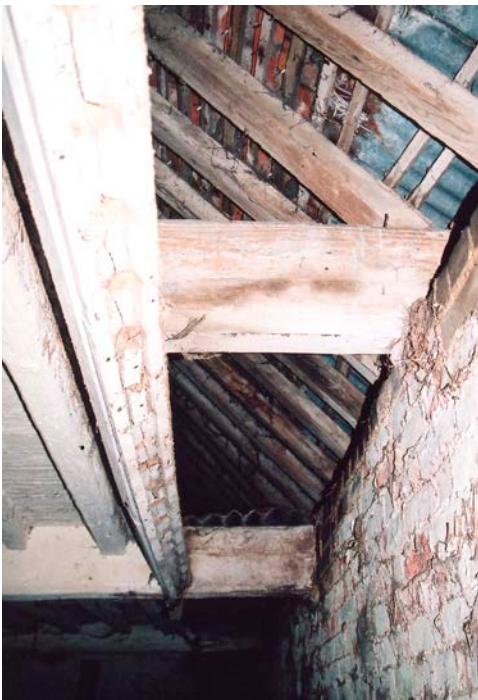
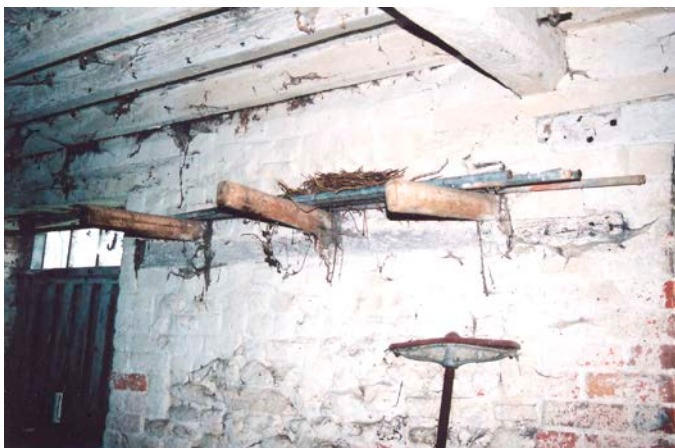
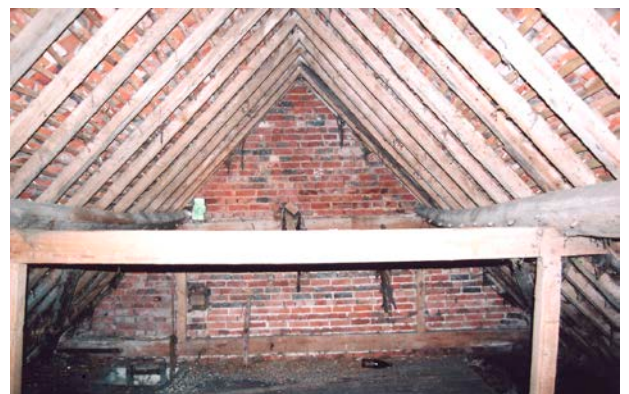
Fig 6 Building 2

Interior looking south-west

Loft looking north-east

Roof truss looking north-east

Loft looking south-west

Saddle brackets by door

Slot in loft floor and top rail
of hayrack

Internally the wall revetting the road is brick throughout and may be rebuilt. The floor is largely brick with a shallow drain running the length of the building. The stalls to the north-west have been removed and are only marked by post-hole settings in the floor. Three built-in wooden saddle brackets are set in the wall by one of the doors and another by a window. The loft floor has exposed beams (one replaced) and joists with a slot 0.6m wide along the north-west wall over the former hayrack; the obliquely-mounted top-rail remains in position. In the loft which has fixed ladder access, there are three free-standing roof trusses and two built into the end walls. They are of pegged construction, partly pine with tie beams independent of the floor structure, straight collars, queen posts and a single tier of clasped purlins.

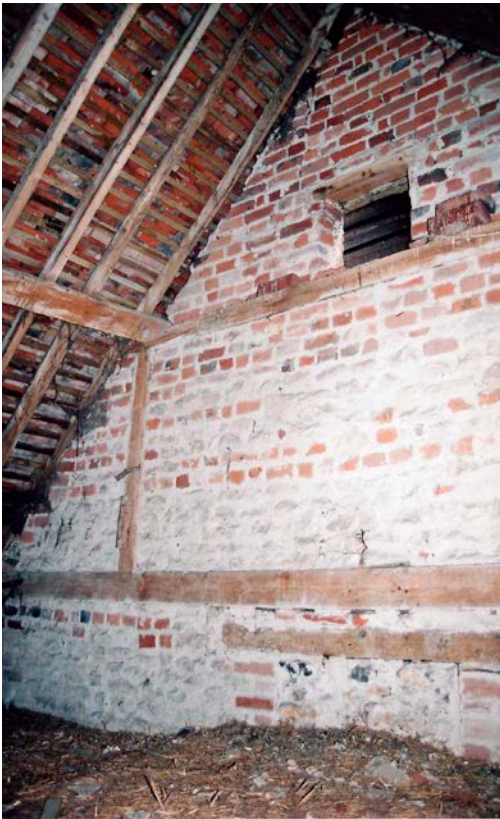
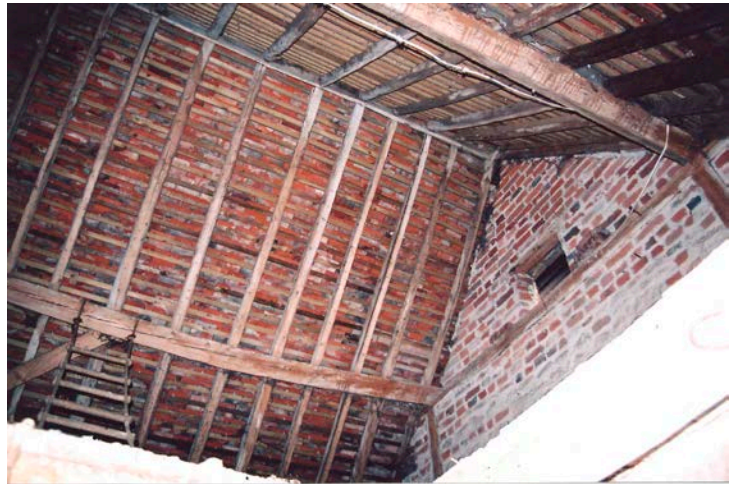
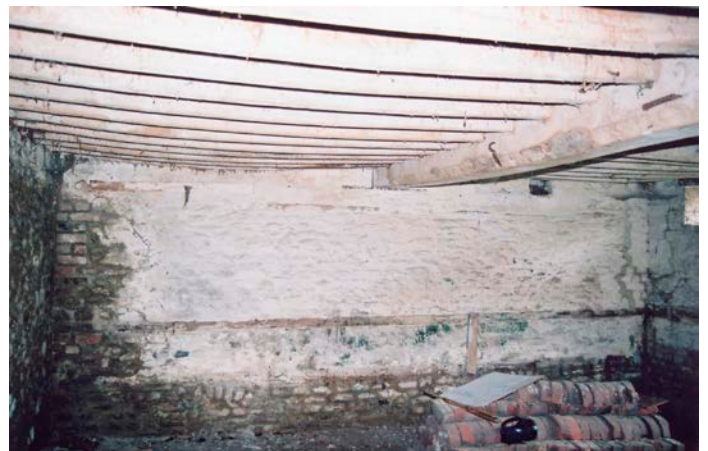
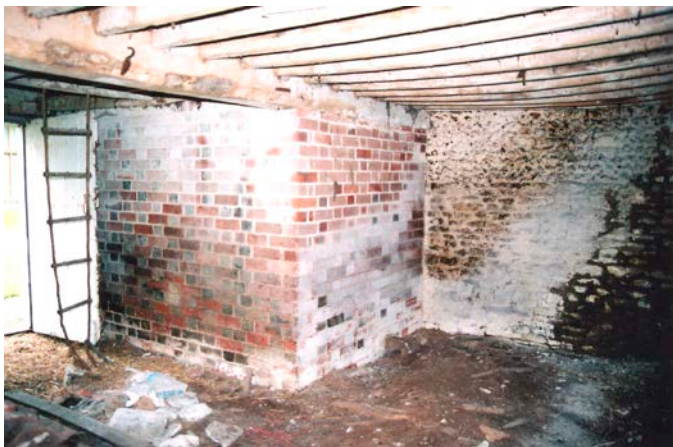
Fig 7 Building 3

Loft, north-east wall with blocked window below truss

Roof at north-east end

Ground floor, north-east wall, arched openings at base

Date incised on beam |1842|

Ground floor looking south

The south-east corner of the interior is partitioned off by a brick wall. The other walls are rubble with timber lacings and two further blocked arched openings can be seen at the base of the north-east wall. There is a large axial ceiling beam, chamfered and stopped with the date 1842 between end bars chisel cut into the north-west face. In the

loft the south-west wall was originally external to building 2 and is built of brick in English bond. The north-east internal wall is more roughly finished and incorporates two blocked windows and a built-in roof truss. The single free-standing truss is like those in building 2 and the tie beam is morticed for an earlier floor: the sawn-off joist ends remain in position.
