The structural development
of
CORNER CLOSE COTTAGE
9 Bell Lane, Thame
OXFORDSHIRE

K A Rodwell
for
JOHN MOORE HERITAGE SERVICES

December 2006

**THE STRUCTURAL DEVELOPMENT OF
CORNER CLOSE COTTAGE, 9 BELL LANE THAME
OXFORDSHIRE**

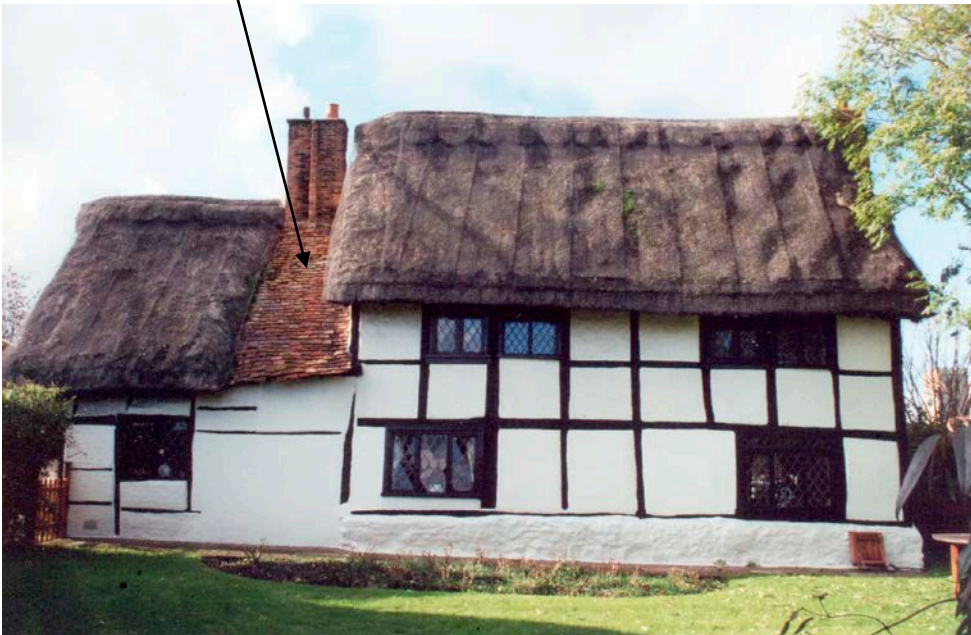
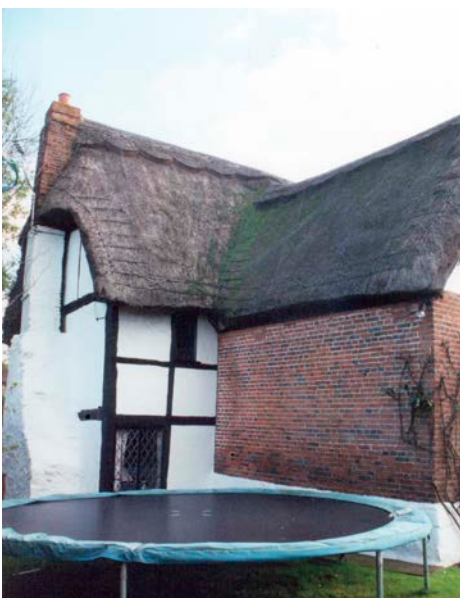
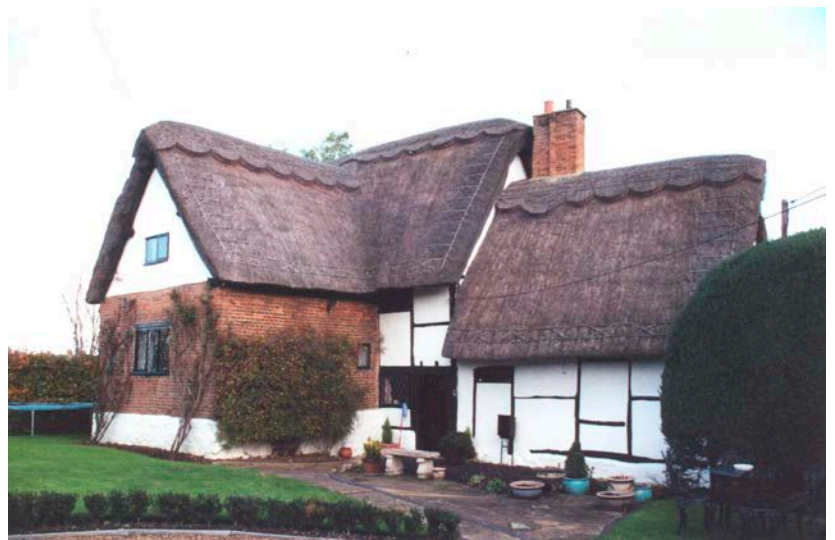
North end of west elevation

On the west elevation the framing of the two-storeyed house mirrors the east side but is largely hidden by the later west wing. The front door lies to the south and is a good quality early 20th century reproduction in 'Tudor' style. It abuts the end post of the two-storeyed range which is tenoned into a cill beam that continues south for a short distance to a blocked doorway at the north end of the lower range. This has a rendered plinth at a lower level and three further panels of slighter exposed framing. The roof slope on this elevation is fully thatched.

The wing is butted against the timber frame and built of thin handmade bricks in English bond (full courses of alternating headers and stretchers) with a rubble plinth and a rendered gable. This elevation has 20th century windows, there are two small probably original windows in the south wall lighting the stair and the basement and the north wall is blank. The north end of the main house is framed like the side elevations with a half-hipped roof and an external chimney stack; the lower half is rubble, the remainder rebuilt in brick.

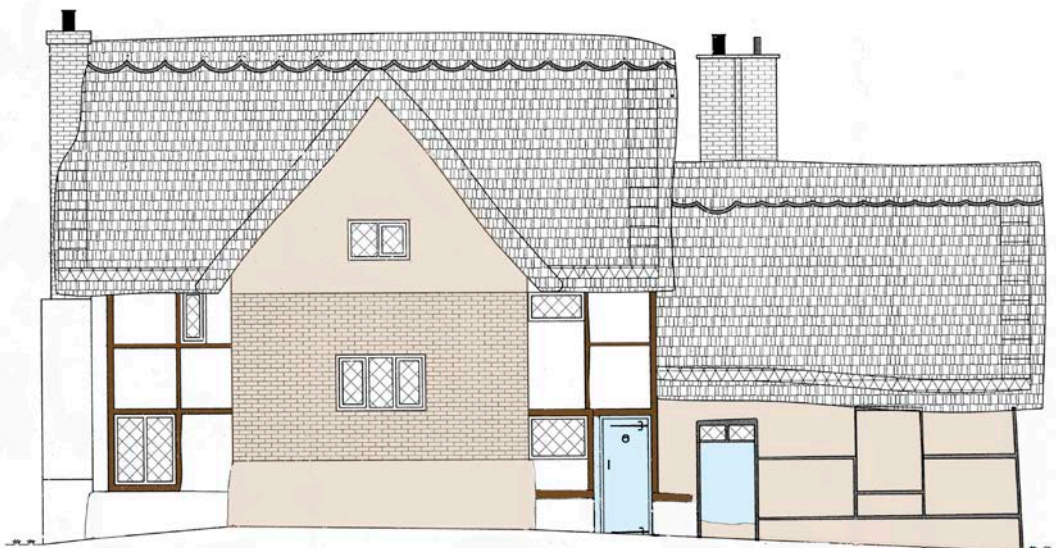
Fig 3 Elevations

East elevation

South elevation

West elevation

White early 17th century
Buff late 17th or 18th century
 (more than one phase)
Blue early 20th century

1 The house appears to have been constructed as a two-storeyed building with a good quality box-frame set on a stone plinth. It was probably three rooms long and had a lobby entry plan with the front door opening into the space alongside the large double-sided chimney between the two southern rooms. The stack appears to be a single-period construction and the cill beam to the west wall extends beyond the end of the extant two-storeyed range, which both imply that the original building was longer and that the south end has been rebuilt. The chimney at the north end of the house may be a later addition and the north bedroom has an original window blocked by the construction of the west wing. The location of the original stairs is not known. The lobby entry house plan developed in the second half of the 16th century and became widespread in the region during the first half of the 17th century; Upper House Farm, Nuffield has a tree ring date of 1624 (VA 20, 47). This house is probably early 17th century but could date to the end of the 16th century.

2 The south end of the house was rebuilt, retaining the main stack but with a lower roofline and on a slightly different alignment. It has slighter brick-nogged framing and an intermittent plinth course; the door position in the lobby was retained.

This reconstruction may have been as a consequence of a fire and is difficult to date closely; it could be late 17th or 18th century and may post-date the addition of the brick wing, which is higher quality work.

3 The brick west wing is butted against the framing of the main part of the house and blocks at least one original window. It contains a cellar and two upper rooms at intermediate levels to the rest of the house. The staircase appears to have occupied its present position since the wing was built, although there appears to have been later modification in its detail. The wing probably dates to the late 17th or early 18th century and is more substantially built than the reconstructed kitchen. It is not certain which came first but the differences in materials suggest that they are unlikely to be contemporary.

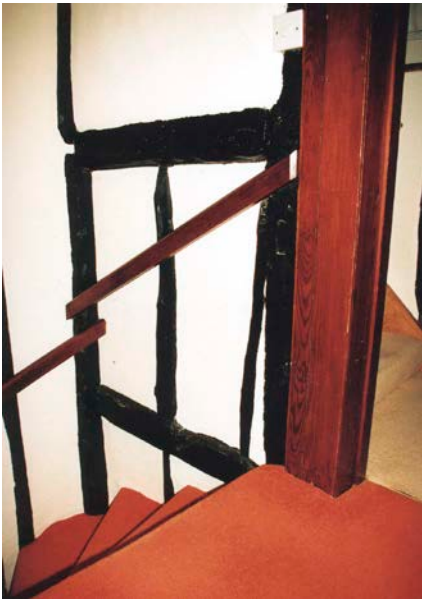
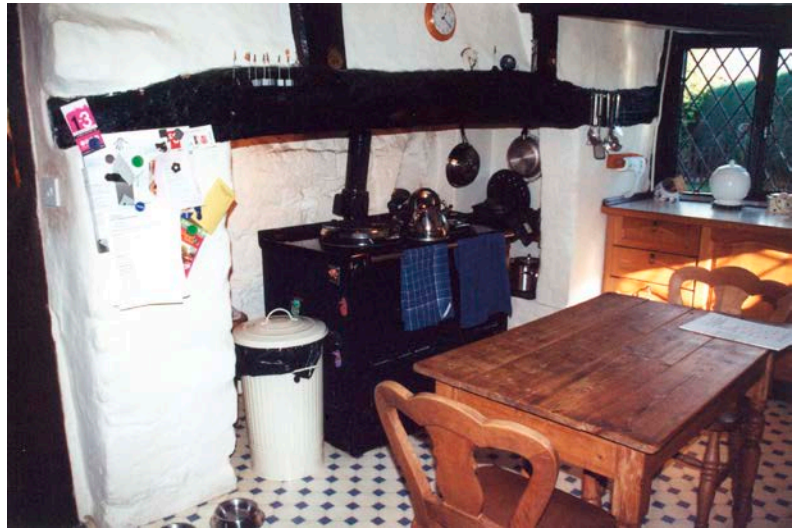
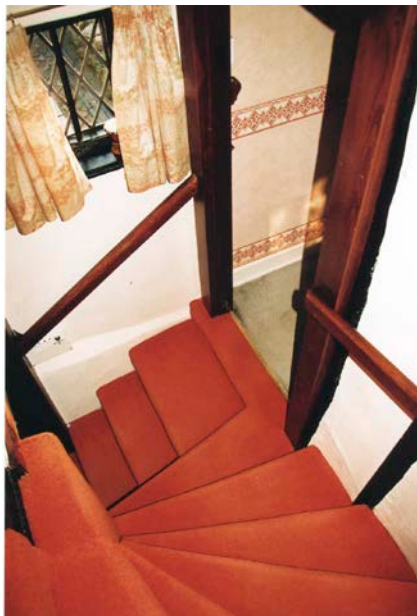
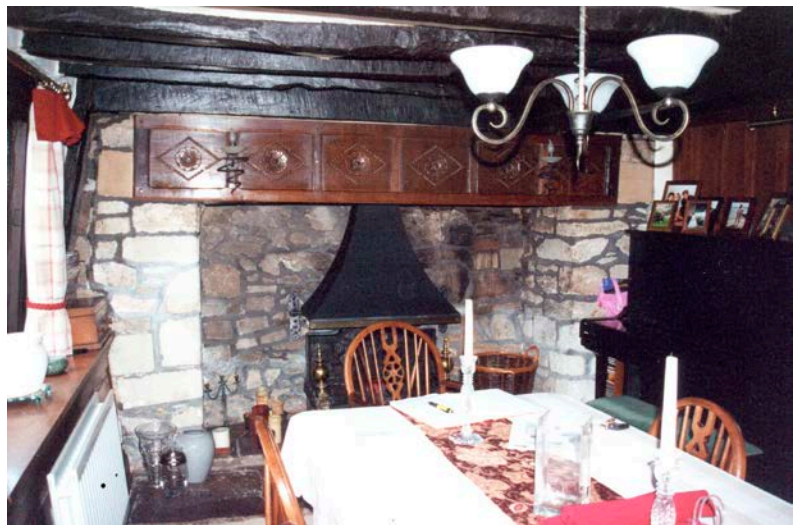
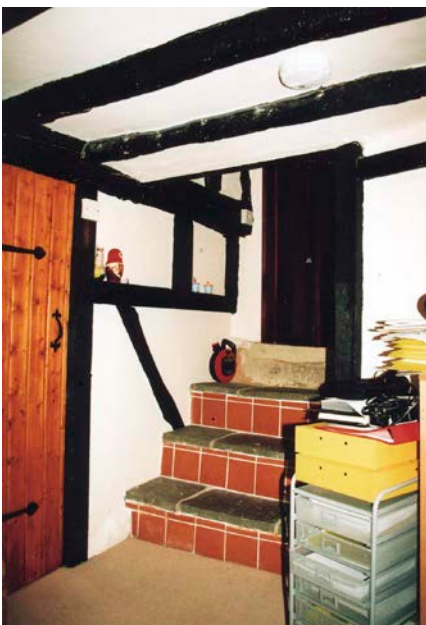
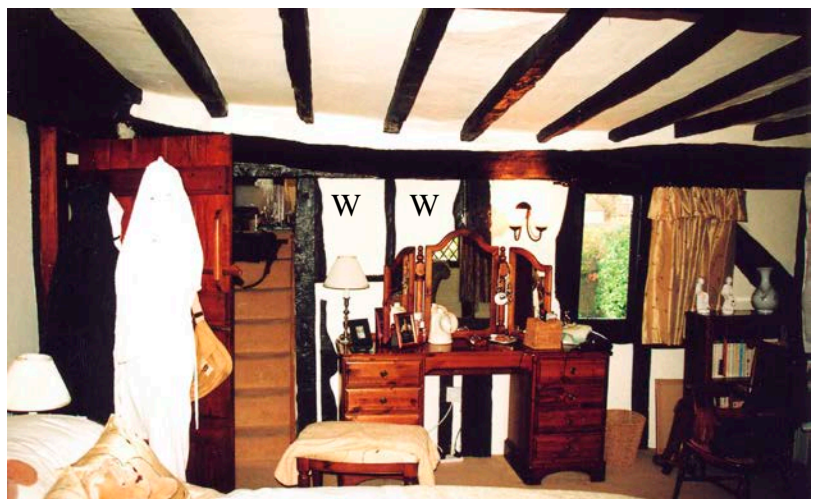
Fig 4 Interiors (clockwise from above)

The main part of the house has three rooms in line, all heated, with a 20th century hallway cut out of the middle room. The timber framing is exposed and the majority of doors are of a reproduction boarded pattern with wooden closers and ornamental strap hinges which date to the earlier 20th century. The sitting room has an early 20th century brick arched fireplace surround with a contemporary panelled overmantel and dado. There is a lateral chamfered ceiling beam and the partition to the dining room is original. This room has exposed ceiling joists and a large fireplace with rubble jambs and a wooden lintel masked by a Jacobean-style panel. To the west of this deep stack is a lobby which formerly had an external door and to the south is the kitchen. This has a large open fireplace in the reverse of the stack with a series of recesses in the side walls. There is no access to the east side of the stack below the tiled roof section. The ceiling height in this room is very low and the beams slope towards the south.

The stairs open off the hall and are housed in the corner of the wing; they are of winder type in an old studwork enclosure but the treads may have been adjusted in the 20th century for access to the room over the cellar; the doorways have early 20th century facings. A separate flight leads down to a semi-basement. The upper wing rooms have floors at intermediate storey heights and are now bathrooms; the attic room has a timber-framed gable wall. On the first floor of the main house the timber framing is exposed in the north bedroom; the internal partition is original and the posts have diagonal braces to the wall plates, not visible externally. The outline of a two-light window blocked by the wing can be seen in the west wall. The ceiling has a lateral beam lodged on the truss tie beams and exposed rafters. In the roof space over this room the partitions are fully plastered (with old plaster) and the floor boarded. The roof has waney elm purlins and pole rafters. The middle bedroom has a raised ceiling and a framed partition at the south end facing-up the chimney stack, which is not visible at this level; the ends of the purlins to the lower south roof are lodged on the tie beam.

- Kitchen fireplace
- Dining room fireplace
- West wall of north bedroom with blocked window (W)
- Stairs to cellar
- Winder stairs from first floor landing
- Top of stairs
