The structural history
of
SARAGOSSA HOUSE
13 NEW STREET
HENLEY-ON-THAMES
OXFORDSHIRE

K A Rodwell
for
JOHN MOORE HERITAGE SERVICES
September 2006

THE STRUCTURAL HISTORY OF SARAGOSSA HOUSE, 13 NEW STREET, HENLEY-ON-THAMES

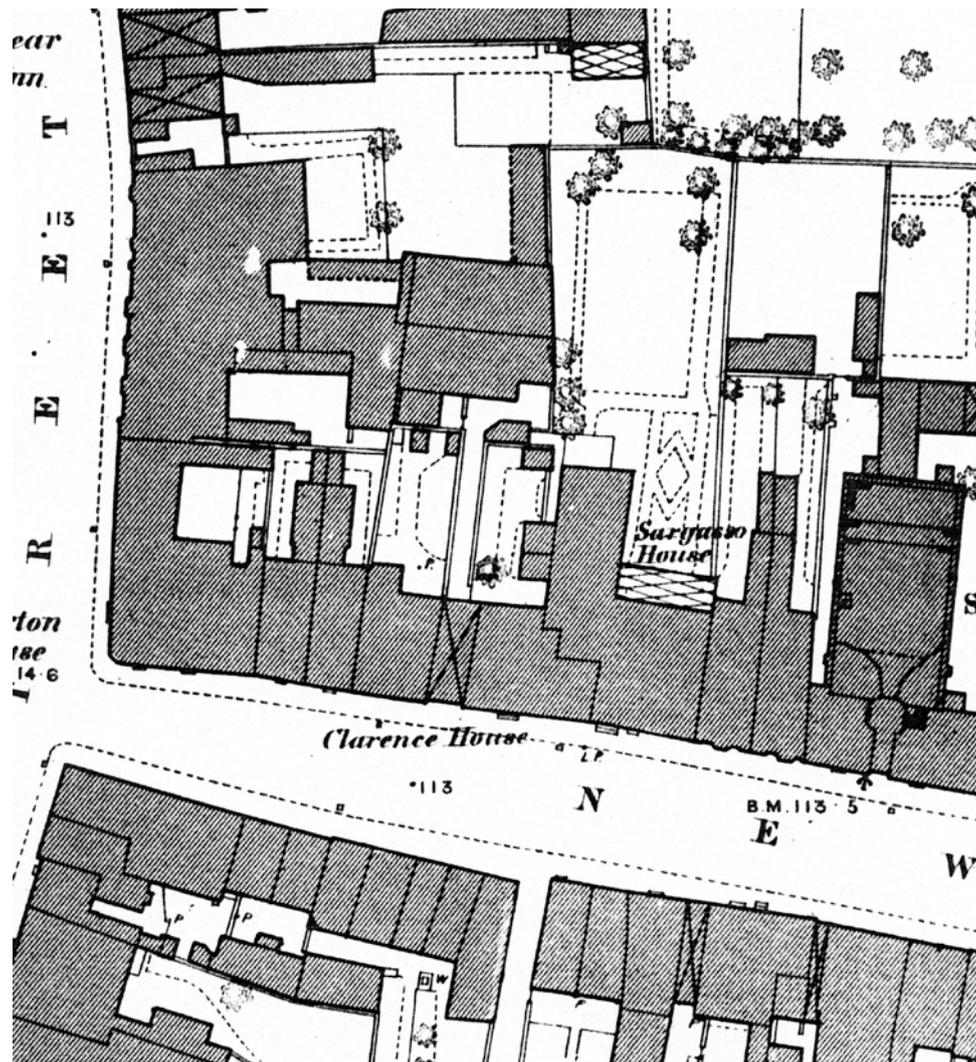
Fig 1

Ordnance Survey map 1879, 1:500: Saragossa House shown with conservatory and formal garden

Henley is a planned medieval new town which was probably laid out in the 12th century (VCH draft) and New Street is the most northerly of three parallel streets running east towards the river. The town developed in the medieval period as a major shipping point for goods to and from London and in the 18th century it became a centre for malting and coaching. The prosperity this brought is reflected in the numerous Georgian buildings in the town and much of New Street was rebuilt during this period (Sherwood & Pevsner 1974, 644). Saragossa House, dating to the beginning of the century, belongs to the earliest phase of this reconstruction. The first large scale map of the town, the Ordnance Survey 1:500 survey of 1879 (Fig 1), shows the house in its present form with an offset rear wing and a conservatory on the back of the main range; it was then known as Sargasso House. A photograph of New Street c.1900 also shows the building much as it is today (Fig 1).

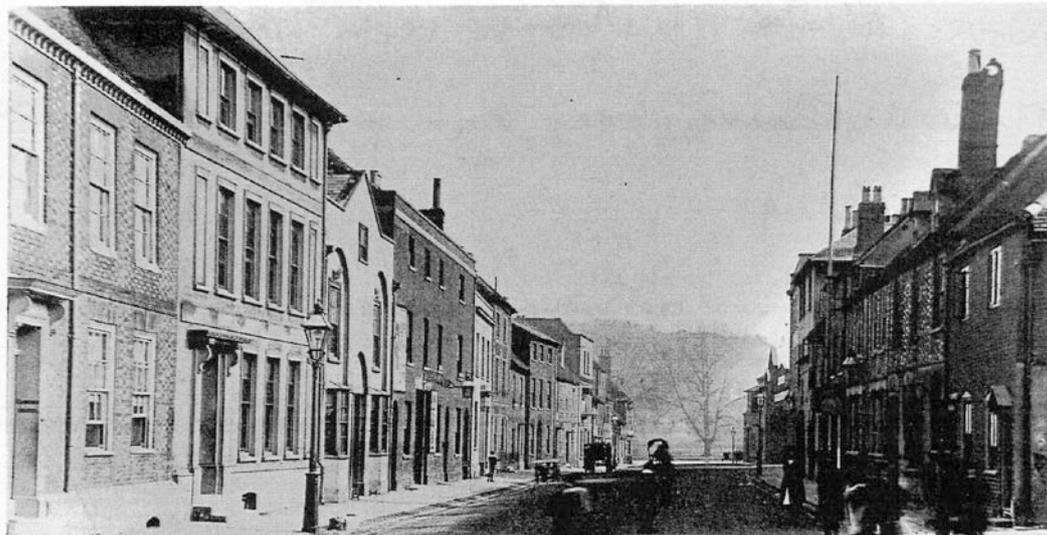
Photograph of New Street in early 1900s; Saragossa House on left; there has been no significant change since this date

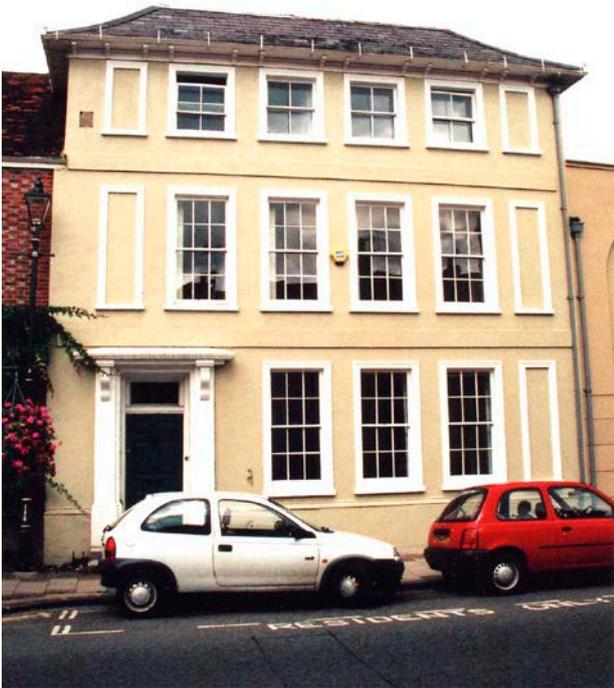
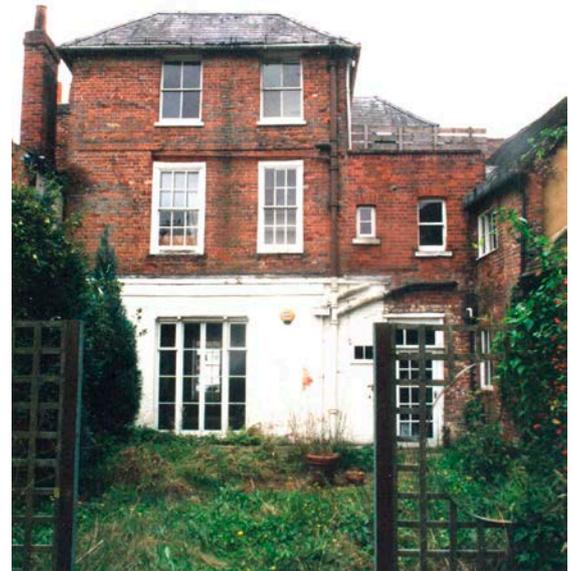
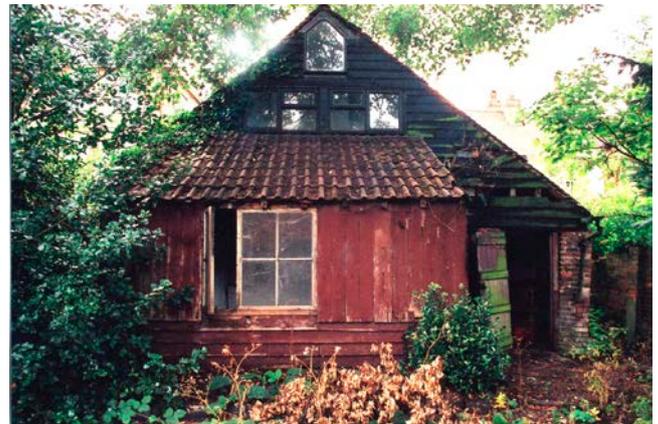
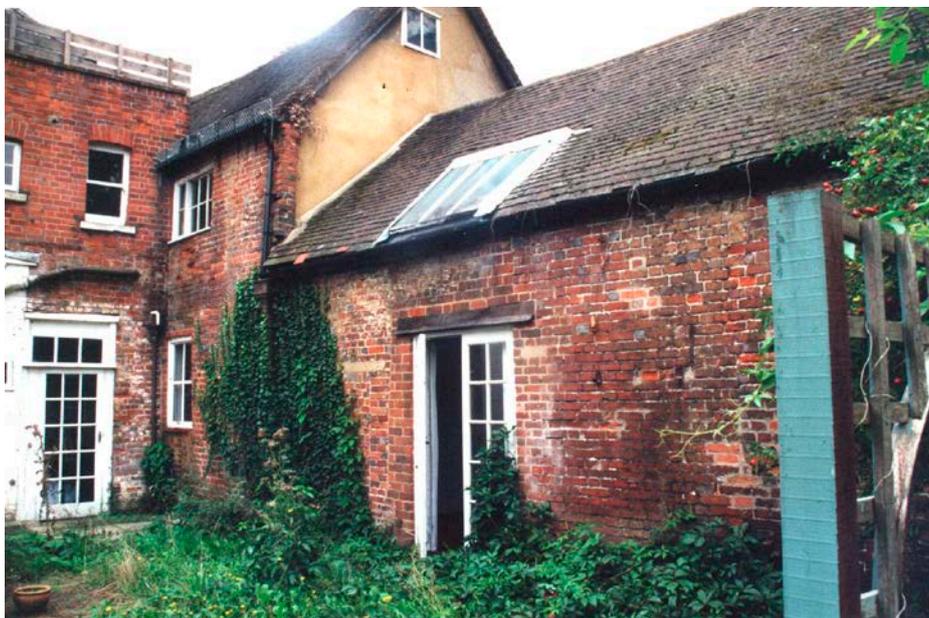
Fig 2 Exteriors

Front elevation (south)

Rear elevation (north) with later infill to right

North elevation of rear wing

Rear wing, east elevation to garden

The house has an imposing street elevation of three tall storeys, defined by a moulded plinth and raised bands at storey height; it is six bays wide with four evenly-spaced sash windows on the upper floors flanked by narrower blind panels at either end. The ground floor has three windows and a door at the north end. The windows have moulded architraves and six-pane sash-lights with narrow glazing bars; the top floor windows have two lights per sash. The door has six fielded panels, a plain rectangular fanlight and an architrave with heavy console brackets supporting a flat canopy. The

façade is stuccoed and lined-out to simulate ashlar; the roof is hipped and slated with deep overhanging bracketed eaves.

The rear (north) elevation of this range is two bays wide with unevenly spaced windows of the same type but with plain architraves on the upper floors. On the ground floor French windows of 19th century type have replaced the original pair; the jamb of the west window is visible as a straight joint. This elevation has exposed brickwork in Flemish bond on the upper floors with the same raised strings between storeys. The ground floor doors formerly led into a conservatory and the extent of the interior is indicated by painted brickwork. Infilling the gap between this range and the older rear wing is a wall in two stages. The ground floor is built of older bricks with modern openings and the first floor is a late 19th or early 20th century bathroom extension with a flat roof.

Running down the western side of the plot at right angles to the frontage there is an older rear wing. It has a lower roofline and is built in two stages; the southern section is two-storeyed and the east elevation is faced in brick which ends in a free-standing stub wall. The gabled return is set back and rendered over a timber frame. On the ground floor there is a 19th century window replacing a door and on the upper floor there is a horizontal sliding sash partly covered by the bathroom extension. The northern part of the range has a lower roof line and a brick east wall with a number of straight joints representing infilled openings and progressive replacement of the timber frame. Both roofs are tiled. At the north end there is a weatherboarded lean-to shed in derelict condition.

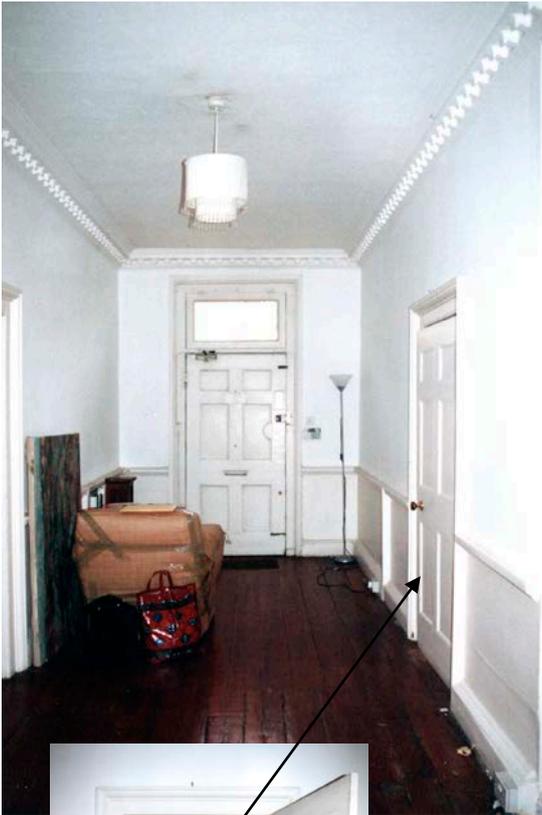
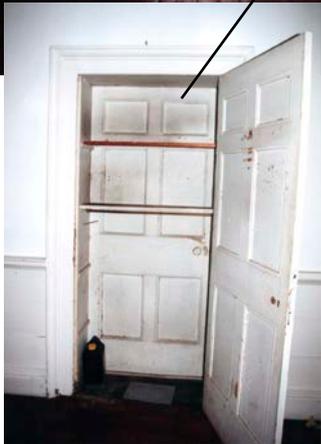
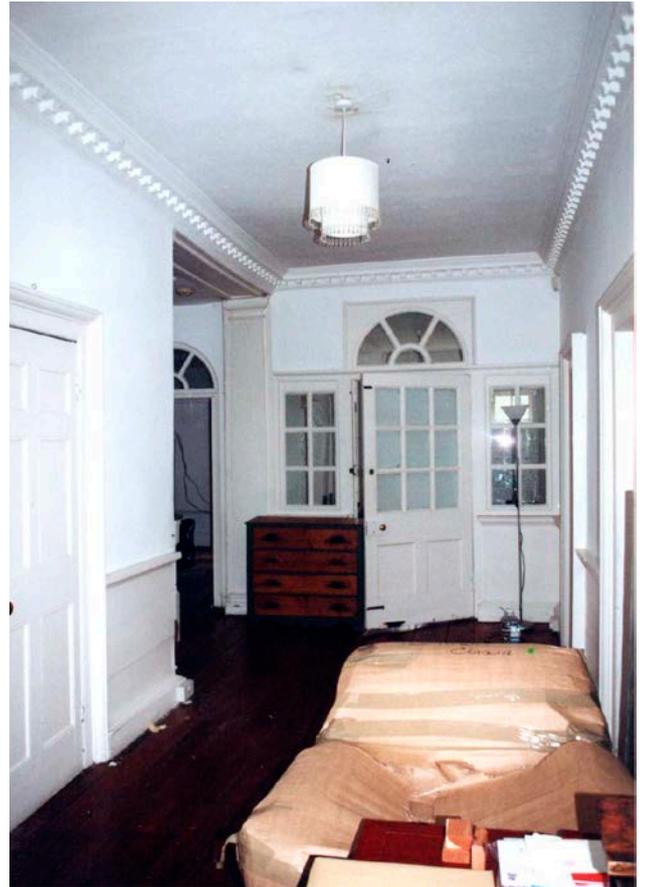
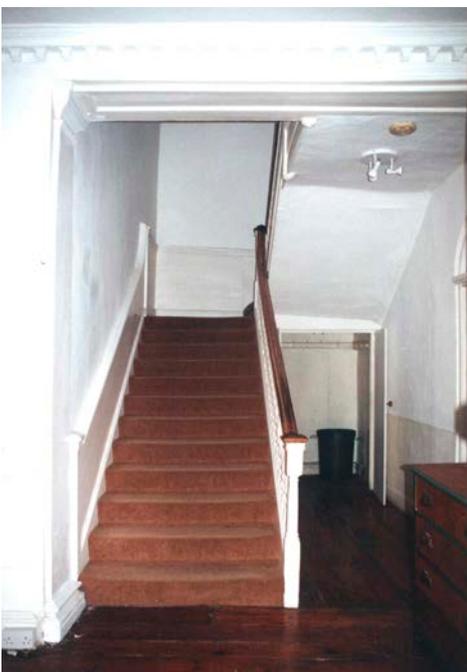
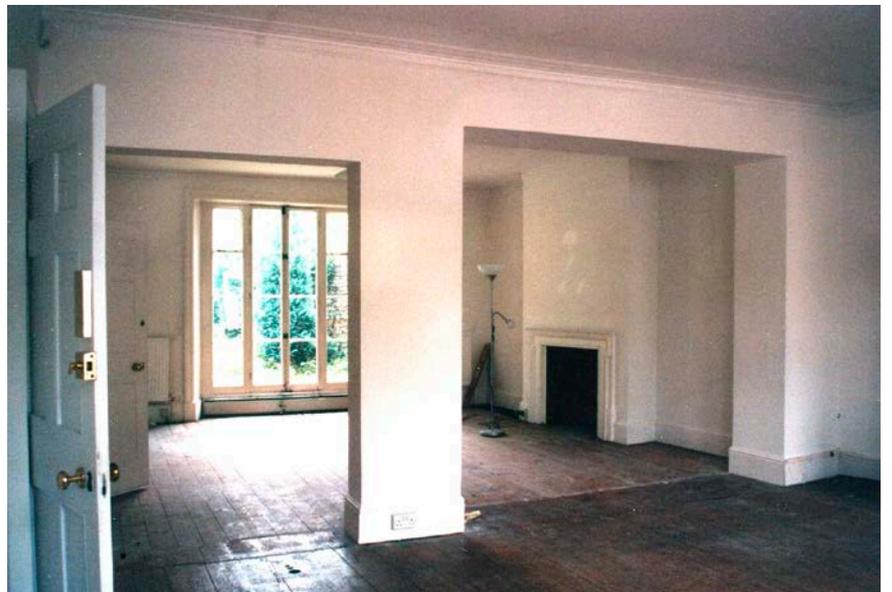
Fig 3 Interiors – front wing
(clockwise)

Hall looking south; inset blocked door

Hall looking north, with opening to stairs

Principal rooms looking north

Staircase

The internal plan is L-shaped and the principal rooms lie to the east of a central hall; to the west, behind the street frontage which is part of a different property, is the staircase and to the rear an older lower wing which extends down the garden. The wide hallway has a boarded dado with a moulded top rail and skirting and a ceiling cornice carried on miniature console brackets. The architraves to the principal rooms are quadrant-moulded and the doors six-panelled with reeded edge-mouldings. A door on the west side of the passage is blocked; it now leads to a separate property. At the

north end of the hall and integrated into the dado panelling scheme is a part-glazed door with a semi-circular fanlight and six-pane sidelights which now leads into a rear lobby. These lights have wide ovolo-moulded glazing bars of early 18th century type.

The two principal reception rooms have been knocked together to form offices and the historic fireplaces have been removed. Both rooms have simple cornice mouldings, the three front windows have shutters and window seats; the rear room has French doors to the garden. The rear hall lobby has a reeded dado moulding, a door to the garden, which replaces a window and a modern door to the kitchen.

The stair hall is at right angles to the entrance hall and the opening is framed by moulded pilasters supporting a cased beam. In the north wall is a door to the kitchen which has a modern surround copying the arched fanlight detail, and under the stairs a door to a cellar. This runs under the eastern part of the house; it has brick and flint walls, a front room with a low joisted ceiling and pavement lights, and a passage with wine bins to the rear. The staircase is of dog-leg type with a half landing and is shallow-pitched with a closed string. It has turned vase-shaped balusters and columnar newels with heavy squared heads, double-width on the half landing. The pine handrail is ramped, matching the dado moulding on the outer wall. There is a dentilled cornice at first floor level and an off-centre top light in the ceiling; this does not look to be original.

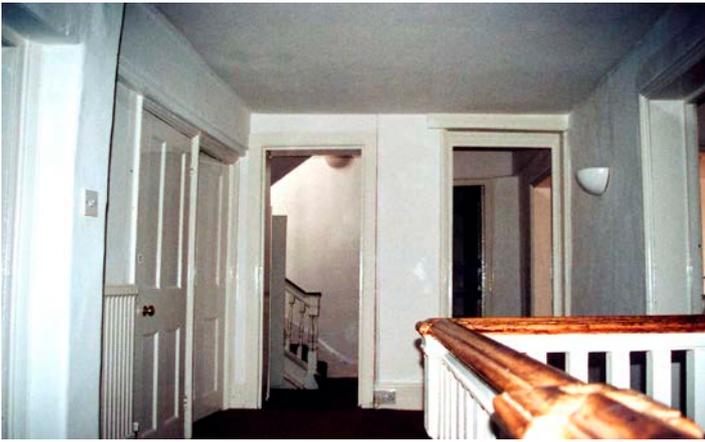
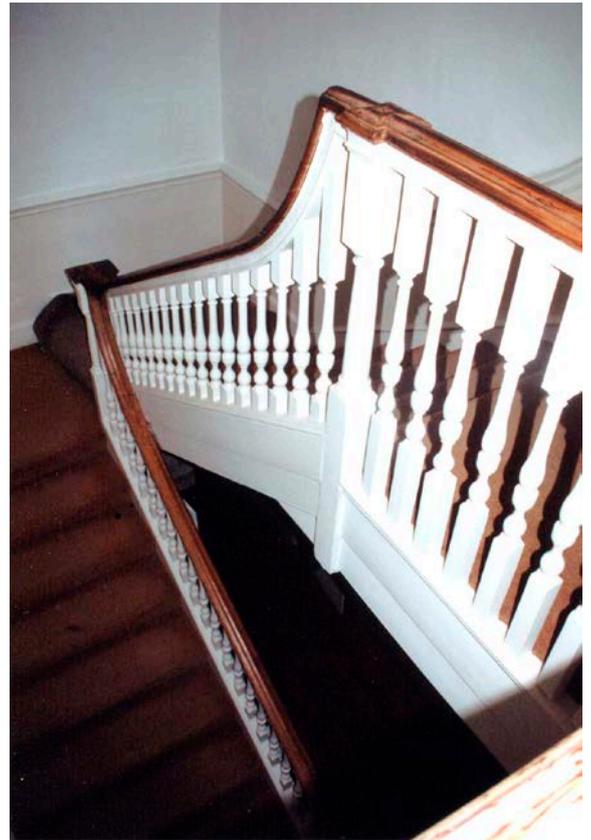
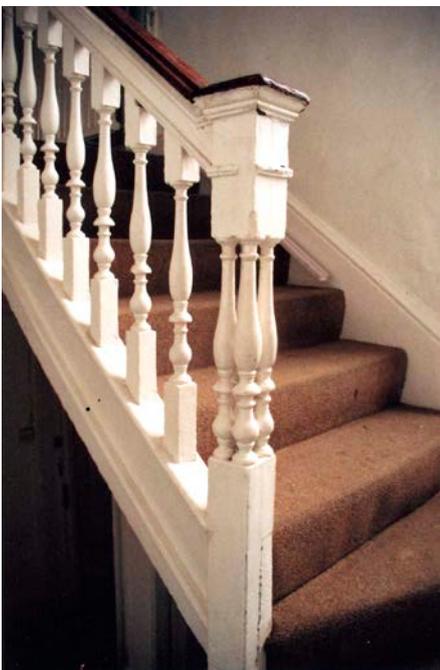
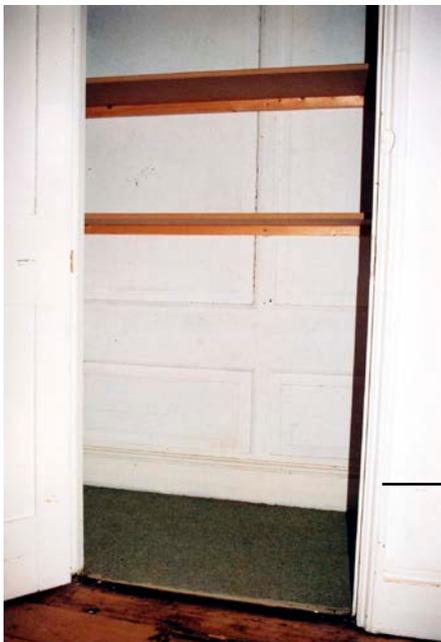
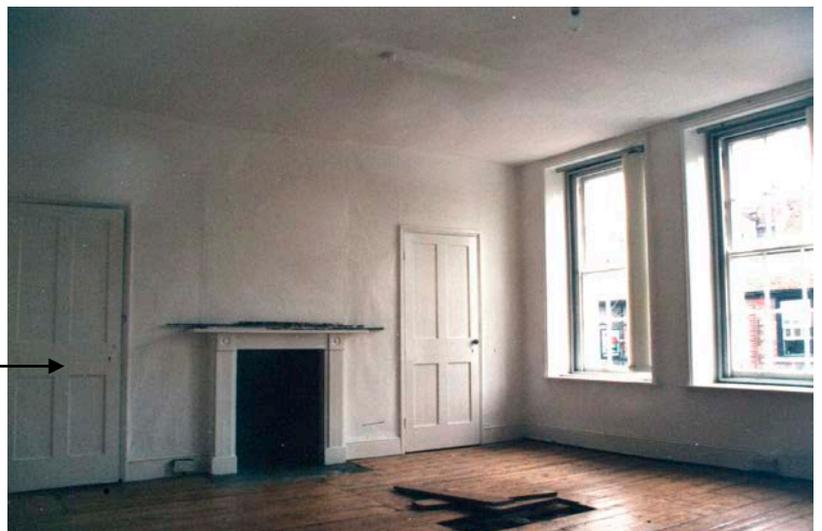
Fig 4 Interiors – front wing
(clockwise)

Staircase landing looking east

Lower stair from landing

First floor front room looking east

Panelling in cupboard by fireplace

Newel post to upper stair

On the first floor the front room was originally a single large space which was later subdivided to form a small unheated room at the west end, lit by a single window. This appears to have taken place in the early 19th century; the doors are of simple four-panelled type and the fireplace to the main room has a reeded surround with bull's-eye corner panels. Surviving details from the earlier house include a reset door of three fielded panels and a section of fielded panelling which survives in one of the cupboards flanking the fireplace. This was full-height with low basal and tall upper panels divided by a missing dado moulding.

resemble the lower staircase, with a closed string, turned vase-shaped balusters and a ramped handrail but no matching dado. The newel posts have square caps and bases linked by four clustered balusters.

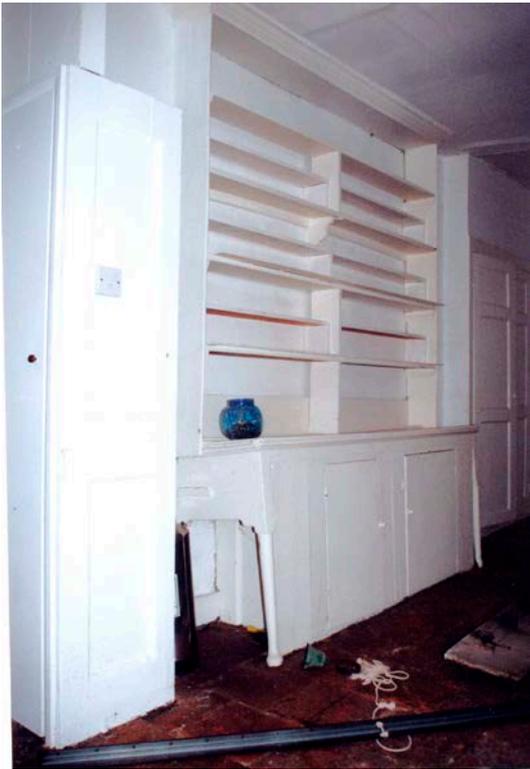
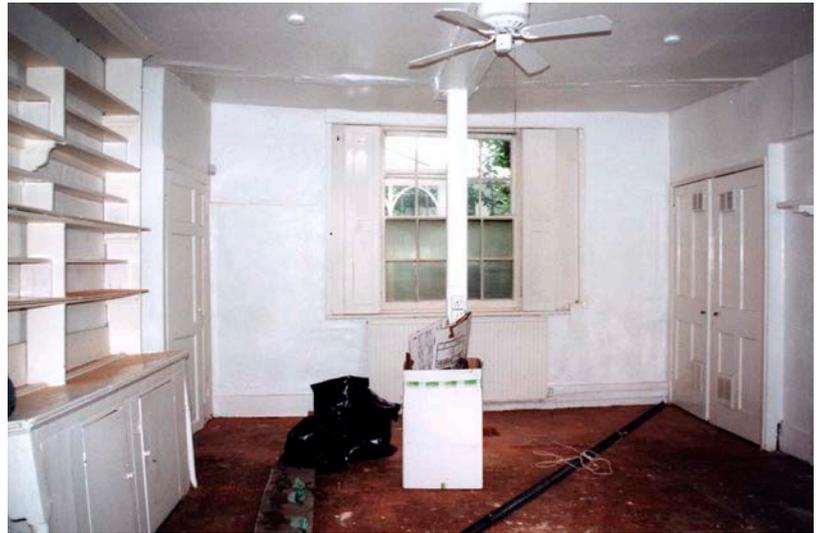
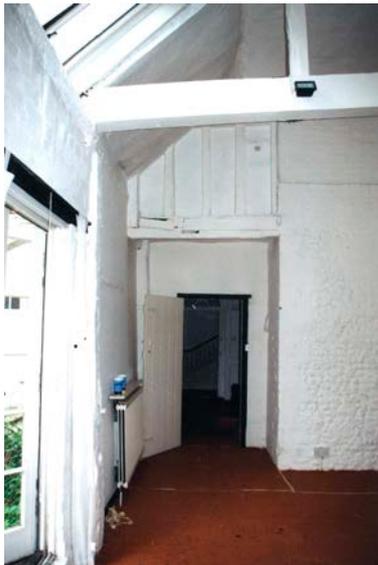
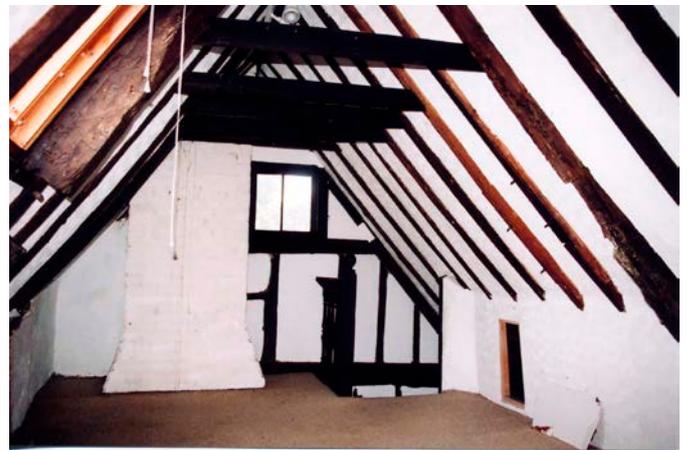
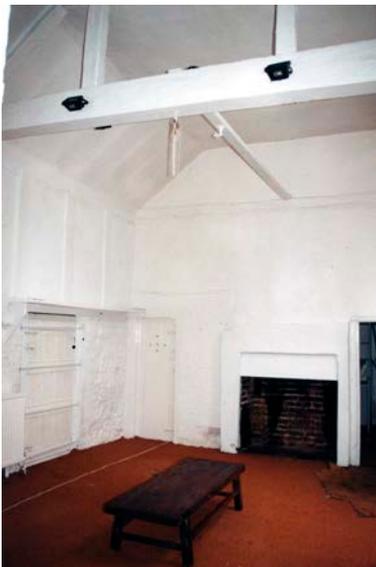
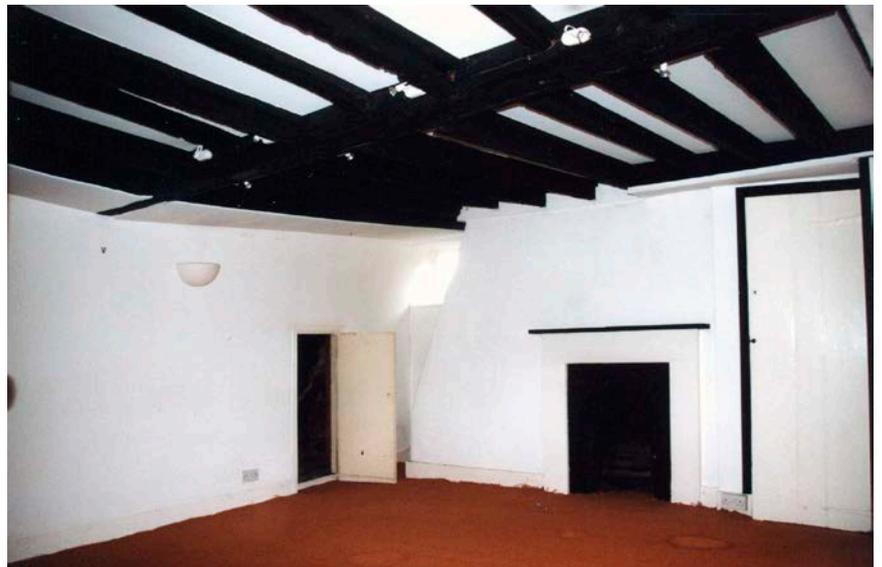
Fig 5 Interiors – rear wing

Kitchen looking west; detail of dresser to left

Attic over kitchen looking north

Room over kitchen looking north

Room north of kitchen looking north

Room north of kitchen looking south

The kitchen has a large blocked fireplace in the north wall and has been extended westwards by c.1.5m in the 19th century; the original transverse ceiling beam stops short of the wall and the end is supported on a post. The window in the extension is of eight-light sash type with shutters on the face of the wall. To either side are full height fitted cupboards and on the south wall an open-fronted dresser board with cabriole legs of 18th century type infilled with later cupboards and shelves.

To the rear is a two bay, originally timber-framed room open to the roof. The south (rear of stack) and west walls are largely flint with brick dressings; there is an added brick flue in the corner and there are limited areas of studwork. The east wall is largely rebuilt in brick of various periods but three principal posts remain from the frame together with a rail and the wall plate. The roof truss is rebuilt; it has a tie beam and collar linked by queen posts. The north wall is studwork flanking a plain brick fireplace with doors leading to a small end room with uneven walls and some remnant framing. A modern stair leads to a self-contained attic with reused purlins and modern windows in the gable wall.

Access to the room over the kitchen is from the first floor landing via an 18th century panelled door. The ceiling joists and central transverse beam are exposed and the latter has stud mortices for a former partition with a door at the west end. There is a

plain 19th century fireplace in the north wall and winder stairs alongside leading to the attic. This is divided into two; a bedroom and an attic space with a raised floor level. The roof timbers are exposed but heavily repaired; a truss has had the collar and a clasped purlin removed and there is a closed frame at the north end.

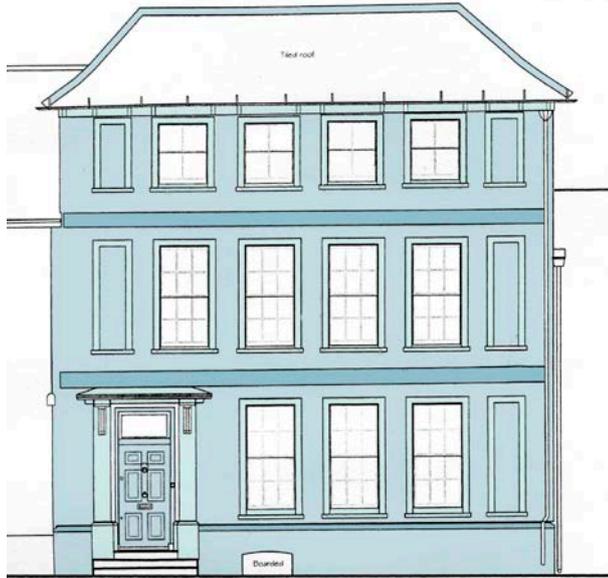
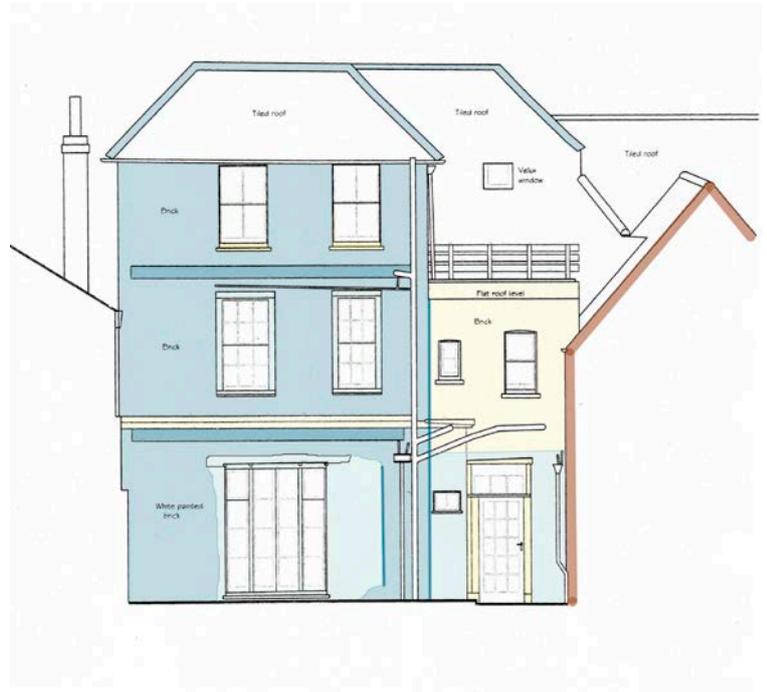
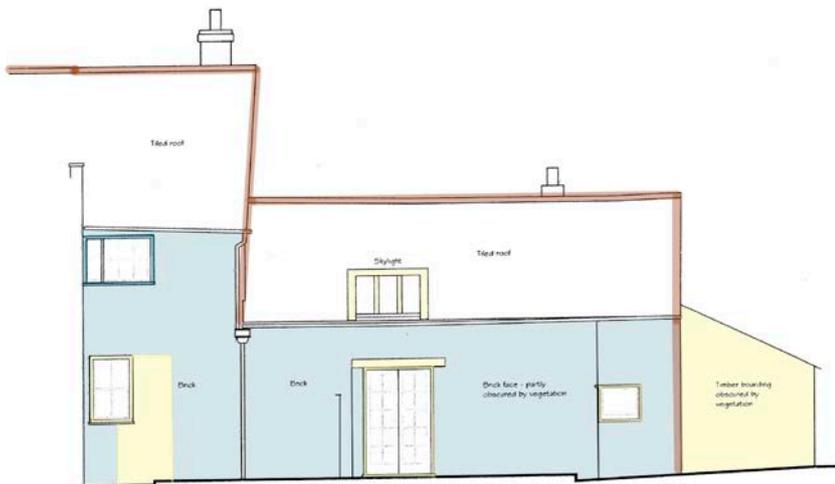
**Fig 7
Plan & elevations**

- pre 18th century
- 18th century
- 18th or 19th century
- early 19th century
- late 19th/20th century

South elevation

North elevation

First floor plan

East elevation (rear wing)

1 The oldest part of the house is the wing at the rear which now backs onto a separate property. This divides into two units, both originally timber framed; the kitchen which was constructed with two full storeys and the single storey service wing to the rear. Neither has any closely dateable features; the kitchen may be 16th century and the lower range 17th century. Both have undergone piecemeal later alteration and rebuilding, including the creation of a habitable attic over the kitchen where it was necessary to remove the collar from the roof truss. These rooms provided the service accommodation for the rebuilt house to the east.

2 The main part of the house dates to the early 18th century; a date of c.1700 is given by Sherwood and Pevsner and the principal surviving features, such as the staircases are characteristic of the period. This was a high quality new build with a symmetrical brick façade of three tall storeys and a hipped roof. There were two principal rooms on each floor linked by imposing staircases; the lower stair was inserted across the older range to the west and at this time the front room also formed part of the property. Later modernisation has removed most of the interior finishes of this period. The principal survivals are the two staircases, the panelled dado, glazed rear door and ceiling cornice in the entrance hall, and some doors, including the front door. There are also the remains of a kitchen dresser and a section of the panelling to the first floor front room, probably then the drawing room. The street elevation was remodelled in the early 19th century but the basic components, including the steep overhanging roof and the blind end recesses date to this time and can be paralleled elsewhere in the town.

3 The house was modernised in the early 19th century with new sash windows and architraves, doorcase, eaves detail and probably stucco finish. The principal rooms were given new doors and fireplaces and most of the panelling removed. By this time a single-storeyed lobby had infilled the space outside the rear hall door and

the adjoining room was given French doors, replacing the original windows. By the 1880s a conservatory had been built and the front room west of the hall had become part of the adjoining property. In the 20th century assorted modernisation and repair has taken place during the most recent use of the building as office accommodation.
