THE STRUCTURAL DEVELOPMENT OF OUTBUILDINGS

RUSH MANOR

WALLINGFORD, OXFORDSHIRE

THE STRUCTURAL DEVELOPMENT OF OUTBUILDINGS AT RUSH MANOR, WALLINGFORD, OXFORDSHIRE

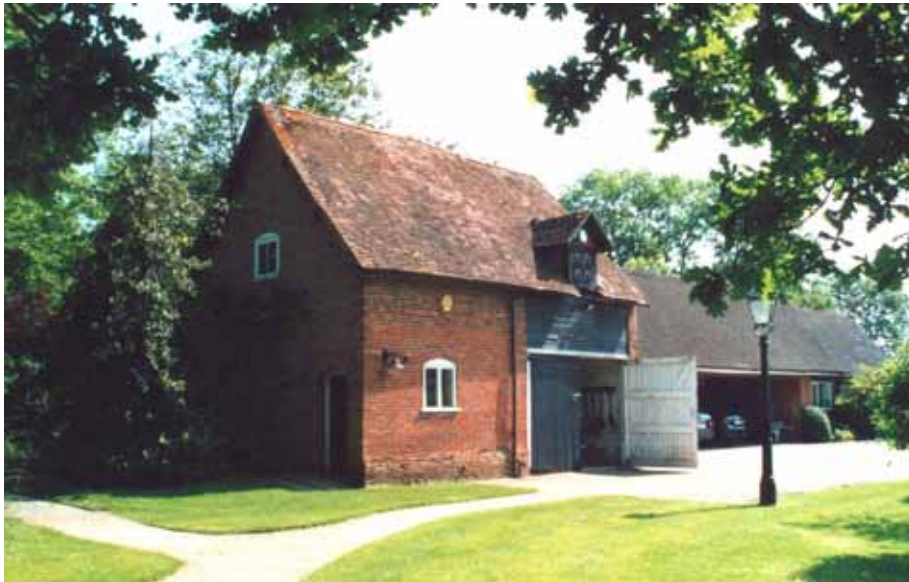
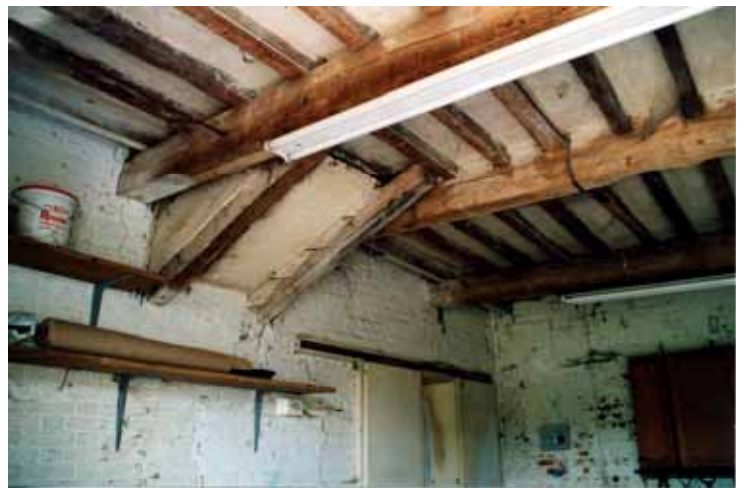
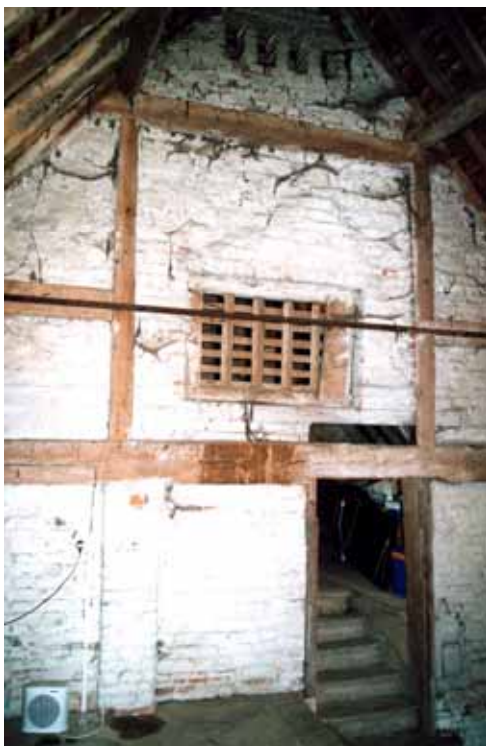
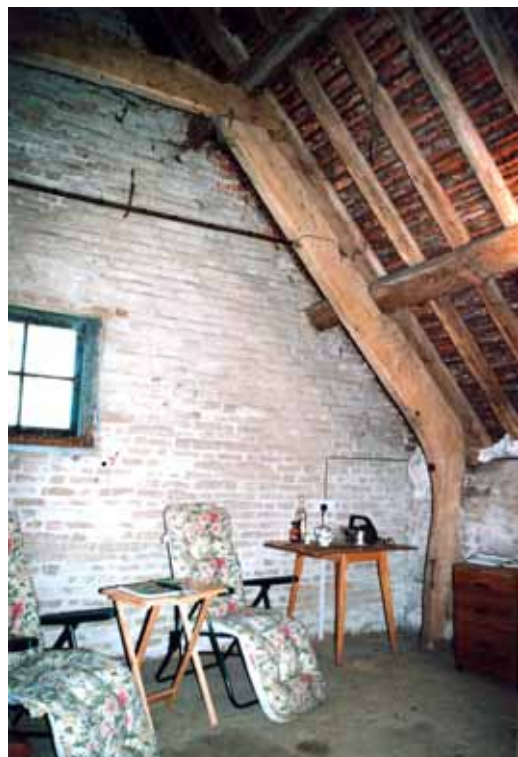
Fig 4 Mill house
(clockwise)
External view from south-west

Exterior - This is a two-cell building on the northern side of the courtyard which backs onto an arm of the moat; a modern carport and bungalow range is butted against its east end. The western half of the principal south elevation is built of thin bricks (60mm) in Flemish bond with random vitrified headers; it has an offset plinth and a two-light ground floor window with a segmentally-arched head. The eastern half is taken up by double garage doors with tongue and groove boarding above and an eaves level gabled dormer; this has a (modern) clock and a former window infilled by a modern board with four pigeon-hole cut-outs. The roof is tiled. The lower part of the east end wall is brick and the upper weatherboarded. The gabled west wall is brick throughout without a plinth; there is a door at the south end, a high level window and overhanging eaves. The bricks are larger than those on the south elevation. The rear north elevation backs onto the moat and has a brick raking buttress on the north-west corner. A straight joint at the mid point indicates that the building has two distinct construction phases with the western half being the earlier. A large modern ground floor window has been inserted into this end; there is a blocked door in the eastern half.

Interior – The ground floor of the western unit is used as a workshop and has a modern door knocked through to the east end. It has a concrete floor, a large elm ceiling beam close to the west wall and exposed ceiling joists; in the southern half of the room these are modern replacements. There is a closed string wooden stair to the first floor which is open to the roof with limewashed brick walls and one free-standing roof truss close to the west end. The principals have curved feet, which rise from the tie beam at floor level to a high collar; there are two tiers of purlins, the upper clasped by the collar. Its position close to the west end and the differences in the construction of the west wall indicate that the building has been reduced in length and externally there are indications of its former footprint in the grass. Set against the brick east wall which was originally the end of the building there is an open framework, comprising an eaves-level tie beam and collar linked by queen posts with side rails. In the centre, set in the brickwork there is a high level window with a pegged frame divided into five-lights by diagonal wooden mullions. In the gable there is a row of four rectangular openings which are probably pigeon holes.

East end, ground floor,
showing first floor structure
and underside of stairs

North side of roof truss at west
end of buildings

Brick partition wall showing
window

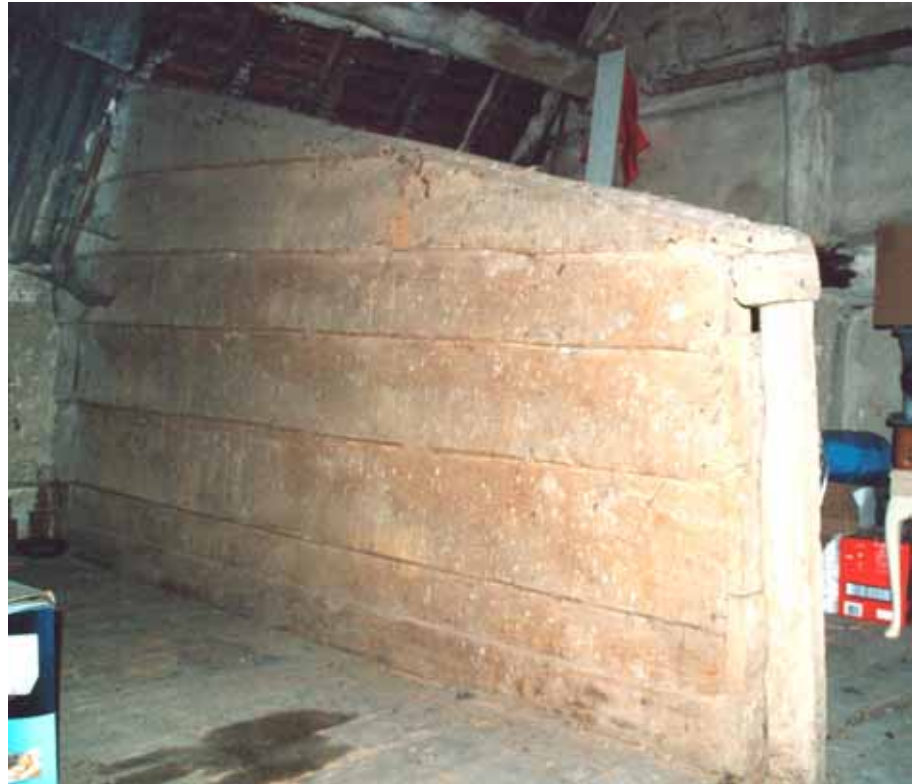
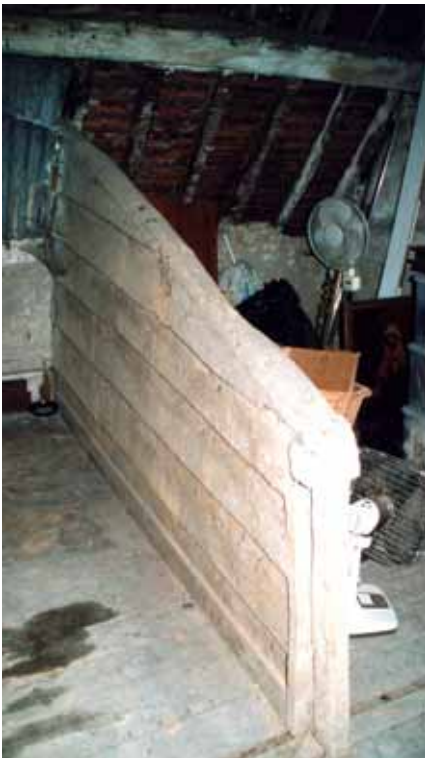
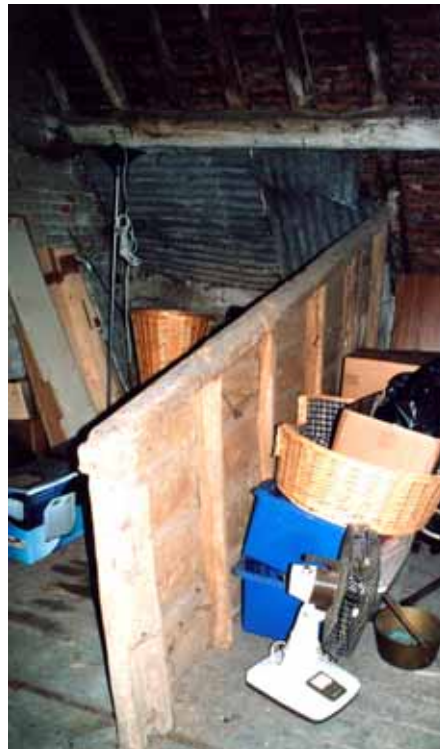
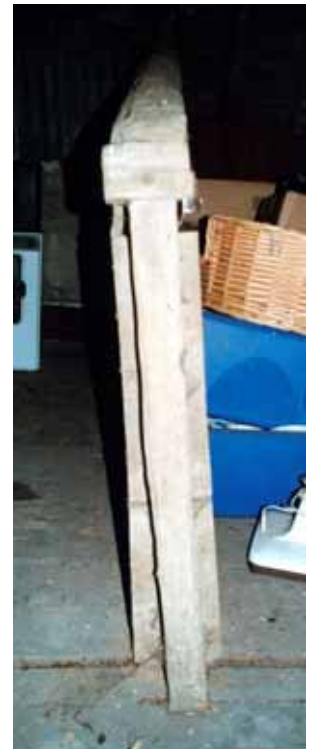
Fig 6
Mill house

Bin partition, east room
first floor -

From the south-west
showing boarding

From the south

From the south-east
showing studs

From the south showing
end post and truncated
boarding

Partition - The room has a boarded floor, formerly divided into a central walk-way with paired bins to either side. The outlines remain as scars in the floor and the partition on the north side survives (Fig 5). It is formed of six tiers of lapped elm boarding, reinforced at the base and with a sloped top-rail; this is nailed to a rafter at the north end. The boards are nailed to six uprights on the reverse (east) side. The end post is tenoned into the floor and retains two truncated horizontal boards at right angles to the partition which once formed the front of the bin; the top rail to this section is also truncated.

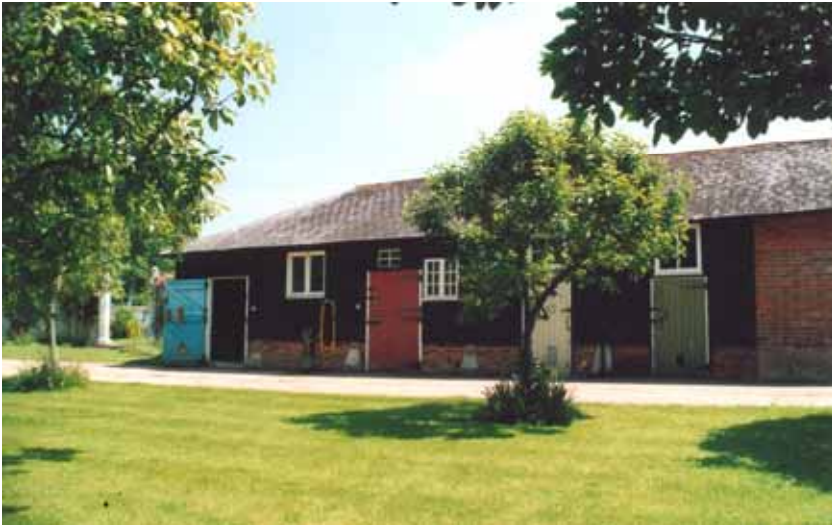
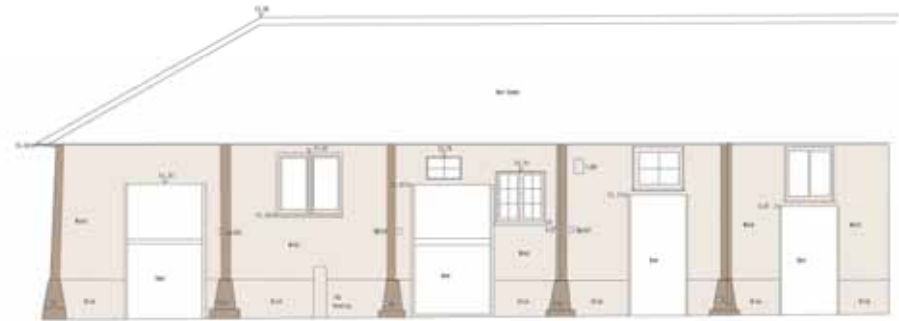
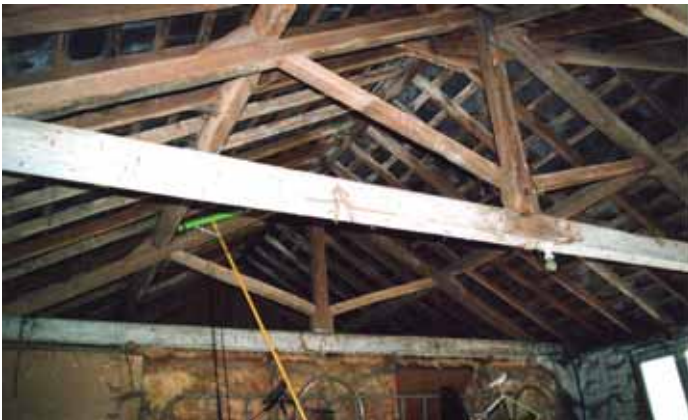
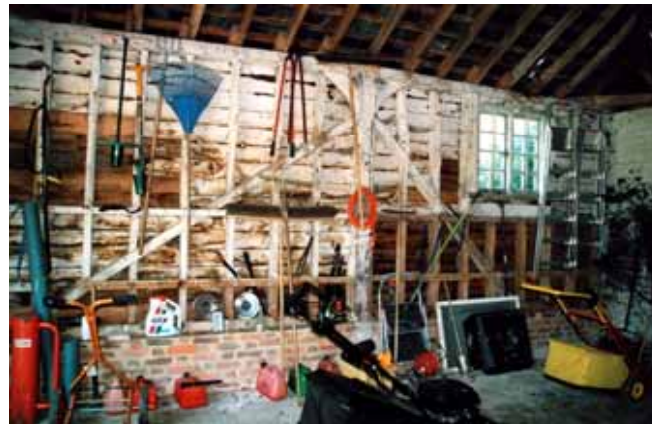
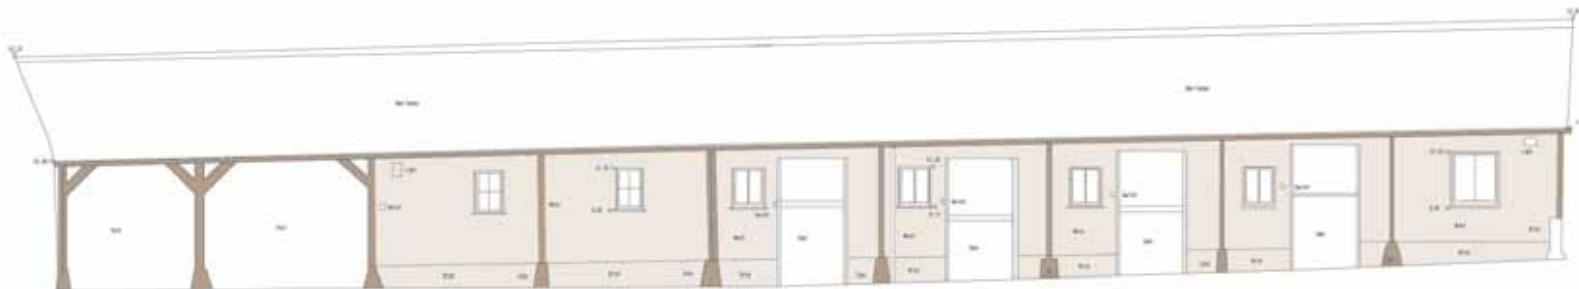
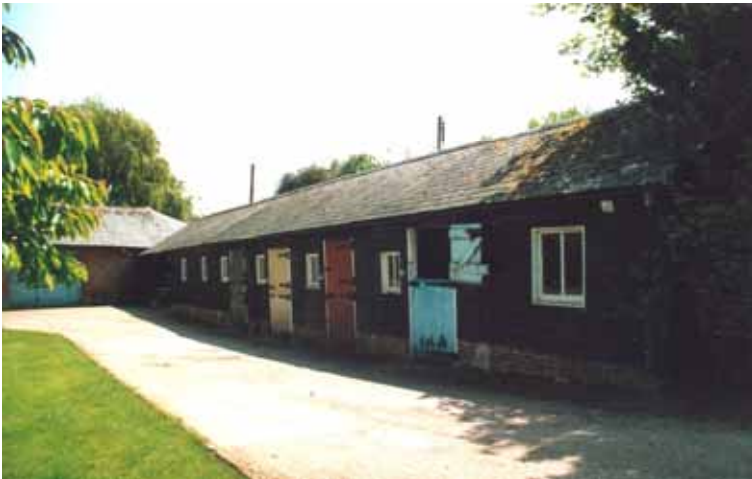
Fig 8 Stables
(clockwise)

Internally the structure is clearest in the two-bay room at the north end where the curved three-way braces to the original posts are visible. These carry the wall plates and are integrated with the roof trusses which are of strutted king post type with a single tier of purlins lodged on applied brackets; the wood is evenly sawn pine. The remaining three bays are subdivided in part by modern partitions and in part by stable boarding; at the end of the range is a tack room with a brick south wall.

East stable from the west

East stable elevation

East stable, north wall interior showing braced post

South stable elevation (for key see fig 3)

Roof to east stable

A These both originated as open-sided sheds built against brick rear walls, with the roofs supported on braced posts. The east stable appears to be the earlier; it has more finely detailed curved braces and a king post roof and probably dates to the first half of the 19th century. The roof of the south stable is formed more functionally of machine-sawn timber and probably dates to the second half of the 19th century; it appears to have been built before 1877 unless it was a replacement for an earlier structure in the same position. The rear wall was probably a pre-existing boundary wall.

B Both buildings were converted into stables by infilling the open structures with weatherboarding on a brick plinth and subdividing the interiors below the trusses with boarded partitions. This probably took place in the early 20th century as part of a general renovation of the outbuildings.

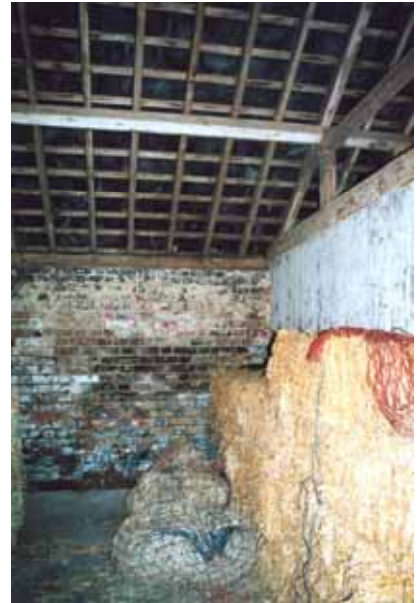
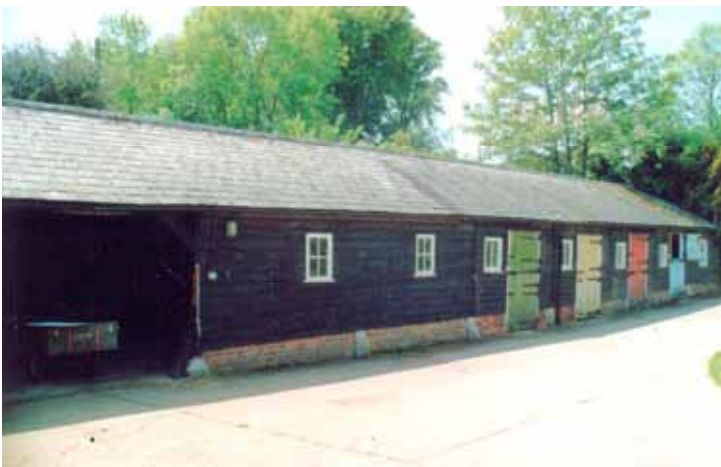
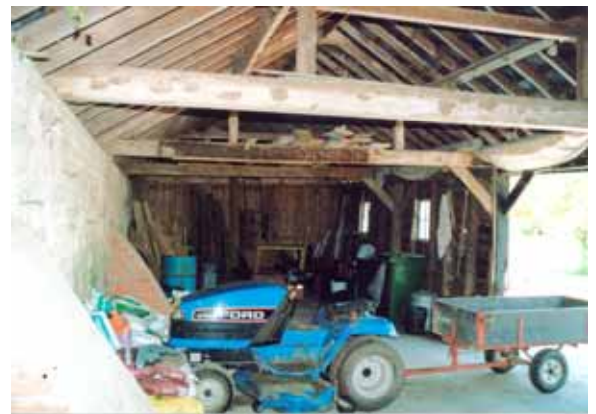
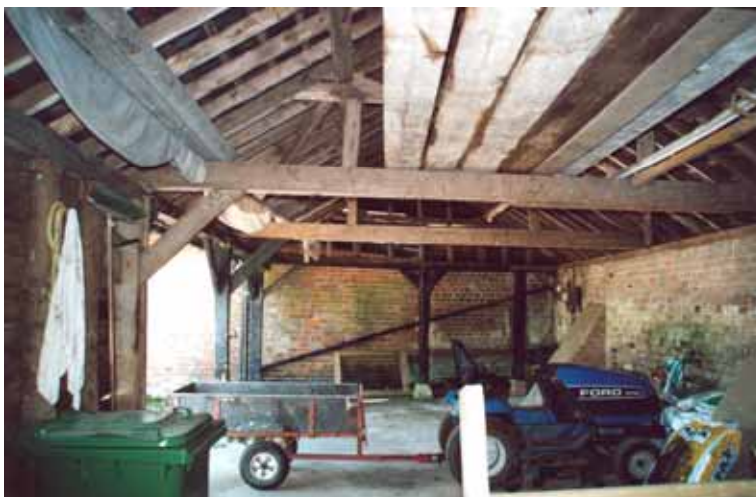
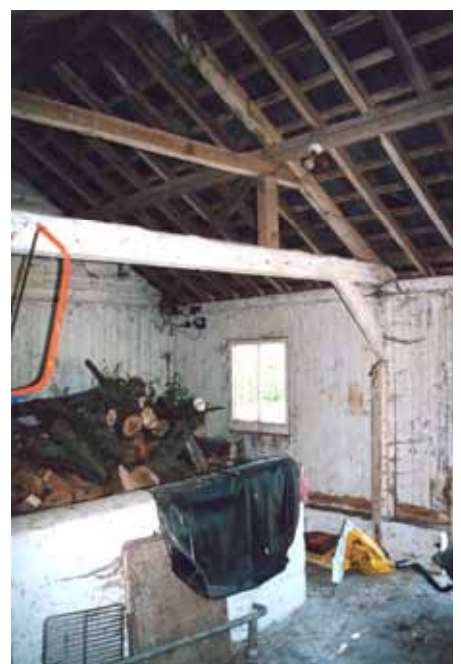
Fig 9 South stable
(clockwise from above)

South stable – this is nine bays long, narrower and somewhat lower than the east stable but similar in construction with a low-pitched slate roof and weatherboarded elevations above a brick basal plinth. It also originated as an open-fronted shed with posts on tapered padstones and the two bays at the south-east end remain open. The posts have straight braces of machine-sawn pine and the roof trusses are of queen-post type with purlins clasped above the collar and a plated apex with a ridge board. The rear wall is brick; it has been pushed inwards by a high external ground level and has been buttressed. The south-east end bay is trapezoidal, open to both north and east and detached from the adjoining brick wall. The three bays to the west form part of the same space, one remains open-fronted, the other two are now closed, each with a small window. Beyond this are four stables, each with a split door and a small window, divided internally by boarded partitions to tie beam level; boards also line the outer walls.

- From the north-east
- From the north-west
- Central stable compartment
- East end looking west
- Stable compartment at west end
- East end looking east
