**AN
HISTORIC BUILDING RECORD
OF
THE GRANGE,
HIGH STREET,
LONG WITTENHAM,
OXFORDSHIRE**

*On behalf of
Mr Graham Neil*

SEPTEMBER 2004

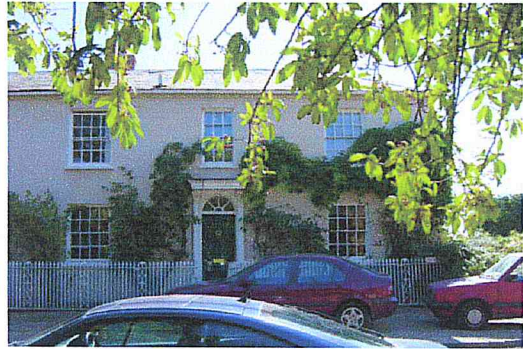
Plate 1: The Original Front Fenestration

- 5.1 The house is of brick, in Flemish bond, the whole painted in white. The property has a hipped roof of slate and the chimneys are brick stacks. The house is a detached house of two storeys in height. The front door bears a fanlight under a flat canopy supported by Doric pilasters. The windows, one on either side of the door with corresponding windows on the floor above are 16-pane sashes, common up to the 1840s. An additional sash window is situated above the doorway in the centre of the fenestration and is of 12-panes, thus placed to light the stair hall at first floor level.

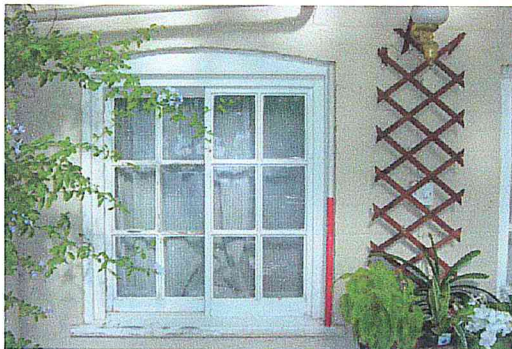
Plate 2: Horizontal Sliding Sash
Exterior view

- 5.2 The western side and rear of the property also incorporate 16-pane sash windows, however, the first floor windows are horned, and as such post-1840 in origin. The rear wall of the property, enclosed by a late glasshouse structure, has two windows at ground floor level. The window to the east (adjacent to the rear door of the property) is a horizontal sliding sash (Plates 2-4 and Appendix 1 for photographic locations). The adjacent window is a three light casement with cockspur catches (Plates 5-7)

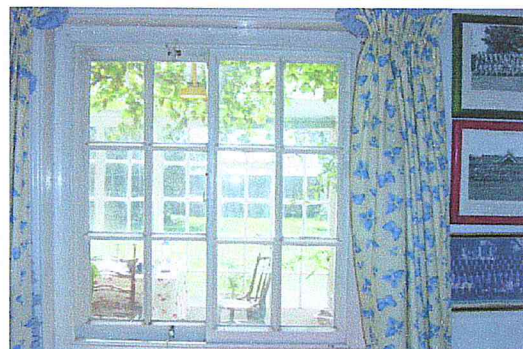
Plate 3: Horizontal Sliding Sash
Interior View

That these windows are of a different style to the others throughout the property may reflect the difference between the higher status rooms of the house and the lower status rooms, typically at the rear of the house. The lower status rooms would have originally housed, kitchen, pantry, larder and cellar access, in addition to a plain staircase to provide access to the upper floor.

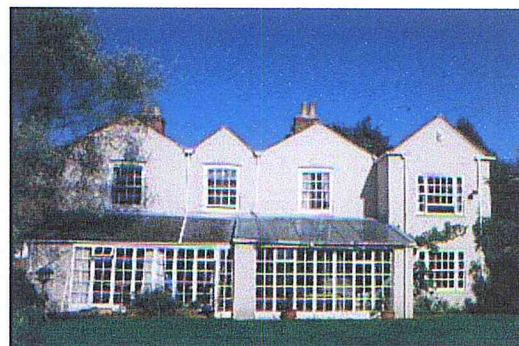
The majority of the structure is 20th century in origin, part of which may have been constructed at the same date as the eastern brick built two-storey extension.

The western end wall is of brick construction in a random bond. The eastern end is later and is formed by the 20th century two-storey extension. The early part of the glasshouse sequence is accessed through a large opening in the southern wall of the kitchen. The opening has a large wooden lintel over, and this may have been the location for the French doors onto the greenhouse as described in the 1941 sale catalogue (Adkin, Belcher and Bowen: 1941). The sequence of construction is shown on Figure 3.

Plate 8: A general view of the glasshouses
from the south

- 5.3 The glasshouse complex abutting the rear of the property will be removed as part of the current programme of works.

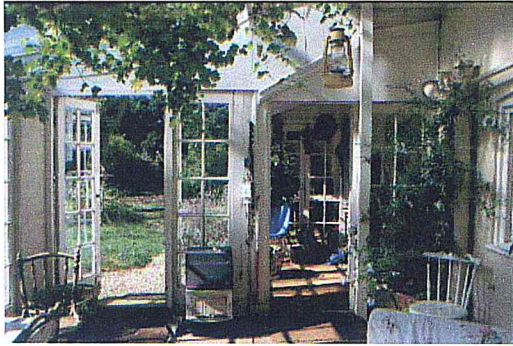
Plate 9: The eastern end of the early glasshouse with the later extension abutting the southern side

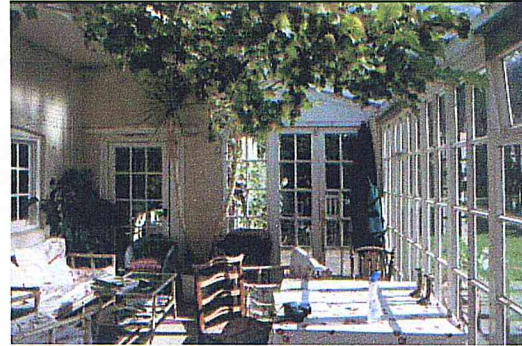
Plate 10: The western end of the later glasshouse, abutting the 20th century extension

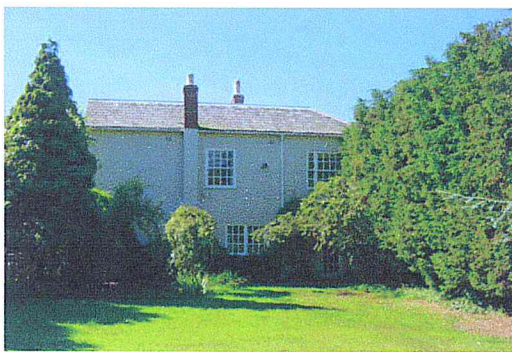
- 5.4 The brick two-storey eastern extension was built in the late 1940s. The structure comprises a single long room on the ground floor and the master bedroom with en-suite on the first floor. The ground floor room is accessed through double doors off the current drawing room, in what was originally the eastern side wall of the property. On the first floor, access is given at the end of the corridor through a door also let into the original fabric of the buildings eastern end wall. The extension is in Flemish bond to match that of the main house. The windows include a matching 16-pane sash to the upper floor on the front elevation, the lower window is however a smaller casement. The eastern end elevation (Plate 11) has a mixed assortment of window types: a 16-pane sash to the north of the chimney stack on the first floor, a casement beneath it on the ground floor and a tripartite window to the upper south side of the elevation. The two windows at the rear of the extension are also of tripartite type (Plate 12).

Plate 11: The assortment of windows in the eastern elevation of the extension

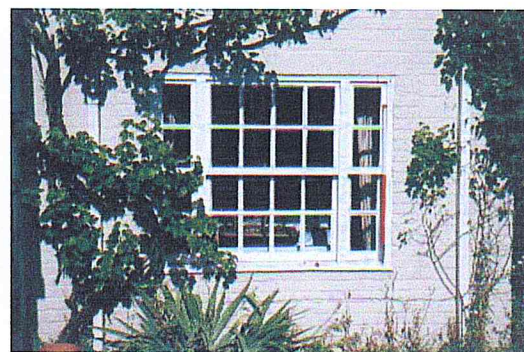
Plate 12: The tripartite window in the rear elevation of the two-storey extension

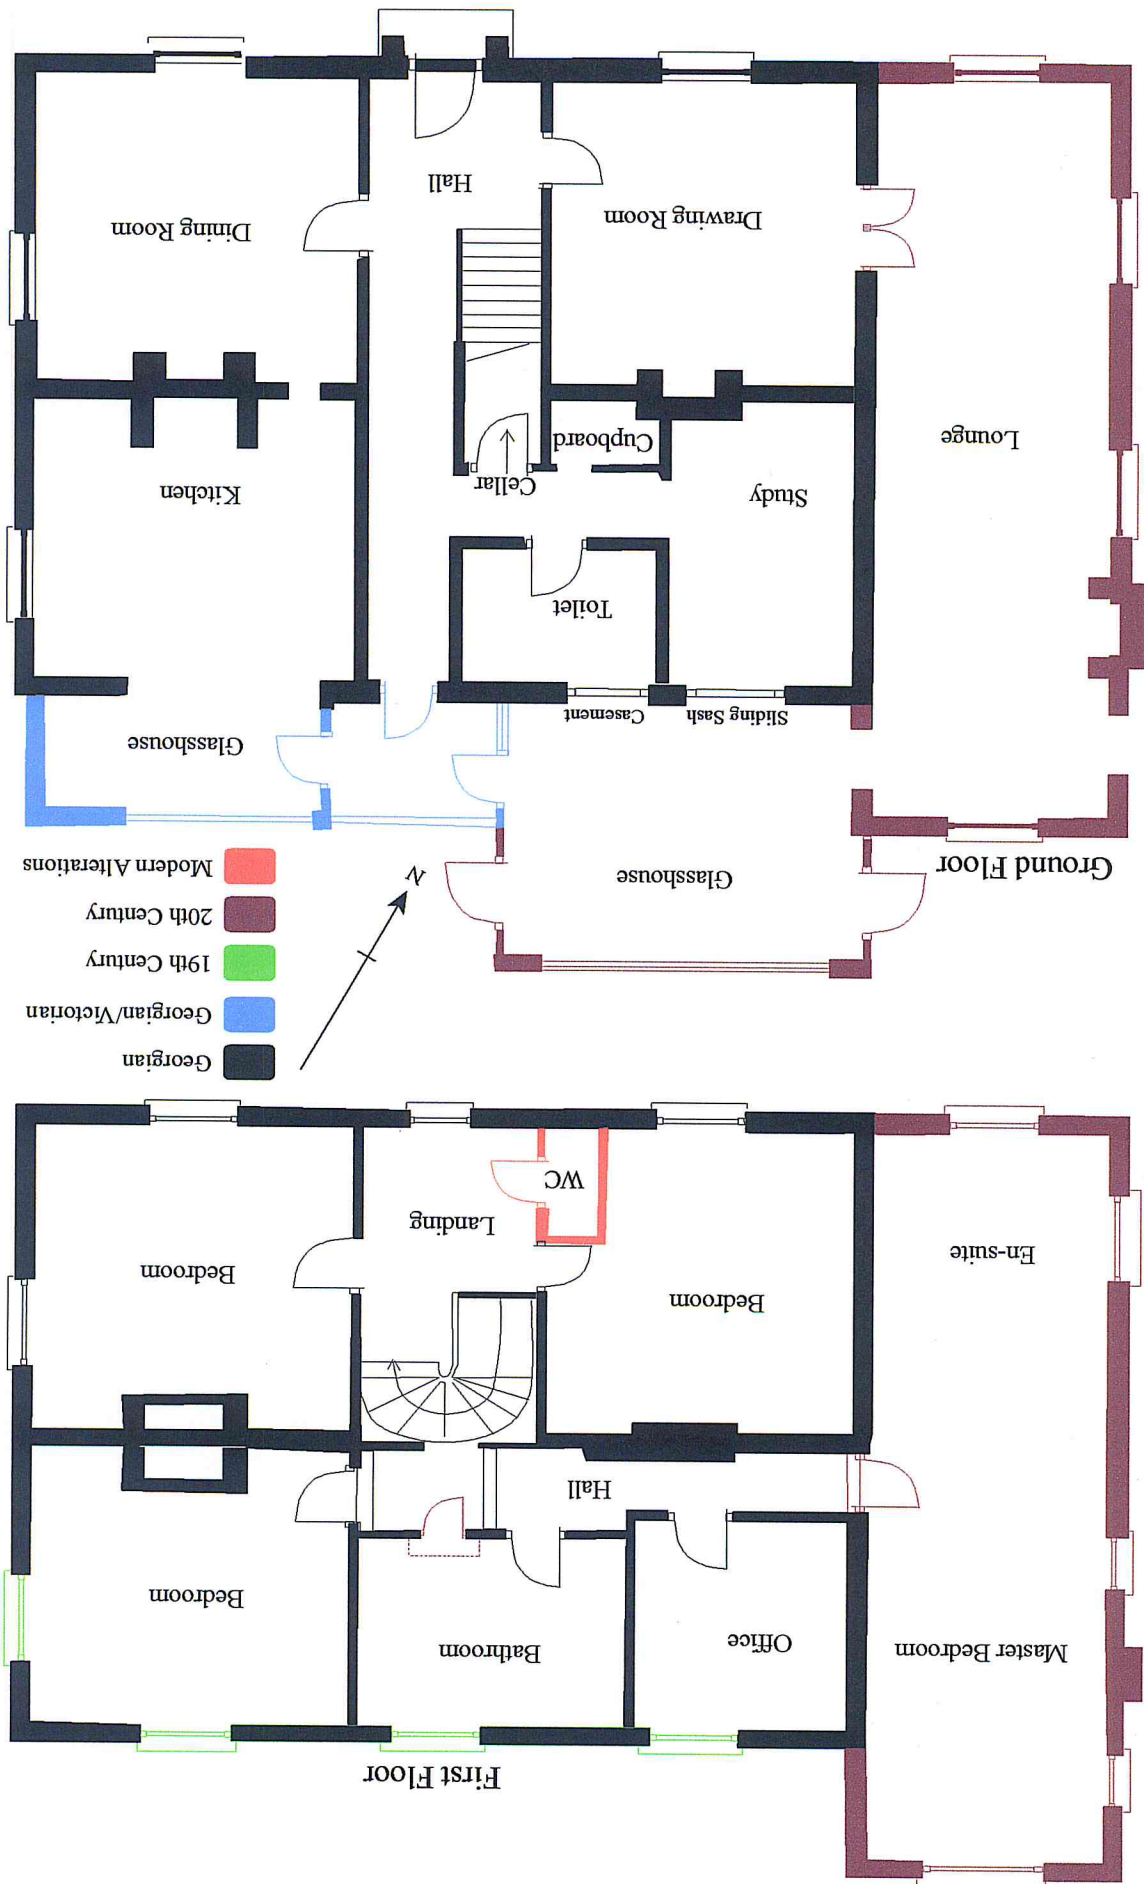
Figure 3: Phased Floor Plans

- 5.5 In plan, the house appears to have originally followed the typical four room plan, comprising a narrow entrance hall with stairway to the upper floor flanked at the front of the house by dining room and drawing room. The rear rooms house the kitchen, extra toilet and a small study. The study and toilet are accessed off a further narrow hall that also provides access to the cellar (Figure 3).

- 5.6 A further staircase was situated at the rear of the building and is mentioned in the 1941 sales catalogue. The additional stair would have provided access for staff. No trace of this stairway was visible during the survey. The extension to the eastern side of the property is later than 1941, as the additional living space provided was not detailed in the sales catalogue of that date. However, a greenhouse accessed through French doors is noted, providing evidence that some of the glasshouse structure was in situ prior to 1941, but was later extended possibly at the same time the brick extension was added (Figure 3).
