The history and structural development

EASTINGTON MANOR

NORTHLEACH, GLOUCESTERSHIRE

**The History and Structural Development
of
EASTINGTON MANOR, NORTHLEACH, GLOUCESTERSHIRE**

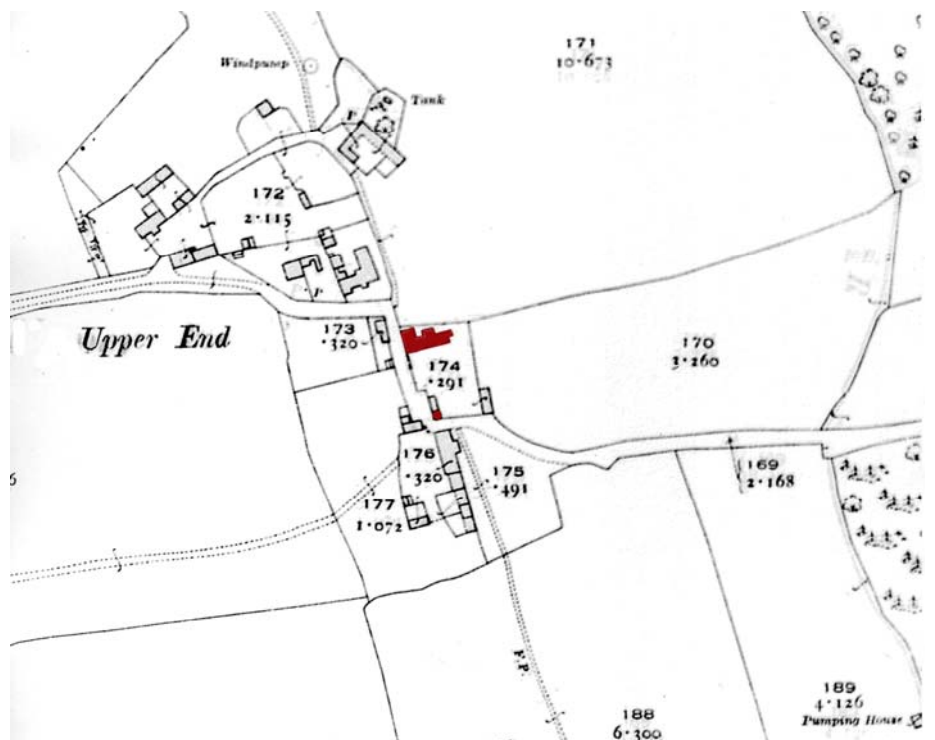
Fig 2 Plans

- 14th century
- 15th century
- 17th century
- 18th/19th century
- 20th century

The house has a complex development and not enough of the basic fabric is visible to resolve its structural sequence in detail. However it is essentially a medieval building of two phases which are distinguished principally by their different roof structures. The house was substantially modernised in the 17th century and miscellaneous additions were made at the back in the 18th and 19th centuries. The house was restored in the early 1920s by William Weir and converted from a working farm to a small country house

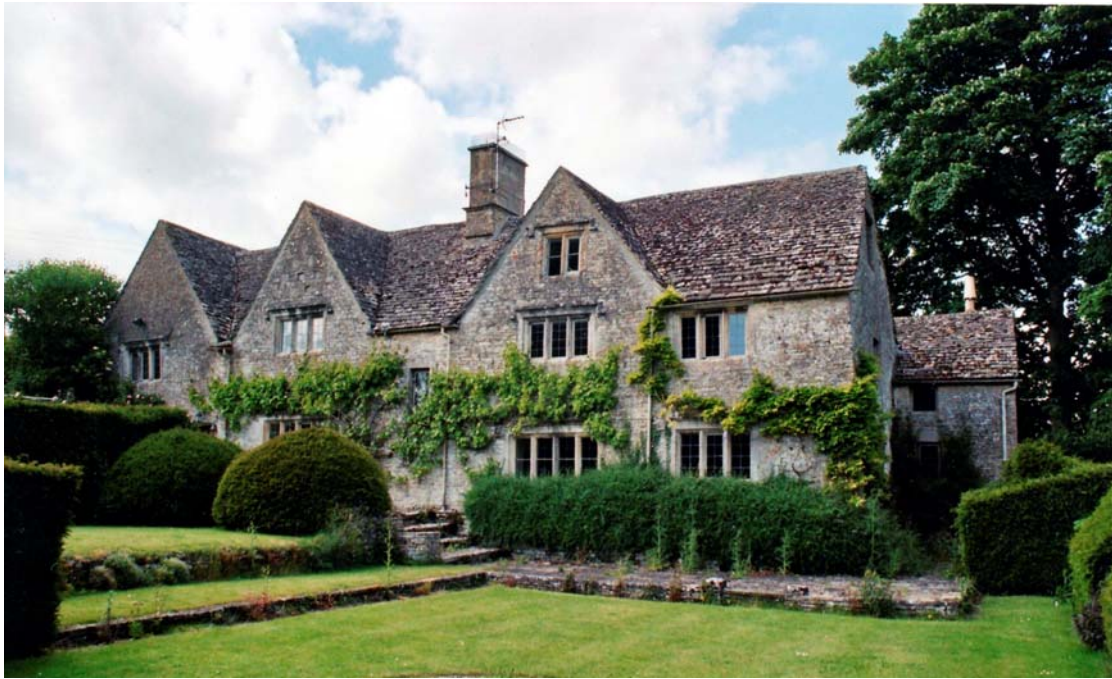
Fig 4

The south front

The house is built of limestone rubble with ashlar dressings and a stone-tiled roof. The principal elevation faces south and has three unequally spaced gables; the middle has blocked pigeon holes and the east an attic light. All but one of the windows have chamfered mullions with hood moulds of 17th century type; some have been restored in the 1920s and the leaded glazing dates to this time. The front door is at the west end of the elevation and has an ashlar surround with a flat arched head; the door dates to the 1920s. The adjoining quoin marks a change in the build between the 17th century work to the east and the older west gable. This has a 2m long vertical joint, visible to
