**ARCHAEOLOGICAL WATCHING BRIEF**

**St MARY MAGDALENE CHURCH,**

**WOODSTOCK, OXFORDSHIRE**

**AUGUST 2017**

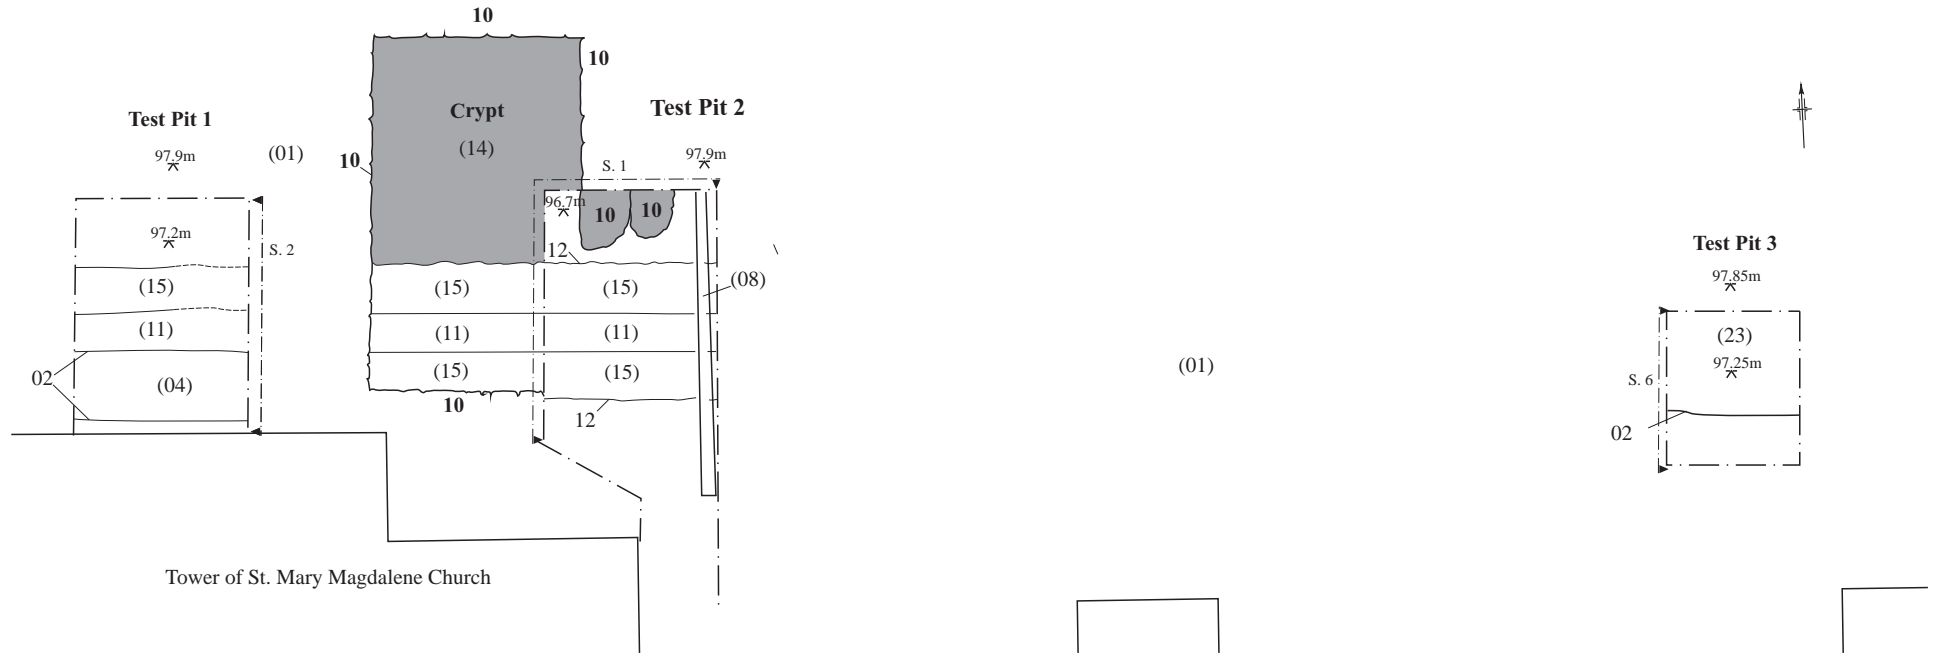
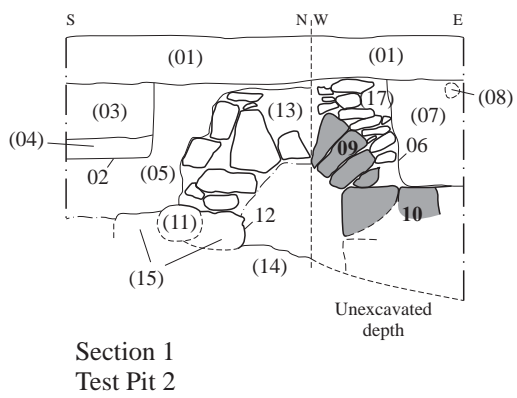
Figure 2: Test Pits outside the church with sections and crypt

The test-pits for the services (Figure 2) were dug in the northern area between the War Memorial and St Mary Magdalene Church. The three test pits were excavated by hand. The dimensions were:

Key  Archaeological features

The crypt, **10**, is located 0.60m deep beneath the northern churchyard ground. It has a chamber of 1.85m in length and 1.10m in width. The chamber had a vault, **09** that lay on the west and the east chamber walls and it is attached to the northern wall. The length of the vault arch is 0.20m (Fig.2 Plan and Section 1; Plate 7). Part of the southern wall was possible to visualize when the interior of the crypt was recorded.

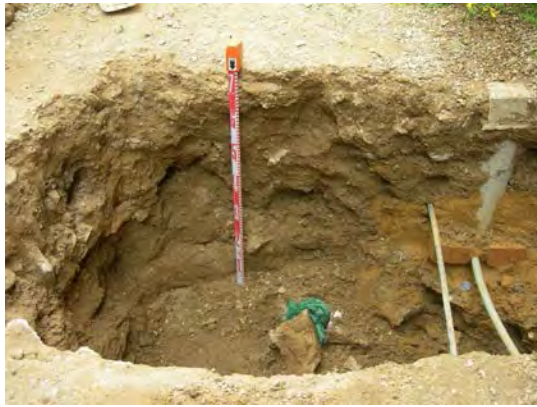
**Plate 1: Test Pit 1.**

(23) (Fig 2, Section 6; Plate 2). In TP 1, Cut 02 was cut through a disturbed layer of mid grey brown clay and limestone backfilling and made ground (16). This deposit overlay concrete (15) which was the setting for a ceramic water pipe (11). These features were only partially revealed in plan and not visible in section (Fig 2, Section 3; Plate 1). The uppermost layer in both test pits was a 0.25m thick deposit of path gravels and trampled ground (01).

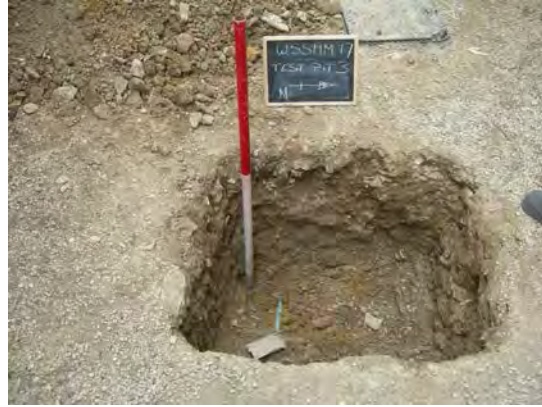
**Plate 2: Test Pit 3.**

Two of the three test pits were devoid of any archaeological evidence. These are Test Pit 1 and Test Pit 3. The deposits in both cases were quite disturbed by a cut 02 - a service trench that was dug at some point during the 1980s or 1990s in order to place services in the northern area of the Church. For both test pits, the depth did not exceed 0.7m. In Test Pit 3, Cut 02 was excavated through a mid grey brown clayey subsoil

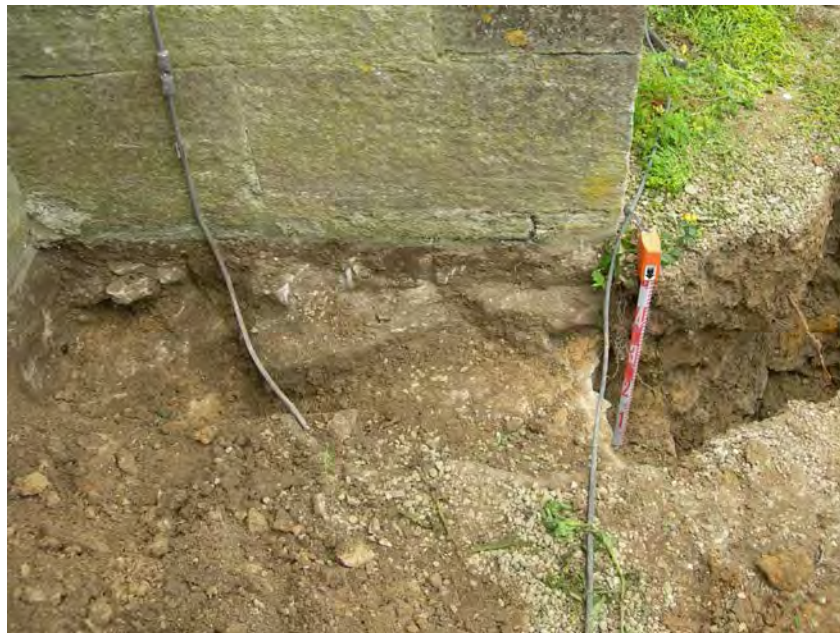
**Plate 3: Foundations of Church Tower.**

The excavation of TP2 was dug deeper than the other two test pits, at a depth of 0.8m, which revealed archaeology. A trench that ran from TP2 to the south was 0.15m deep and showed the foundations of the tower that was built by Townesend and John Churchill of Woodstock in 1784-6 (Baggs et al. 1990).

The foundations were constructed with the same limestone that we find in the tower, although the foundation stones were roughly hewn in comparison (Plate 3).

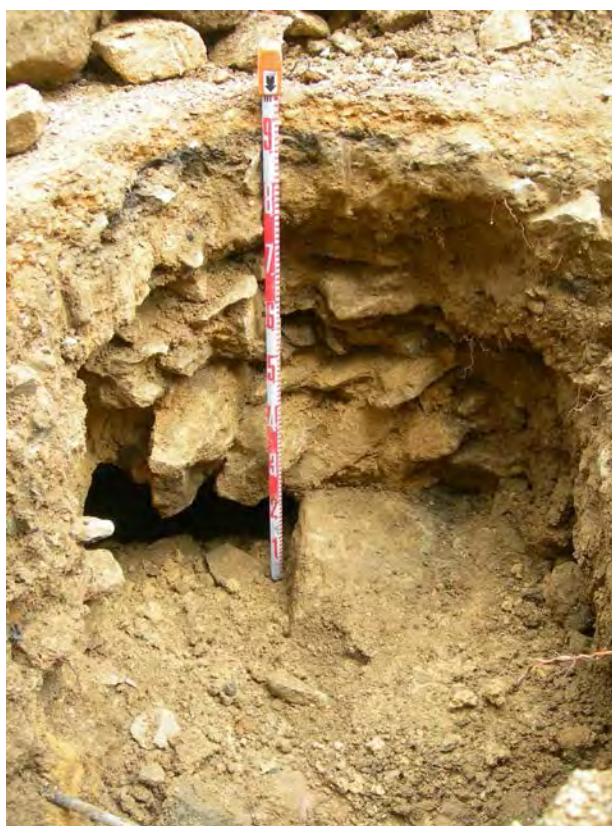
**Plate 4: Situation of TP2 before being cleaned.**

During the excavation of TP2 a hole in the ground became clearly visible of approximately 0.4m in diameter. This allowed access to the interior of a crypt (Plates 4, 5 and 6). An archaeologist was not present during the excavation of the test pit and

the situation when we were present was the one visible in Plate 4. Once it was recorded photographically, it was cleaned archaeologically.

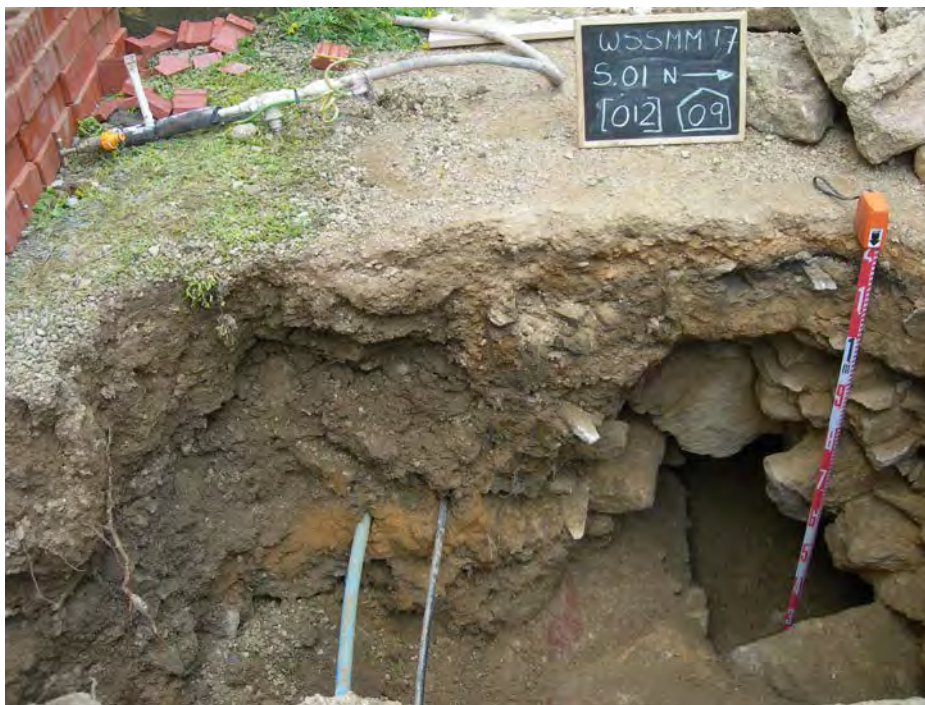
**Plate 5: Western profile of TP2 (S.01)**

The W, E and S walls of the crypt were partly demolished by the service trench 12. This cut was probably more than 0.7m wide (Fig. 2, Plan and Section 1; Plate 5). It was created to install the ceramic pipe (11). This pipe was set in concrete (15) and was also observed in Test Pit 1 (Fig. 2). This type of clay pipe was in use in Britain until the 1960s, so it was placed some time before this date.

Overlying this pipe in TP2 was a backfill (13), a light brown yellowish clayey silt containing a good deal of hewn sandstone fragments of fine and medium size and rare pieces of modern concrete. These fragments of hewn sandstone are similar to the ones that we can find in the crypt vault **09**. Deposit (13) was overlaid by deposit (05) a mid-brown sandy clay deposit with lumps of green clay. This deposit was identified as made ground and backfilling and was greater than 0.65m thick. The ground in section appeared very disturbed and it was not possible to identify any cuts or differentiate these backfills from any surviving subsoil deposits (Fig. 2, Plan and Section 1; Plate 5).

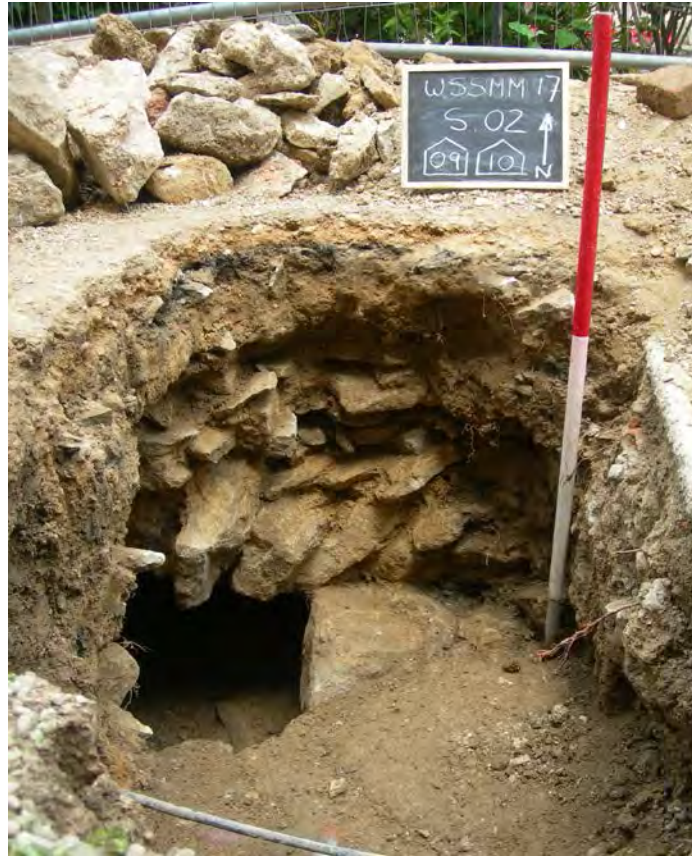
**Plate 6: Northern profile of TP2 (S01).**

Overlying the crypt vault **09**, and visible in the northern profile of TP2, was deposit 17 (Fig. 2, Section 1; Plate 6). The deposit was a 0.55m thick light brown yellowish clayey silt. The deposit contained the same sandstone material as the crypt vault and may have been deposited close in time to when the build of the vault was completed.

In the northern profile of TP2, (Fig. 2, Section 1; Plate 6), we can see service trench 06. This service trench was 0.55m deep and cut backfill (17). It contained a gas pipe (08) and was backfilled by a mid brown clayey sand (07). Service trench 06 was at least 0.4m wide and ran from the North towards the church. The service trench was probably dug at some point during the 1980s or 1990s.

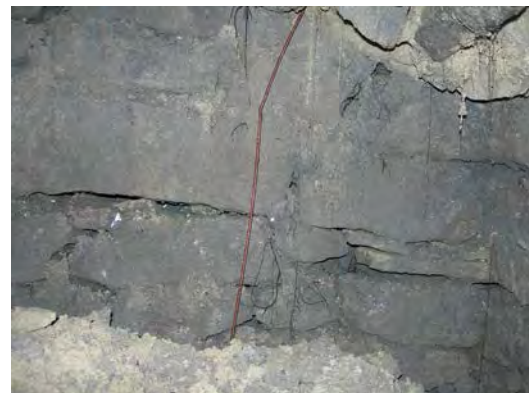
**Plate 8: Northern wall 10 and fill (14).**

The cavity of the vault was filled by deposit (14), a very soft mid-brown clayey silt deposit with inclusions of roughly hewn sandstone fragments of medium size (plate 8). Potsherds were found on surface, one fragment of a pipe made of clay and one small bone fragment. The pottery was collected and the bone, possibly an animal bone, was left inside the crypt. Some of the pottery was stuck into the walls of the crypt. The deposit (14) was thicker in the central part of the crypt and decreased in thickness into the north area of the chamber. In this area the distance between the roof and the fill (14) was 0.9m.

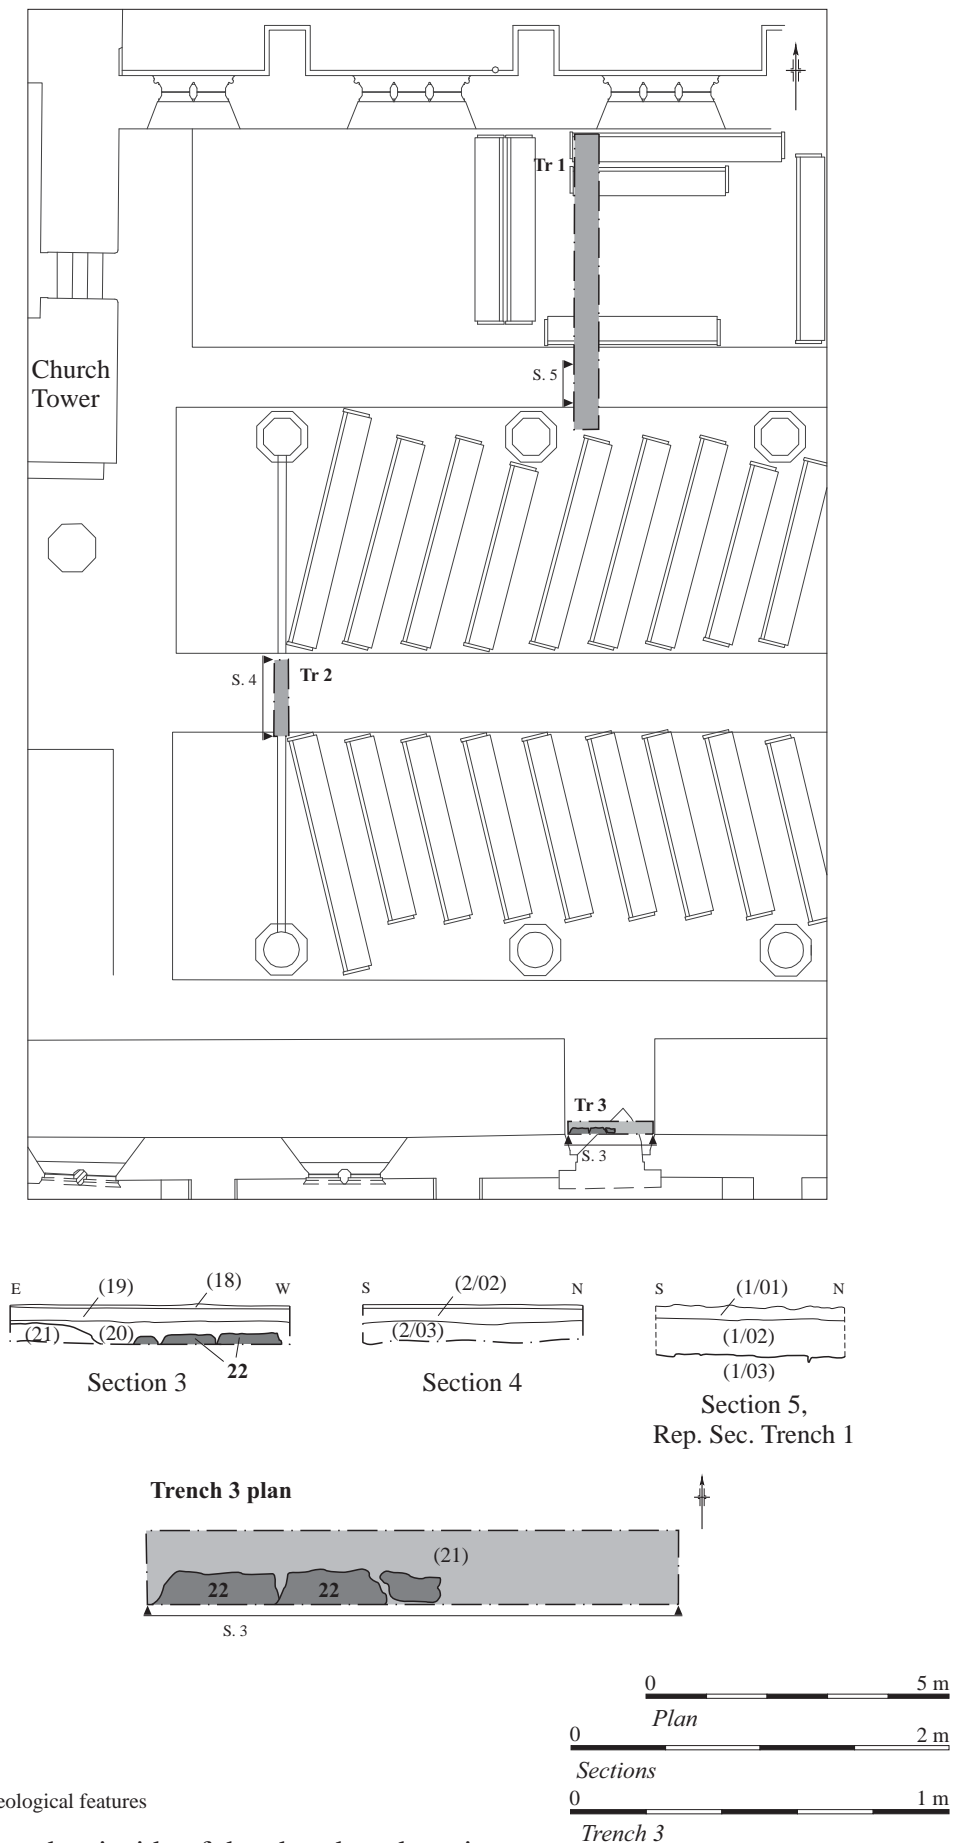
Figure 3: Trenches inside of the church and sections

Three service trenches (Figure 3) were excavated inside of the Church for the placing a water pipeline. The dimensions were:

1. Trench 1: 4.25x0.25x0.25m
2. Trench 2: 1.10x0.20x 0.20m
3. Trench 3: 1.40x0.20x0.20m

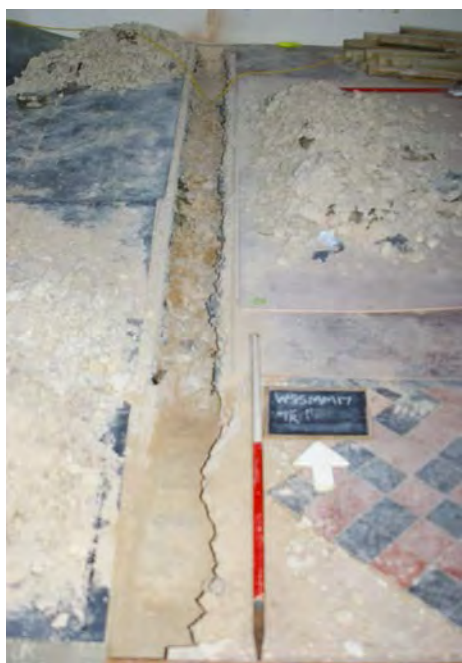
**Plate 9: Trench 1.**

In all the three trenches contractors had to use heavy duty drills to pierce through top layers. Subsequent deposits were removed using a mattock, shovel and trowel. Trench 1 was situated in the north aisle of the church, running for 4.25m from the south to the north and into the northern wall (Fig. 3, Section 5: Plate 9) It was 0.26m deep and a concrete layer (1/01) was found of 0.06m thickness. Below it a layer 0.20m thick of crushed concrete was encountered. Underneath this deposit lay another layer of concrete (1/03).

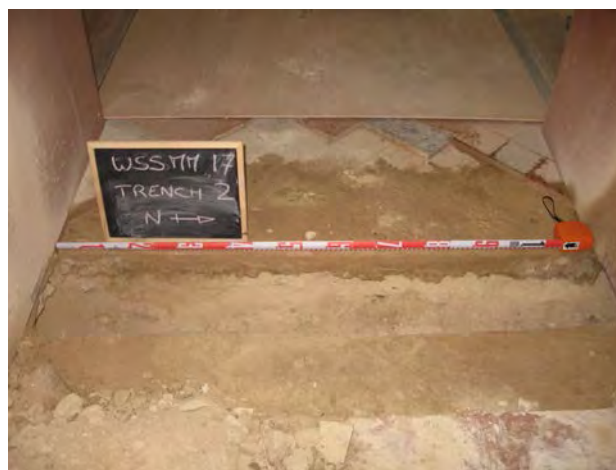
**Plate 10: Section Trench 2.**

Trench 2 was located right in the middle of the nave, in the southern part of the Church, between the entrance bay and the next bay (Fig.3, Section 4; Plate 10). The floor in this area consisted of tiles (2/01) 0.02m deep. Underlying this was a layer of concrete (2/02), 0.06m thick. Below the concrete was a levelling layer (2/03), 0.10m deep, a mid-grey sand deposit with a moderate number of inclusions of fine angular fragments of limestone. The trench was devoid of any archaeological remains.

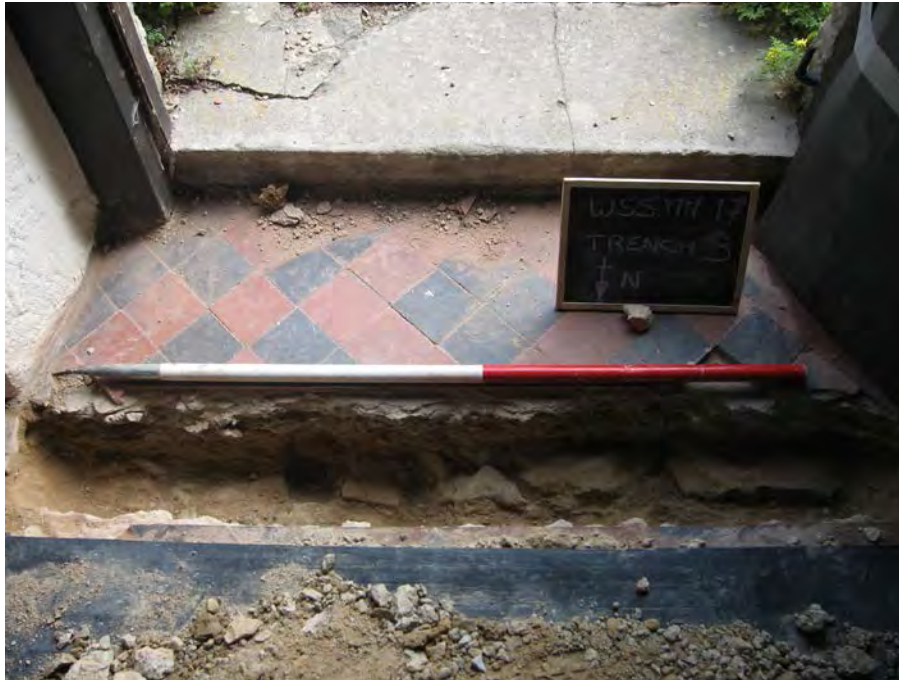
**Plate 11: Section Trench 3.**

Trench 3 was undoubtedly the most interesting trench from an archaeological point of view. It was located in the south aisle of the church, immediately before the threshold of the doorway (Fig. 3, Trench 3 Plan, Section 3; Plate 11). Again in this trench a tiled floor was found (18), 0.02 m deep and beneath it the same layer of concrete (19). This was 0.06m thick and was recorded in the other two trenches. The concrete overlaid what was possibly a levelling layer (20), a mid-yellow brownish sand deposit with inclusions of fine/medium sub-angular fragments of limestone. Below this layer a

dark yellow-greenish deposit of clay (21) was encountered, with no finds in it. This deposit appeared in the western part of the trench and it was more than 0.08m thick. It was not possible to finish excavating it due to the constrained width of the trench. In the eastern part of the trench, what was interpreted to be the foundations of the 13<sup>th</sup>-century church were discovered. At 0.14m below the current floor (22), two sandstone blocks of medium size were identified (Fig 3, Trench 3 Plan and Section 3; Plate 11) . These sandstone blocks had an average size of 0.25m and they were roughly hewn. The bonding material was a type of clayey sand mortar of low quality. The two blocks were facing the North, showed an East-West orientation and were parallel to the Norman 12<sup>th</sup>-century southern doorway (Plate 12).

The archaeological watching brief carried out at this site has produced some really interesting results. The foundations of the medieval wall, built in the 13<sup>th</sup> century of the south aisle were recorded,. As has been mentioned, two roughly hewn sandstone blocks of medium size were found. They were facing the North, showed an East-West orientation and were parallel to the famous Norman 12<sup>th</sup>-century southern doorway. This doorway was reset when the south aisle was built in the 13<sup>th</sup> century (Baggs et al 1990). This gives a dimension of the foundations of the 13<sup>th</sup>-century wall for the south aisle of a minimum of 0.70 m width.
