JOHN MOORE HERITAGE SERVICES

**HISTORIC BUILDING ASSESSMENT
AND ARCHAEOLOGICAL WATCHING BRIEF
ON
ABBEY LODGE, MAIN ROAD,
FARTHINGHOE, NORTHAMPTONSHIRE NN13 5PB
NGR SP 53584 39797**

OCTOBER 2017

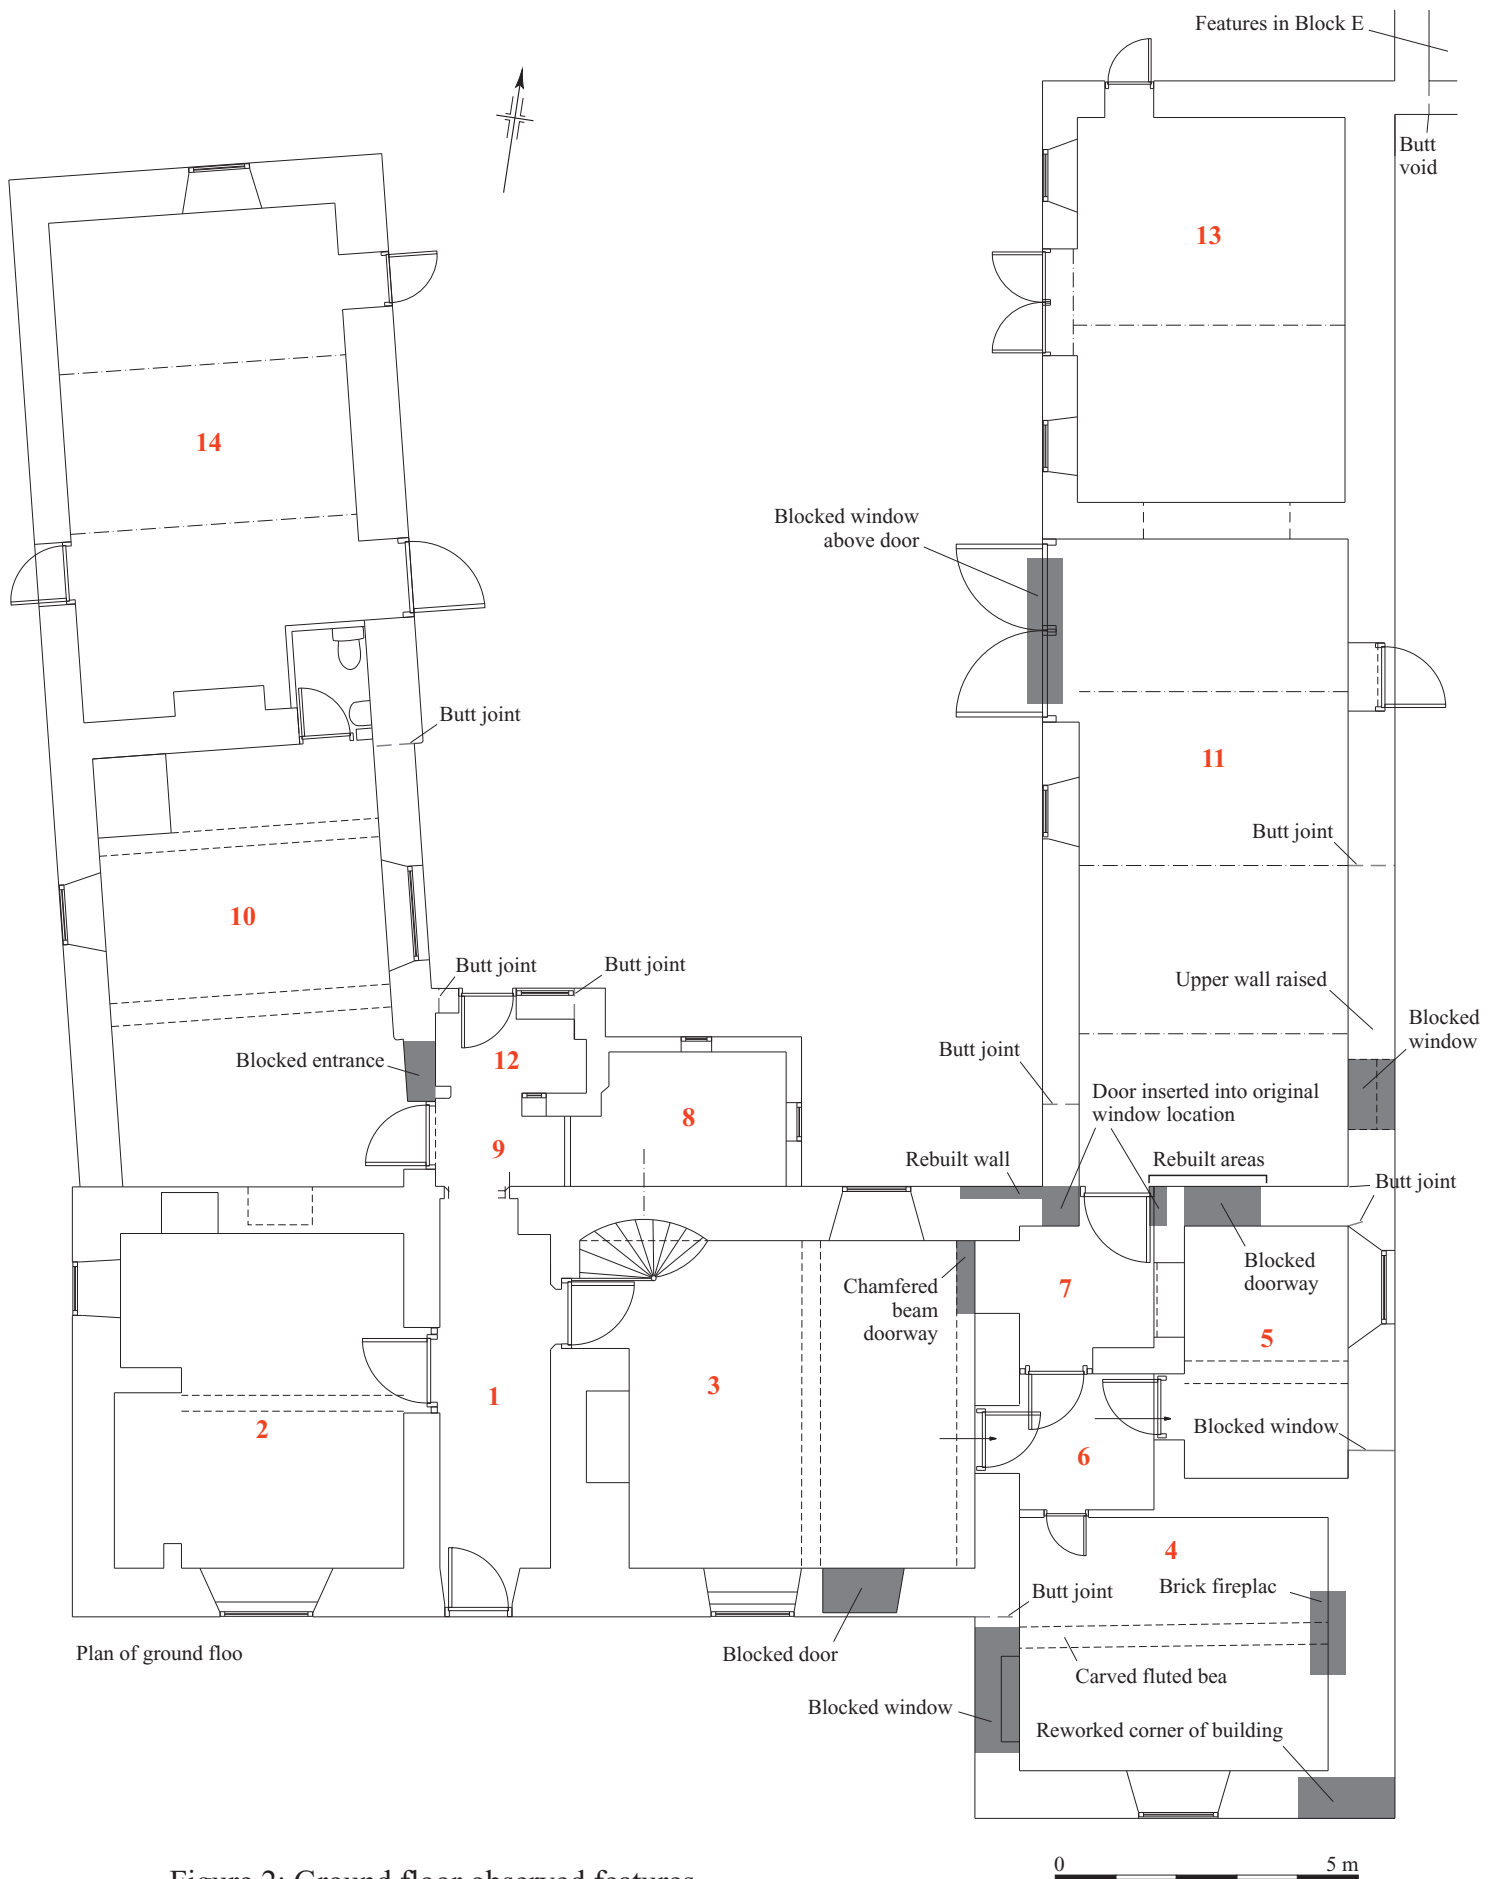
Figure 2: Ground floor observed features

Ground floor (Fig. 2)

Room 3 (main hall) has indications of a blocked doorway in the south wall, both internally and externally (plate 1). In the northeast corner there is a chamfered beam doorframe or opening.

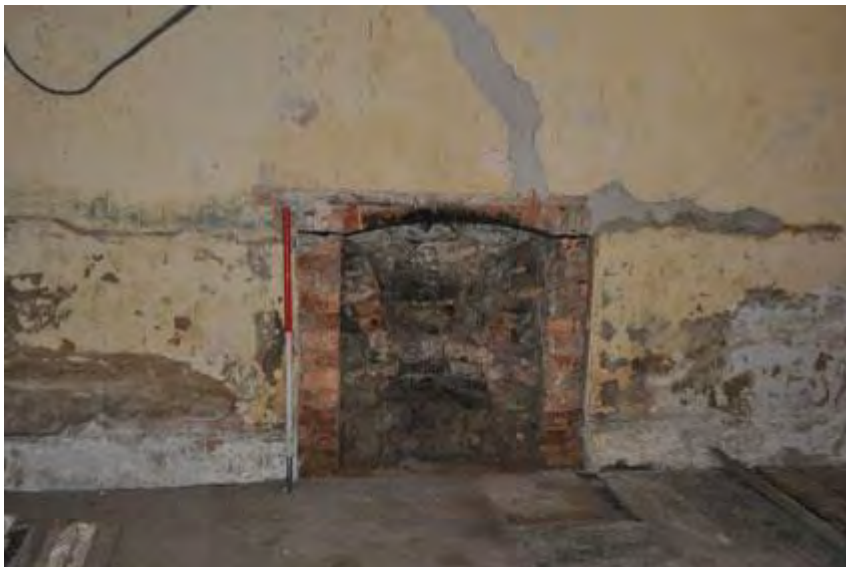
Plate 2: Brick fireplace

Room 4 has had plaster removed that has uncovered the remains of a brick fireplace in the east wall (plate 2). The bricks are about 65mm to 70mm in depth. In the west wall there is evidence of a blocked window (plate 5). Uncovered in the ceiling there is a carved fluted beam (plate 3). Externally to this room on the south east corner there are indications of a reworking of the corner (plate 4).

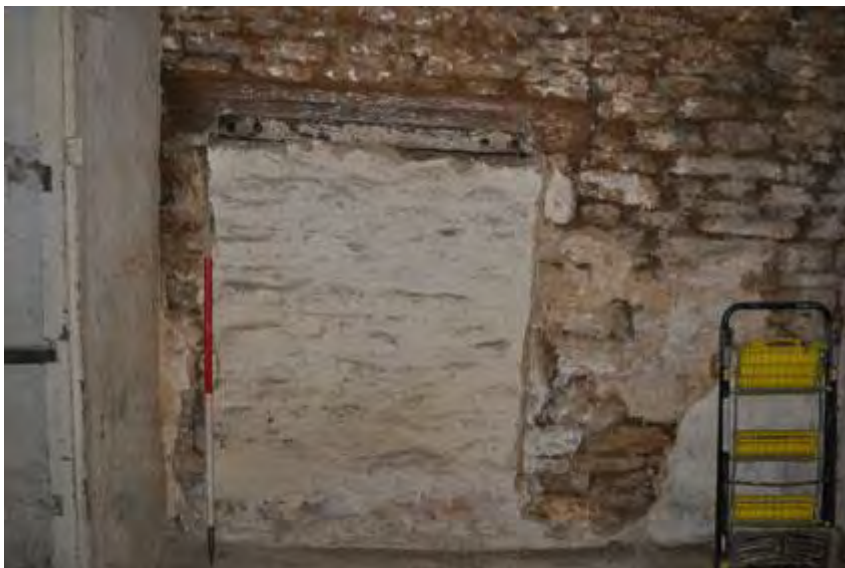
Plate 6: Blocked door

Room 5 had its plaster removed and had indications of a butt joint in the northeast corner of the room (plate 7). In the southeast corner of the room there is evidence for a blocked window (plate 8). In the north wall there is evidence for a blocked doorway (plate 6).

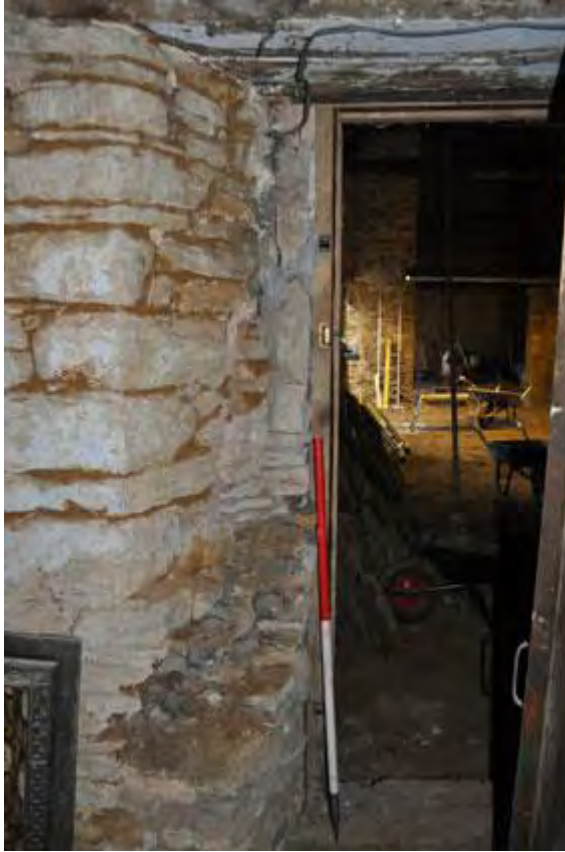
Plate 9: Door inserted in original window location

Room 7 has also had plaster removed, which has produced evidence that the door in the north wall was inserted into the location of an earlier window (plate 9). Externally to room 7 on the northwest side is evidence of the reworking of the wall (plate 10), probably the rebuilding of part of the stone structure.

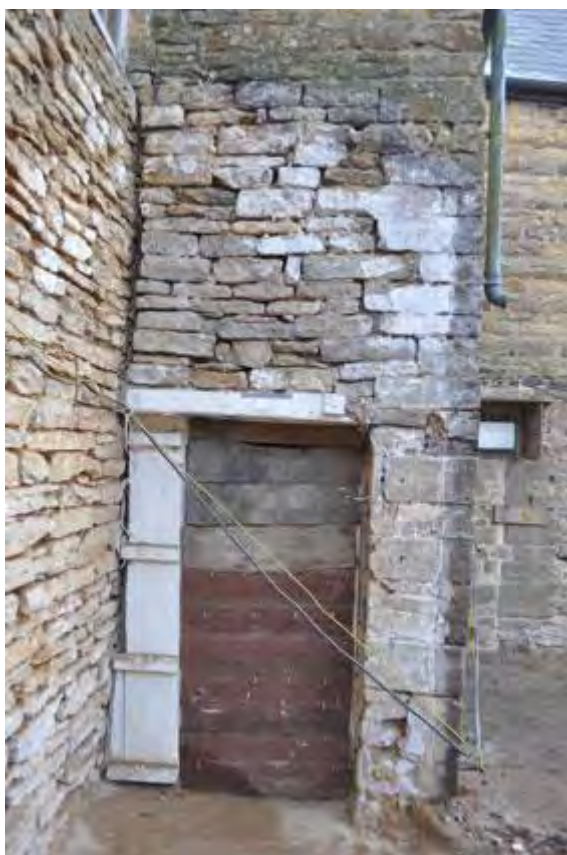
Plate 11: Butt joint in rebuild

Rooms 8, 9, and 12 were butted up to the back wall of the main building (plate 11).

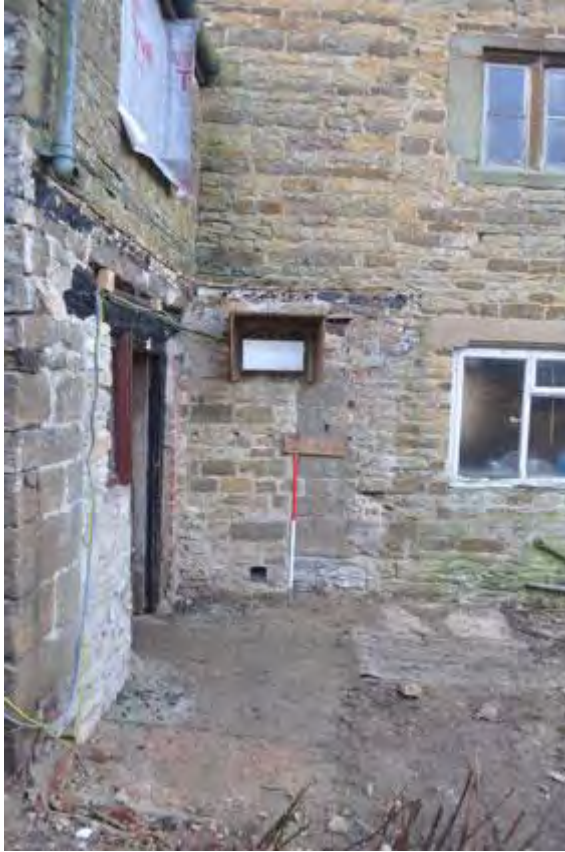
Plate 12: Blocked doorway and window

Room 10 after the plaster had been removed had indications of a blocked entrance in the east wall (plate 12), which was adjacent to the current opening. In the north wall a door was inserted. In the northeast corner externally there was evidence of a butt joint. The implications of this last piece of information is that room 14 (Block C2) originated as a stand-alone structure.

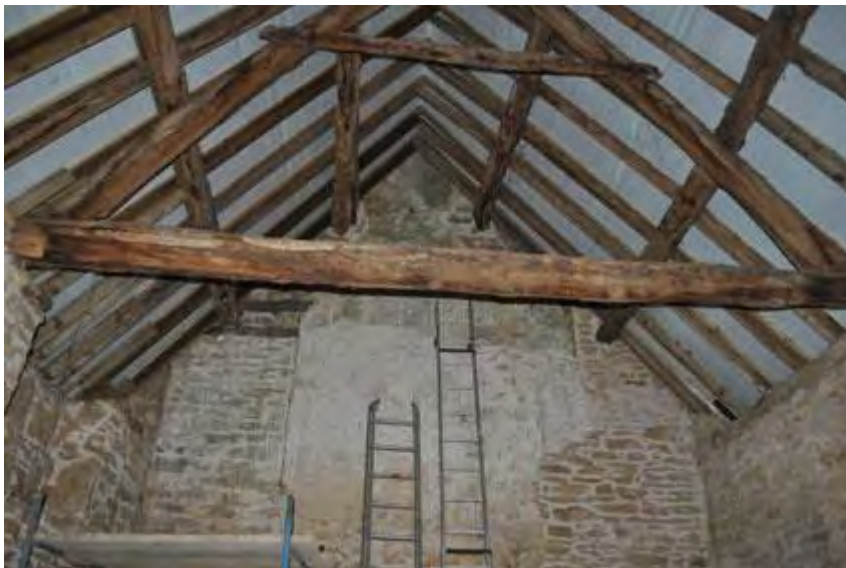
Plate 13: Blocked window in gable and in east wall

Room 11 is primarily dealt with in the ground reduction associated with the Watching Brief. The east wall shows signs of a number of alterations over time. There are a series of butt joints both inside and out (plate 16). There is a blocked window in this wall that is evident internally (plates 13-14). The level of the wall has also been raised. In the south wall there are indications of a blocked window - ground floor and in gable (plate 13), and a door and a butt joint in the southeast corner. In the west wall there is a butt joint and a blocked opening above the double door (plate 15), which has a moulded surround with an ovolo moulding. Such mouldings are recorded as being of a 16th or 17th century origin (Alcock and Hall 1994, 38-39). This implies that this phase is of a late 17th century at the latest.

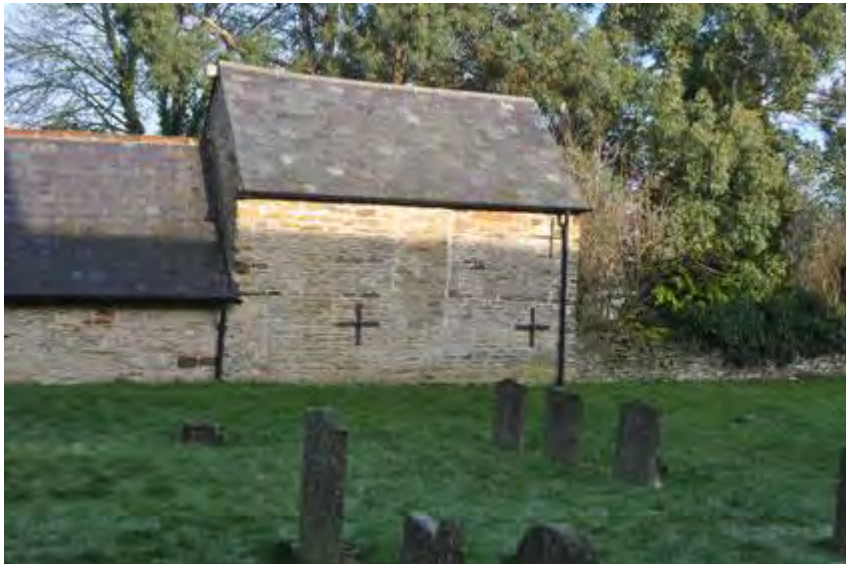
Plate 17: Butt joints and infill in the south wall

Room 16 shows a number of butt joints in its south wall, including a blocked wall (plate 17).

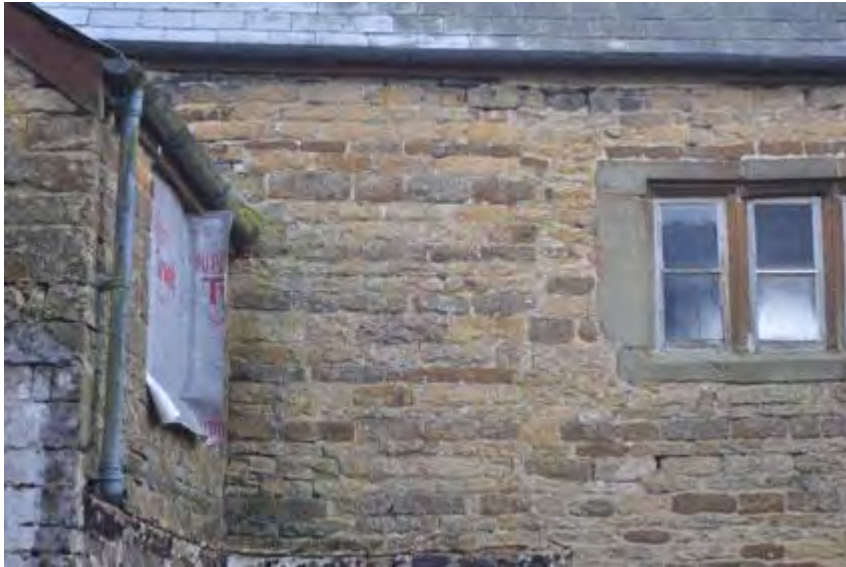
Plate 18: Blocked window F1 and F3

In the east wall of rooms F1 and F3 there was evidence of their being a blocked window in the inside and outside of the building (plate 18). In the northeast corner of room F1 there is evidence of a butt joint. In the east wall of the L-shaped room F3 there is also evidence of a butt joint.

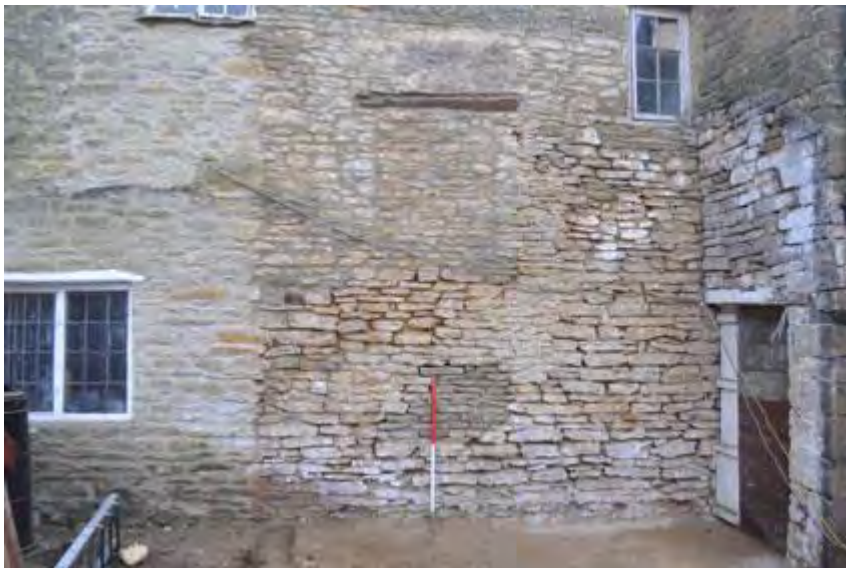
Plate 19: Blocked window near stairwell

In the north wall of room F7 and the round stairwell there is a blocked window (plate 19).

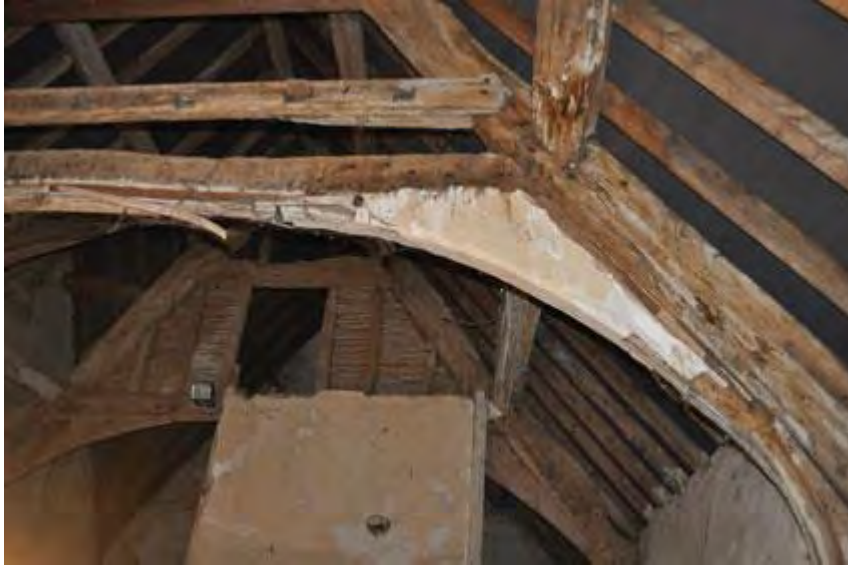
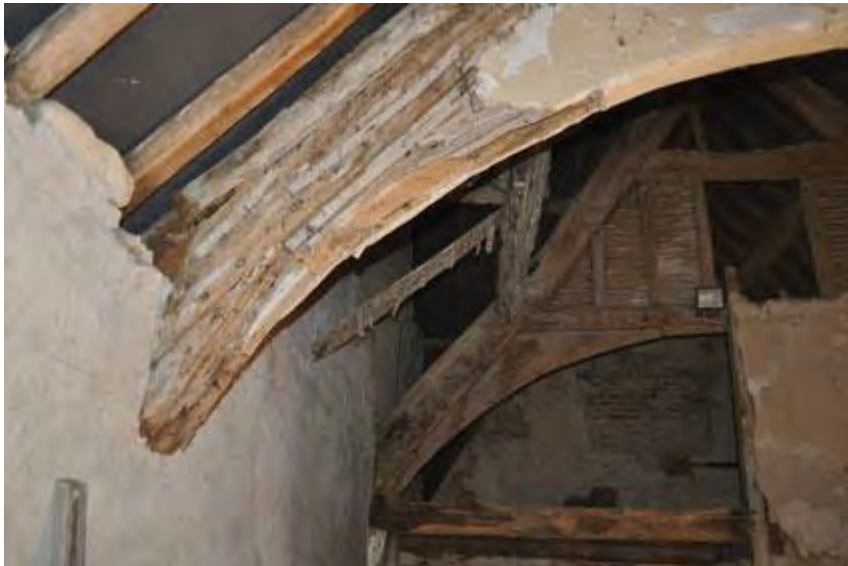
In the upper space of F9 the wall stub in line with the front wall continued up into the wall space. The trusses were stripped back (plates 41-42). In both the south and north gable end there is the remains of blocked windows (plates 43-44). There is also the remains of a square or rectangular, plaster free, and stone filled space, possibly a blocked window in the gable end.

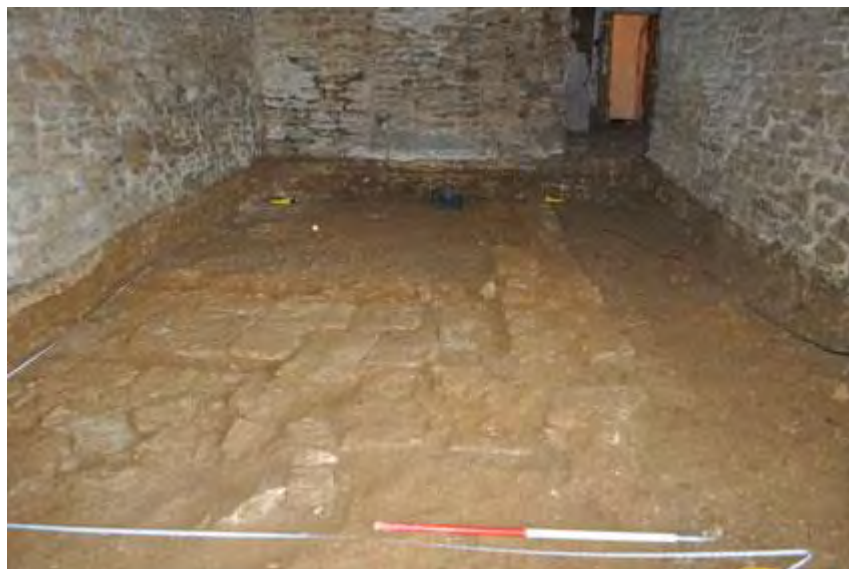
Plate 45: Overall photo of structure 08 looking south

Directly over this layer in the southeast side of room 11 was structure **08** (Fig. 5, plate 45), where excavations revealed the remains of an earlier structure that related to features noted in the east and south walls. Structure **08** was constructed from limestone blocks and consisted of east – west walls **02** and **04** that formed a corridor with a flagstone pathway **05**, and all these abutted north – south wall **03**.

Foundation cut 11 contained wall **02** (plate 45) was orientated east – west and formed the northern extent of the structure, it was 0.8m wide, 3m in length and exposed to a height of up-to 0.1m. The wall consisted of typically roughly hewn tabular limestone, with flat faces on two sides 0.05m – 0.1m thick, 0.2m -0.3m wide and 0.2m – 0.6m in length. These formed a partially exposed and disturbed wall consisting of the limestone blocks utilising the flat faces on the interior and exterior of the wall. No bonding was present between any of the stones. Traces of this wall were also evident on the west facing wall of room 11 next to a blocked doorway that would have originally would have opened out to the churchyard situated on the eastern side of the wall.

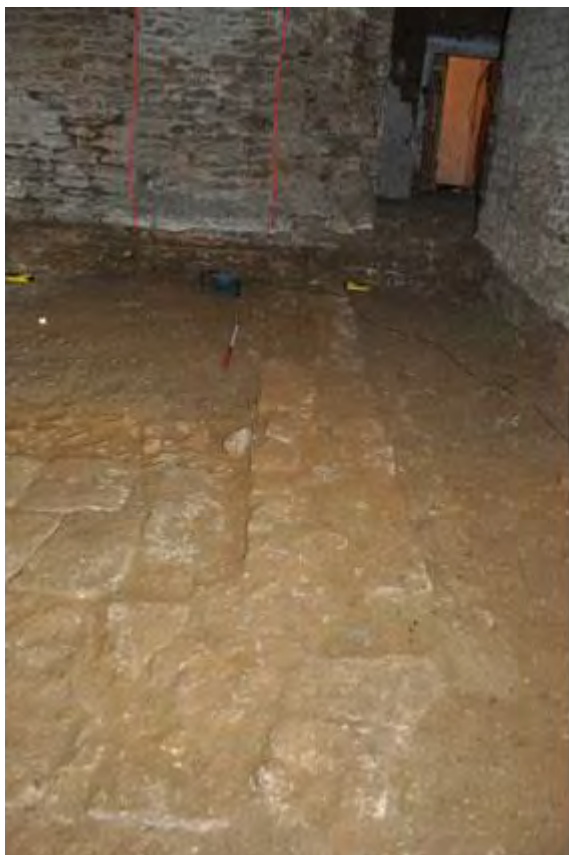
Plate 46: Wall **03** looking south, blocked doorway highlighted in red

Foundation cut 12 contained wall **03** (plate 46), was orientated north – south and formed the western extent of the structure, it was 0.55m wide, 5.2m in length and exposed to a height of up-to 0.1m. The wall consisted of typically roughly hewn tabular limestone, with flat faces on two sides 0.05m – 0.1m thick, 0.2m -0.3m wide and 0.2m – 0.6m in length. These formed a three course thick wall that had the flat faces on the interior and exterior of the wall. Intermittently along the wall the stones were bonded with a very compact orange / brown clay (07) and had a thickness of between 0.02m – 0.05m and contained no finds. Traces of this wall were also evident

on the north facing wall of room 11 next to a blocked doorway that would have led into room 5.

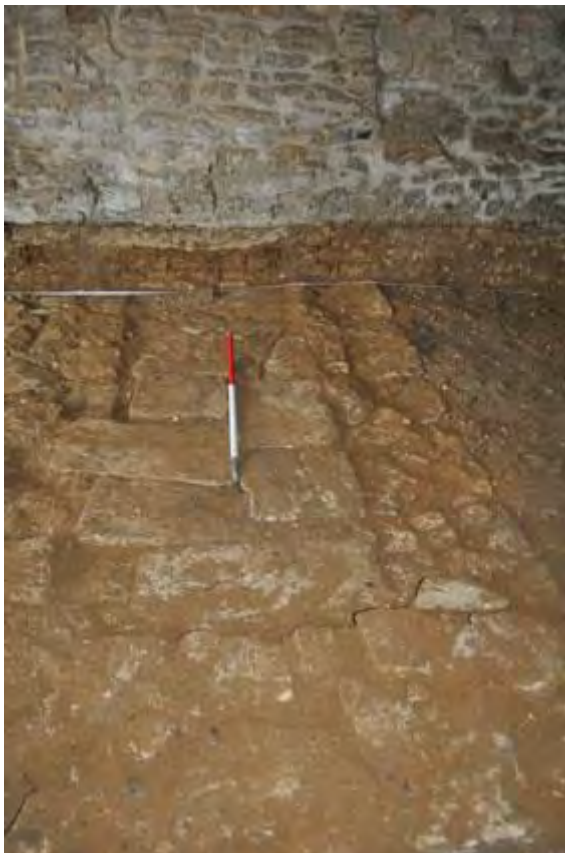
Foundation cut 13 contained wall **04** (plates 47-48) was orientated east – west and bounded the corridor to the south, it was 0.3m wide and 2.7m in length and exposed to a height of up-to 0.1m. The wall consisted of typically roughly hewn tabular limestone, with flat faces on two sides 0.05m – 0.1m thick, 0.2m -0.3m wide and 0.2m – 0.6m in length. These formed a partially exposed and disturbed wall consisting of the limestone blocks utilising the flat faces on the interior and exterior of the wall. No bonding was present between any of the stones. Traces of this wall were also evident in the east wall of room 11 next to a blocked doorway that would have originally opened out to the churchyard situated on the eastern side of the wall.

Butting up against walls **02**, **03**, and **04** were flagstones **05** (plates 45 & 48) that was orientated east – west, it was 1m wide and 2.7m in length and exposed to a height of 0.05m. The floor surface was constructed with mostly large rectangular limestone flagstones, 0.4m – 0.5m wide, 0.5m – 0.6m long and c. 0.05m thick.

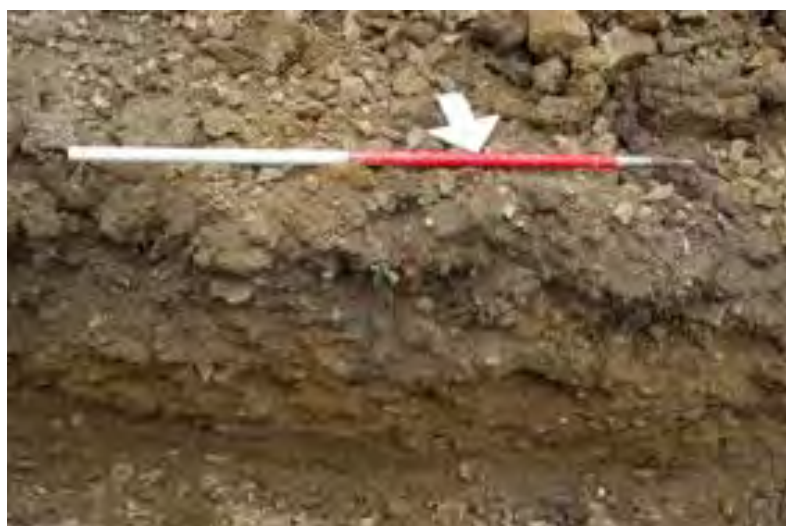
Plate 50: Banding in section in service trenches

The lowest recognised layer was (01) in the external service trench cuts (plate 47), but it is probably the case that there were at least three different layers in this context (plate 50). These layers probably included (10) and something akin to (06). The upper layer (09) was a dark grey silty loam with frequent amounts of building debris
