ARCHAEOLOGICAL WATCHING BRIEF

**P16/S3920/FUL – LAND TO SOUTH OF THE OLD
SCHOOL HOUSE ACCESS ROAD TO STOKE
TALMAGE,**

STOKE TALMAGE, OXFORDSHIRE OX9 7EU

NOVEMBER 2017

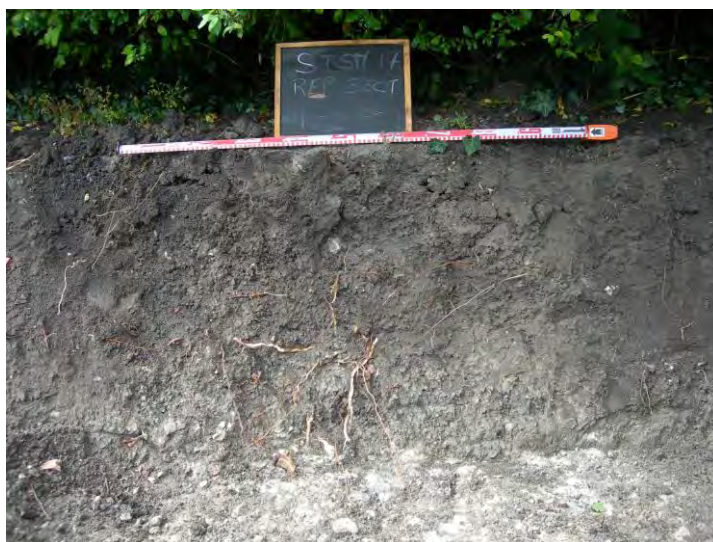
Plate 1. Representative Section S.02

The results of the excavation revealed no archaeological remains. The lowest layer recorded was the light grey limestone geological horizon (04). Above the natural was the subsoil, a silty clay layer of mid grey greenish colour (05). This layer varied in depth from the 0.5 m at the flat top of the building area to the 0.15 m on the slope

(Fig. 2). Above it, finally, was the topsoil (06), a dark brown layer 0.38m thick of clayey silt which showed a high degree of bioturbation. The topsoil contained some archaeological artefacts (animal bones and some clay tobacco pipes), mainly located on the slope where the foundation trenches were dug for the new building.

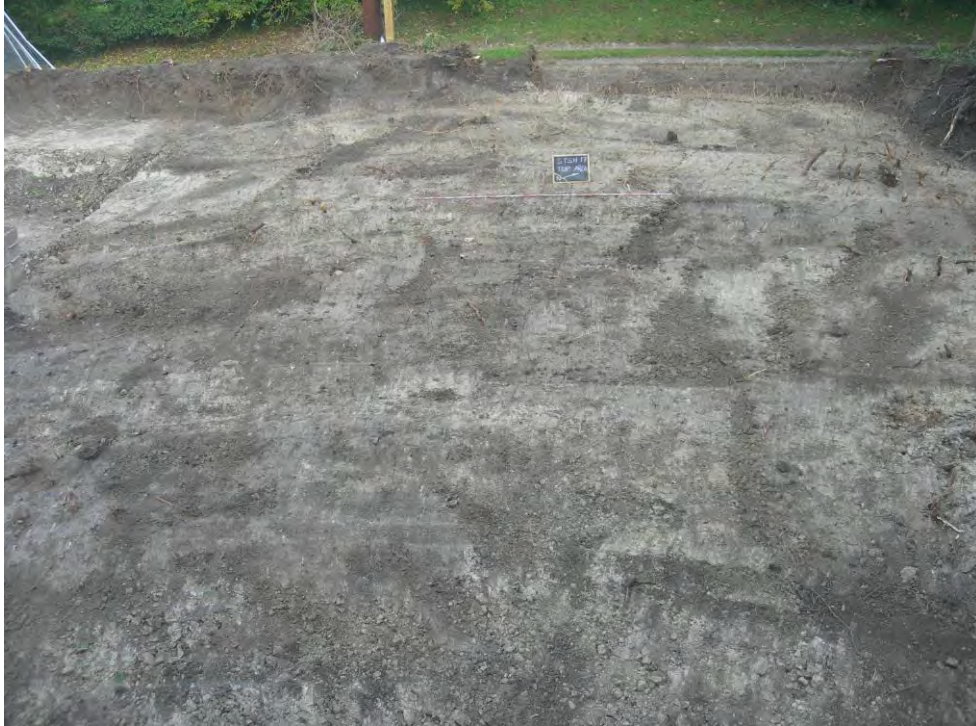
Plate 2. View of the N area

No archaeological features were identified in plan or section neither in the parking area, located in the NNW of the property, nor in the foundation trenches for the building (Fig.2).

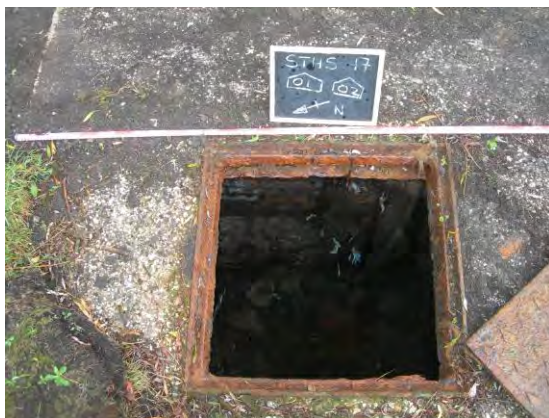
Plate 3. Septic tank

Two elements of ethnographic interest were found in the area. First, a septic tank was recorded that had been in use until very recently. It was built in two phases, initially using rough limestone 01 and in a second phase using bricks 02. The septic tank had a square shape and the length of the walls was 1.6m. The feature was located in the NE of the property (Fig. 2) and was covered by a layer of concrete (03).

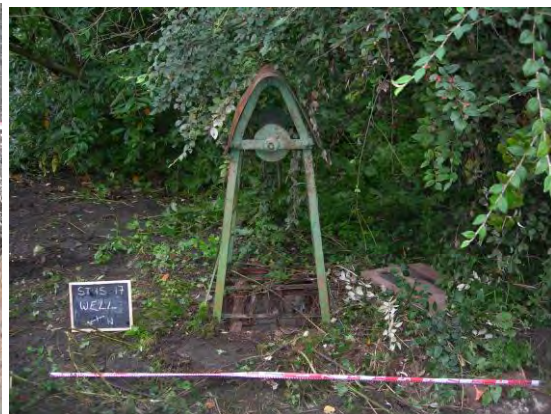
Plate 4. Metal windlass

Secondly, in the south corner of the property a metal windlass was still preserved, used to raise water from a well 07. The well had a circular shape and was 1m in diameter. It was made using regular bricks.
