**HISTORIC BUILDING ASSESSMENT**

**AND WATCHING BRIEF**

**150 FISHPOOL STREET,**

**ST ALBANS, HERTFORDSHIRE**

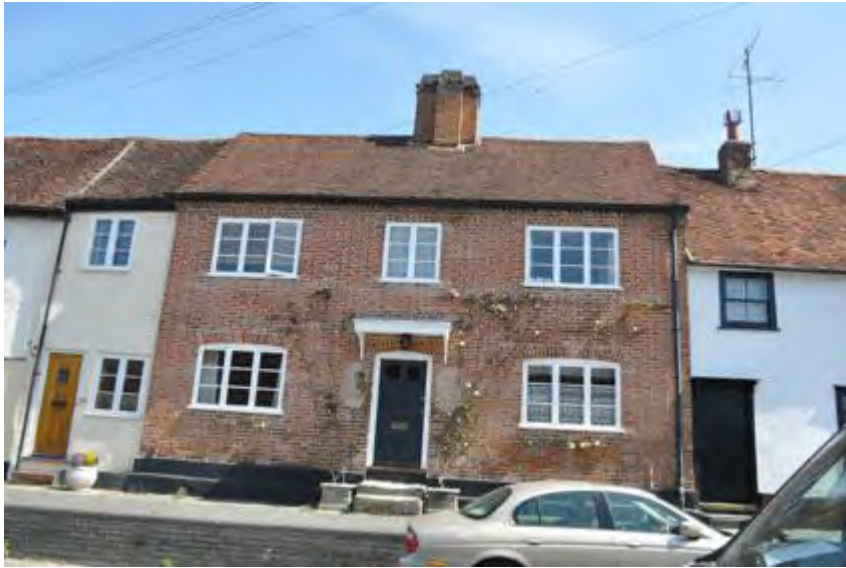
Plate 1: Front façade

The building is a two storey structure with a brick frontage of an 18<sup>th</sup> century date in Flemish bond (plate 1). The building has three bays and a plinth. On the ground floor windows flank a central panel door. The heads are created by segmental arches with soldiers. The door has a porch. The first floor has three windows. The roof is of red clay tile and set more or less centrally on the ridgeline is the remains of the chimneybreast with four flues in a rough cross shaped form (fig. 3, plate 2). The upper water tablet was of a decorative form.

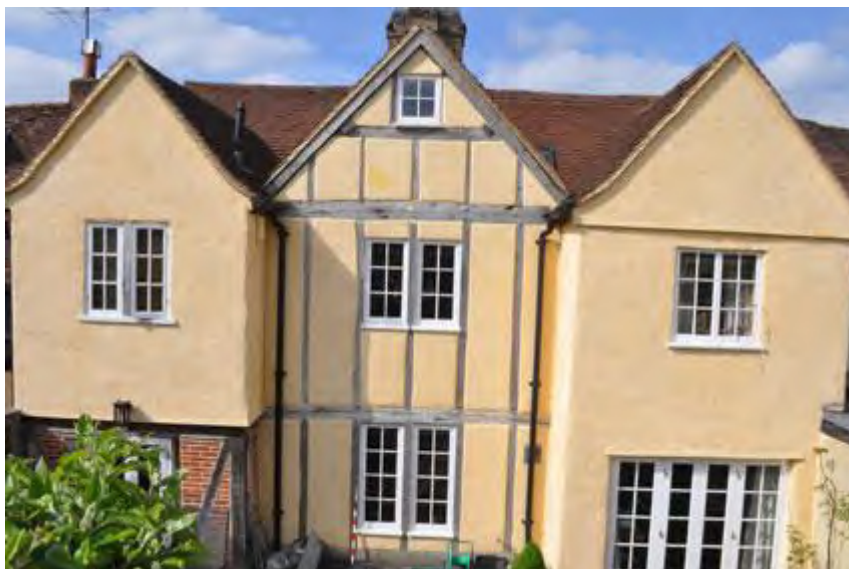
Plate 3: Rear of building

The rear of the house has three gables all of which contain a bay (plate 3). The two outside bays are modern extensions. The left-hand one has a timber and brick ground floor, with a rendered area above. The right hand gable is rendered on the ground and first floor. The central gable is the old gable, which would have been the rear extension that contained the stairwell. This has stud framing on both the ground and first floor. There is a window into the attic space. The roofs of all three gables are clad in red tile. These adjoin the main part of the roof which is generally orientated east to west, and runs adjacent and parallel to Fishpool Street. Placed centrally on the ridge of the main roof was the chimneystack (fig. 3, plate 4-6), which was of a cruciform shape and aligned with the ridgeline of the central rear gable projection. Some of the decoration is missing from the rear extension of the water tablet.

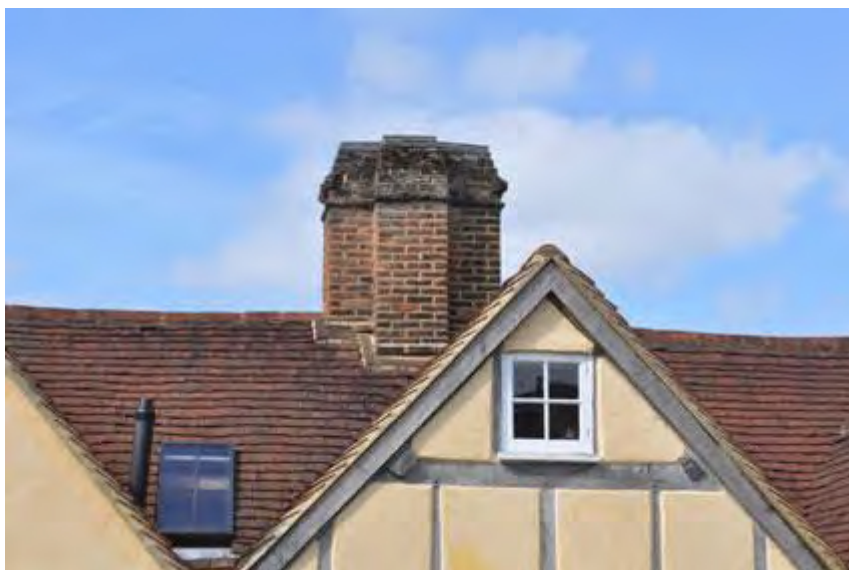
Plate 4: Rear of chimney

The chimney as described in ‘Proposed Restoration of the Chimney’, highlighted the fact that the central chimney had been removed. It was noted in the listing of 1970 that:

The photos are indicative as is stated that the chimneystack has been reduced and altered in design. However, of the first two it is not possible to obtain a clear understanding due to the standard of the photographs. I am inclined to agree with the interpretation of Steven Taylor in this case that a series overhangs and drips have been removed and that what appear to be decorative projections were designed to support a more elaborate water tablet. The three or possibly four rows of bricks above this have replaced the upper more elaborate tablet, probably because this was all of the brickwork that could be salvaged (plates 2, 4-6). The pots have gone, but it would be possible to suggest that they were not 17<sup>th</sup> century examples surviving on the historic photographs but probably mass produced examples.

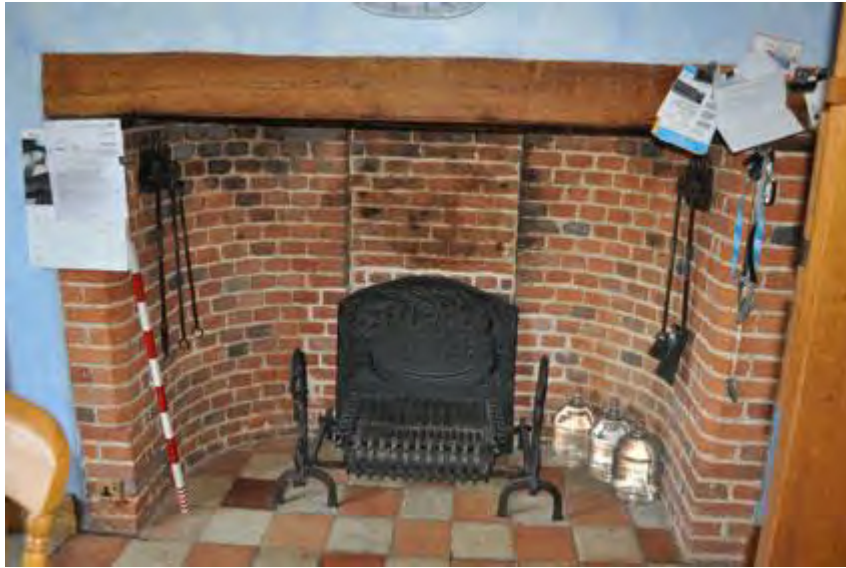
Plate 7: East fireplace

The two main ground floor rooms (the kitchen and the sitting room) both have the remains of historical inglenooks, which are located back to back below the chimneystack. The kitchen on the east side of the building contains a stud framed wall on the east side of the room, and in the west wall there is an inglenook fireplace, which is probably of a single design and date (plate 7). The rear of the fireplace is a band of protruding brick that are 230mm x 50mm. The rear bond is English Cross Bond, which is flanked by two quarter circular wall that use Header Bond, and which towards the outer part of the curve becomes an English Bond. The curving walls are undoubtedly to provide space for the spice box and the bread oven in the other (west) inglenook. The end walls contain a chamfer with stops formed by shaped bricks. Above the fireplace there is a lintel with chamfer also. This fireplace was presumably originally associated with the parlour. Either side of the fireplace there are plank doors. A mixture of monochrome tiles are laid in the base of the fireplace. The old part of the room has a ceiling with an axial beam that is roughly shaped with a chamfer.

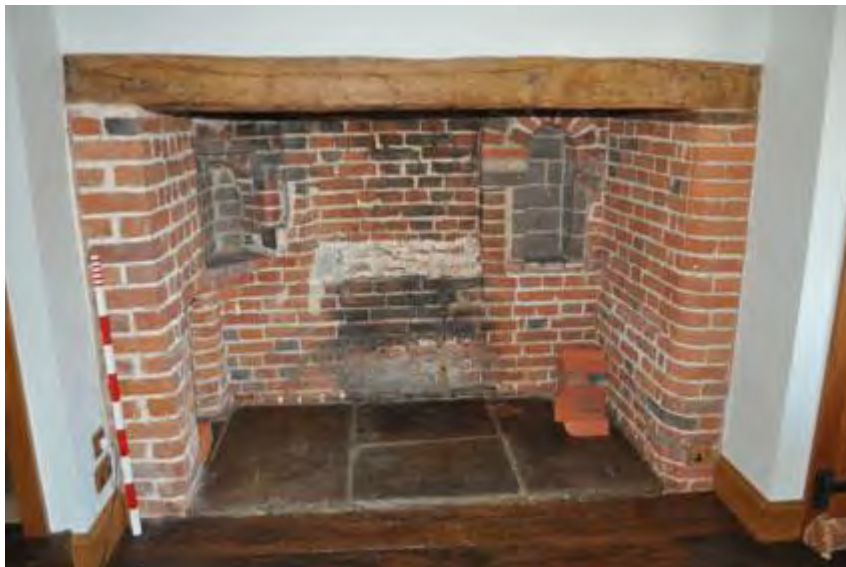
Plate 8: West fireplace

The sitting room is in the west part of the house. In the east wall there is a large inglenook fireplace with lintel above, with a chamfer (fig. 4, plate 8). A detailed account of this fireplace was given in the ‘proposed restoration of the Inglenook’ by Steven Taylor. The fireplace is of a general rectangular plan, with narrow 17<sup>th</sup> century bricks at the rear and on the right-hand side that measure 230mm x 50mm. At the base of the rear wall are a group of bricks that are considered of a modern insertion. In the right-hand corner at the back of the fireplace was a round-headed arch arrangement that had been blocked in. The programme for alterations is correct that this feature ‘described as a salt box’ is a mockery, as it does use blue brick 235mm x 100mm x 65mm. It is possible that this could have originated as a spice or salt cupboard (plate 9). At its current angle there is very little room (with the original untouched inglenook to its rear) for a feature to have originally existed here. On the right side of the fireplace the bricks measured 230mm x 50mm, and are chamfered with a decorative quirk that divides the chamfer from the adjoining wall. This wall looks original and relatively untouched. On the left-hand corner of the fireplace there is a further arch,

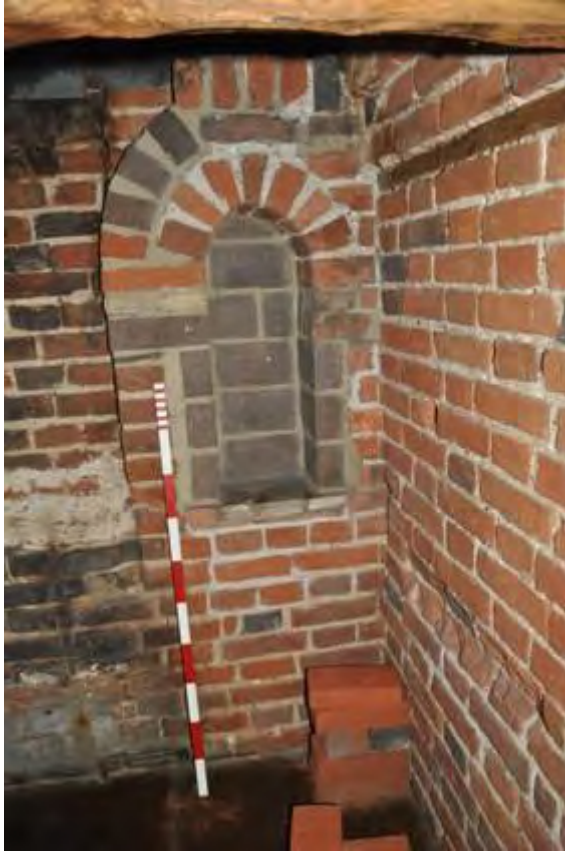
Plate 9: Claimed salt or spice box

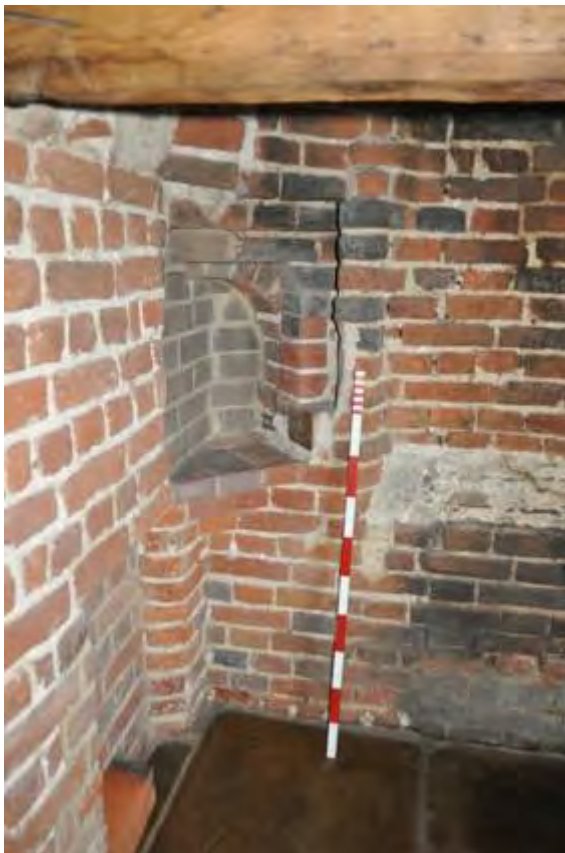
Plate 10: Remains of bread oven

but this one is set at angles between the two wall lines. This is described as the Bread Oven, and it is highly likely that there could have been one there (plate 10). The opening is blocked by blue-grey bricks that measured 220mm x 65mm. The left hand wall of the fireplace has been reworked with larger bricks measuring 235mm x 63mm, and are probably post the brick tax of the late 18<sup>th</sup> century (plate 11). There is a large square-headed opening in the lower part of the left-hand side wall. Chamfered bricks occur on the right-hand side, which may be distinctive and significant. In the base of the fireplace are large flagstones. Fragments of timber framing are evident in the original north wall of the building. The ceiling has an axial chamfered beam with joists.

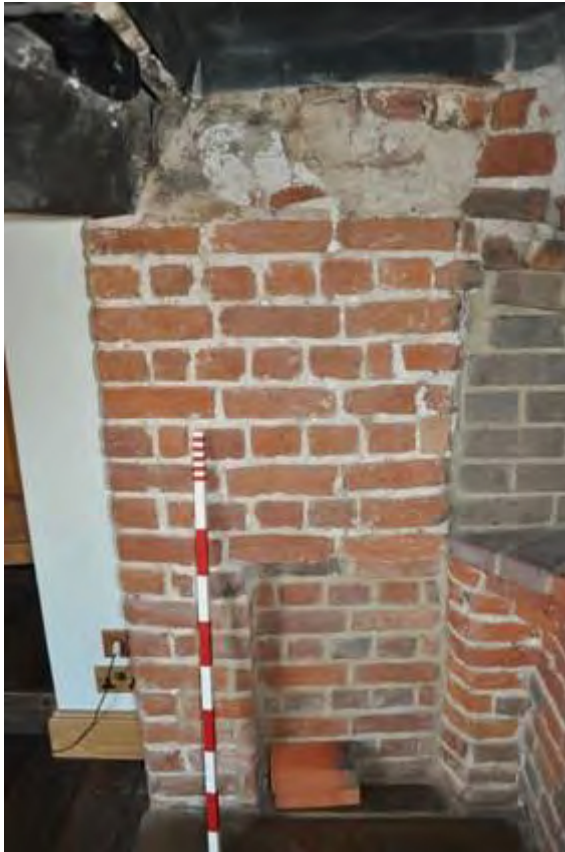
Plate 11: Reworked left-hand wall

A photograph also shows an unusual line on the timber produced by smoke blackening indicating a different wall line previously (plate 11), which could only have been produced by a different wall arrangement. There was a brick joint above the opening for the mouth to the bread oven, which may also be a result of the removal of a spiral staircase (plate 21). These are possible indications that a spiral staircase existed on the north side of the west fireplace, and that its removal led to the reworking of the left hand wall. The rebuilding of this left-hand wall is indicative of a feature being removed (plate 22).

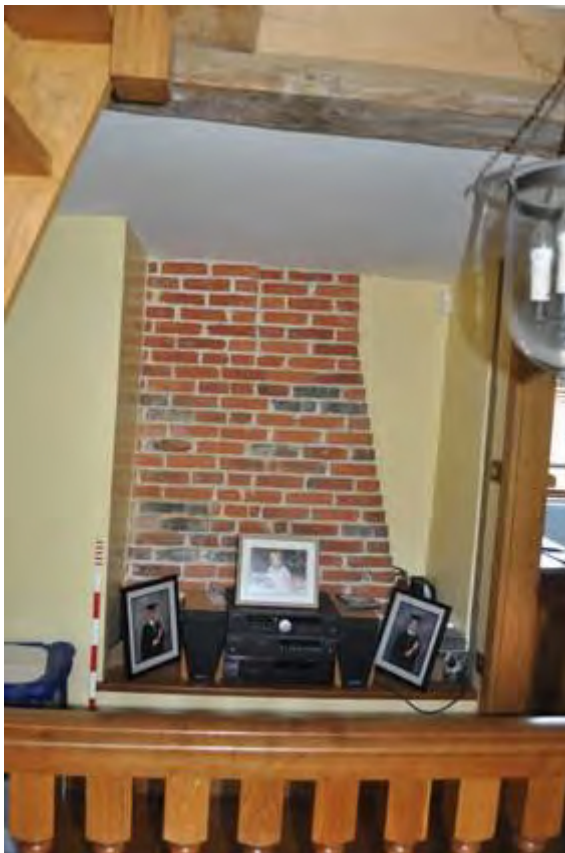
Plate 12: Chimneybreast from stairwell

On the first floor there is a section of the chimney evident from the stairwell (plate 12). In this build there is evidence of the chimneybreast tapering in, and a butt joint towards the ceiling. This part of the chimney is constructed of the smaller 17<sup>th</sup> century bricks.

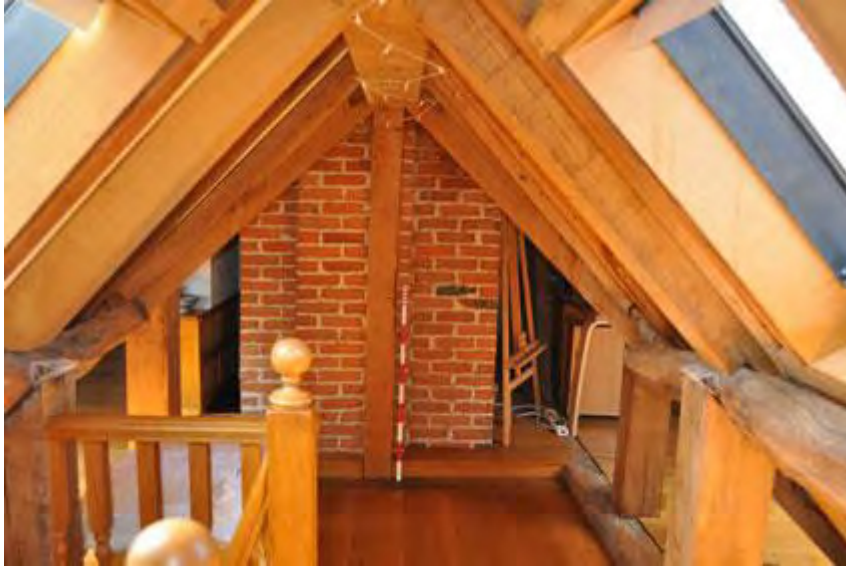
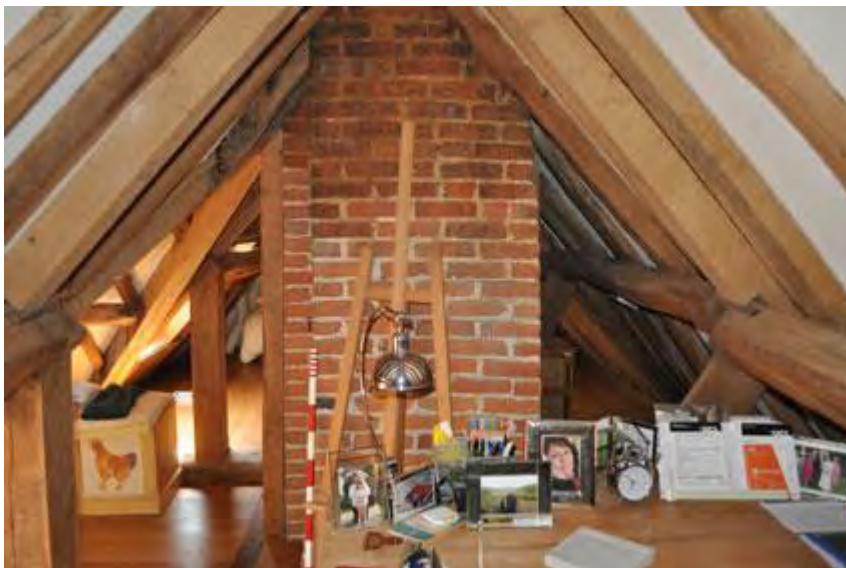
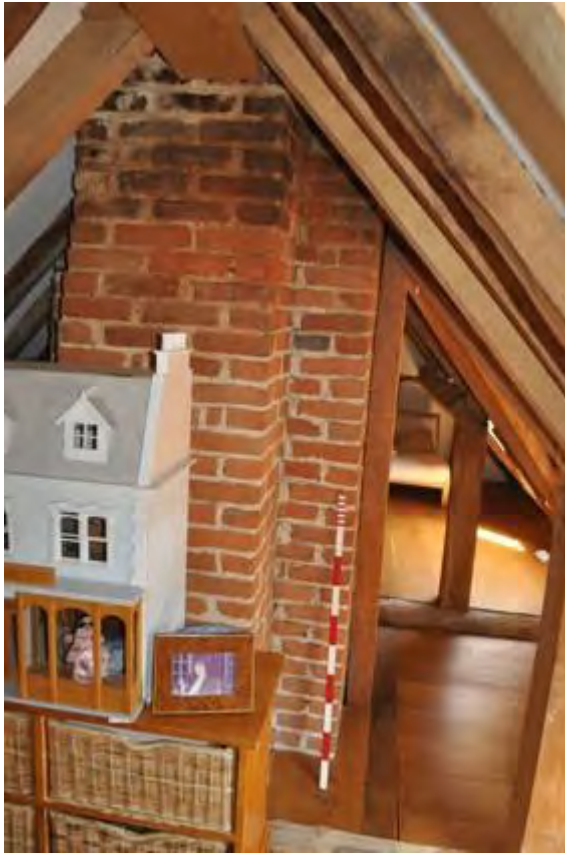
The chimney must in some form take on its above roof shape in the attic space (plates 13-15). Externally one can recognise a type of cruciform arrangement but internally to the attic the chimney appears to be a rectangular shape with a rear projection, a form that reflects the older part of the house with its Front Range and middle gable extension. Internally to one of the chimneys it is apparent that one of the chimneys had an internal wall, meaning that a ground floor fireplace and a first floor fireplace used the same parts of the chimneys.

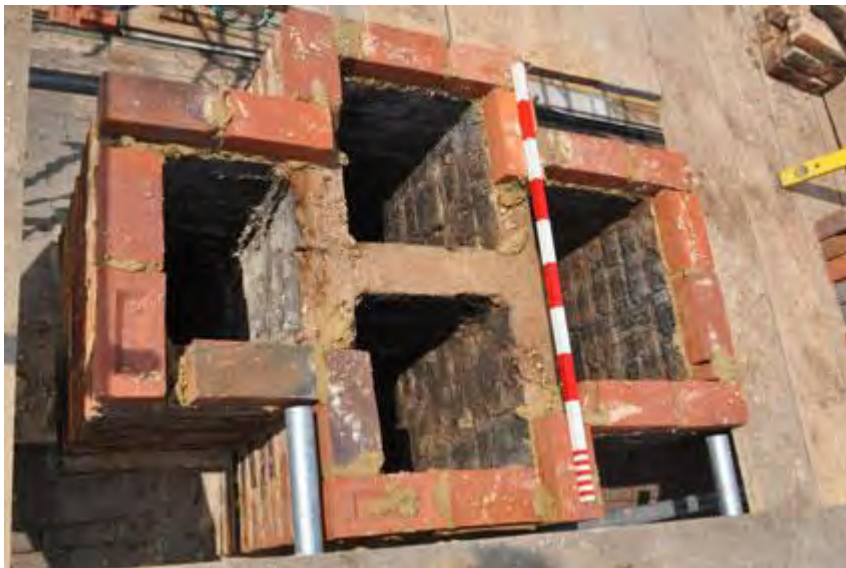
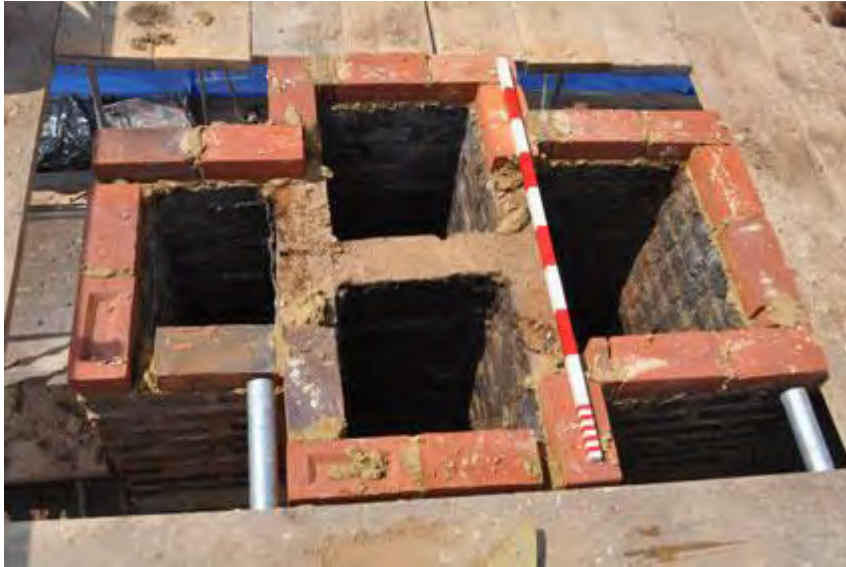
There was little that was revealed by the removal of the upper part of the chimneystack (plates 16-17).

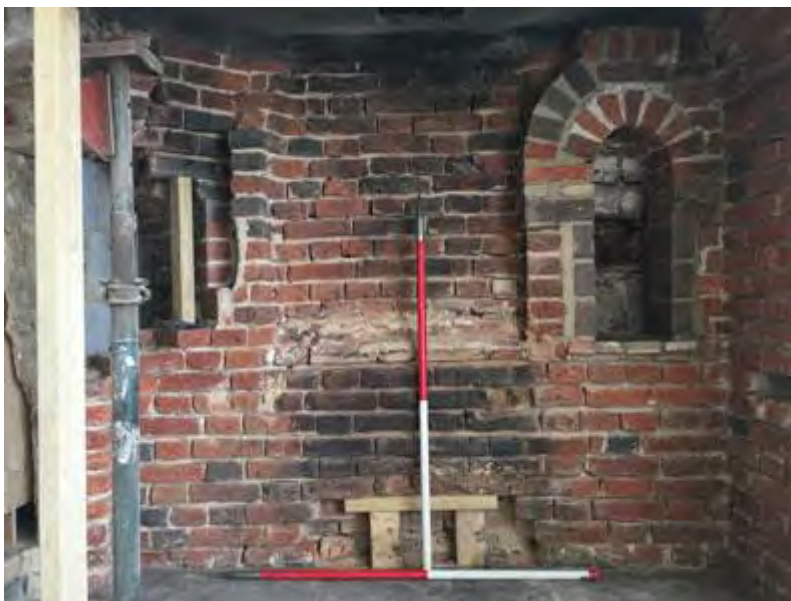
Plate 18: Rear wall of west fireplace

The removal of the later bricks in the area of the fireplace revealed very little to what was already evident structurally without their removal (plate 18). The new bricks inserted in the salt or spice box were removed (plate 19). Bricks that would have extended into the area of the passageway, have been broken off for the insertion of the breeze block walling. The line of the flue to the bread oven was noted as running back to a space adjacent to the north of the eastern inglenook (plate 20). The chamfered bricks in the left hand wall appear to be broken off, indicating that this was not an original chamfer. In the passage to the north of the current fireplaces it is apparent in the new staircase arrangement that part of the original sill beam is missing. The ceiling timbers have heavy saw marks so are not 17<sup>th</sup> century.

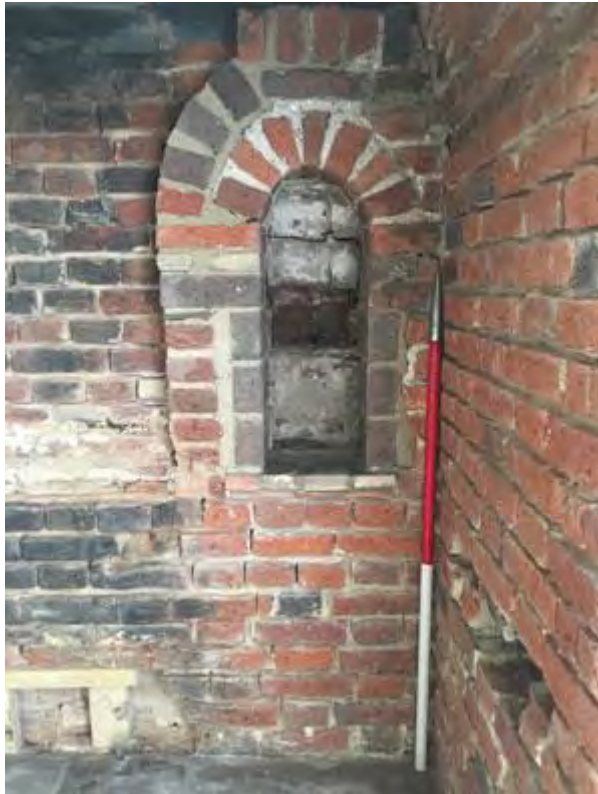
Plate 19: Salt or spice box, with bricks removed

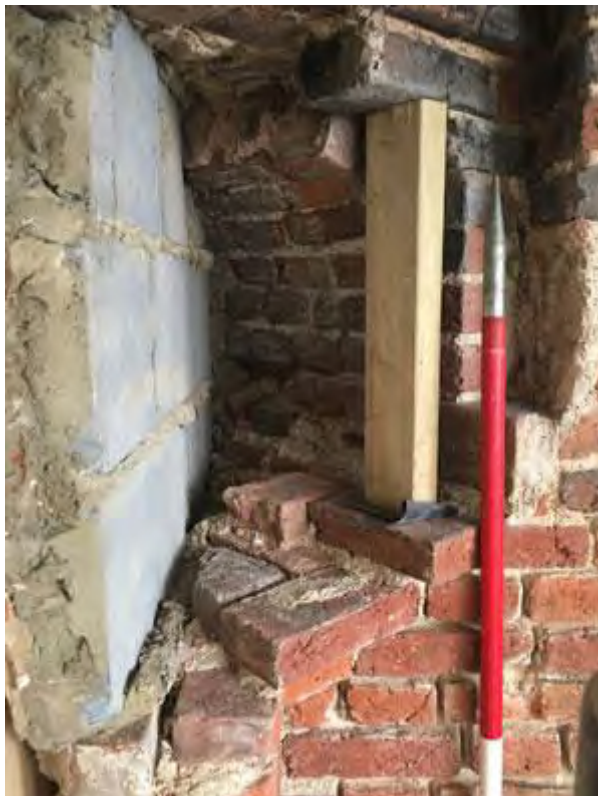
Plate 20: Opening to bread oven

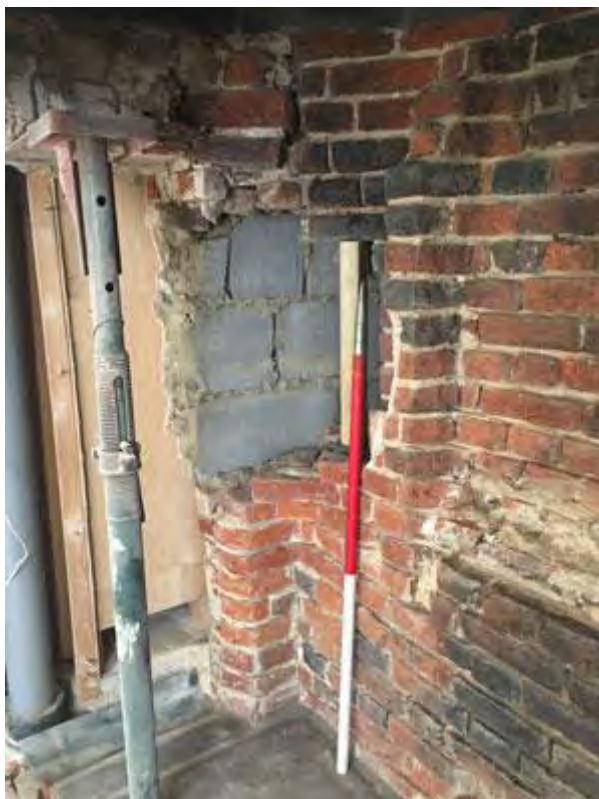
Plate 21: Line of rebuild above bread oven entrance

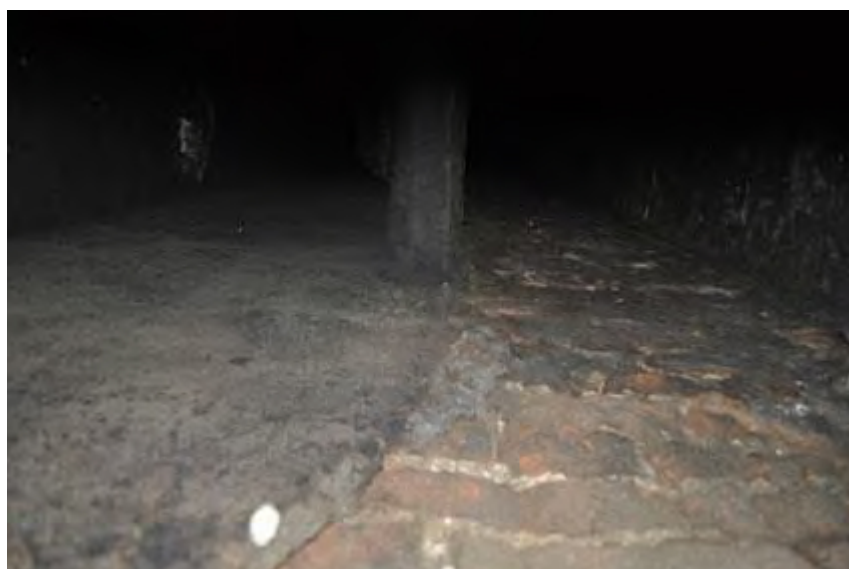
Plate 23: Internal division of chimney flue

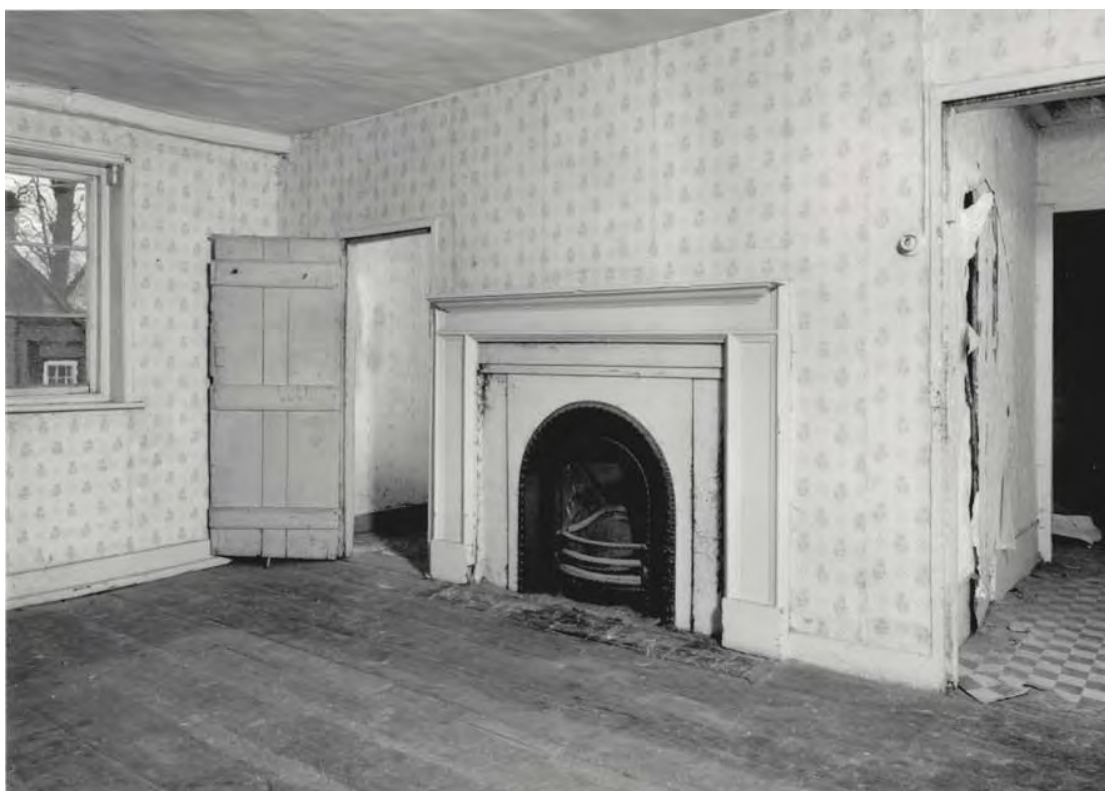
Plate 24: First floor fireplace

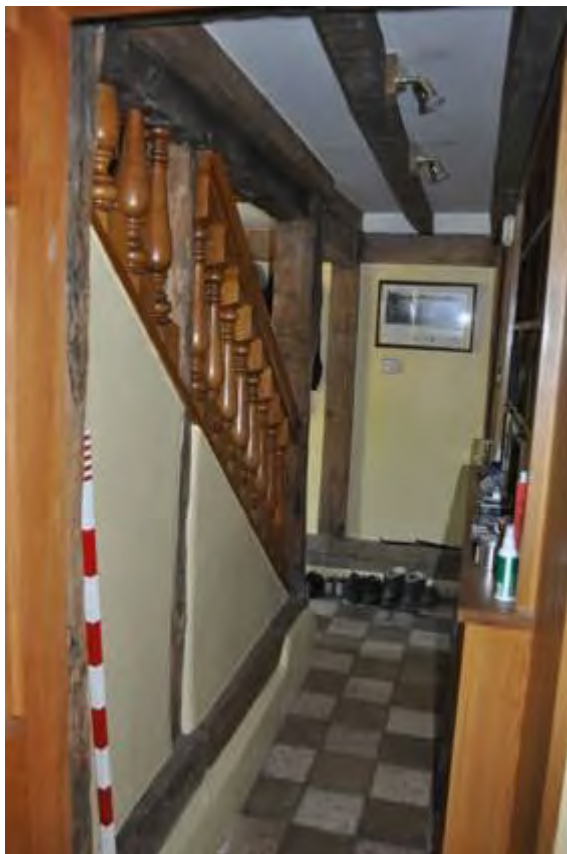
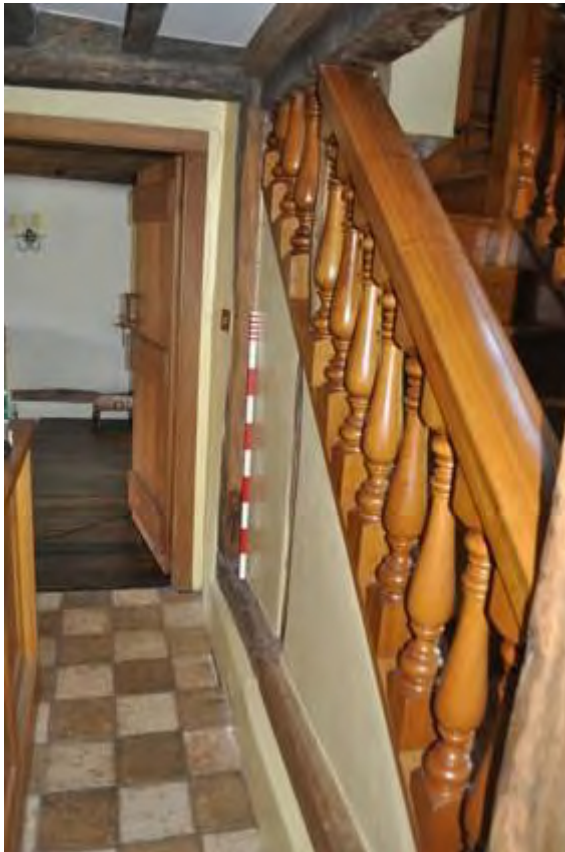
Plate 25: Passage with sill beam

Plate 26: Passage with sill beam

construction. The date must be post 1681, but how much later than that is uncertain. It is noticeable that in the design of the current stairwell that part of a sill beam is missing, and that it has been filled in with a new piece of wood to match (plate 25-26). This gap appears in the ground floor plans of 1965 and 1990, which have been provided in previous documentation for Listed Building Consent on this structure.

The passageway to the north of the two inglenook fireplaces is evidently a later creation, and associated with the movement of the stairs and the dismantling of parts of the chimney structure. In vernacular buildings passageways are used to link rooms predominantly from the later part of the 18<sup>th</sup> century. Prior to this rooms were linked one to another. Johnson (1996) links these developments to growing concepts of personal space through the development of Capitalism. An argument that the passageway should be a reason for the non-existence of the bread oven is thus not based on the known development of English houses. The passageway was in existence by 1965, but could be part of a development from the late 18<sup>th</sup> century if not the 19<sup>th</sup> century.

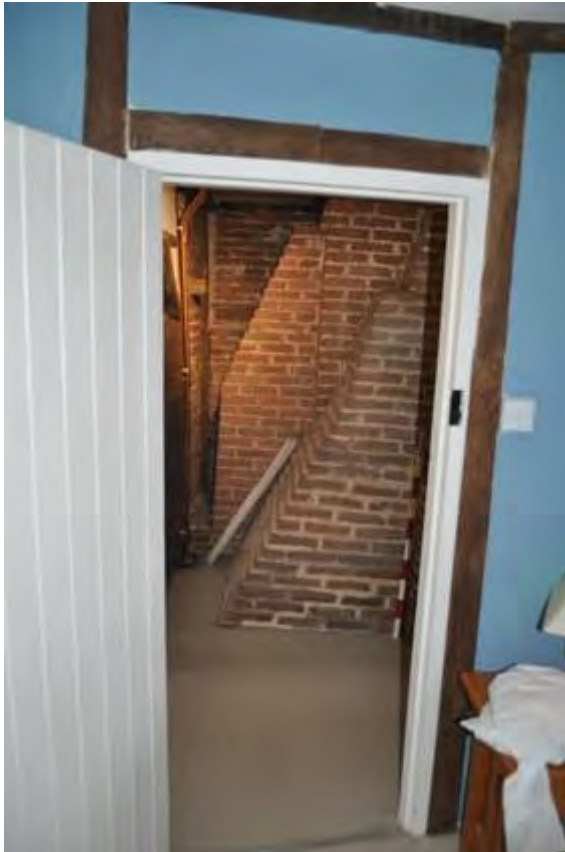
Plate 27: Dells Farmhouse chimney system

A recent visit to Dells Farmhouse, Stokenchurch, Buckinghamshire, in the Chilterns, has revealed a similar type of chimney and fireplace arrangement in design and style. Dells Farmhouse is a three unit lobby entrance house. Here the lobby unit was flanked by two fireplaces back-to-back, above which there are a group of chimneystacks that are cemented together and decrease in size towards the roof (plate 27). In this case it is apparent that the primary inglenook is of such a size that it had the kitchen fireplace and the bread oven to the rear. The bread oven has been damaged here with the insertion of the boiler (plate 28), but can be seen to occupy the place that would have
