JOHN MOORE HERITAGE SERVICES

ARCHAEOLOGICAL WATCHING BRIEF
AT
LYCHGATE HOUSE, MONGEWELL PARK,
MONGEWELL, OXFORDSHIRE

MAY 2018

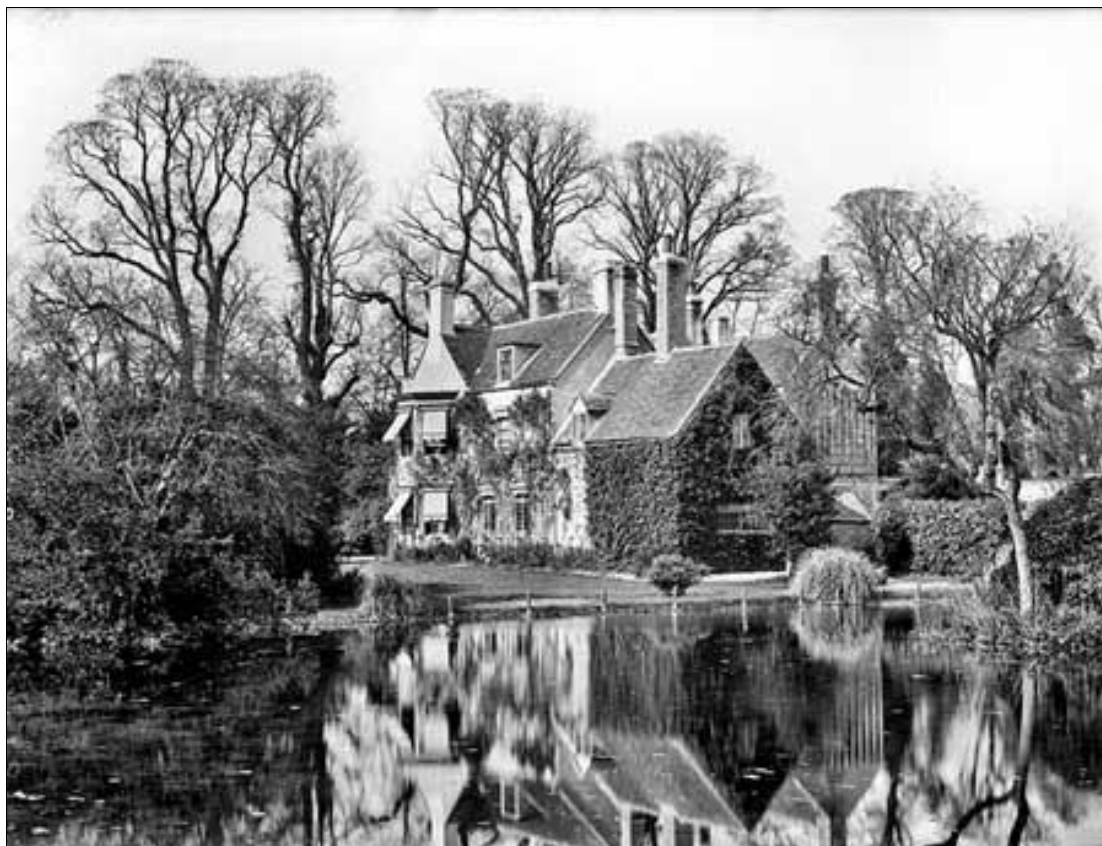
Plate 14: Photograph of Mongewell Rectory taken in 1901 (Historic England Archive).

A photograph of the rectory taken by Henry W. Taunt in 1900 during a photographic survey of the Mongewell Park Estate gives further detail of the rooms seen archaeologically (Plate 14). The photograph is taken from the south west, therefore the western façade of the building is the most visible. The most northerly portion of the wing is a gable end, indicating that the front of the house was aligned east – west; a parapet is just visible on the northern façade of the building, perhaps indicating that the front face of the building had a Georgian style façade. This is likely considering the 1776 date of the renovations by Dr Robert Price. A two storey bay containing windows on both floors is present on the gable end of the wing and fabric sun shades are seen extending from the tops of these windows. A chimney stack located on the ridge of the gable end perhaps suggests that the bay was a later addition to the house.
