JOHN MOORE HERITAGE SERVICES

ARCHAEOLOGICAL WATCHING BRIEF

ST. MICHAEL AND ALL ANGELS CHURCH,

MAY 2018

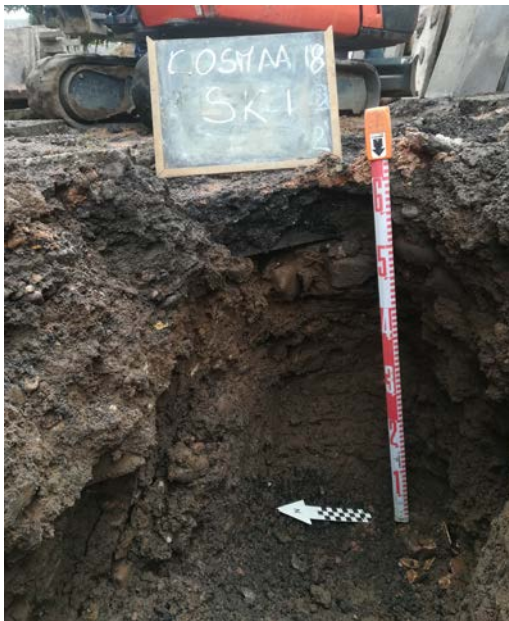
Plate 3. SK1 cranium

Cut into graveyard soils (02)=(06)=(08), at a depth of 0.65m below the current ground level, was grave cut 14, the burial for SK1. The grave cut was not clearly detected during the excavations, a common occurrence in long-established graveyards; however, the presence of an intact cranium (Plate 3) facing east, as well as the possible association of the remains with the *in situ* gravestone 82 (GS82, Fig. 2 and Plate 5) and based on their respective positions, suggested the burial could be undisturbed. SK1 grave's fill (12) was a soft, light brown clayey silt deposit.

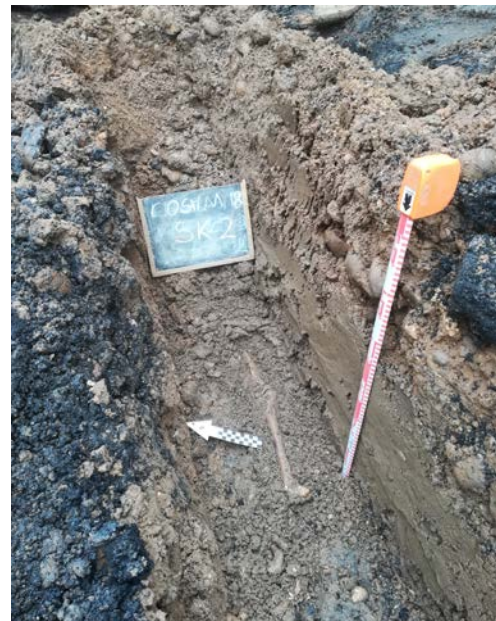
Plate 4. SK2

A second grave 15 was cut into graveyard soils (02)=(06)=(08). The grave cut was not clearly visible; its proposed extent was based on the position of the revealed human remains. SK2 was only partially uncovered; the left femur, patella and proximal tibia were visible. The remains lay in grave fill (13), a soft light brown clayey silt deposit, at a depth of 0.7m below the current ground level.

The lowest layer uncovered during the excavation was (09), a dark yellow-brownish clay sandy deposit (Fig. 2, Plate 4); it was only revealed in the East end of the service trench, and identified as the underlying natural geology.
