ARCHAEOLOGICAL WATCHING BRIEF

PATCHFIELD BARN, STANDLAKE ROAD,

NORTHMOOR, OXFORDSHIRE

JUNE 2018

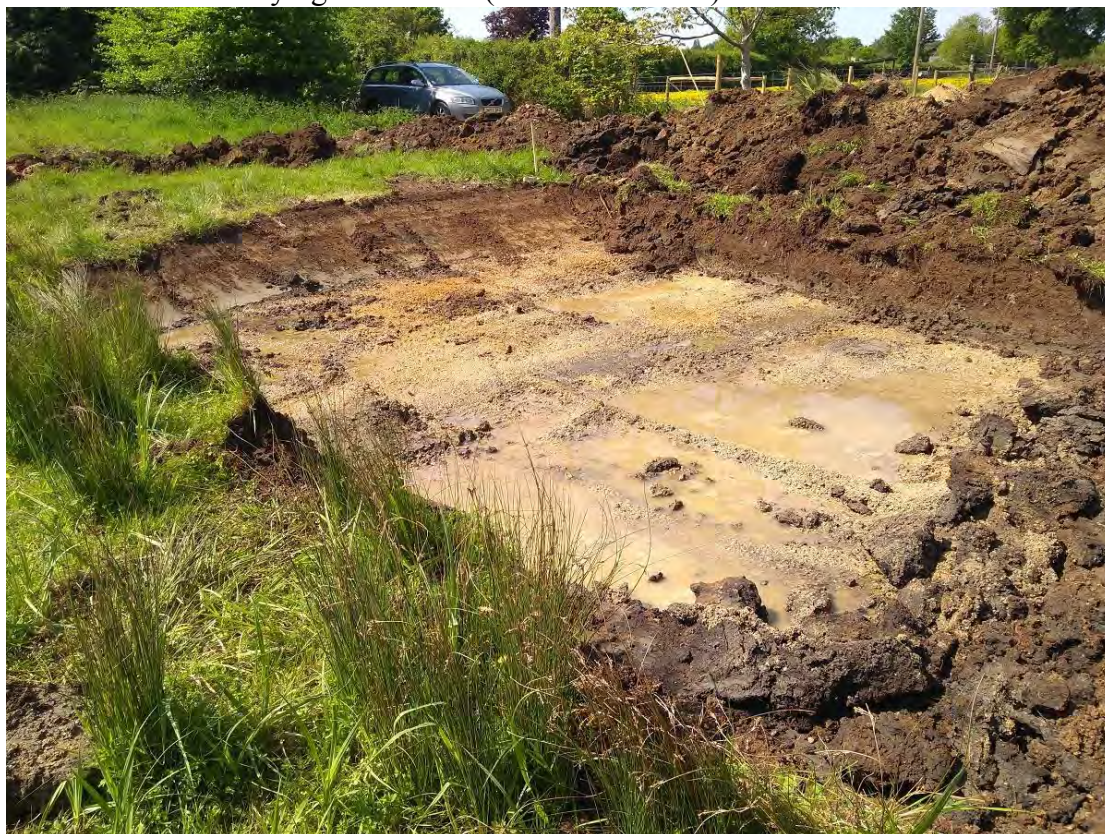
Plate 1. Working shot of pond excavation pre-water ingress. Facing SW.

The area of service trench which extended to the east of the gravel drive was excavated to a maximum depth of 0.72m. As the service trench approached its easternmost extent where it required the greatest maximum depth for the fall of the waste pipe, the same natural gravels (12) were encountered at a depth of 0.52m or less as in the area surrounding the structure to the west (see Section 04 on Fig 2). The area of the retention pond was photographed as work progressed due the rapid ingress of water from the low-lying water table (see Plate 1 and 2).

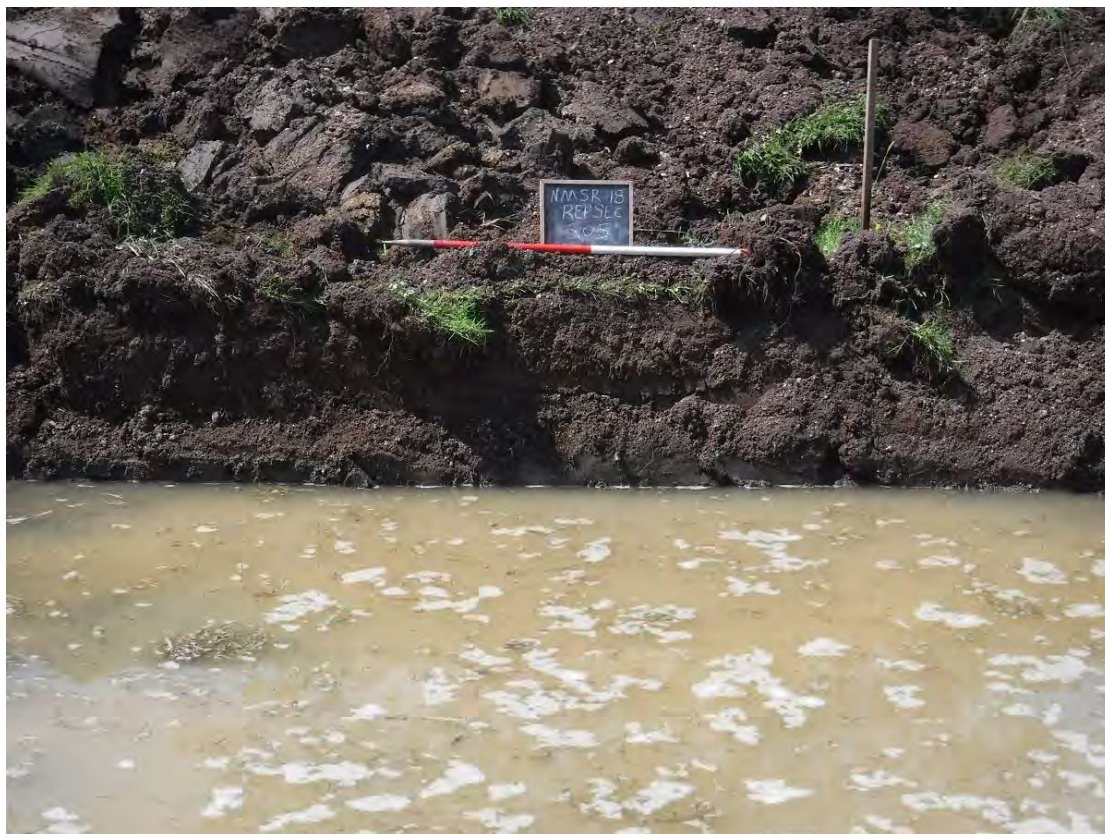
Plate 2. Representative Section of the pond, post-ex S.05. Facing NW.

Due to the natural slop in the terrain, there was a layer of colluvium (11) which had accumulated above the gravels in the low-lying area nearest the gravel drive. It was a dark blueish-grey silty clay which was friable but firm and very clean of any inclusions and was 0.21m thick at its deepest point. Above this colluvium was a layer of dark brown clayey silt flood plain deposit (10) which was up to 0.41m thick. This extended across the entire eastern area of excavation where the drive/parking area gravels were not present. Above this was the topsoil (09) which was across the entire area not comprised of the gravel.
