**ARCHAEOLOGICAL WATCHING BRIEF**

**DUNTHROP HOUSE,**

**HEYTHROP, CHIPPING NORTON,**

**JUNE 2018**

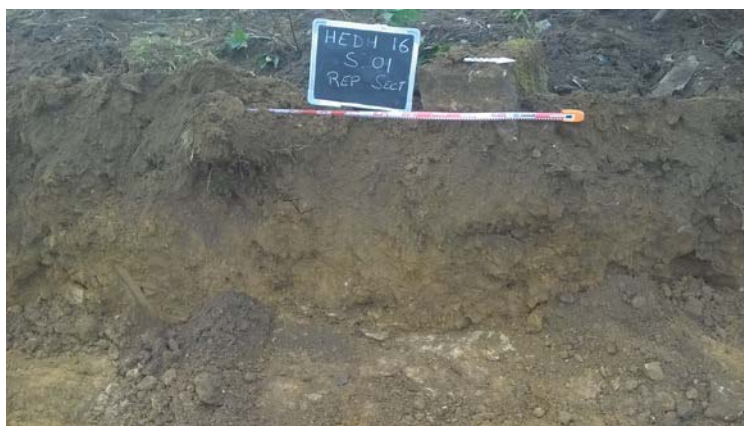
The lowest deposit identified was limestone with a matrix of yellow clayey sand bedrock (08) (Fig.2, section 1; plate 1).

Plate 1. Representative section of site.

Above the limestone deposit (08) was the subsoil (02), a soft light brown yellowish clayey silt layer 0.35 m (Fig. 2, section 1; plate 1).

The uppermost layer recorded on the site was the topsoil, (01) a 0.35 m. thick, soft dark brown clayey silt layer (Fig. 1, section 1; plate 1).

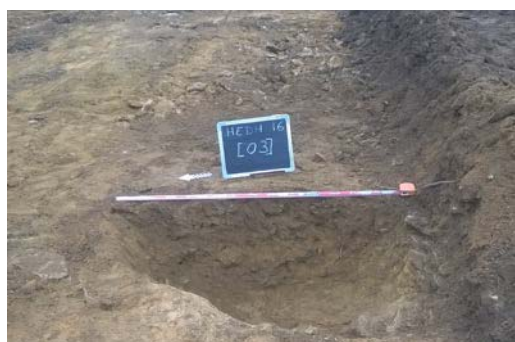
Cutting the limestone were several pits. Towards the south of the site in the area of the new swimming pool was pit 03 (Fig. 1, plan, section 2; plate 2). The pit had an oval shape and a WNW-ESE orientation. It was 2.8m long, greater than 1.4 m wide and 0.6 m deep with concave sides and base. The lowest fill was a 0.25m thick, yellowish mid-brown silty clay deposit with rare fragments of limestone (13). Overlying (13) was a 0.2m thick, light brown silty clay fill (05), which contained rare fragments of fine limestone. The uppermost fill was (04), a 0.35m thick, mid-brown yellowish silty clay fill with rare inclusions of fine to large fragments of limestone and some very crumbly fragments of slag (the only finds in the pit).

Plate 2. Possible quarry pit [03]

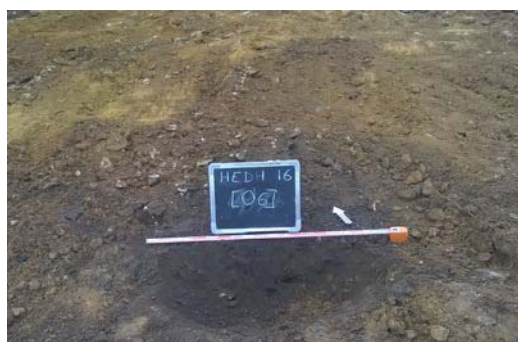
Plate 3. Small pit [06]

Towards the centre of the area excavated for the new swimming pool and cut into the subsoil was a sub-circular pit 06 that was 0.9m in diameter with a concave base and sides. It contained a single fill of 0.25m thick, dark grey clayey silt (07). The fill contained rare fragments of fine limestone and no finds (Fig 2, plan, section 3; plate 3).

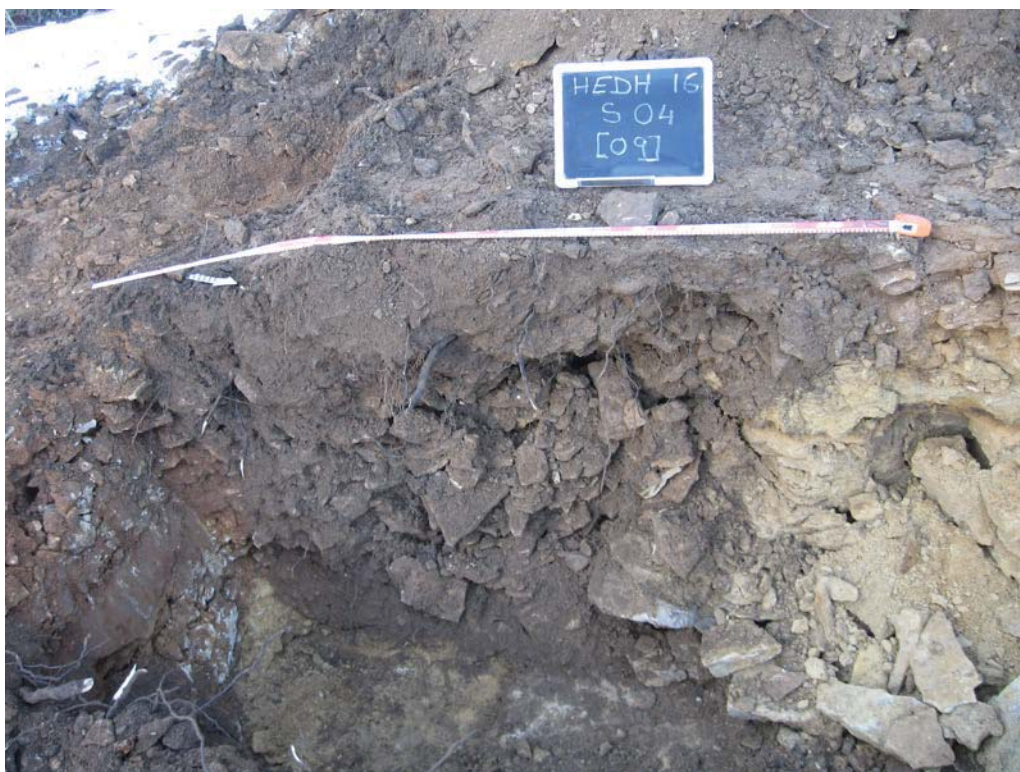
A possible quarry pit was located towards the north west of the site in the northern excavation area. Pit 09 had an oval shape and WNW - ESE orientation (Fig.1, plan section 4; plate 4). It was 6.6m long, 2.8m wide and 1.2m deep. It had a straight side on the south-west edge and an irregular edge in the north-east, the base was flat. The lowest fill of the pit was a 0.2-0.3m thick, dark brown sandy clay, (10). Overlaying (10) was a 0.8m thick, dark brown sandy clay deposit with frequent fragments and blocks of well sorted limestone, (11). Fill (11) contained two fragments of medieval glazed ridge tile, two fragments of pottery, and an iron fitting. The uppermost layer of pit 09 was a 0.2m thick fill of dark brown silty clay which contained rare fragments and blocks of limestone of different sizes and two fragments of modern brick.

Plate 4. Section 04 of Quarry Pit 09
