**ARCHAEOLOGICAL WATCHING BRIEF**

**LAND TO R/O NORTHFIELD HOUSE,  
11 NORTHFIELD END, HENLEY-ON-THAMES,**

**SEPTEMBER 2018**

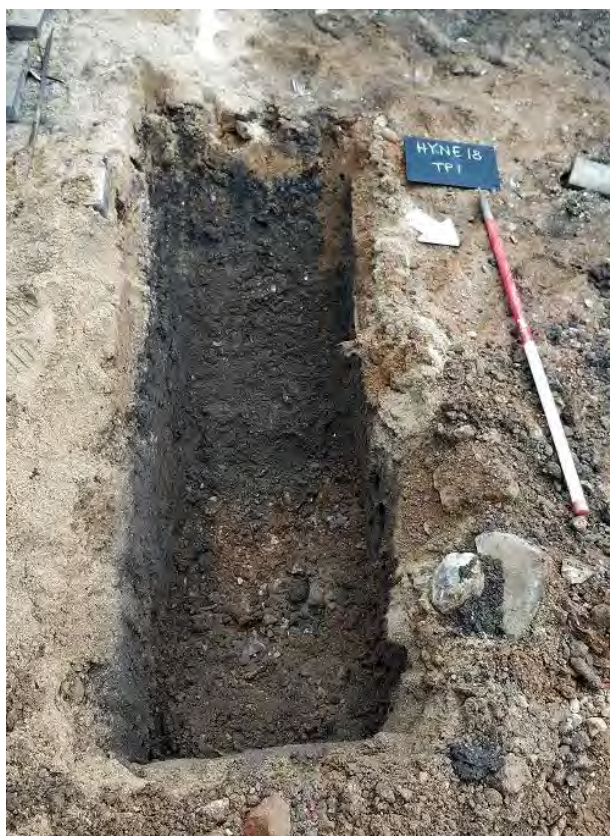
Plate 1. Test pit 1

Test pit 1 (Fig. 2, Section 1; Plates 1-2) was located at the south-eastern end of the building footprint, was oriented NE-SW and measured 1.9m in length and 0.7m in width.

The lowest deposit encountered was (04), a firm, light brown-yellow sand and gravel deposit, identified as the underlying natural geology, visible at a depth of 0.75m below the current surface level.

Truncating (04), and extending beyond the limit of the test pit, was 05, a cut feature with a flattish base. The exact dimensions of the feature remain undetermined due to the ground conditions; however, the observable portions of the feature inside the footing trenches indicate an extent of *c.* 6x3m. Its fill (03), a friable, dark brown-greyish sandy silty loam with frequent stone and flint inclusions, measuring *c.* 0.9m in thickness, was found to be saturated with water and interpreted to be the fill of a modern soakaway.

This deposit was overlain by layer (02), a friable, dark brown-greyish silty sand deposit with occasional stone and flint inclusions. This was identified as a modern made up ground or levelling layer, measuring 0.1m in thickness and extending beyond the limits of excavation. The latest deposit was (01), a loose, light brown-yellow sand and gravel deposit measuring 0.1m in thickness, connected to the construction of the current parking area surface.

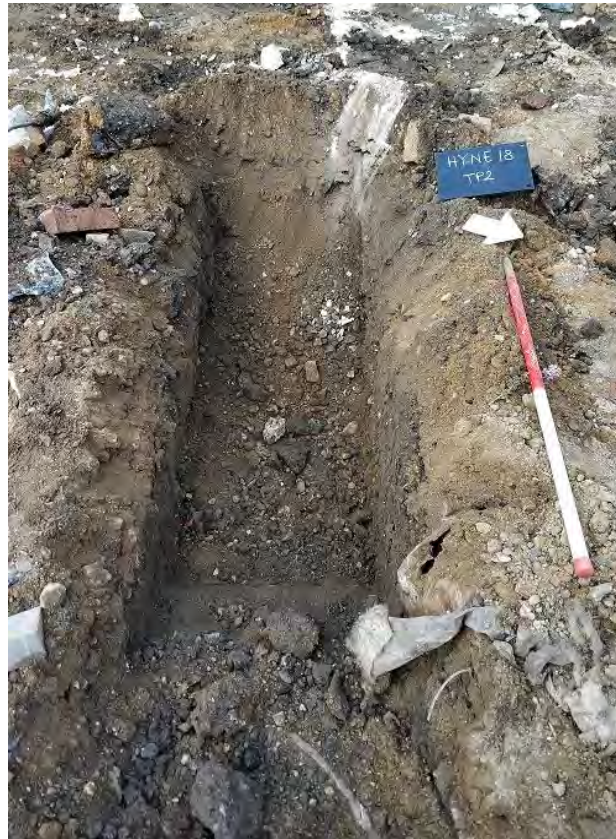
Plate 3. Test pit 2

Test pit 2 (Fig. 2, Section 2; Plates 3-4) located at the opposite (north-western) end of the building footprint, was orientated NE-SW and measured 2m in length and 0.7m in width. The initial location of the test pit, *c.* 0.7m further north-east, was changed as one modern service pipe trench was encountered *c.* 0.1m below the surface (Plate 3).

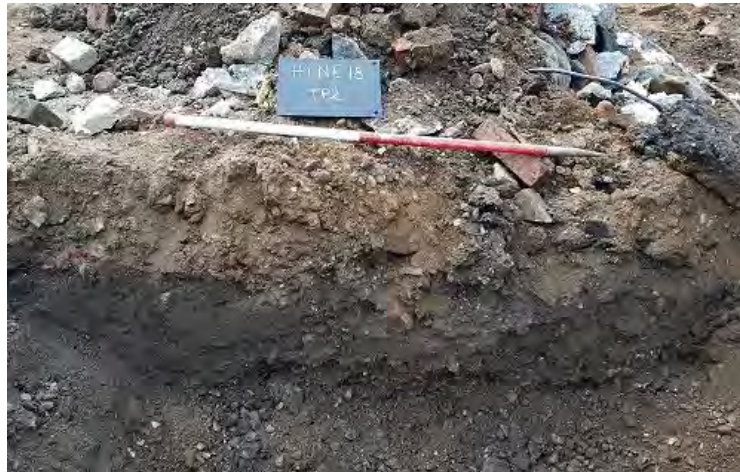
Plate 4. Section 2, Test pit 2

The geological layer (04) was encountered at a depth of 0.7m below the current surface. Directly above this, modern made up ground (08) was recorded. This was a compact, mid-brown silty sandy loam deposit, with frequent stone and flint inclusions. A large amount of rubble, consisting of modern brick fragments, was also observed within the deposit. This layer extended beyond the limit of the excavation, and measured between 0.4 and 0.5m in thickness.

The uppermost deposit observed in test pit 2 was a loose, light brown-yellow sand and gravel deposit (07) very similar to (01) but richer in flint inclusions. Interpreted as modern made up ground, it measured *c.* 250mm in thickness and, similarly to (08), contained a large amount of modern brick fragments.

The material present on site was limited to brick, both fragmentary and complete. The material was sampled for observation on site, and not retained as identified as machine-made 20<sup>th</sup> century frogged brick (Plate 4).
