JOHN MOORE HERITAGE SERVICES

ARCHAEOLOGICAL MONITORING OF TEST PITS

1 FISHER ROW, OXFORD OX1 1JY

SEPTEMBER 2017

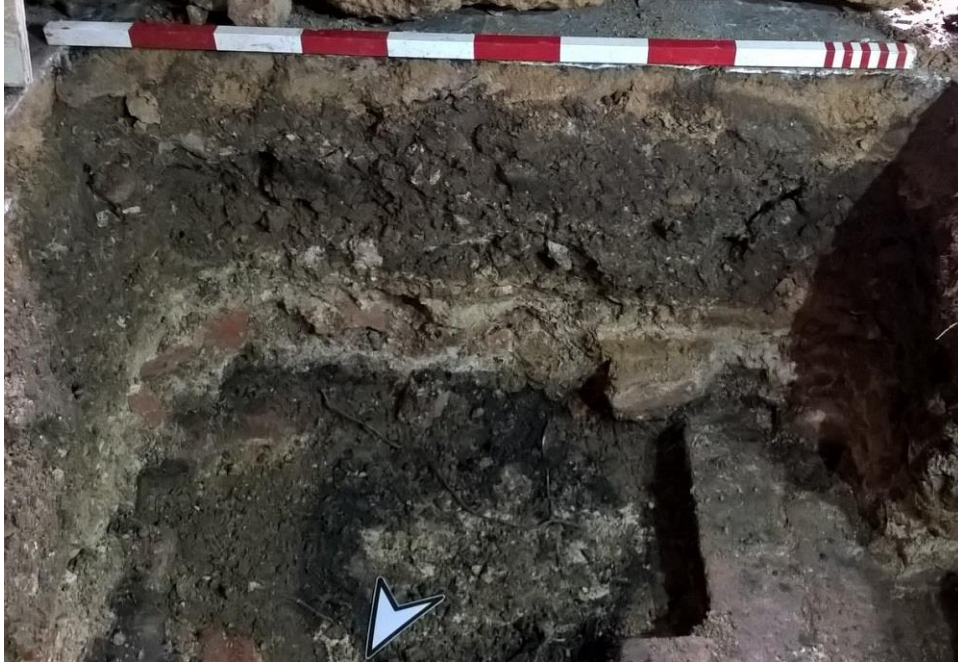
Plate 2. Test Pit 1 section, showing layer (1/05)

Above the brick floor a deposit of burnt material (1/05) was recorded, measuring a maximum of 0.05m in thickness, as observed in the southern section of Test pit 1.

Building materials including slate and ceramic roof tile were recovered from this deposit, as well as a single 17th century pottery sherd.

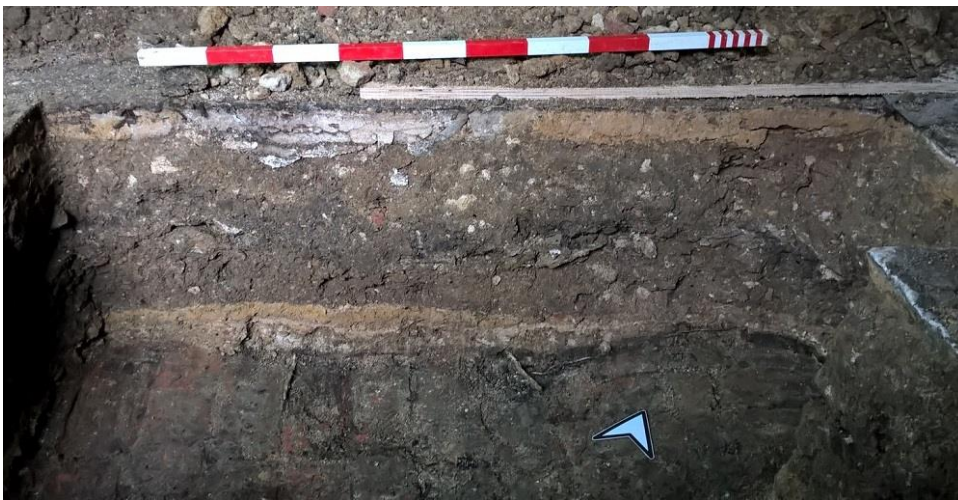
Plate 3. Test Pit 1 section, showing brick floor **1/06** and clay floor **1/03**

Floor **1/06** was a stretcher bond brick floor, extending beyond the limit of excavation. The bricks, measured 230x100x60mm, and were bonded with a sandy mortar. Later activities observed in the eastern area of the test pit disturbed floor **1/06**, resulting in the partial removal of the bricks. Localised settling of the bricks resulted in an uneven level as shown in Fig. 2 Section 1.02.

Clay floor **1/03** was recorded above this layer. The compacted deposit, extending beyond the limit of the excavation, measured 0.03m in thickness and was devoid of any inclusions. The installation of a new floor level of different material could indicate a change of use of the room. A slight depression in clay floor **1/03** was observed in the south-facing section, apparently orientated towards a now blocked door in the northern wall of the room. This could represent the remains of a drainage system, designed to facilitate the movement of excess water towards the door and outside.

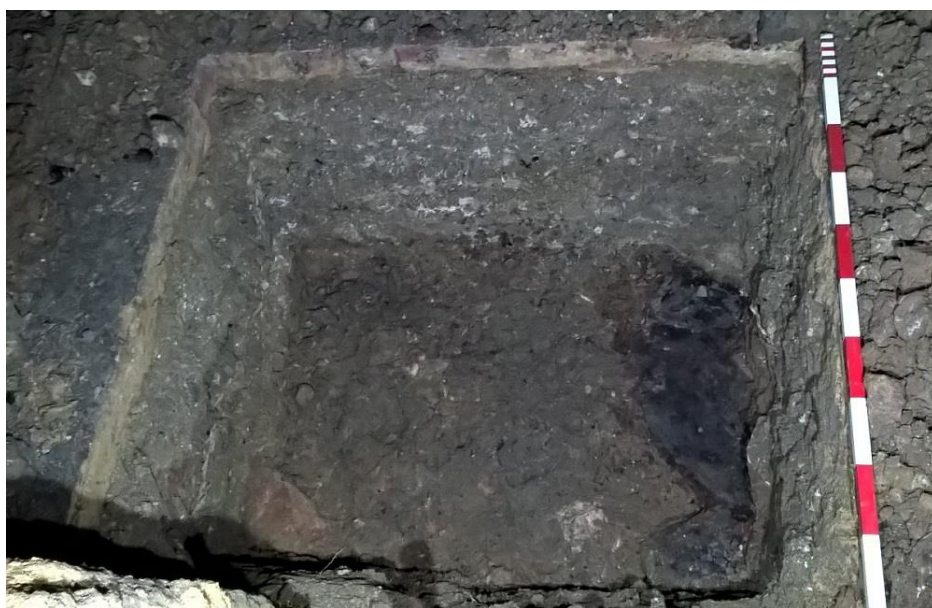
Plate 4. Test Pit 2

Test pit 2, measuring 1.15m in length and 0.95m in width and orientated NNW-SSE, was located in the innermost partition of the western vault. The excavation reached the required 0.5m depth and revealed a series of levelling deposits above the remains of a possible hearth.

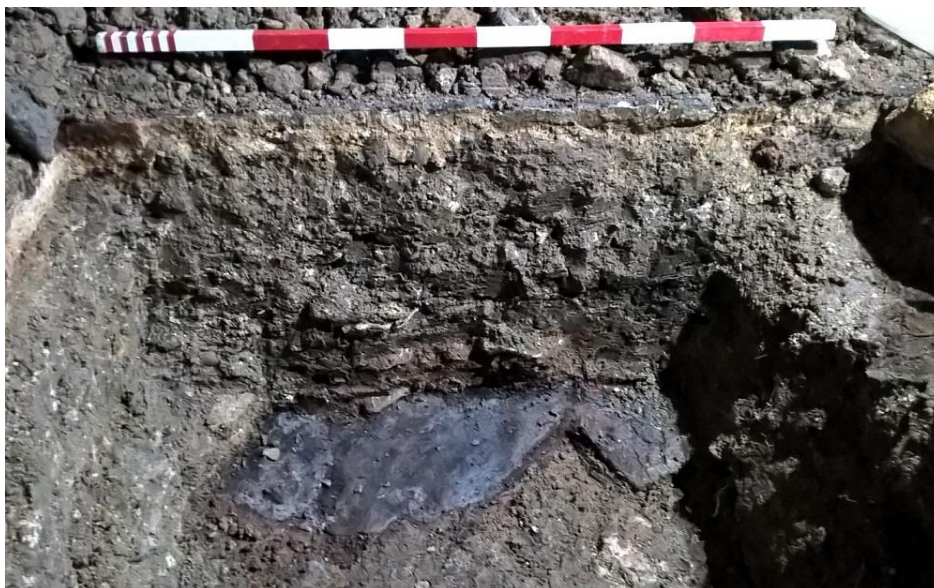
Plate 5. Test Pit 2 section, showing hearth **2/07**

Above this deposit a scorched limestone structure **2/07** was observed. This was identified as a possible hearth.

Hearth **2/07** was overlain by a 0.08m thick made-up ground deposit (**2/06**), formed by mid-brown, soft sandy clay, and extending across the excavated area.

The most significant feature in Test Pit 2 was a possible post-medieval hearth **2/07**, uncovered at a depth of *c.* 0.5m below the present stone floor. A possible later surface or floor level is represented by deposit (2/05), only visible in the north-facing section of the excavated area.
