HISTORIC BUILDING RECORD

SMITHS FARM OUTBUILDINGS

SMITHS FARM, DIDCOT, OXFORDSHIRE

DECEMBER 2018

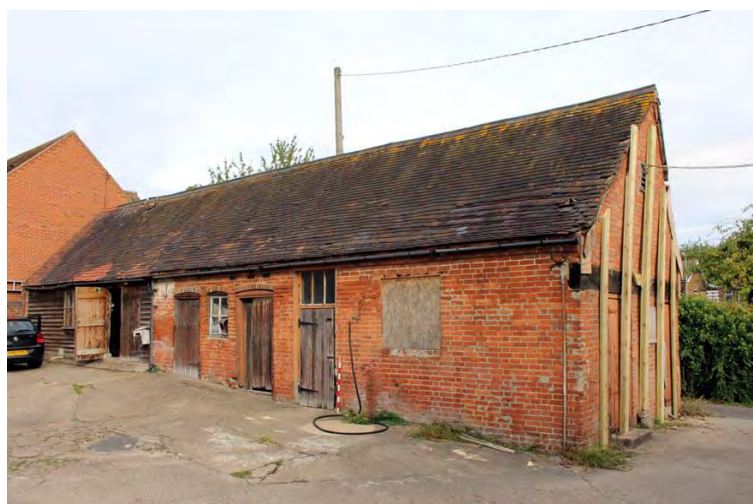
Plate 1: North building, southern elevation.

The southern elevation of the northern building comprises two sections (Plate 1). The western section is weatherboarded, and consists of 3 structural bays. The left hand bay is blank. The central bay contains a rectangular fixed window of 4 panes and the right bay contains a planked double door. The eastern section is of red brick set in a Flemish garden wall bond and also of three structural bays; brick corbelling is present below the eaves. The bricks used in construction measure 223mm x 105mm x 66mm. The left hand bay is occupied by a plank door headed by a segmental brick arch. To the right of the doorway is a rectangular window. The second bay is occupied by a wider doorway containing a plank door and headed by a segmental brick arch; to the right is another doorway, also containing a plank door. This doorway is headed by a mullioned light of 3 panes. The third bay is occupied by a boarded up window. This is headed by a timber lintel.

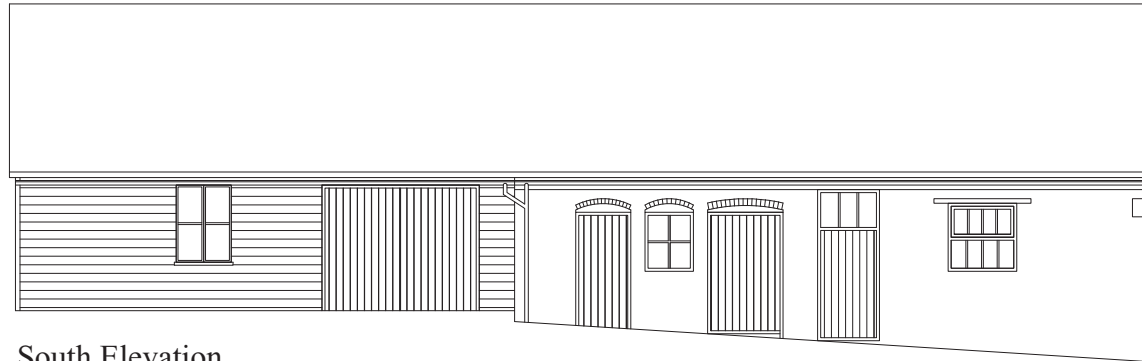
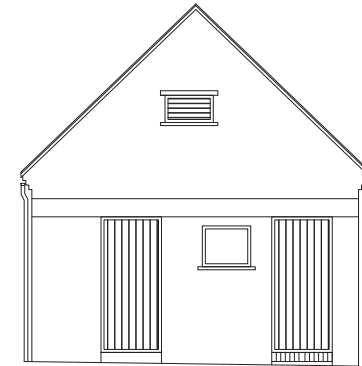
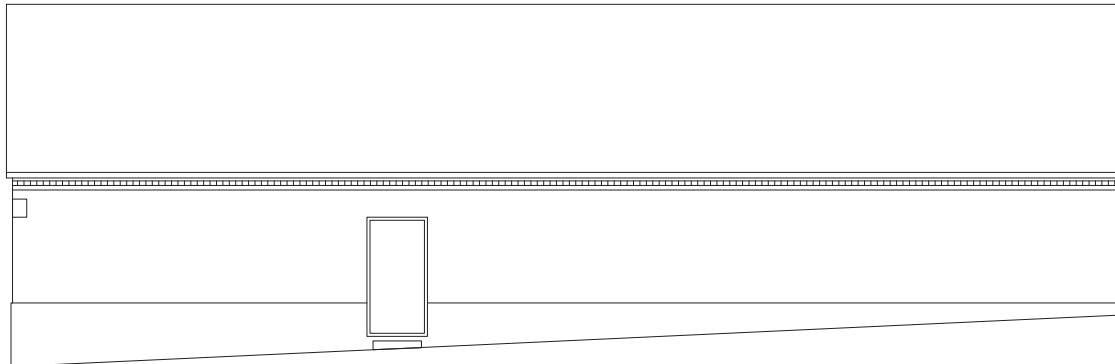
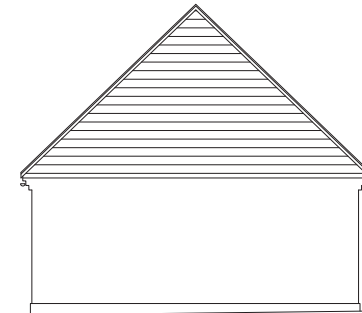
Figure 4: External elevations - north building

South Elevation

East Elevation

North Elevation

West Elevation

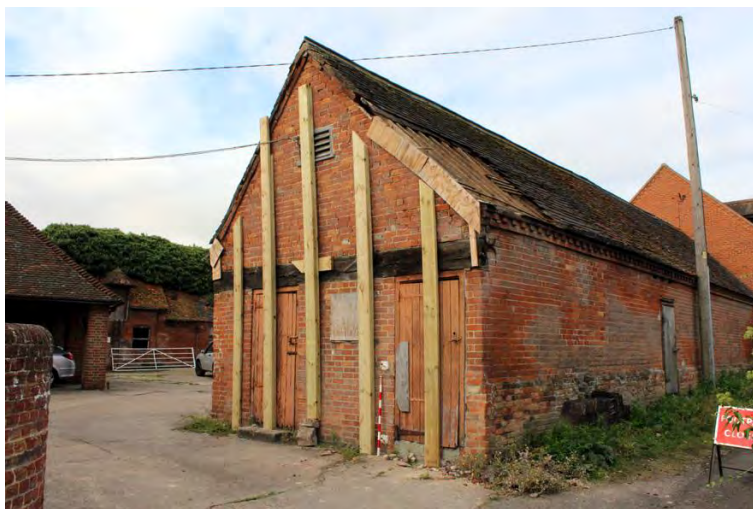
Plate 2: North building, eastern and northern elevations.

The northern elevation of the building is brick built (Plate 2). A brick plinth is present, increasing in height as the ground drops from west to east. The brick corbelling evident below the eaves on the southern elevation is seen again here. A doorway is located in the third bay from the eastern end of the elevation; this is occupied by a metal plated door.

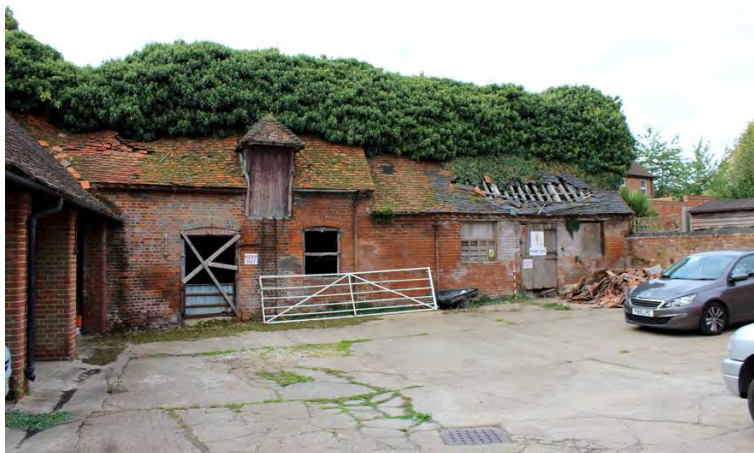
Plate 3: Southern building, northern elevation.

The eastern half of the building, which is 1 ½ storeys, comprises 3 ½ bays (Plate 3). The building is built of bricks measuring 226mm x 95mm x 67mm that are set in an English bond; half a bay at the western end of the structure is built of bricks measuring 223mm x 105mm x 66mm set in a Flemish garden wall bond, suggesting it may be a later addition. Brick dentilation is present below the eaves.

The western end of the building is a single storey structure of 3 bays (Plate 3). This is built of brick in a Flemish garden wall bond. Brick corbelling is again evident below the eaves. The left hand bay of the northern elevation contains a square fixed light window of 1 pane over 4, headed by a wooden lintel. This is blocked from inside the building; to the left of the window is an iron downpipe. The central bay contains a wide doorway occupied by a planked stable door, headed by a wooden lintel. The right hand bay contains a square boarded up window.

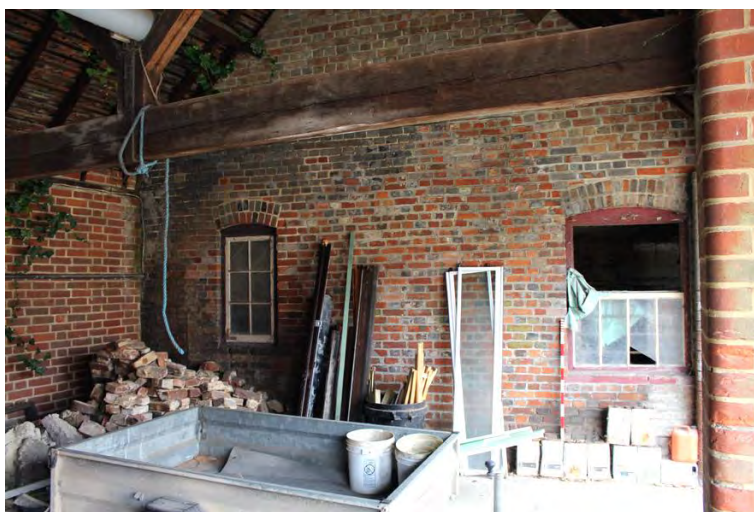
Plate 4: Southern building, eastern end of northern elevation.

The left hand bay of the north elevation contains a small rectangular fixed window of 6 panes headed by a segmental brick arch (Plate 4). The middle bay contains a rectangular fixed window headed by a segmental brick arch. The right hand bay contains a wide doorway headed by a segmental brick arch that opens onto the ground floor. A metal barred gate is present in the lower half of the doorway. Located above and to the right of this is a doorway to the first floor; this is located at a higher level and is accessed by a metal ladder. The doorway sits within a small hipped and tiled dormer that extends from the roof. The sides of the dormer are weatherboarded. The half bay contains a 2 light rectangular window; the upper light is a casement while the lower is a fixed light, also containing a single pane. To the right of this window is an iron downpipe.

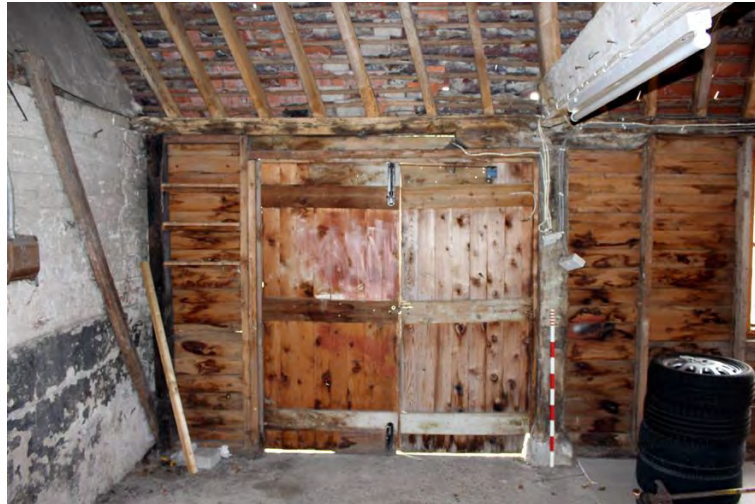
Plate 5: Northern building, modern weatherboarding and original post in room G1.

Room G1 is entered from the south through planked double doors. These appear to be a modern addition; as does the weatherboarding that forms the southern wall of this room.

Adjacent to this wall are two posts, set on stone pads, which support truss beams (Plate 5). The north and east walls of the room are whitewashed. The eastern wall is rendered to a height of approximately 1.00m, above which the brick is exposed; the northern wall has a concrete plinth to a height of 0.4m; the base of the western wall has two courses of concrete block, overlain by red brick. The floor is concrete. The room is open to the roof; three bays are visible, formed from two tie beam trusses with angled posts and clasped-purlins (Plate 6). The central bay also contains a metal tie in the place of a king post. Lateral beams extend west from the centre of the tie beams into the apex of the roof; these are likely to be a modern addition, installed in order to counter the lean of the roof timbers, which are slanted to the east. The gables at each end of the room are boarded.

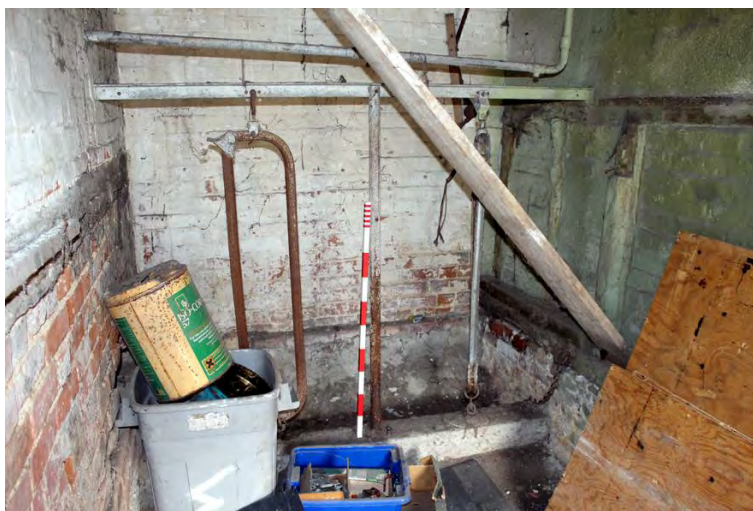
Plate 7: Northern building, trough and collars in room G2.

The northern wall is whitewashed; a concrete trough is present at the base of the wall. Associated with the trough is a metal frame to which two collars are attached (Plate 7). The western wall is brick, with a horizontal timber beam at a height of approximately 1.2m. This wall extends to the base of a truss. The room is open to the roof and two trusses are visible; the western truss has a king strut and tie-beam; two angled struts and two queen struts are also present on either side of the truss. The eastern truss has a tie-beam with angled struts. A support has been added that extends from the eastern wall to a collar beam near the apex of the western truss. This has failed. The floor is concrete.

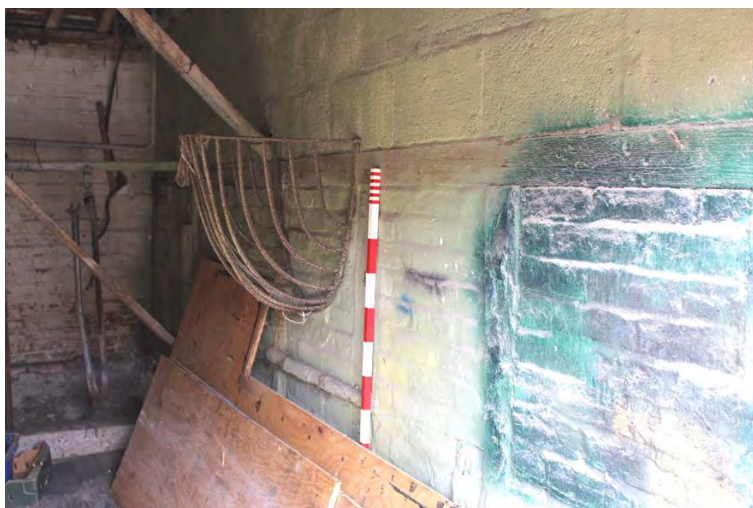
Plate 8: Northern building, original partition with later concrete block extension in room G2.

Room G2 is entered from the south through a planked door; the southern wall is brick, finished in whitewash. The eastern wall has a brick plinth approximately 0.4m in height; above this the wall is timber framed, with brick infill, to a height of approximately 1.5m. Above this are 4 courses of concrete block, extending to the base of a tie beam (Plate 8). A small hay rack is attached to this wall.

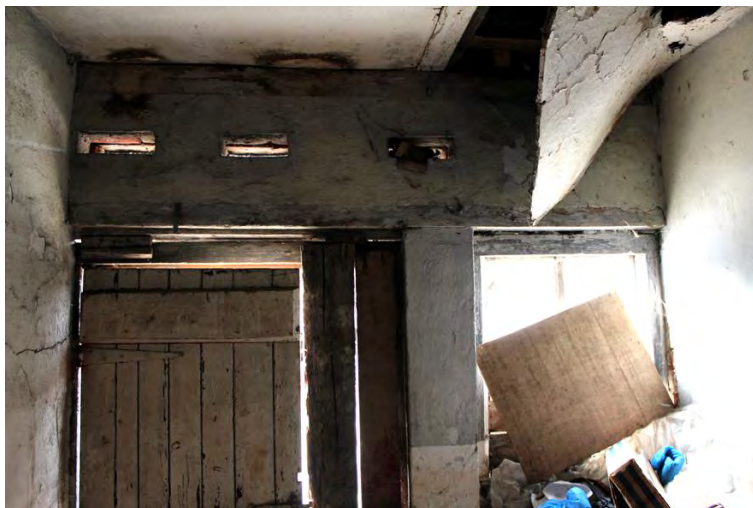
Plate 9: Northern building, ventilation in room G3.

To the west of the door is a rectangular fixed light window with 4 panes separated by wooden glazing bars. Three rectangular vents are present at the top of the wall (Plate 9). The eastern and northern walls are built from concrete blocks; the western wall is the same as the eastern wall of room G2. The floor is unfinished concrete and the ceiling is plain board.

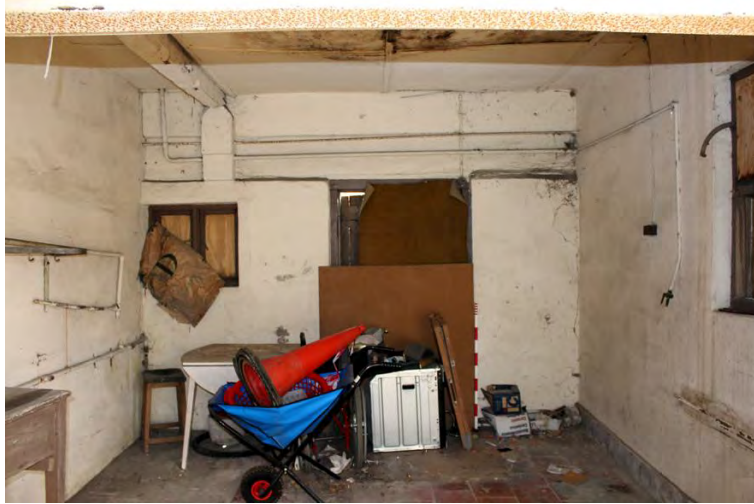
Plate 10: Northern building, eastern wall of room G4b.

Rooms G4a and G4b appear to have been created by removing a wall between two smaller rooms. Room G4a is entered from the south through a planked door. The eastern wall contains an opening to room G4b; the northern wall is blank. The western wall contains the doorway to room G5; to the south of this doorway a machine of unknown function is mounted onto the wall. Room G4b is entered to the west from room G4a (Plate 10); there is no barrier between the two rooms. The southern wall of room G4b contains a square 2 light window; the upper light is a bottom hung casement of 4 panes while the lower is a fixed light, also containing 4 panes; a partially blocked doorway that contains a plank door is located on the eastern wall, to the north of which is a 2 light side hung casement window with 1 pane in each light. With the exception of some pipework the northern wall is blank. The floor of rooms G4a and G4b are tiled; the tiles extend up the base of the walls by a single course. A transverse steel beam is present at ceiling height in the presumed location of the former wall between rooms G4a and G4b; a longitudinal beam runs from the centre of the eastern gable end into the western wall of G4a. This appears to be a re-used wall post.

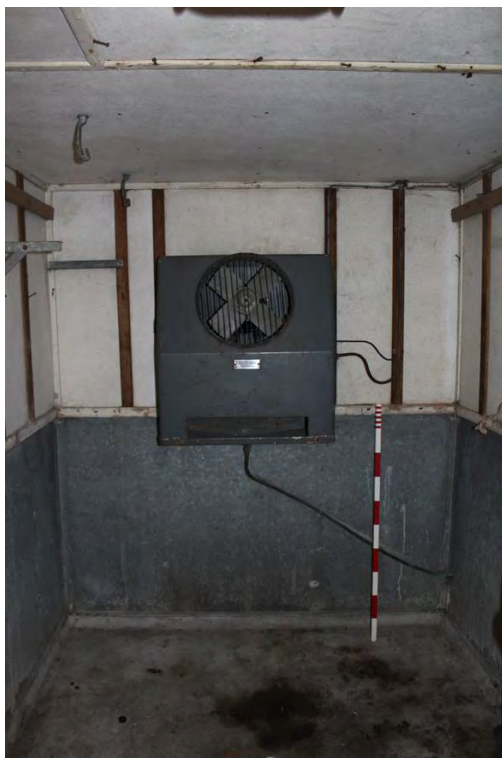
Plate 12: Northern building, western wall of refrigeration room (room G5).

Room G5 is entered on the eastern side from room G4a. It is accessed via an insulated door. The room appears to have been designed for refrigeration. The lower half of each wall is metal lined, as is the floor, while the upper parts of the walls are boarded (Plate 12). The northern wall contains a doorway giving access to the exterior. A fan is present on the western wall.

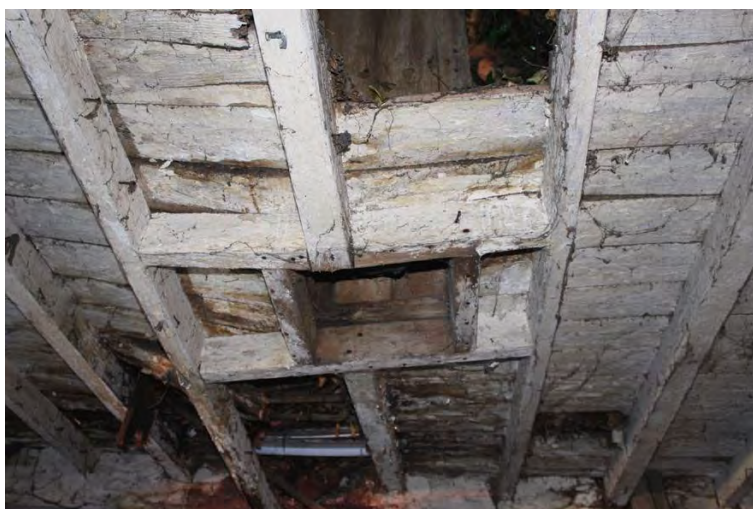
Plate 13: Southern building, square opening in ceiling of room G1.

Room G1 is accessed on its northern side through a metal framed gate. The walls are rendered to a height of approximately 1.2m, above which the fair-faced brickwork is whitewashed. The floor of the room has a concrete slab. A square opening is present in the ceiling of the room, located centrally on the longitudinal axis of the building, to the east of the doorway (Plate 13). This opens into a shaft that extends upwards into the roof.

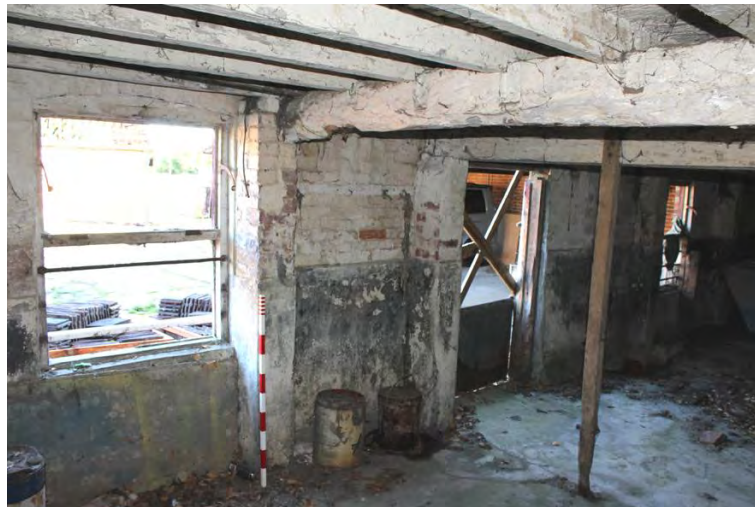
Plate 14: Southern building, northern wall of room G1

From east to west the northern wall contains: a single light side hung casement window with 2 panes over 3; this is protected by 5 horizontal metal bars. To the west of the window at ceiling height is a transverse beam which supports longitudinal joists

for the floor above. The beam is chamfered but has no decorative stops. To the west of the beam is a brick support, upon which rests a transverse beam at ceiling height; unlike the beam to the east this is not load bearing and may indicate the location of a former partition. A casement window of 2 lights is located to the west of this support; the upper light of the window is missing, although the remaining fixtures indicate that this light was a bottom hung casement. The lower light is fixed and contains 4 vertical panes. Another brick support is located to the west of the window; this supports a load bearing transverse beam which in turn supports ceiling joists. This beam is also chamfered; the southern end displays simple run out stops. Where found in domestic buildings these have been dated to 1599, 1608/9 in Hampshire examples (Roberts 2010, 113), which appears too early for this building but could include timber of an older date, or indicate the beginning of a style that continued to be used.

The entrance to the room is located to the west of this beam (Plate 14); a further brick support with transverse ceiling beam is located on the western side of the doorway. To the west of this beam is a further brick support, upon which rests a transverse beam at ceiling height; this support marks the position, seen both on the exterior and interior of the building, where the size and bond of the brickwork changes, indicating a

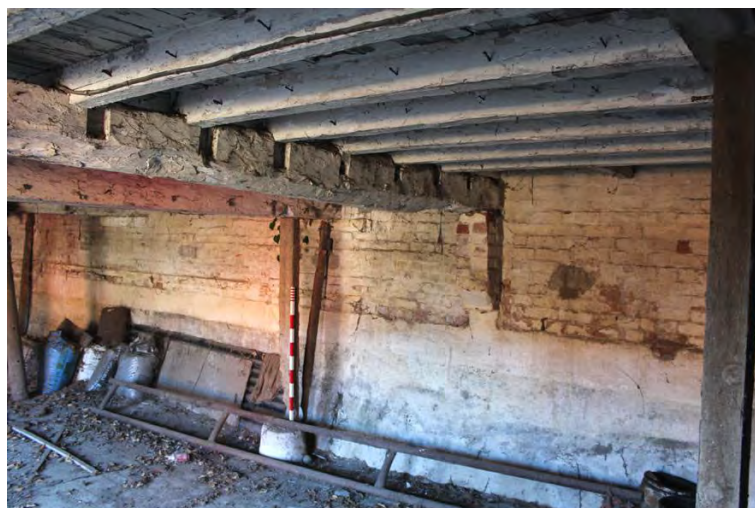
Plate 15: Southern building, room G1 showing reused or repositioned beam.

separate phase of construction. This beam is chamfered and appears to have been reused or re-positioned; joints for joists are present along the length of the beam however these do not house the joists present in the ceiling (Plate 15).

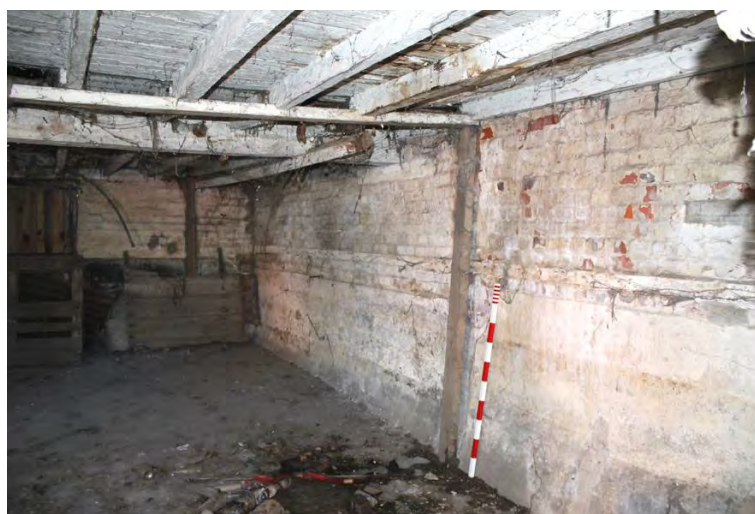
Plate 16: Southern building, southern wall of room G1 showing rail for hay rack attached to ceiling beam and possible partition beam.

The eastern wall contains a large central window; this was blocked and no evidence of glazing was seen. The southern wall is relatively devoid of features (Plate 16). A timber rail is set into the wall at a height of approximately 1.3m; from the western end of the wall this runs for a length of approximately 9m; this may be associated with a square sectioned rail attached to the carrier beams that runs parallel, approximately 0.5m north of the southern wall. Only a short section of this beam is present, although notches in the transverse carrier beams indicate that it ran for a similar distance as the wall rail. These features are likely to be the remnants of a hay rack. A post is located against the wall, 3.5m from the eastern end; this supports a transverse non-load bearing beam that is possibly associated with a former internal partition. A brick support is located 3.5m from the western end of the wall; this holds a transverse beam and is mirrored by a similar support on the northern wall. Located 1.5m from the western end of the wall is a short brick wall that extends approximately 0.8m north from the wall. This is also associated with a transverse beam that runs to a corresponding brick support on the northern wall.

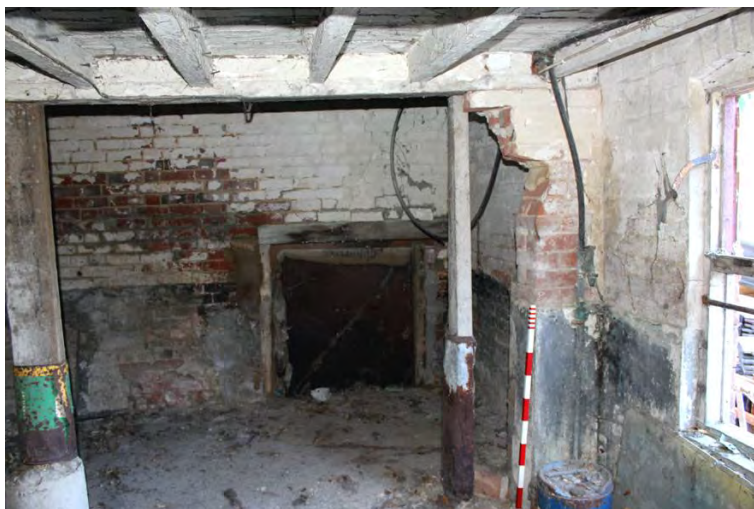
Plate 17: Southern building, access point to room G2 in western wall of room G1.

The western wall contains a blocked hatch that opens into room G3 (Plate 17); this is 1.12m in height and 1.1m in width. The westernmost section of the room is open to the roof; the western wall extends to the height of the purlins, which are supported on brick pedestals built into the wall. Above the purlins the wall contains horizontal boarding.

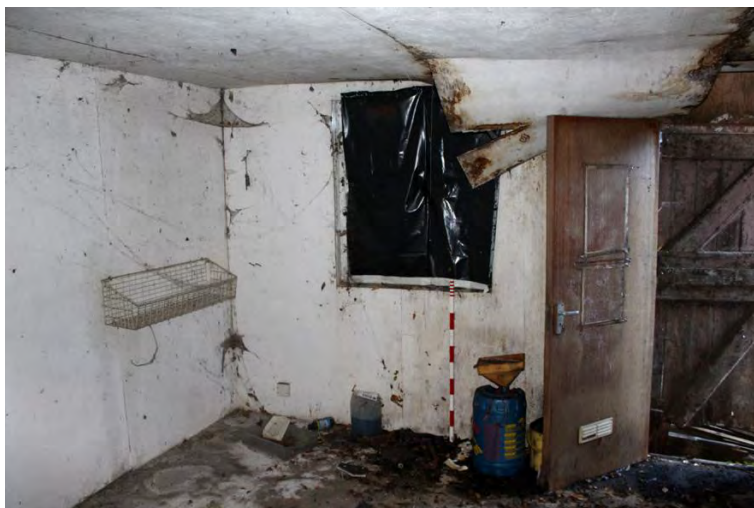
Plate 18: Southern building, northern wall of room G2.

Room G2 is accessed on its north side from the courtyard. The room is entered through a planked stable door and a modern panel door. The walls of the room have been clad in wooden sheeting, obscuring any original features (Plate 18). The floor is a concrete slab. A window is located in the north wall to the west of the door, however this has been blocked from the inside; the eastern wall contains a doorway to room G3. The remaining walls are blank.

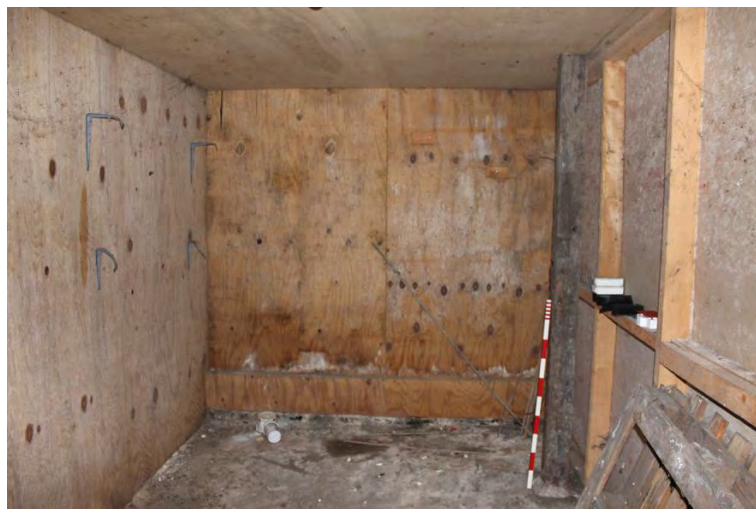
Plate 19: Southern building, southern wall of room G3.

Room G3 is accessed on its west side from room G2 through a modern panel door. This room seems to be a modern creation through the insertion of a stud partition and its separation from room G2 (Plate 19). A post is located against this wall, approximately 1.0m from the southern wall; this extends through the ceiling. The north wall contains a window; however, this is blocked from the inside. The remaining walls are blank.

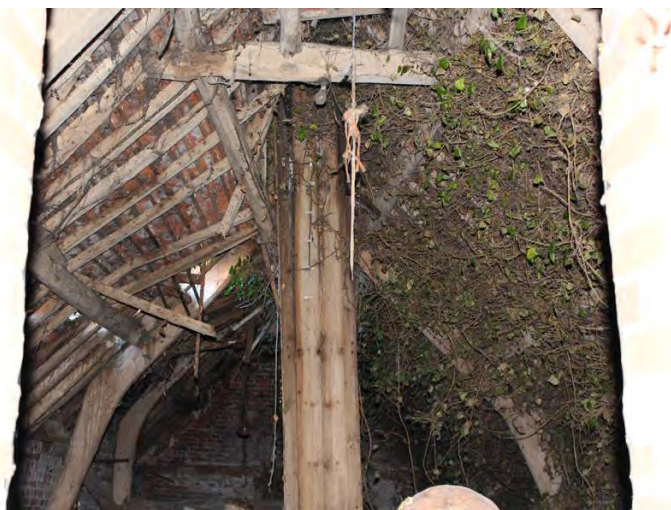
Plate 20: Southern building, roof trusses and vent structure in room F1.

A square wood planked structure, located in the centre of the room, rises from the floor into the roof; there was no evidence that this structure could be accessed from within the room (Plate 20). As such this may be a ventilation shaft, installed in order to allow the circulation of air through the ground floor of the building.

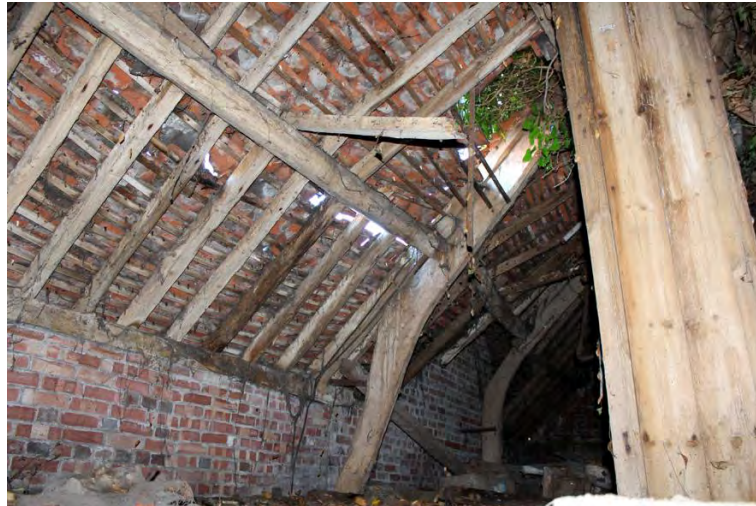
Plate 21: Southern building, roof trusses in room F1.

Room F1 is accessed via a metal ladder from the courtyard. This room could not be accessed during the site visit due to safety concerns. However, views of the room were possible from room G1 due to the deterioration of the floor of F1. The room is a low-walled half storey loft, located above room G1. The floor is boarded.

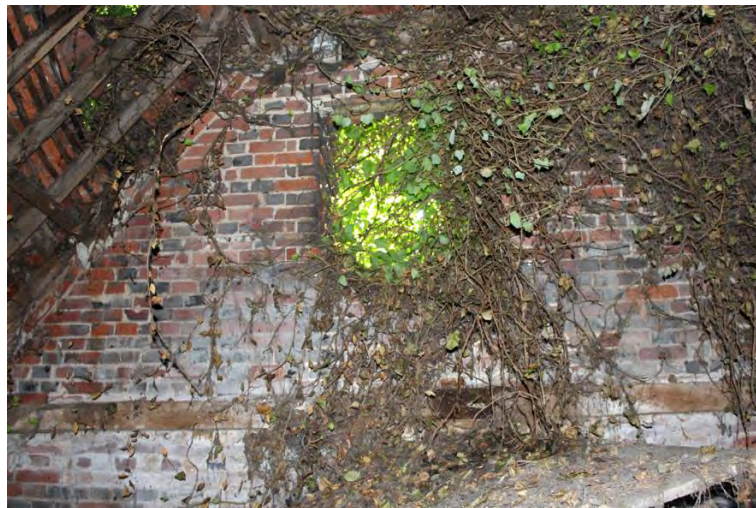
Plate 22: Southern building, window in eastern gable wall in room F1.

The eastern gable contains an unglazed square window (Plate 22); the western gable contains a low window or access point headed by a segmental arch that opens into room G1 (Plate 23). The roof structure is divided into 3 ½ bays; these are formed by 3 trusses. The extension to the western end of the building, as indicated by the brickwork, has resulted in the creation of an additional ½ bay. The trusses are upper base cruck trusses with a single collar and trenched purlins (Plate 21); metal ties run horizontally from the back of each cruck blade into the wall, performing the function of a cruck-spur. Cruck construction is recognised as a means of construction from the late 13th century to the late 15th century (Roberts 2010, 15). This is indicative of the timber frame being from an earlier medieval building.
