**ARCHAEOLOGICAL WATCHING BRIEF**

**67 CHAPEL STREET, THATCHAM,**

**NGR SU 522674**

**JANURARY 2020**

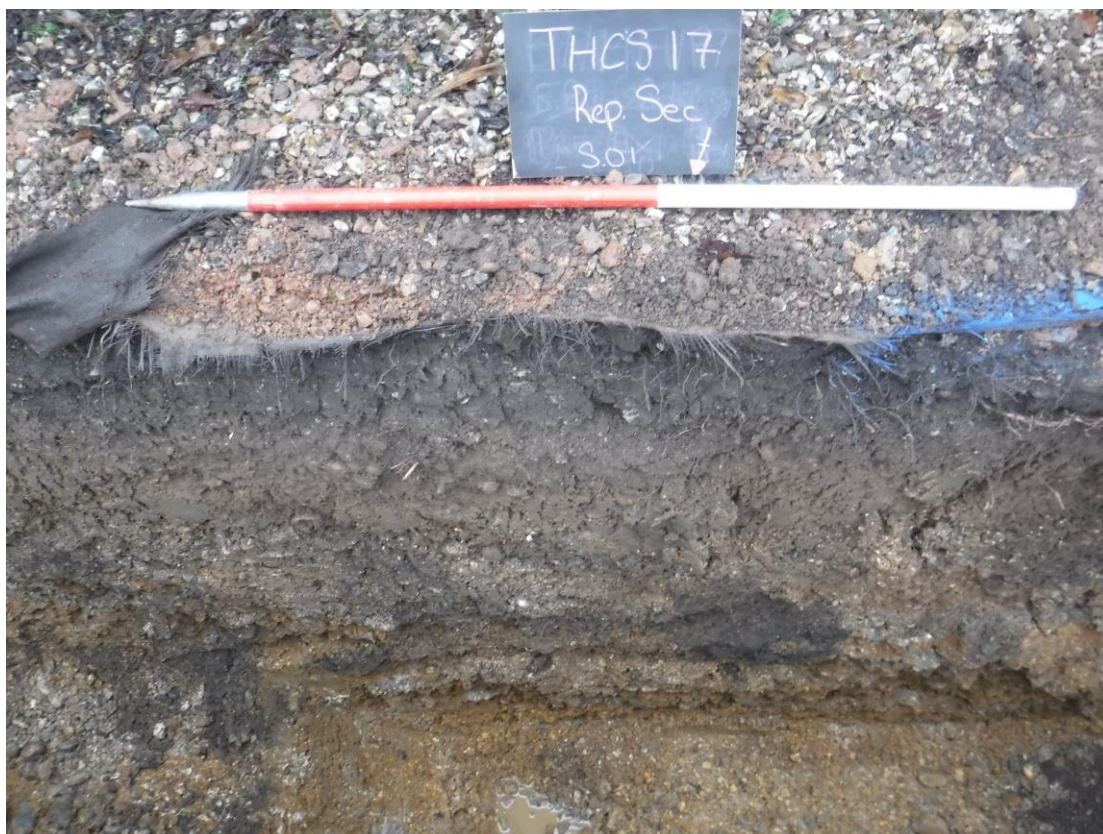
Plate 1: Section 1: Southern footing trench, looking north.

The lowest deposit encountered was the geological horizon (04); this was present throughout the footings trenches, with a maximum seen thickness of 0.5m to the limit of excavation. The natural geology (04) was overlain by subsoil, (03) a compact, mid to light brown grey silt, 0.58m in thickness, with 70% gravel inclusions. A garden soil (02) overlaid the subsoil; this was a friable mid grey brown silt clay, 0.22m in thickness, with frequent gravel inclusions. The parking pad (01) covered the garden soil. This was a mixed gravel deposit, which appears to have been laid down and levelled out on a membrane, directly on top of the garden soil.

No finds were recovered during the Archaeological Watching Brief.
