JOHN MOORE HERITAGE SERVICES

ARCHAEOLOGICAL INVESTIGATION

31 COWLEY ROAD, LITTLEMORE, OXFORD

JANUARY 2018

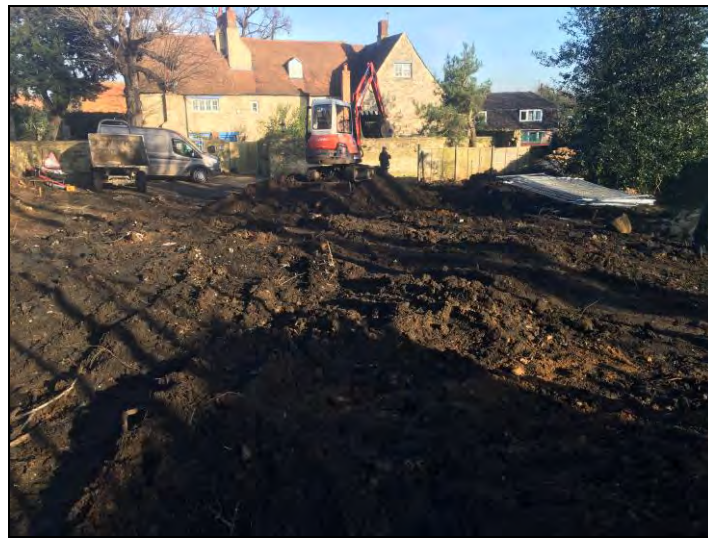
Groundworks had begun with the levelling of the site and reduction of general ground level of the construction area, which was originally around 1.5m higher than the level of Cowley Road.

Plate 1: North facing view of the levelled site from the south end

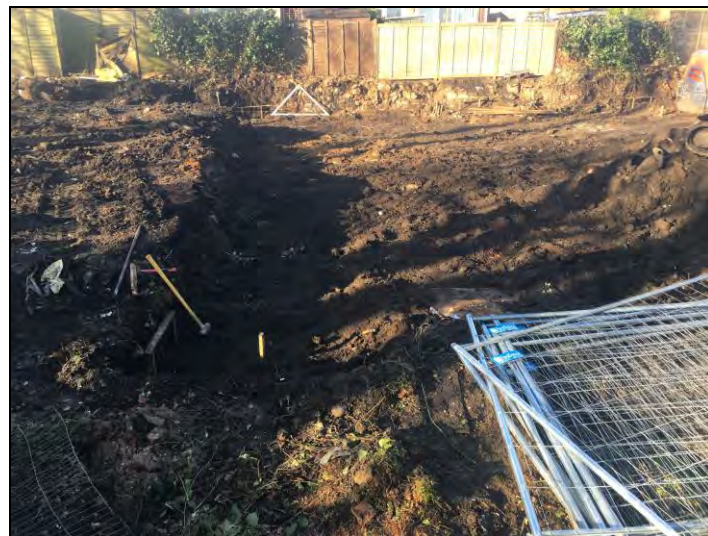
Plate 2: West facing view of the reduced construction area

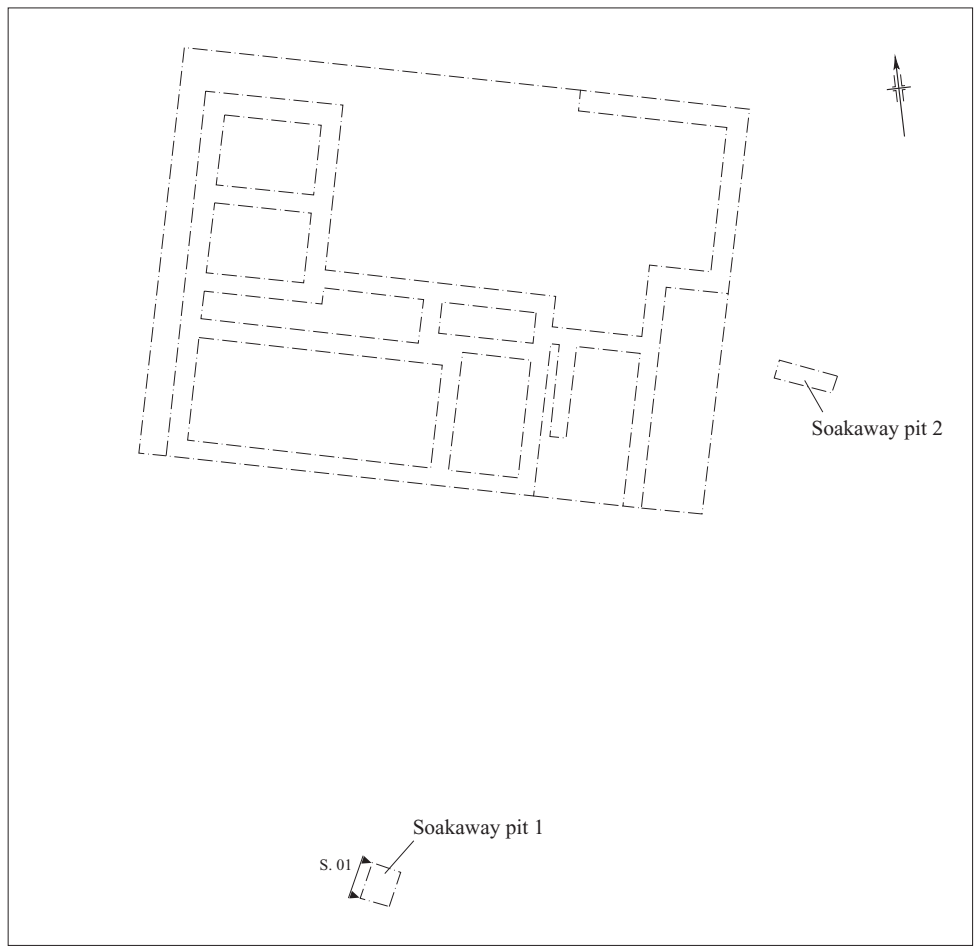
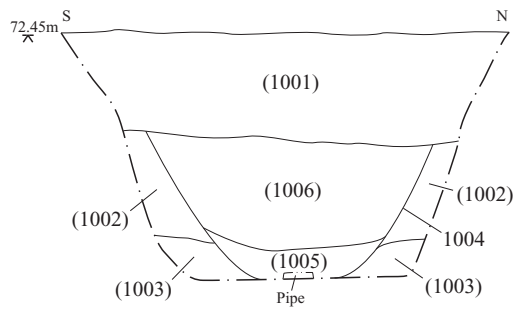
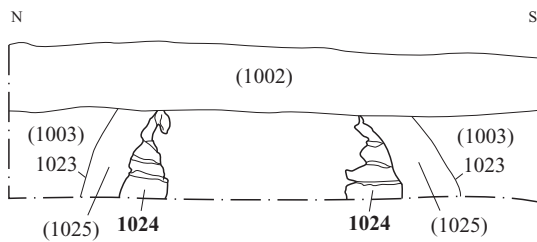
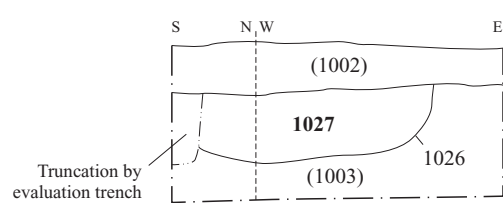
Figure 3: Sections 1, 7 and 8

The natural geology (1003) remained consistent throughout the site and comprised a light brown/yellow silty sand with areas of limestone brash. The natural was overlain by made ground deposit (1002) of a dark brown yellowish grey silt which was present across the entire investigation area measuring between 0.20m and 0.40m. This was in turn overlain by made ground layer (1001) of a dark brown/grey silt with a varying thickness of 0.45m – 0.60m. Made ground layer (1001) contained considerable modern material and was completely removed by machine from the construction area of the house (Figure 3, section 1).

Within the centre of the northern stretch of the footings metaled floor surface **1027** was constructed of roughly shaped limestone, tile fragments and irregular small pebbles (40mm – 0.60mm) set in a lime mortar. It was constructed in a random patterning style with most stones laid flat (Plates 16-18). The floor measured 4.2m wide and 0.40, deep. It did not extend beyond 3.8m to the south west due to its partial excavation in the previous investigation (JHMS 2011) from which the evaluation trench was visible in the footings (See section 8). Cut 1026 was proposed for the floor surface.

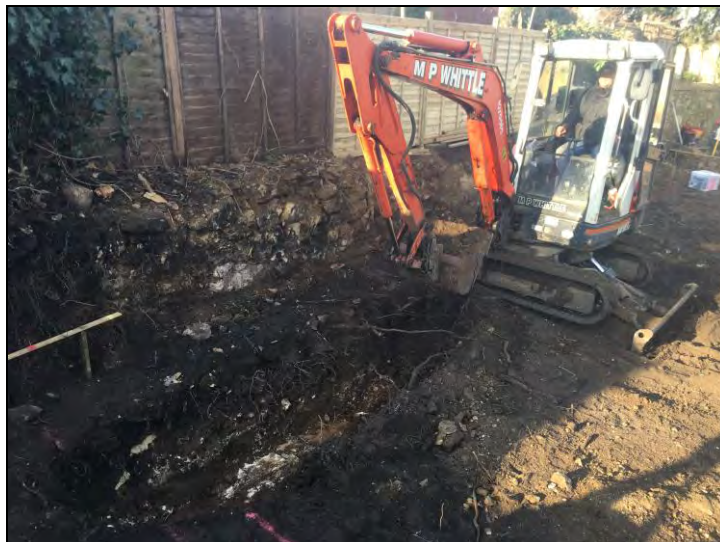
Plate 3: North-West facing view of initial trenching

(Plates 1-3). The development foundation trenches were excavated to a depth of around 0.40m from the reduced area (Plate 4).

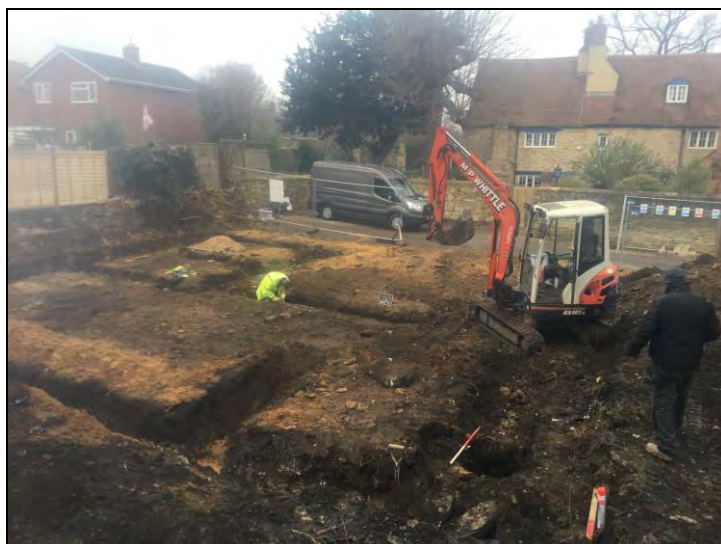
Plate 4: North-West facing view of site

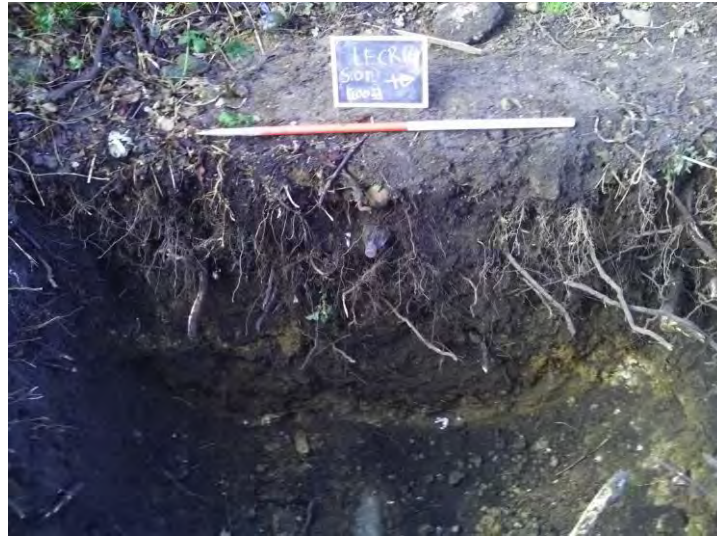
One rectangular soakaway pit was excavated, situated south of the footings measuring 1m wide, 2.25m long and 1.25m deep. A rectangular cable duct was also excavated west of the footings along the eastern wall measuring 0.60m wide, 2m long and deep.

Plate 5: East facing section of south soakaway pit

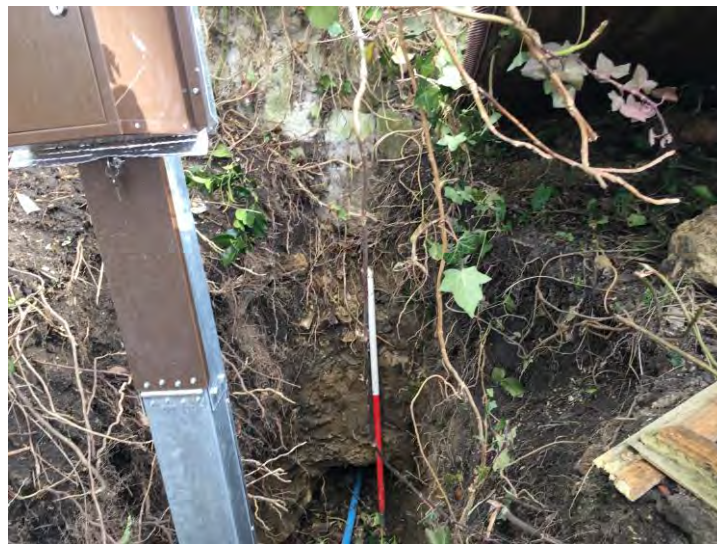
Plate 6: West facing section of cable duct

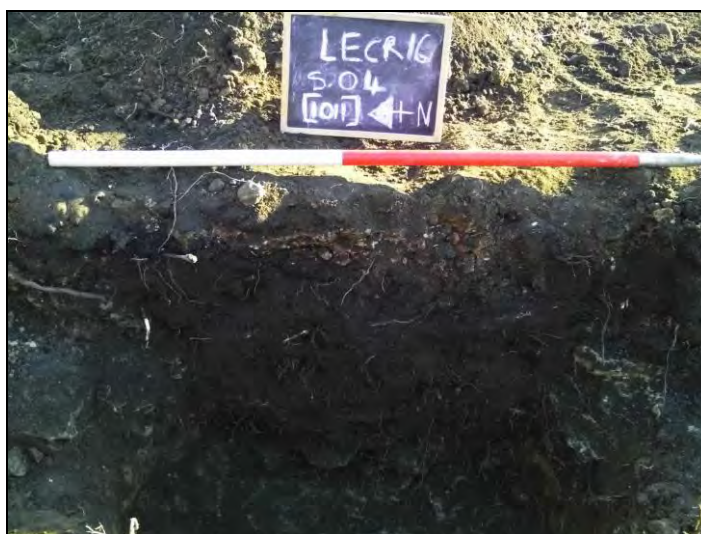
Two pits were recorded in the northwest area of the footings (See Figure 2). They were cut into the natural silty sand (1003) and overlain by made ground deposit (1002). Pit 1011, situated on the western side of this area, was >0.60m wide, 0.96m long and 0.64m deep (Plate 7). It was flat bottomed with broadly straight sides at a gradual angle. Pit 1014, situated east of pit 1011 measured >0.60m wide, 1.10m long and 0.62m deep (Plate 8). Pit 1009 was located in the south facing section of the southern stretch of footings. It measured 0.37m wide, 0.71m long and 0.27m deep and its profile was U shaped (Plate 9). Each of these pits contained similar disuse fills (1008, 1013, 1015) of loose dark brown/grey silt. Pit 1011 contained a base fill of redeposited natural stony silt measuring 0.5m thick. It also contained Post-medieval pottery, brick, metal and glass in its upper fill (1013). Butchered fragmentary animal bone of sus, oyster shell and charcoal was also present in this fill.

Plate 7: East facing section of pit 1011

Finds in pit 1011 are sealed in undisturbed fill (1013) and provide secure dating to post-medieval period. Although the two other pits 1009 and 1014 contain no dating evidence, their fills (1010, 1015) are of a very similar nature to (1013) in terms of composition and preservation and therefore are presumed to be of the same date.

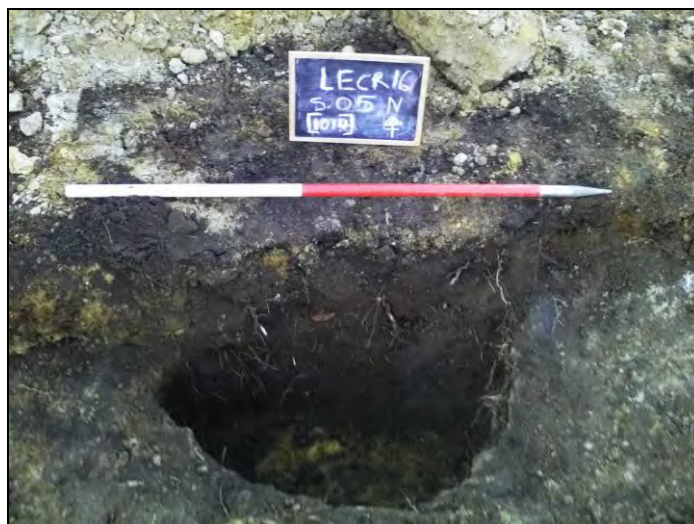
Plate 8: South facing section of pit 1014

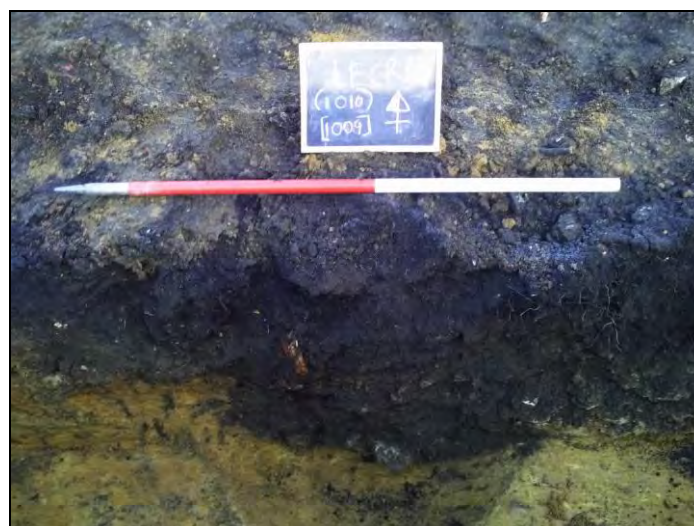
Plate 9: North facing section of pit 1009

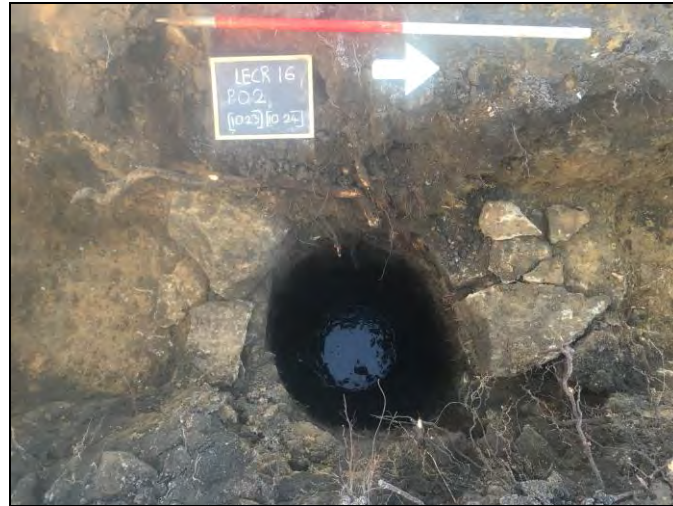
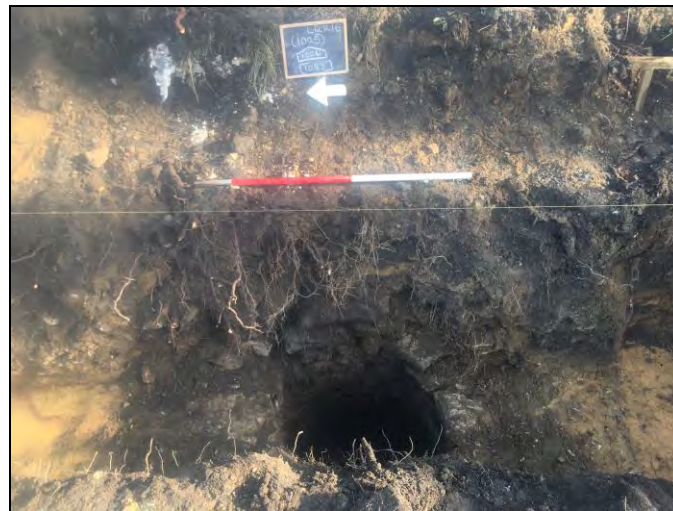
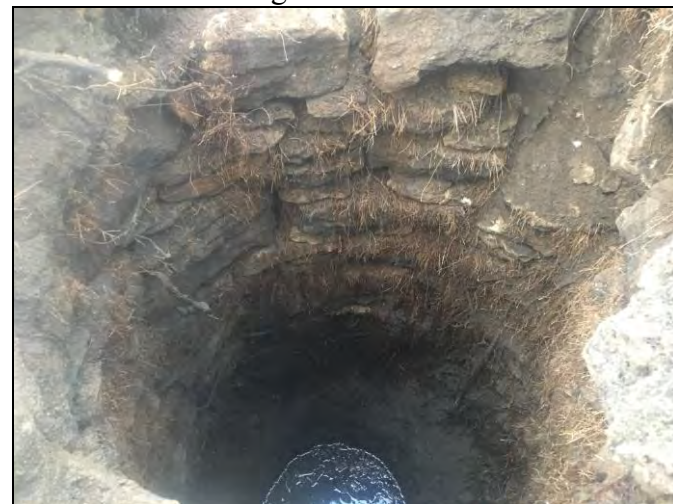
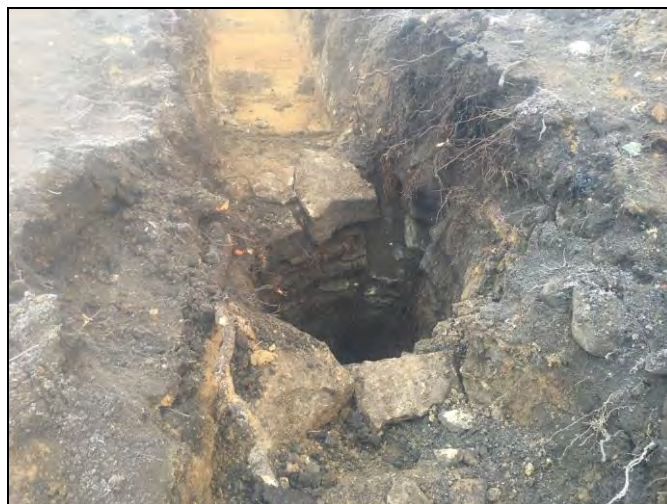
Formerly recorded (JMHS 2011) open well **1024** was re-exposed to a greater extent, located in the north-south oriented footings of the south eastern portion of the house construction. It was excavated by hand and machine in cross-section through its north-south axis to the depth and width of the footings trench and thus recorded in profile and plan within these limits (Plates 10-13). It was constructed of rectangular blocks which varied in size from 0.10 – 0.40m with a bonding agent of clay. The well had a total depth of >6m down to the level at which it was silted up (1m of standing water) and measured 1.60m in diameter. It was barrel shaped, with concave sides, and therefore likely did not extend a significant amount beyond its measurable depth. The well was built in a circular construction cut 1023 that measured 2.10m in diameter. Within this cut, and filled around well **1024**, was a firm dark brown/grey silty sand (1025) that contained two large stems of Post-medieval clay pipe and a tile fragment of the same date. This fill represents a deliberate cavity backfill.

Plate 10: Plan view of well 1024

Plate 11: West facing section of well 1024

Plate 12: Interior view of well. North East facing

Plate 13: General view of well. North West facing

Dating evidence from the archaeological features investigated is derived from the 19th century AD. Backfill (1025) would have occurred during the construction of well **1024** and therefore provides well secured dating for its installation. The well is located inside or within the peripheral zone of the north western stretch of the structure along the eastern boundary shown in 19th century OS maps and could have served as a viable water source for its function as a coach house.

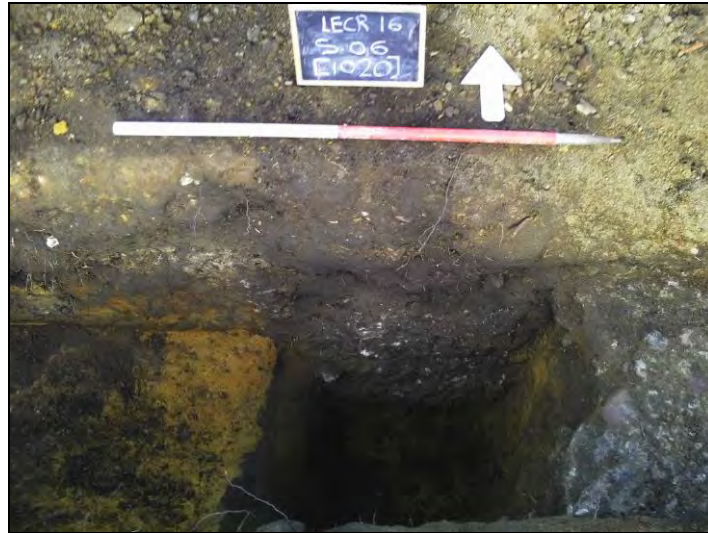
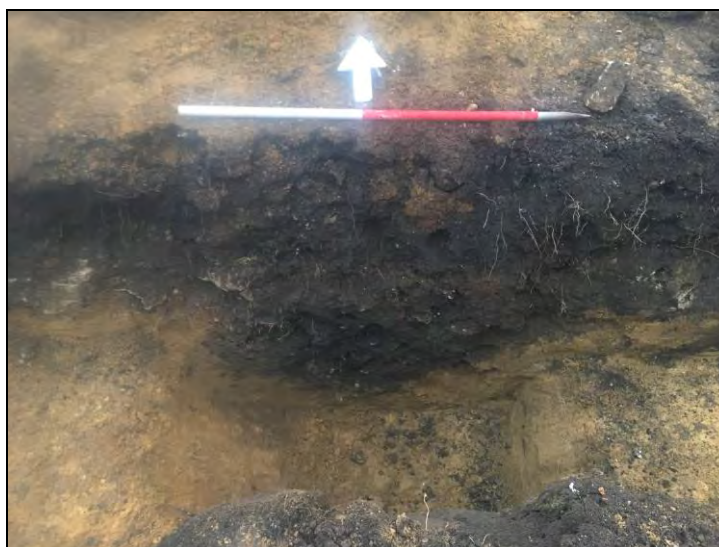
Robber trench (1020) was 0.62m wide, 0.62m deep and greater than 2.90m long (Plates 14-15, & 19). This represents the robber trench formerly recorded in the evaluation stage (JMHS 2011). This feature contained a 0.40m thick redeposited natural (1028) of a light brown/yellow silty sand in its base. This was overlain by 0.70m thick fill (1021) of a very firm dark brown/grey silt and contained clay pipe, tile, pottery fragments, glass and metal all dated to the 19th century AD. Fill (1021) also contained some butchered sus bone fragments and was in turn sealed by 0.36m of mid-brown clay rich silt.

Plate 14: South facing section of robber trench 1020

Plate 19: North facing section of robber trench 1020
trench in evaluation location (JMHS 2011)

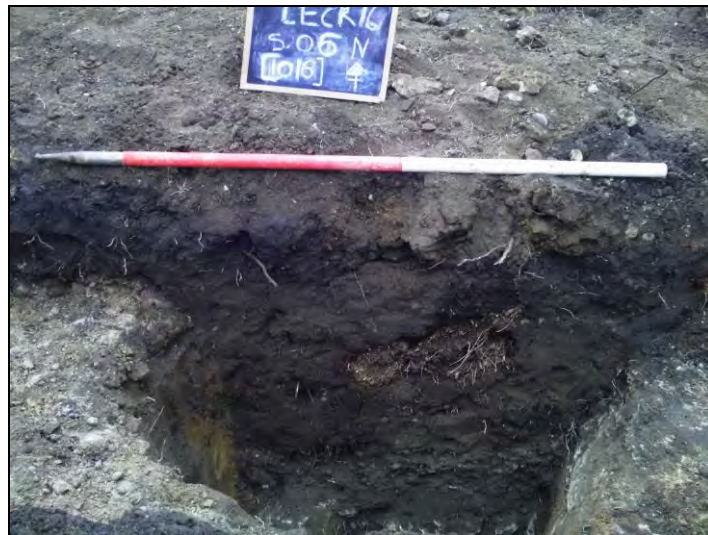
Robber trench 1020 and south west terminus of robber trench 1016 both ran generally parallel to each other from south west to north east. They were very straight sided with flat bottoms. Robber trench 1061 was a squared off terminus measuring 0.61m wide, 0.63m long (as exposed) and 0.62m deep. It contained a 0.10m thick basal fill (1017) of irregular large limestones stones (>250mm) which was overlain by a dark greyish sandy silt (1018). This contained Post-medieval pottery and was sealed by upper fill (1019) of a dark brown/grey silt which also contained Post-medieval pottery and butchered sus (pig) bone.

Plate 15: South facing section of robber trench terminus 1016

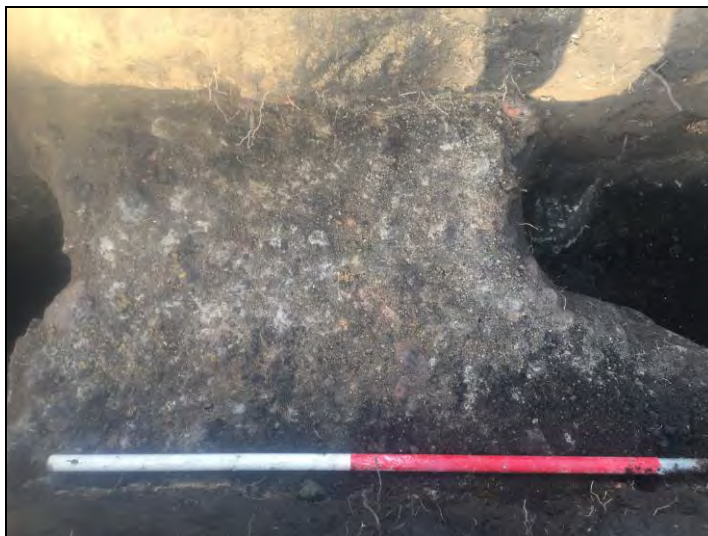
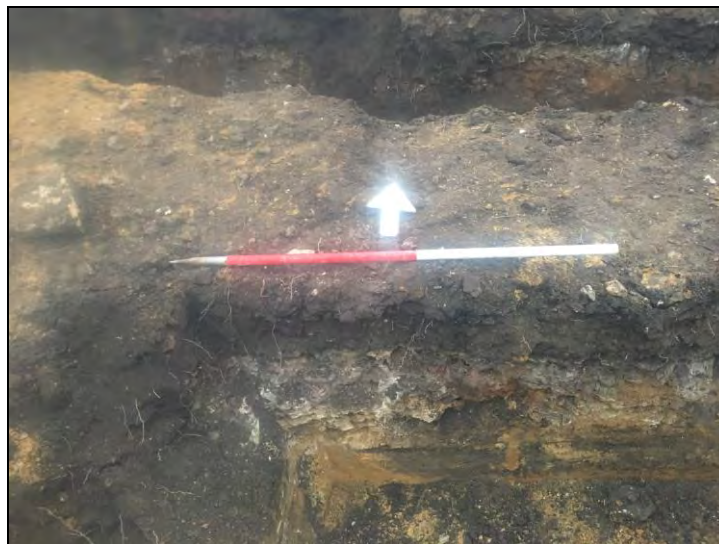
Plate 16: Plan view of floor surface 1027

Plate 17: North West facing view of floor surface **1027**

Plate 18: South facing sections (background & foreground) of floor **1027**

Floor surface **1028** is aligned along the same orientation as an extension shown projecting north west from the northwest corner of the potential coach house shown on the OS maps. The robber trenches are also aligned along this path which would have been created in removing stones from internal walling of building segmentation or a fireplace. The fact that the deeper robber trench 1020 does not contain large blocks of limestone as seen in the much shallower trench 1016 sheds light on their purpose for removal of stone. Dating material within the robber trenches indicate that building material had been removed during the demolition of the coach house by the 1930s and, furthermore, implies this as a relatively short lived structure during the 19th century AD as opposed to one built contemporary with St George's 15th century house. The coach house, together with the pits recorded in both stages of investigation (JMHS 2011), provides evidence for increased activity in the post-medieval period and imply that made ground layer 1002 is likely the result of demolition works in the early modern period.

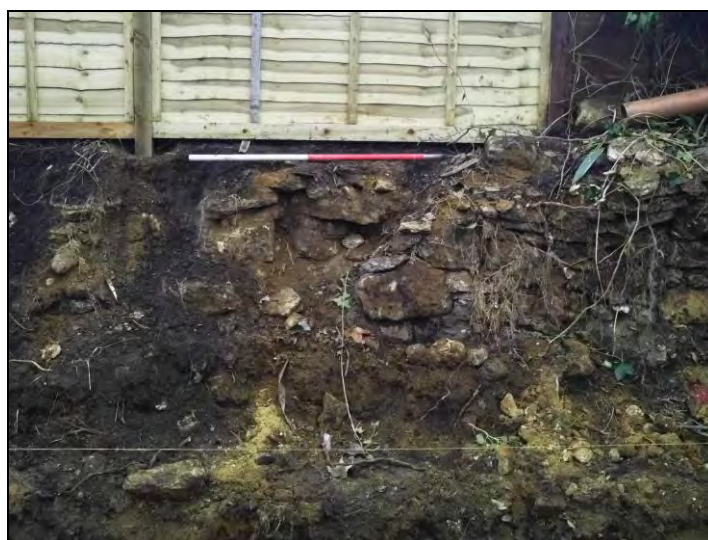
Dry stone wall **1029** was dismantled in order to restore it in its same location during construction works. It was located along the eastern boundary and measured 0.40m wide, 1.20 metres tall and 16m long. It was constructed of rectangular limestones varying in size from 0.10m – 0.40m long, >0.20m thick and >0.20m wide. No bonding agent was present, however significant silt build-up and degraded limestone was present between the stones which secured them and contained to dating evidence.

Plate 20: West facing view of wall **1029**
