**THE PRIORY, CHURCH LANE,**

**THATCHAM, BERKSHIRE**

**ARCHAEOLOGICAL WATCHING BRIEF**

**NGR SU 51640 67284**

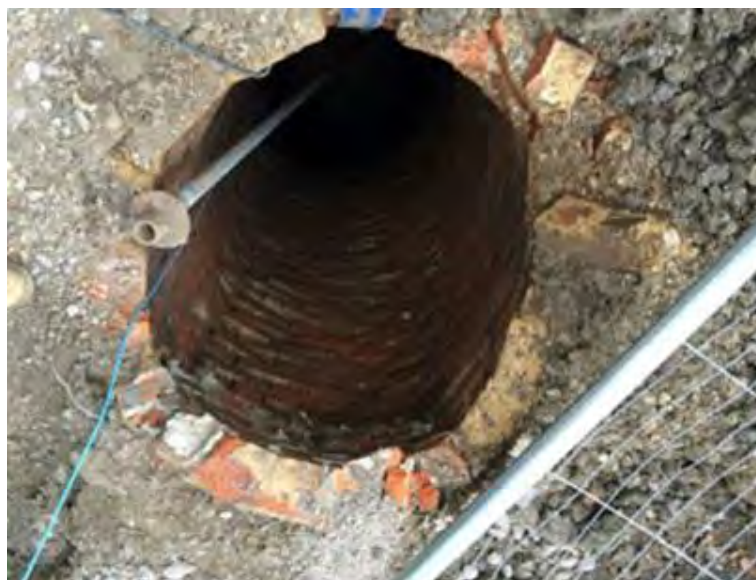
Plate 1. Brick well.

Photographs were provided by the building contractors for inspection by the archaeologist and whilst the photographs did not provide evidence for all the excavations it was possible to note the presence of a brick-built well in the south west corner of the extension footing trench (Fig 2. Plate 1). From what else could be observed from the photographs, there was no strong evidence that would indicate that the extension foundations had revealed any archaeological features but the potential for accurate observance was limited. There was a possible indication of a feature, possibly a linear feature, in the NE corner of the foundations but the smearing of the section made this impossible to ascertain from the photograph (Plate 2). No photographs for the internal platform reduction to the extension were available and the photographs of the foundations for the w/c were also limited in their usefulness, the presence or absence of archaeological features in these areas is thus entirely unknown.

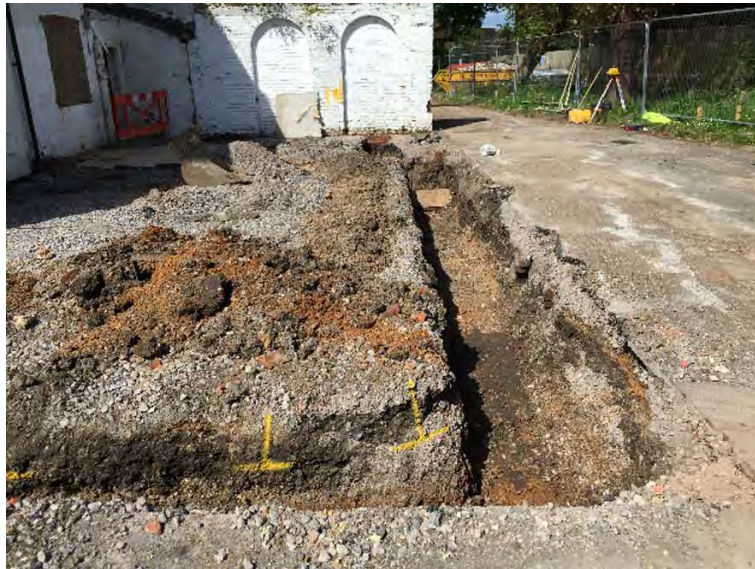
Plate 2. Foundation trenches. West view

Due to an oversight, the archaeological contractor was not informed of the commencement of excavations. This meant that there was no archaeological watching brief conducted during the excavation of the foundations to the new build extensions or related ground reductions, no observance during the excavation of the parking area to the west of the site, and no archaeological observance of any service trenches excavated up until after the archaeologist was requested to attend site on 30<sup>th</sup> August 2015.

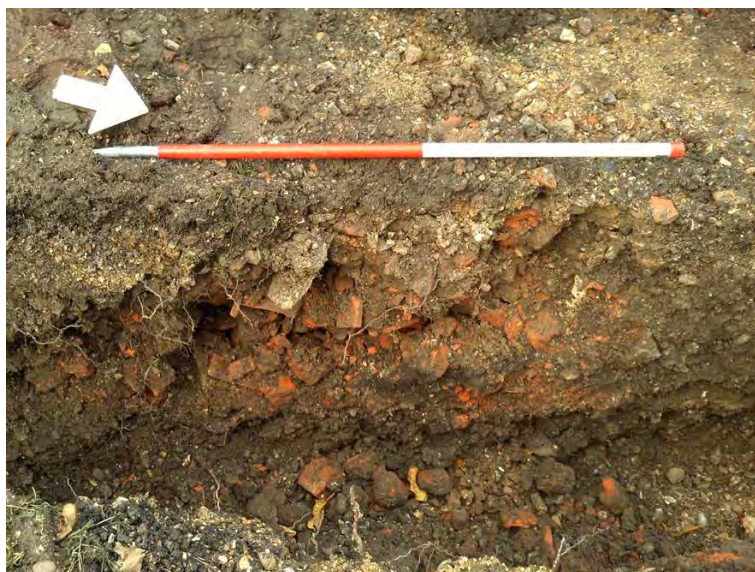
Plate 3. Section 2. WSW view

In the area of the cable trench that was excavated along the western front of the building, the lowest layer identified above the natural gravel (2) was a 0.2m to 0.3m

thick layer of very dark brown sandy loam (8). This layer may have been the same as layer (1) but it appeared to have a higher gravel content than (1). It was identified as the vestiges of a thick topsoil layer that had been buried under later made up ground. Deposited above (8) was a 0.3m thick layer of mid grey brown sandy loam (7) which contained frequent inclusions of angular flint. The layer contained fragments of brick and tile which were not retained. Cut into this layer towards the NW corner of the building was the remains of a large pit or maybe a wide ditch, cut 6 (Fig 2. Section 2; Plate 3). The pit seemed to be cut on the north side of a line of kerbing stones that defined an area previously set aside for car parking. In section the cut was 1.25m wide and 0.6m in depth. It had concave sides and was filled with fill (5) which had a very dominant inclusion of broken brick and tile. Deposited above this layer was a 0.2m to 0.4m thick layer of loose orange and yellow gravel (4). This layer may have been recently laid following the removal of tarmac in the area to create a temporary surface.

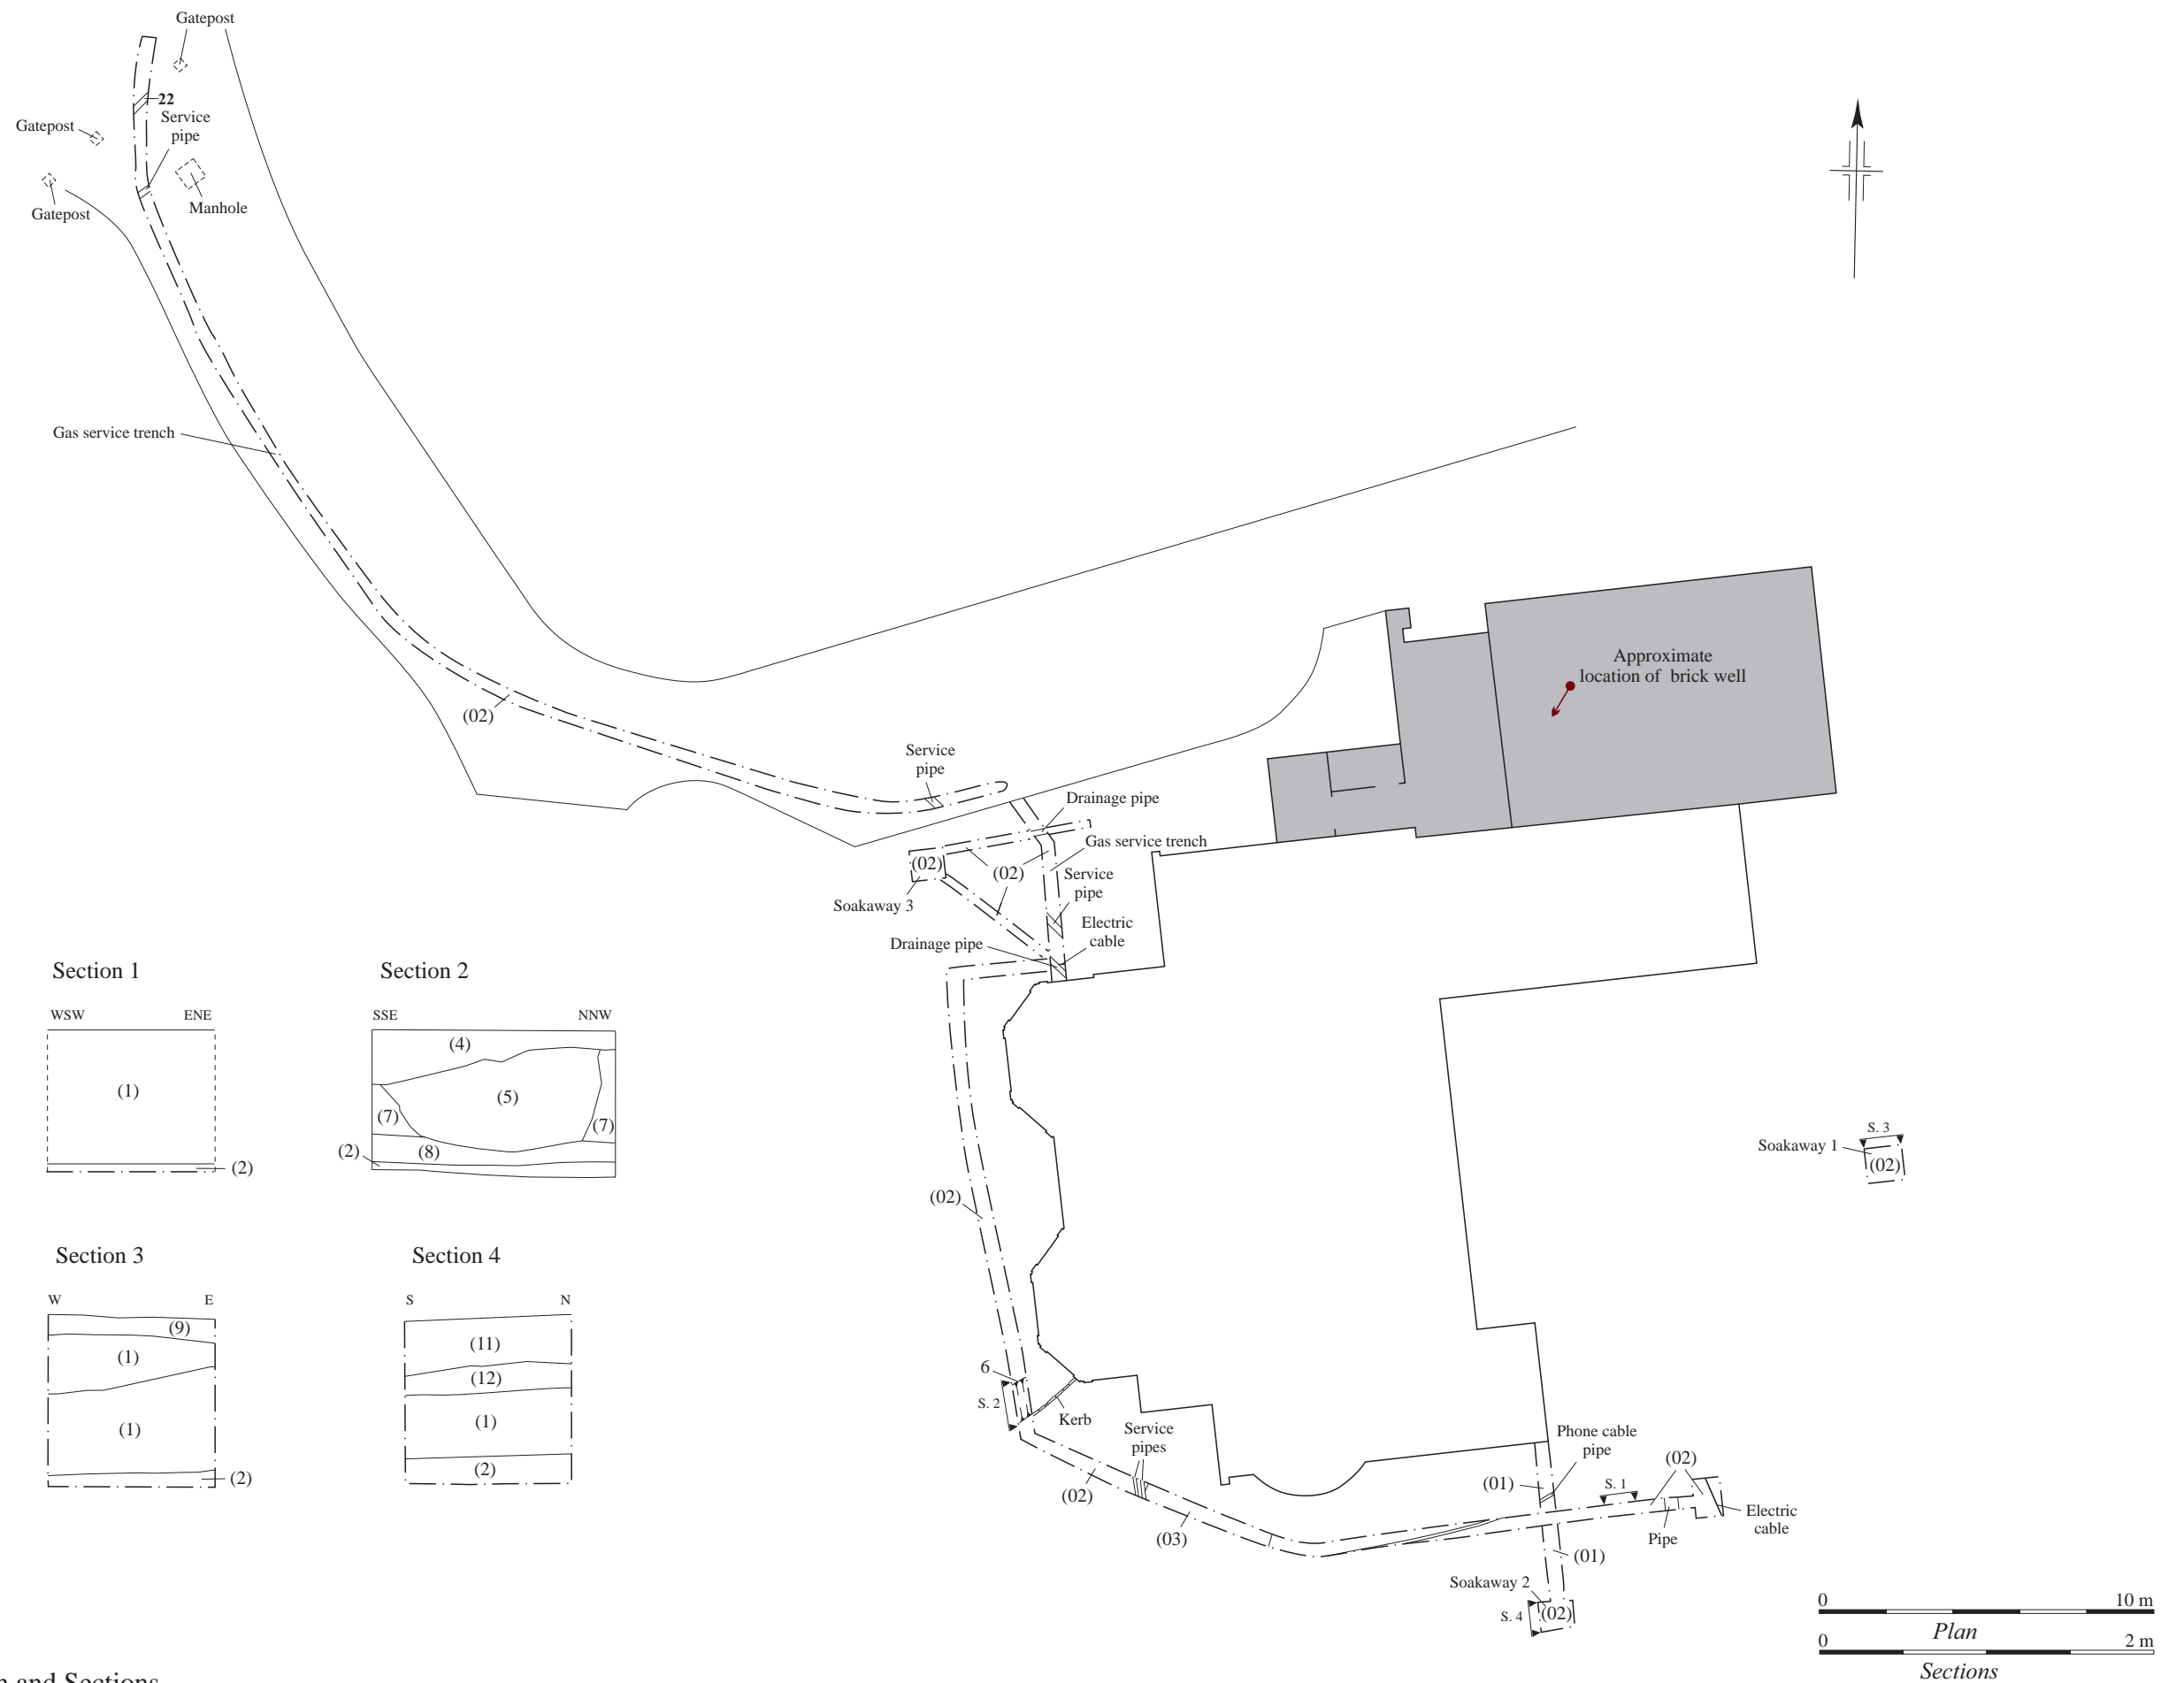
Figure 2: Site Plan and Sections

In Soakaway 1 the lowest layer identified was layer (2) the natural gravel. Deposited above this was the thick topsoil layer, (1). This layer appeared to be 0.9m thick in the south and east sections but in the north and west sections was 0.5m to 0.6m thick. In these sections layer (10), a 0.34m thick deposit of fine, light yellow gravel mixed with mid to dark brown sandy loam was deposited above (1) (Fig. 2, Section 3). Layer (10) was possibly a levelling layer and it separated layer (1) from a 0.15m thick layer of very dark brown sandy loam topsoil (9). In the south and east sections the horizon between layers (1) and (9) could not be identified visually or texturally.

In Soakaway 2, layer (1) was between 0.4m and 0.5m thick. Deposited above this was a 0.1m to 0.15m thick layer of mid brown sandy loam with a dominant inclusion of fine light yellow gravel (12) (Fig.2, Section 4). The deposit contained fragments of pottery, brick and tile, and a fragment of clay tobacco pipe stem. This layer was visible in the west section of the soakaway but extended into the adjacent sections by only 0.1m or less and was absent from the east section. It is possible that this layer was a levelling layer and may have been continuous with layer (10) observed in Soakaway 1. Deposited above this was a 0.35m of dark brown sandy loam (11). This layer could not be separated visually from layer (1) except where (1) and (11) were clearly separated by layer (12).

In Soakaway 3 on the NW side of the building the lowest layer identified was the natural gravel (2). Deposited above this was (15), a layer of soft, very dark brown sandy loam that was similar to layers (1), (8), (9) & (12) in appearance. Deposited above this was (14) a friable mid grey brown sandy loam. It contained frequent stone and brick and tile. It was 0.25m to 0.3m deep and was identified as made up ground. Above this was a thin 0.2m layer of mid grey brown, wet loamy sand which contained a dominant inclusion of gravel and brick and tile (13). This layer of overburden was identified as a disturbed layer that had been created by recent site operations.

A wall, **22**, was identified as the gas service trench was cut through the gateway. It was aligned east -west along the line of the four rectangular iron gateposts that form part of the current gateway, the wall may relate to its construction or perhaps[s an earlier gateway.
