ARCHAEOLOGICAL WATCHING BRIEF

**POND FARM BARN, CHURCH ROAD,
WANBOROUGH, SWINDON, WILTSHIRE**

APRIL 2016

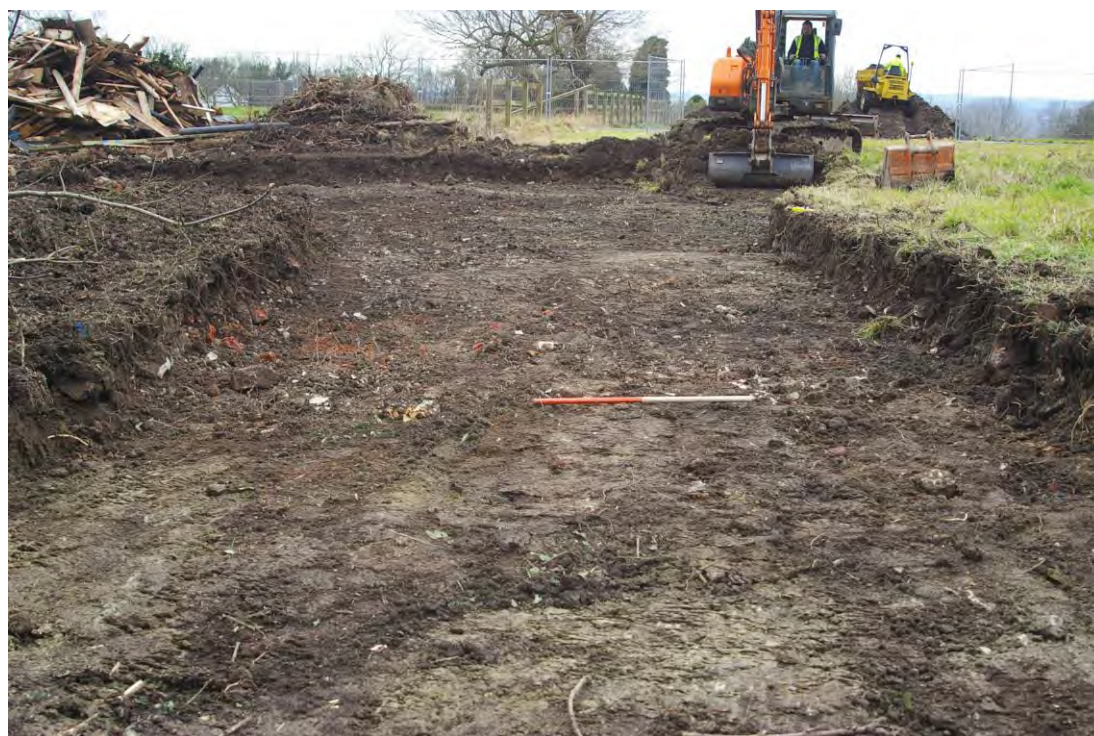
The watching brief involved the monitoring of an area for parking and access to the site that was stripped directly northwest of the barn (Fig. 2, Plate 1). This involved removing 0.4m overburden from the area; a 0.4m thick layer of a dark grey / brown silty sand (04) that was a topsoil that contained frequent amounts of demolition material. A representative sample of finds were collected that included one brick,

three sherds of pottery and tile fragments that had a 19th – 20th century date. Topsoil (04) overlay the natural greensand (02) that was heavily disturbed on the upper surface with only pockets of clean natural surviving.

Plate 1. Ground reduction of new driveway and parking area, looking northwest

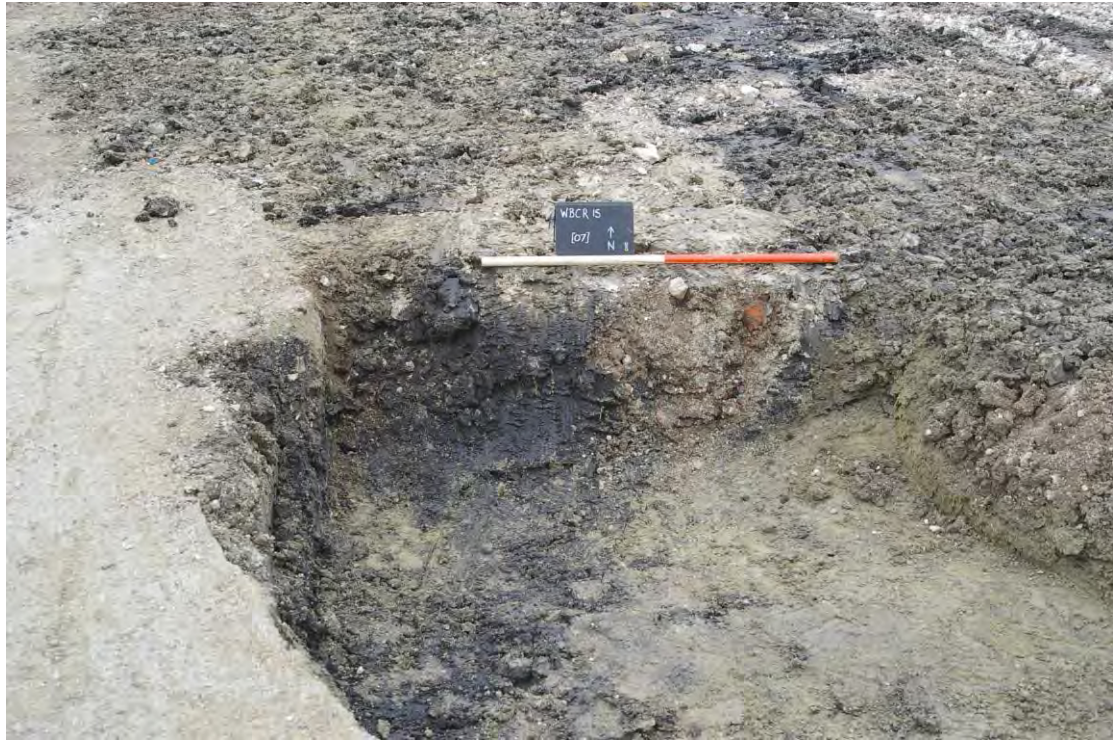
Plate 2. Linear pit 07 looking north

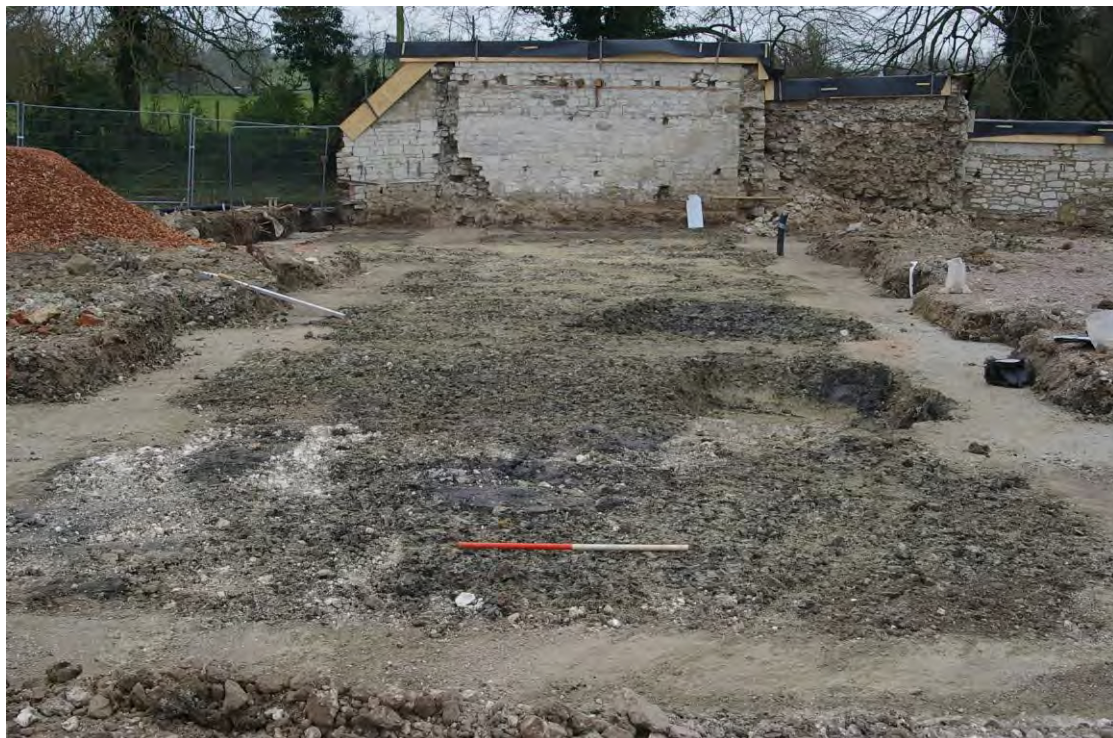
The final stage of work involved monitoring ground reduction by 0.4m within the footprint of the new foundations. This revealed a continuation of topsoil / disturbed ground (04) especially in the southeastern extent of the building and two further pockets of disturbed ground further northwest (Fig. 2, Plate 3).

Plate 3. Reduced ground within the foundations looking southeast
