A Historic Building Survey
of
REX'S SHED, MANOR FARM
HAMPSTEAD NORREYS

BERKSHIRE

August 2008

A HISTORIC BUILDING SURVEY OF REX'S SHED, MANOR FARM, HAMPSTEAD NORREYS, BERKSHIRE

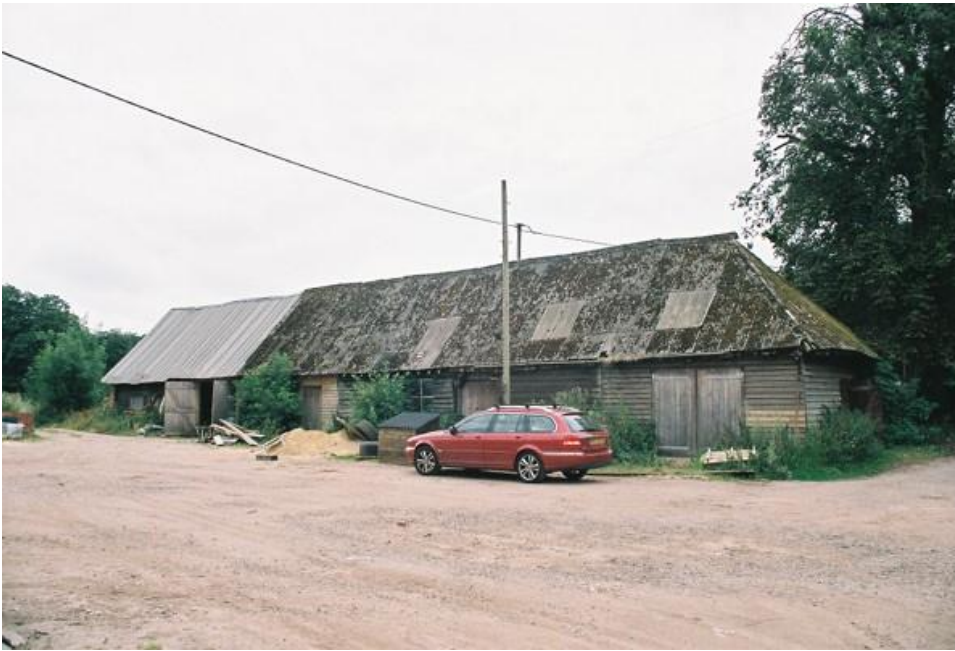
Fig 4 Rex's Shed

North-east elevation, general view

South-east elevation; extension

North-east elevation, originally open

North-west elevation showing aisle

North-east corner

The building, currently used as a workshop and store, is single-storeyed and was originally open-fronted, facing north-east into the yard. This elevation and the north-west end are clad in 20th century weatherboarding with doors and windows at intervals and most of the roof is covered with corrugated asbestos, replacing thatch; the north-west end is hipped. The two bays at the south-east end are clad in more modern corrugated steel and the gable wall at this end is brick to eaves level with openwork ventilation slats framing a central loft door above. The rear south-west wall is cut into a bank and incorporates an outshot, giving it a low eaves height. The two bays at the south-east end are brick-built and the remainder is concrete blockwork on a brick base.

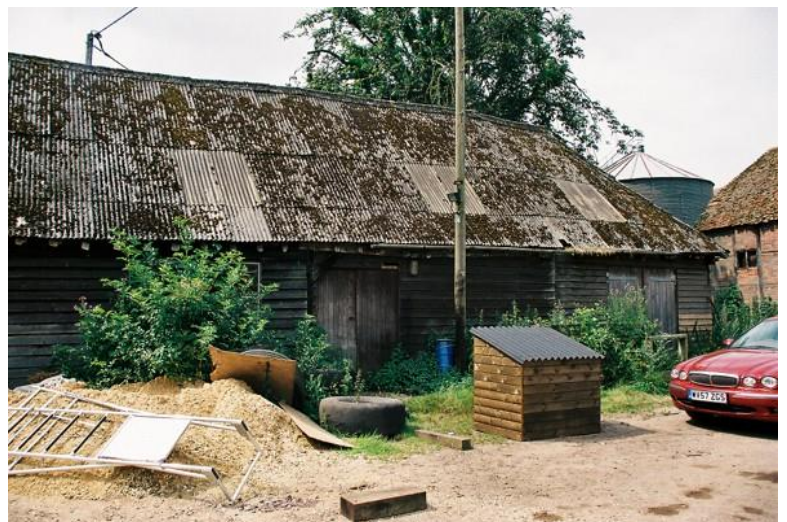
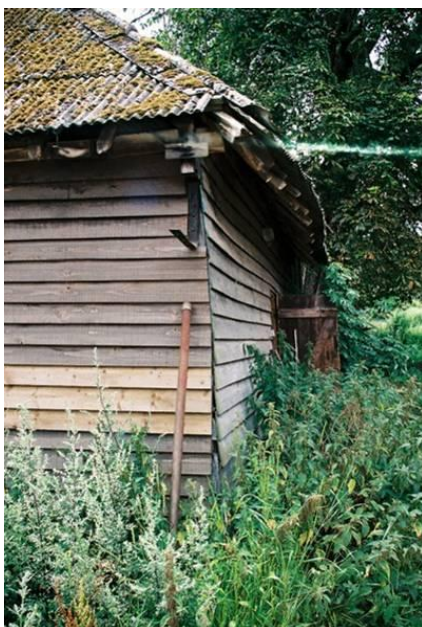
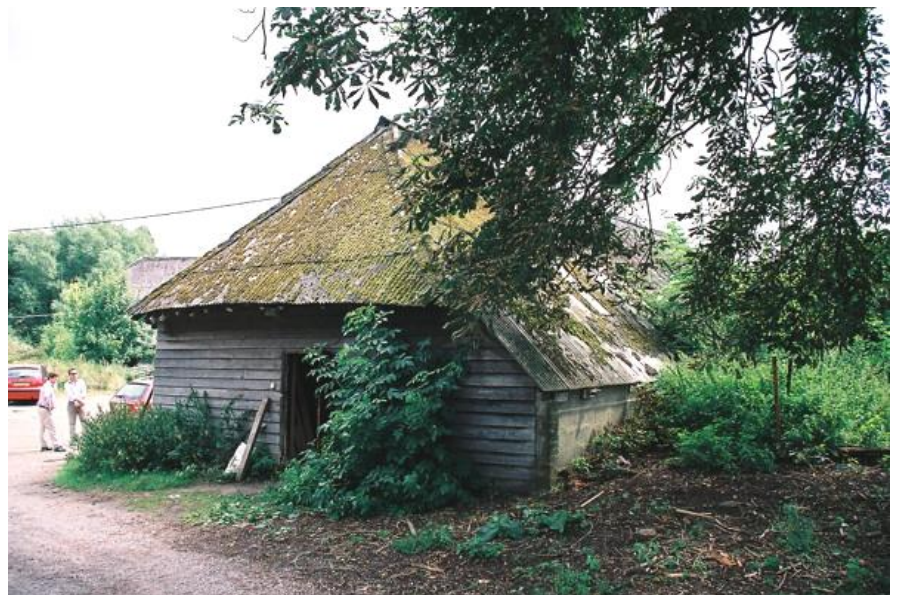
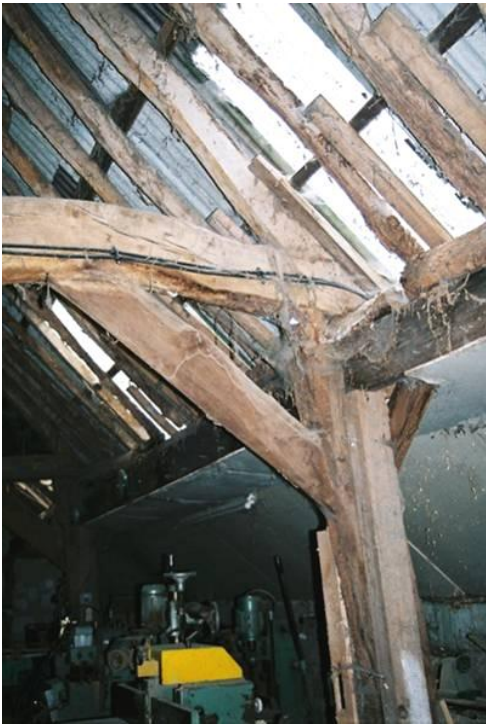
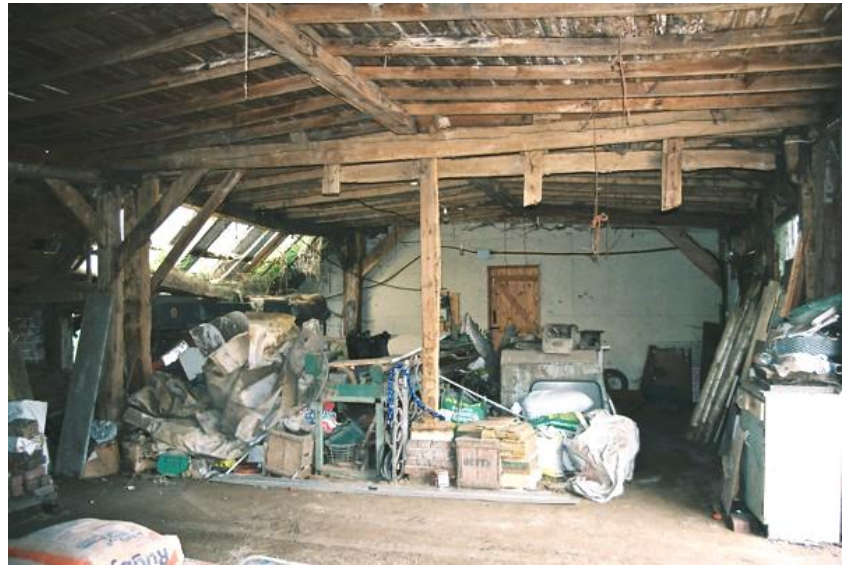
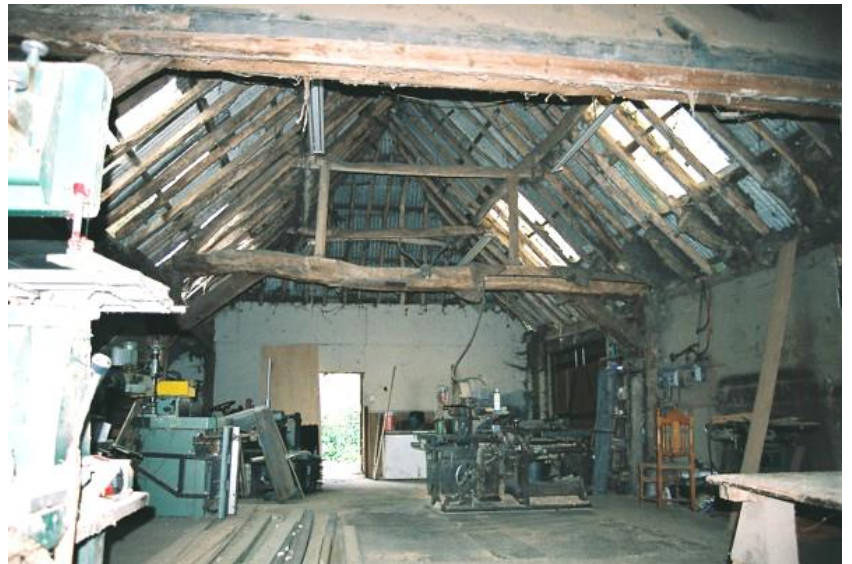
Fig 5 Rex's Shed

Jowled post detail, aisle side with reinforced wall plate

South-east end of original building, now internal with sawn-off studs and retained central post

General view looking north-west

General view looking south-east

Aisle cill beam detail

construction built of mixed oak, elm and possibly chestnut. These have posts with jowled heads carrying substantial tie beams (one markedly waney), slighter principal rafters pegged at the apex, queen struts and straight collars clasping a single tier of purlins. The posts are morticed for wall plates which pass beneath the tie beams in normal assembly and have straight three-way braces. The upper, north-west faces have an inconsistent series of chisel-cut, carpenters' marks. The front posts sit on basal blocks which appear where visible to be replacements and are linked by original wall plates, now bowed. The rear posts sit on short brick piers and form an open arcade into an original south-west aisle. They are linked to the external wall by extant cill beams and have mortices for missing aisle ties. The wall plates, which are jointed adjacent to the trusses, have failed and are underbuilt with modern replacements. The rafters, c.11 per bay, are waney split quarter-trunks and largely original but the aisle rafters are replaced.

The north-west end wall is clad in plasterboard internally and it is not clear if the frame survives although a cill beam is partially visible. The original south-east end is now internal and consists of jowled corner posts linked by a wall plate which is morticed for five studs. The stubs of four remain; the fifth in the centre has been retained and is tenoned into a short length of cill beam set on a brick plinth. The framework of the hipped roof at this end survives in the loft space above.

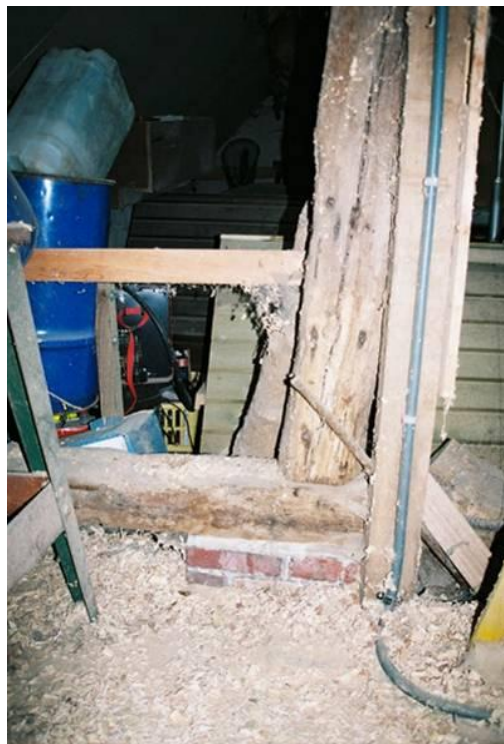
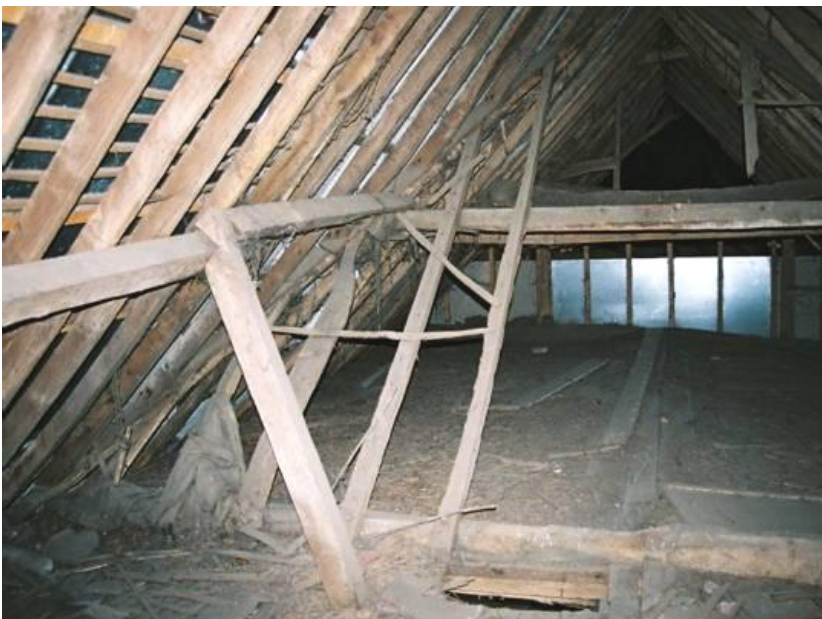
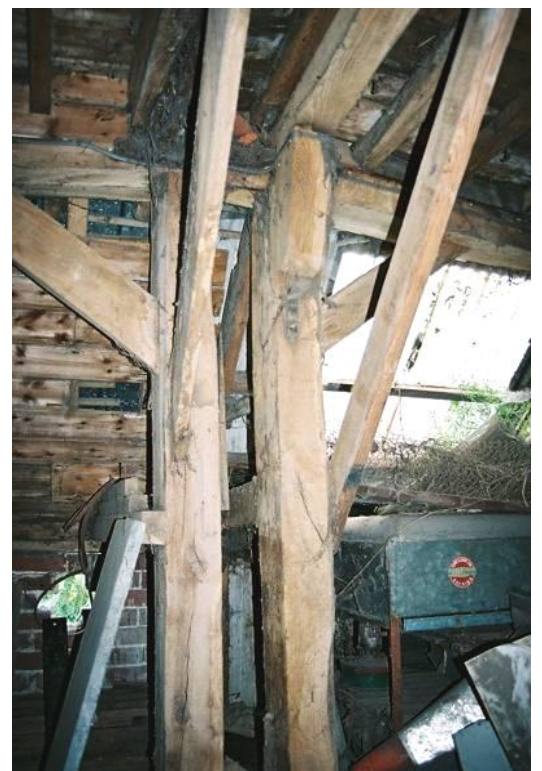
Fig 6 Rex's Shed

General view of extension looking south-east

Roof to extension

Junction of original building and extension

Framework for original hipped roof in loft space

The two bays at the south-west end are a more modern addition, also formerly open-fronted but with brick rear and end walls. There are two pairs of braced square posts carrying the wall plates, the end pair butted against the older structure and an inserted loft floor with a centre post supporting an axial ceiling beam. The loft has a machine-sawn common rafter roof with a single tier of purlins and a ridge board; this roof was formerly tiled.

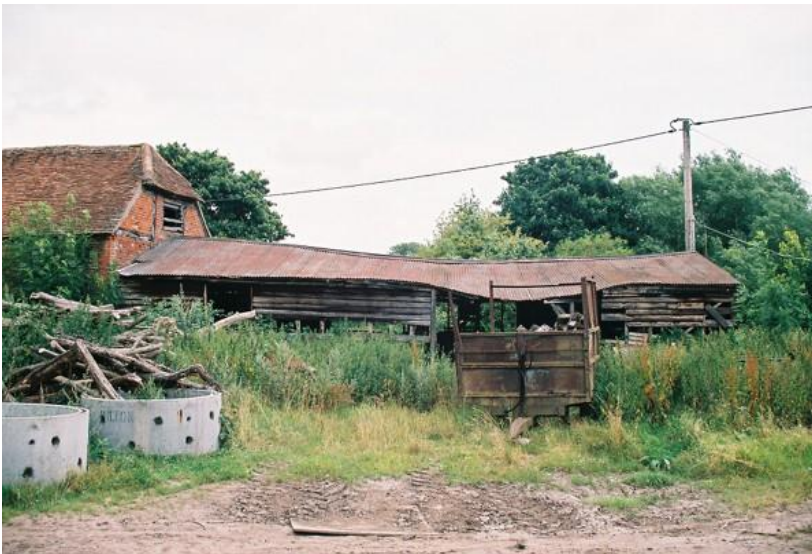
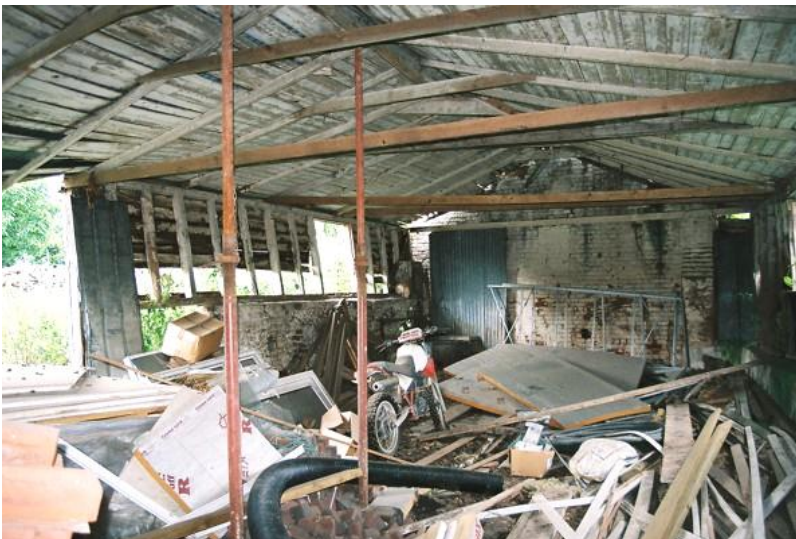
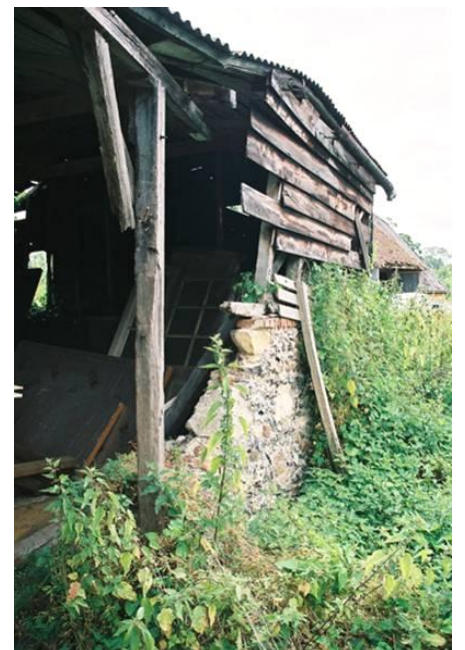
Fig 7 Outbuilding

This building is butted against the brick gable wall of the stable block and is in derelict condition. The western wall has a base of random brick and flint rubble with a studwork superstructure clad in boarding; there is a wide central doorway. The other walls are brick also with a studwork superstructure and there are feeding troughs along the eastern side. The shallow-pitched roof is formed of pairs of machine-sawn common rafters with alternate collar ties and a ridge board. A number of secondary ties have been inserted but the structure has collapsed. It is roofed with corrugated iron over boarding.

External elevations and block plan

View from the west

Interior looking north

West wall detail

- This building is an unlisted mid 19th or later structure of no intrinsic architectural interest.
- It is in a derelict structural condition and does not merit retention.
