**ARCHAEOLOGICAL WATCHING BRIEF**

**THE ELMS, 16 CASTLE STREET,  
WALLINGFORD, OXFORDSHIRE OX10 8DL**

**NOVEMBER 2019**

**JMHS Project No:**                         4072  
**OASIS No:**                                 johnmoor1-370942  
**Site Code:**                                 WACS 19  
**Archive Location:**                        The archive currently is maintained by John  
Moore Heritage Services and will be transferred  
to Oxford County Museum Service with the  
accession number OXCMS:2019.38

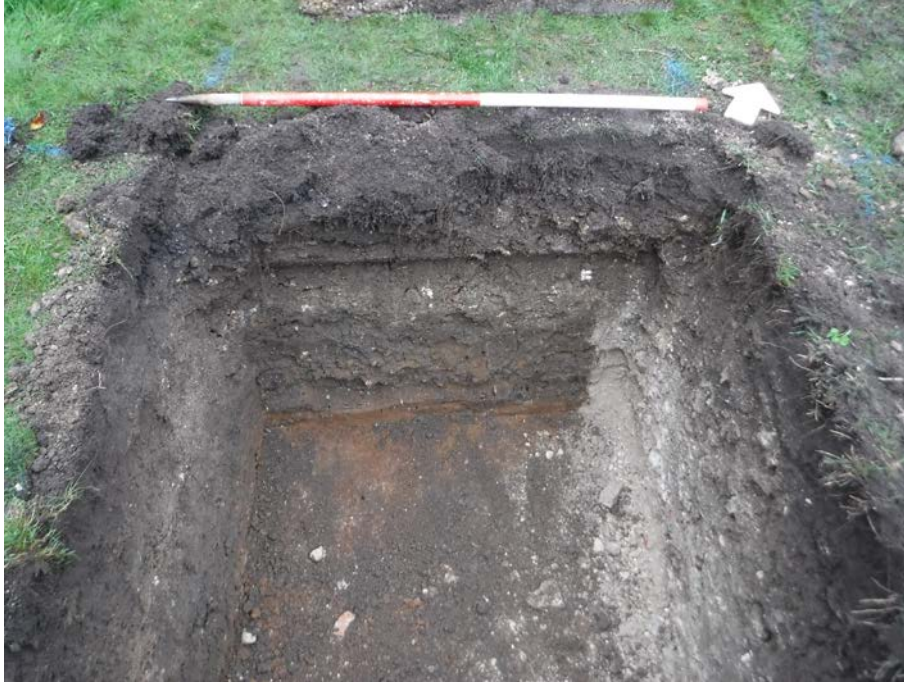
Plate 1: Section 1: Soakaway 1, looking north west.

The lowest deposit encountered was the geological horizon (06); this was present within soakaways 1 and 3. Slightly different stratigraphy was encountered within each soakaway. Within soakaway 1 (06) was overlain by a compact, mottled, dark orange/brown clay silt 0.46m in thickness, with flecks of charcoal and chalk, sub-rounded flint and small fragments of brick and/or ceramic tile inclusions (05). This deposit was interpreted as a heavily bioturbated subsoil. Cutting (05) was an

indeterminate feature in both form and function. The west edge of cut 03, ran diagonally across soakaway 1, this had a sharp break of slope and vertical sides. The base was not reached within the limits of the soakaway. This straight-sided feature had dimensions, within the soakaway of 1.6m long, 0.9m wide and 0.54m deep. A single fill was observed; this was a loose, mid grey white crushed chalk, with small fragments of brick and/or ceramic tile and larger chalk inclusions (04). Above (04), was an occupational, or ground levelling deposit (02), a compact, mid brown grey sandy silt, 0.24m in thickness, with occasional chalk flecks and small fragments of brick and/or ceramic tile inclusions.

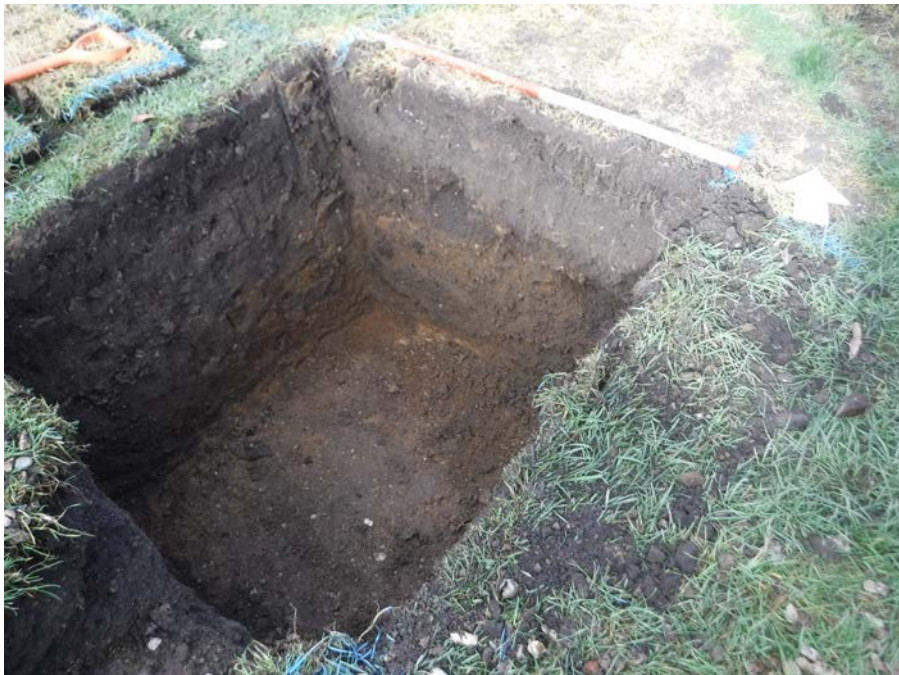
Plate 2: Section 3: Soakaway 3, looking north.

Soakaway 3 had the same basic stratigraphy as soakaway 1, with the exception of feature 03, which is not present in soakaway 3.

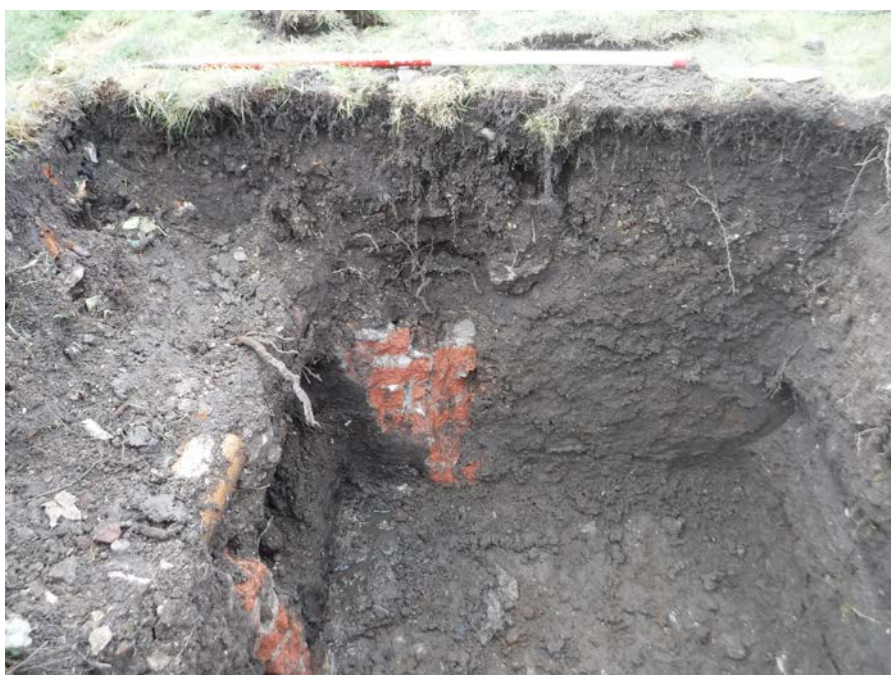
Plate 3: Section 2: Soakaway 2, looking west.

The lowest deposit encountered within soakaway 2 was (08), a loose, mid brown grey, clay silt, 0.66m in thickness with rooting and c.10% brick inclusions. This deposit was interpreted as made ground, and may have been associated with the manhole seen in S.2. Above (08), was a demolition, or ground levelling deposit, associated with the demolition and disuse of the wall to the west of the soakaway and the manhole found within it. Deposit (07) was a loose, mid grey brown clay silt, 0.28m in thickness with c.40% gravel and occasional brick inclusions. Overlaying deposits (02), and (07), was deposit (01), which was present across site, this was a garden soil 0.3m thick.

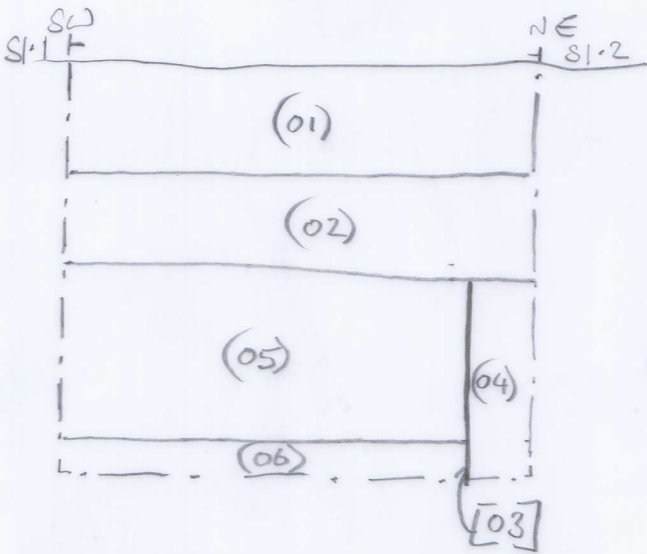
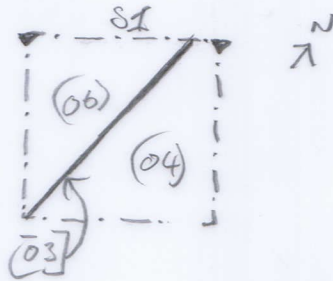
P.1 SOAKAWAY 1  
1:50 | 0.5m

S.1 SE.F.S. OF SOAKAWAY
