JOHN MOORE HERITAGE SERVICES

ARCHAEOLOGICAL WATCHING BRIEF

CHALLIS FARM, HIGH STREET,

LONG WITTENHAM, OXFORDSHIRE OX14 4QH

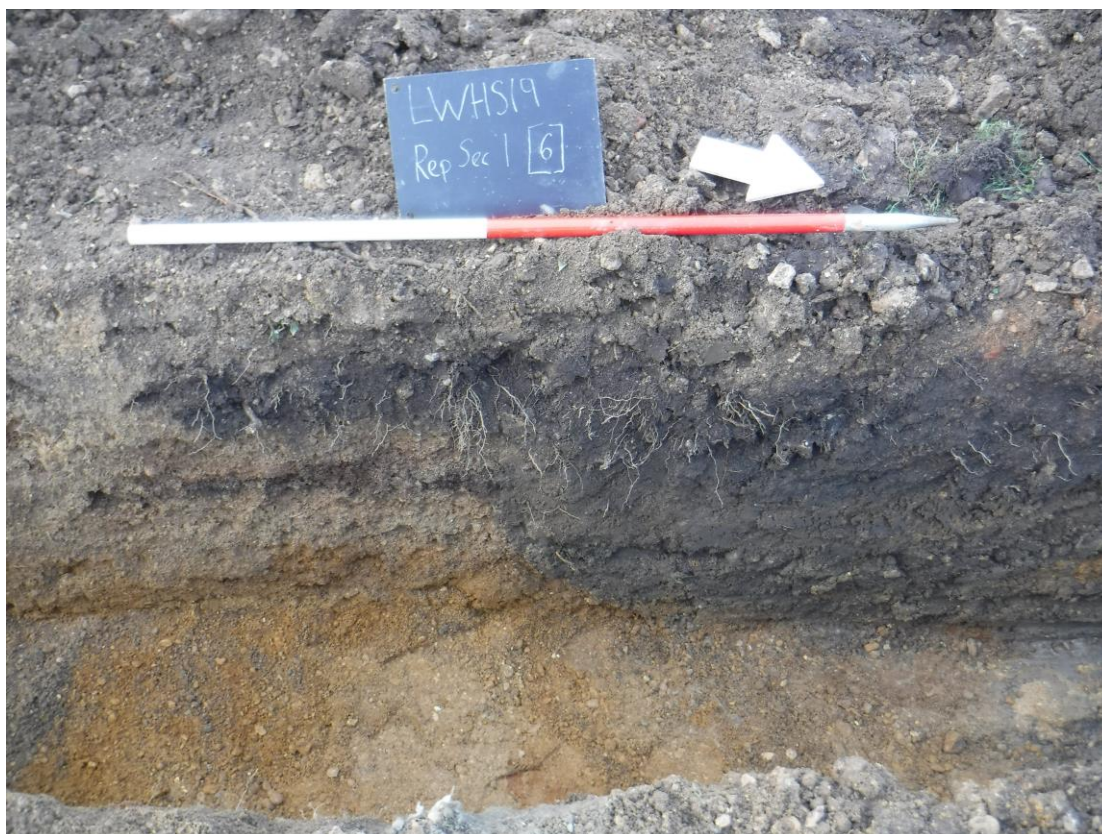
Plate 1. Section 1. Facing west-south-west.

Overlying deposit (5) was a layer of redeposited material, which was comprised of friable, light grey sand gravels (4). This deposit had a slim, 50mm thick band of dark brown silty sand material going through it (Figure 2; Plate 1). This deposit had a maximum thickness of 0.77m at a maximum depth of 1.02m (Figure 2; Plate 2). This material was observed throughout the full extent of the foundation footings, and in the north/north-west and east/north-east extents, this deposit was observed in the base of the footings.

A deposit of friable, dark grey-brown sandy silt (3) was overlying deposit (4). It contained inclusions of infrequent small rounded stones, as well as infrequent rooting. It had a thickness of 0.15m, at a depth of 0.40m. It was observed in the west/south-west extent of the excavated footings, and not observed elsewhere. This deposit has been identified as a redeposited layer, during a period of deposition around the same time as the modern pit feature 6 was created.

Cutting into deposit (3) was a 19th century pit feature 6. This pit was observed in the west/south-west area of the excavated footings (Plate 1). It measured 1.93m in width, and was greater than 0.60m in length, as it extended beyond the limits of the trench. The depth of this pit feature extended beyond 0.64m, and the base was not fully exposed, as it was below the level of impact. The pit was observed to have had rounded edges, and a semi-circular shape in plan (Figure 2). The break of slope at the top was sharp, and near vertical, with steep sides at both edges.
