**ARCHAEOLOGICAL WATCHING BRIEF**

**ROBINSWOOD HILL COUNTRY PARK,**

**GLOUCESTER,**

**DECEMBER 2019**

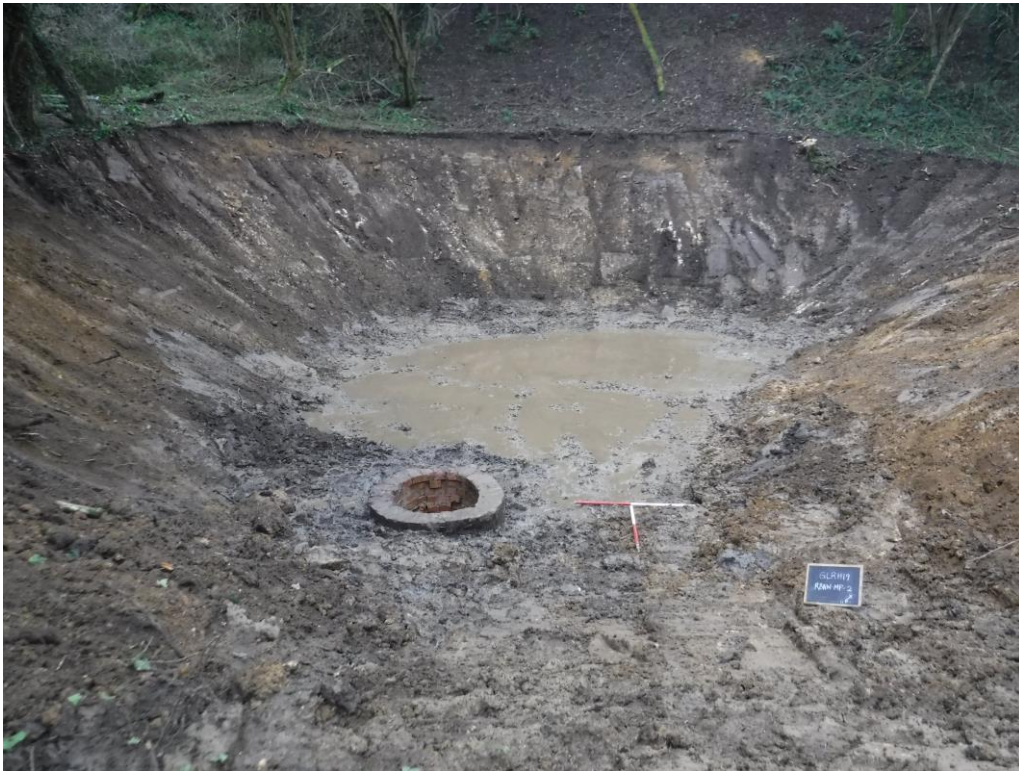
In this area, the lowest stratigraphic deposit exposed was a friable mid brownish orange silty clay superficial geological layer, with large cobble and boulder inclusions (05). Cut into this natural layer was circular construction cut 07, approximately 1.36m in diameter and 3m deep, which housed *in situ* well **06** (Plate 2); a redbrick and mortar cylindrical structure, with header brick bonding for the top nine layers (~0.63m), and stretcher brick bonding for the bottom ~2.36m. The outer diameter of the well is 1.16m, and the inner diameter is 0.74m. A wooden well cover with metal reinforcements lay over the opening, and this measured 1.2m in diameter (Plate 3). Following the groundworks, it was placed back over the well and covered over with spoil. The well does not appear on historic maps, but can be dated to the 19<sup>th</sup> century by its bricks (see section 5.1).

Stratified above layer (05) and well **06** was the naturally-accumulated silting fill in the base of Pond 2, a compact dark brown clayey silt about 15m x 9m in size (04). The fill contained post-medieval and modern refuse, including glass, metal, and plastic; a representative sample was collected (see section 5.2).

The uppermost layer was a mid brown silt topsoil with an unsurprising high concentration of roots and other organic material (08). The topsoil covers much of Robinswood Hill, but was not seen within the ponds. It was therefore only excavated in small amounts where necessary, around the top edges of the ponds, and in the access area of Pond 2.

Plate 1. The Completed Groundworks of Pond 2 (RBNW-MP-2).

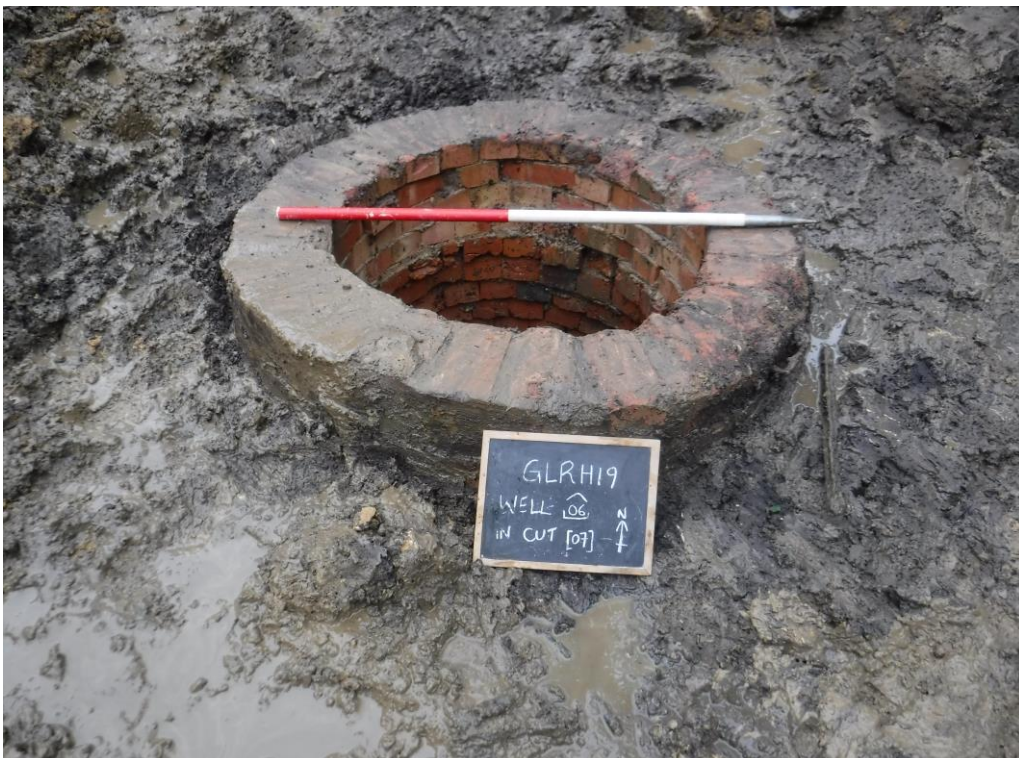
Plate 2. Well 06 in Construction Cut 07.

A sample of the materials used in the construction of well **06**, comprising two complete bricks and one additional fragment of ceramic building material, were collected for analysis.

One of the examples was a frogged brick, weighing 4400g and measuring 230x110x80mm, and made of a sandy, orange-pink fabric with very rare small inclusions. The second brick, of a dark red fabric with frequent small inclusions, weighed 3618g and measured 230x110x70mm. Both objects preserved traces of mortar. The dimensions and the general aspect of the bricks indicate a 19<sup>th</sup> century dating.

The earliest indication of anthropogenic activity was seen within Pond 2, represented by construction cut 07 and the in-situ well 06 and well cover, which the bricks date to the post-medieval period. The only other activity was evidenced by the horseshoe, glass, and other refuse within fill (04), which indicates accidental and deliberate littering from the post-medieval and modern periods.

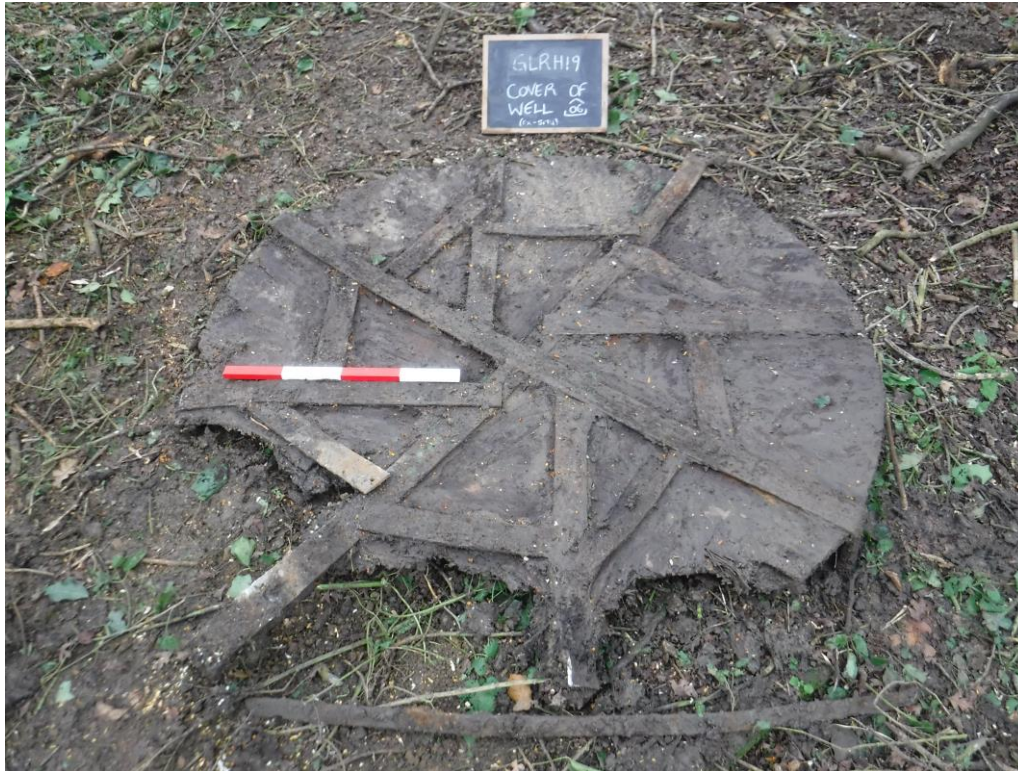
Plate 3. Cover of Well 06.

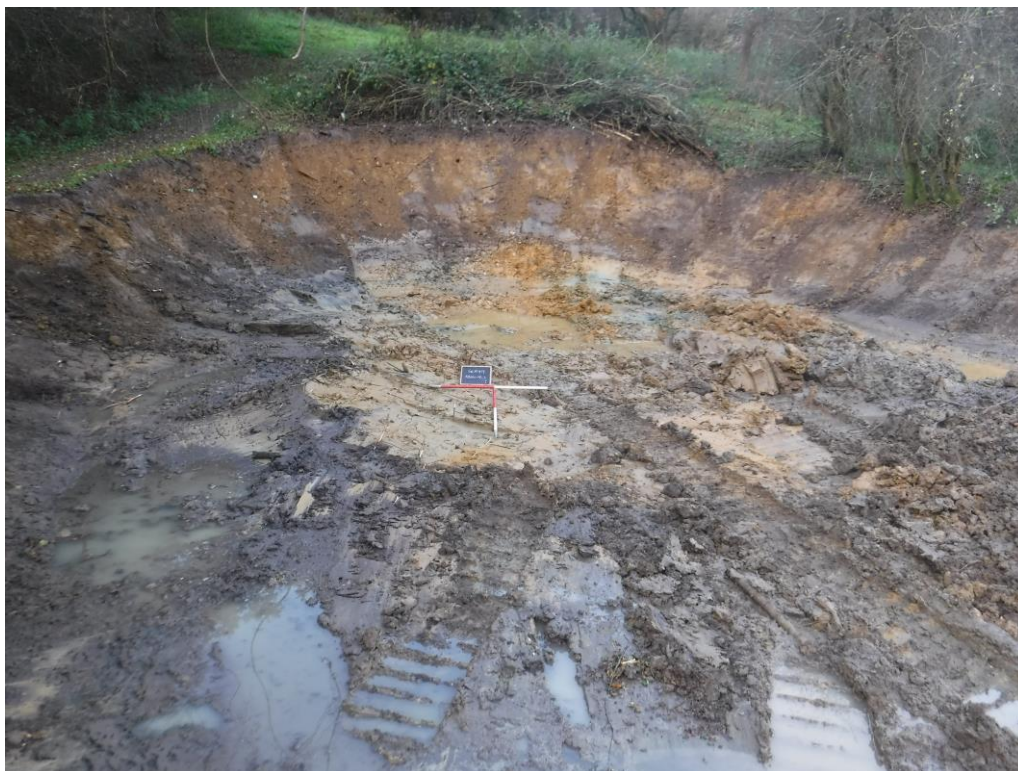
No features or finds of archaeological interest were discovered during this stage of work. The lowest deposit encountered was a natural geological clay layer with frequent medium and large cobble inclusions, which were well sorted towards the base of the pond (03). The clay was mid blueish yellow in colour, with infrequent irregular patches of dark greenish blue sandy clay. Stratified above this was a friable mid yellowish orange silty clay of approximately 0.15m thickness (02), which was a naturally-accumulated silting basal fill of Pond 3. This was overlain by the top pond fill (01), a compact mid to dark brown clayey silt about 0.2m thick, containing bricks, glass, and fencing, which was clearly recent modern refuse. It was very similar to fill (04) in Pond 2.

Again, topsoil (08) was present as the stratigraphically highest layer outside of Pond 3.

Plate 4. The Completed Groundworks of Pond 3 (RBNW-MP-3).
