JOHN MOORE HERITAGE SERVICES

ARCHAEOLOGICAL WATCHING BRIEF

TITHE BARN COTTAGE,

TEMPLE LANE, BISHAM, BERKSHIRE

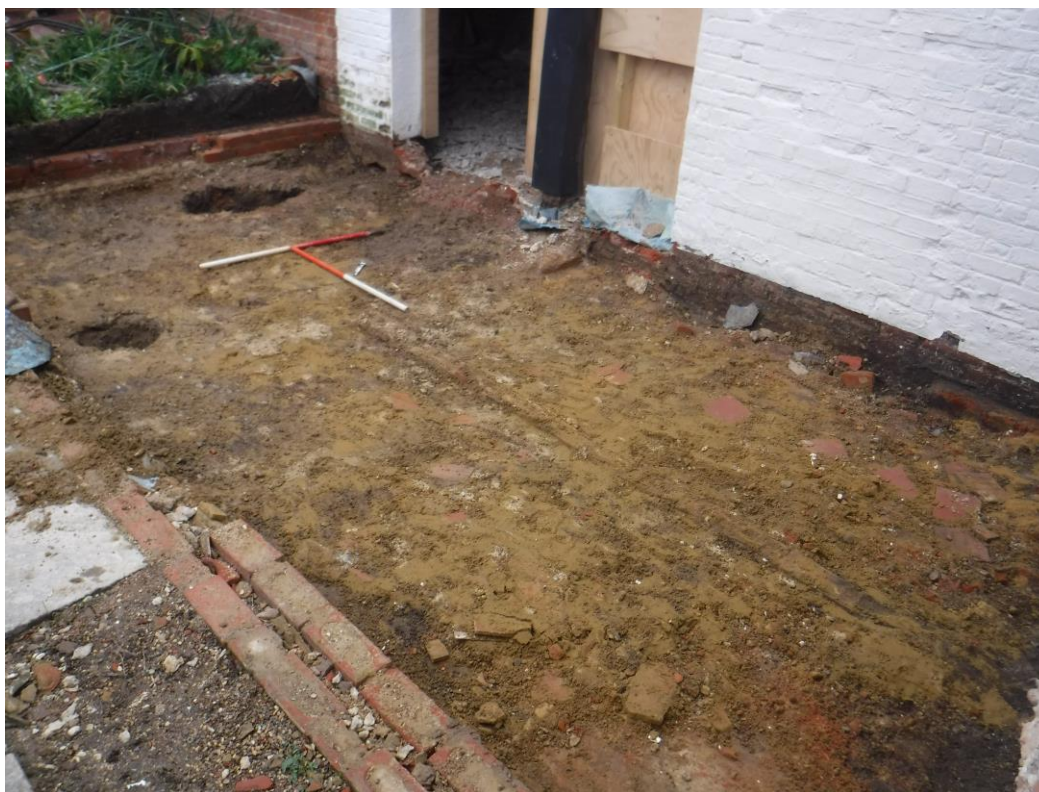
Plate 1: General Shot of Area 1 looking north

The earliest deposits encountered within Area 1 were a firm mid-dark greyish brown sandy loam >0.3m thickness at a height of 29.04m AOD (1014), and a friable mid – dark greyish brown, silty clay with no inclusions at a height of 28.91m AOD (1005). Both contexts were identified as layers of made ground; it was thought likely that both contexts were associated with the same levelling action, and butt against each other. Both of these deposits were covered by another layer of modern made ground (1013). This consisted of a loose, orange sand with frequent inclusions of modern ceramic building material, hereafter referred to as CBM and had a direct stratigraphic relationship with four contexts; 1012, 1011, (1009), and (1003). Two of these were modern construction cuts; 1012, and 1011, both of which were rectangular in plan, with vertically sloping sides, sharp breaks of slope at both the top and base of the feature, and a flat base. Both contexts were associated with the construction the walls; construction cut 1012 with wall **1004**, and construction cut 1011 with wall **1010**. Wall **1010** was composed of frogged red brick with 2-3 courses of stretcher bond, running north-south in the central part of Area 1. This wall was packed with a large deposit of mortar on at the eastern extent of the wall. Wall **1004** was almost identical in make-up, being composed of frogged red-brick with 2 to 3 courses in a stretcher bond pattern. It does however differ from wall **1010** in its orientation, running east-west, as well as surviving more than a metre longer than wall **1010**. These walls butted against each other at a 90° angle, and likely formed part of a small out-house structure formerly attached to the cottage.

The last context with a direct stratigraphic relationship with the layer of made ground, (1013), was another probable levelling layer, (1009) which is thought to be the same as context (1001). This context was composed of a loose, light greyish yellow, fine sand with no visible inclusions, and had a thickness of c. 0.05m (29.17m AOD).

Cutting into both context (1009) and (1001) was 1006. This was found to be a construction cut associated with the laying of modern services; as such it was typical of other modern service cuts being linear with vertically sloping sides, sharp breaks of slope at the top and base of the feature and a generally flat base. This cut was filled by deposit (1007), a friable, mid-greyish brown, silty clay with occasional sub-rounded inclusions. Deposit (1007) was found to contain modern services, somewhat confirming the earlier assessment of 1006 as being a cut associated with modern services.

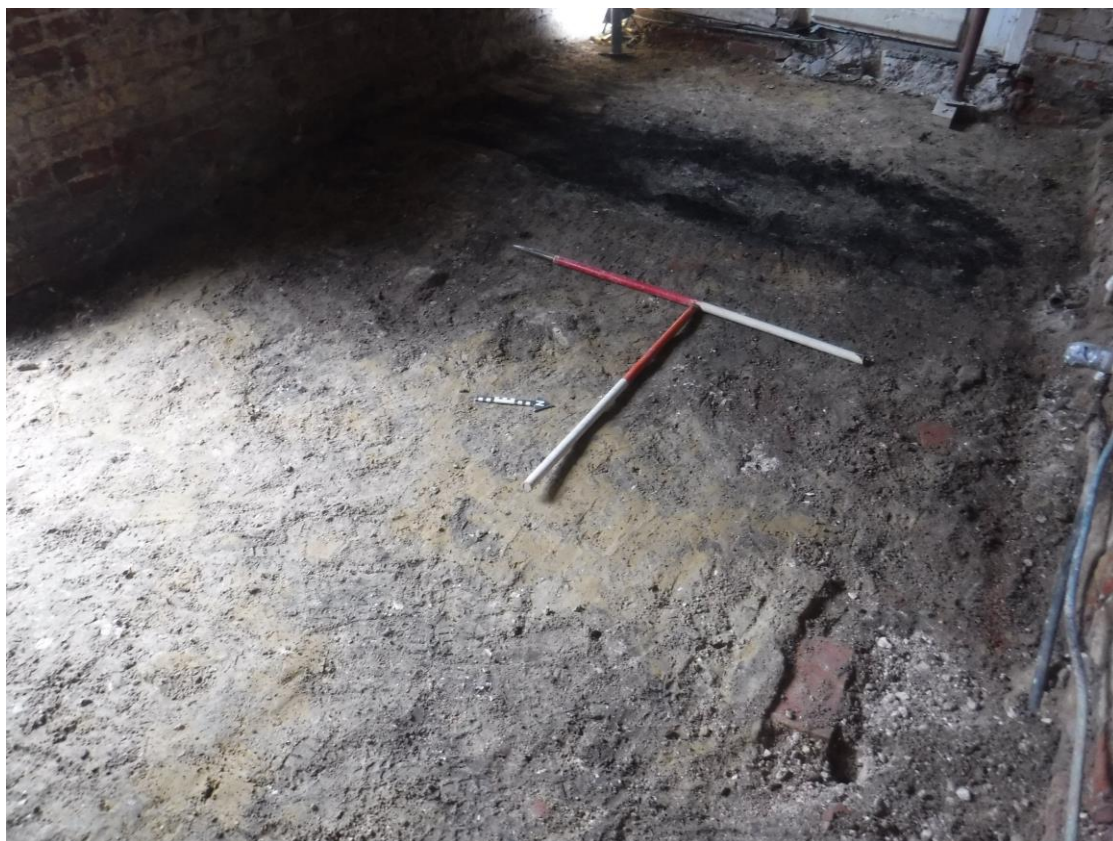
Plate 2: General Shot of Area 2 looking west

The earliest deposit encountered within Area 2 was a layer of modern made-ground (2014) at a height of 29.03m AOD. This layer was a friable, mid greyish brown, gritty sandy loam with frequent small angular stone inclusions and CBM flecking. The deposit was cut by a moderately small linear feature 2013, running east-west across the middle of Area 2. This cut was approximately 2.6m long and c. 0.1m deep and was associated with the construction of context **2012**, a dividing wall. The dividing wall **2012** was constructed of frogged red brick (measuring 110mm x 236mm x 57mm) and light point mortar, standing 1-2 courses high in a stretcher bond formation. Although the brick material was clearly modern, the fact that this wall was completely covered by a layer of made ground, (2011), indicates that it had been demolished some time ago.

Context (2011) was a layer of made ground which both sealed the dividing wall and covered the majority of Area 2. It was found to be composed of a friable mid brown, gritty sandy loam, and had frequent small, angular, stone inclusions. This layer is cut by a small linear feature running southwest-northeast across the northwest part of site, 2010. This feature was associated with the cut of modern foundations for context **2009**; as such its shape was typical to other modern construction cuts, having very steeply sloping, regular sides, with sharp breaks of slope at the top and base of the feature and a flat base. It was filled by a concrete foundation, **2009**, which were light brownish grey and included the occasional flint and CBM inclusions. The concrete foundation **2009**, had a direct stratigraphic relationship with three contexts; (2004), (2005), and (2008). Although these three contexts have been attributed different contexts numbers, it is likely that all of these contexts refer to the same event and are

made up of the same material. The main reasons for believing this is the fact that they have all been described identically as friable-compact, mid-yellowish brown, silty clay with moderate amounts of modern refuse inclusions, and they have all been recorded at a similar height (29.09-29.13m AOD). All of these layers are thought to be modern demolition layers, judging by the consistency of modern refuse inclusions. Directly above layers (2005) and (2008) was structure **2006**. This structure was thought to be the remains of a coal store as a large amount of very dark ashy soil was found within the structure, (2007). Structure **2006**, was constructed with unforged red bricks, measuring 106mm by 160mm by 56mm. The remains of the structure were one course tall and arranged in a stretcher bond. Context **2006** was found to have a shape similar to a single square bracket, '[', though it was likely to be rectangular prior to its deconstruction. Context (2007) was found within the confines of structure **2006**. This deposit was composed of a friable, dark blackish brown, sandy, ashy silt with no inclusions. This deposit is believed to be related to the use of structure **2006**, and may be associated with the storage of coal.

Demolition layers (2004) and (2005) were both covered by layer (2003). This context was a friable, light greyish yellow, fine sand. This may have been a levelling layer associated with the latest modern floor layer. It is cut by 2002, which might be associated with a currently demolished structure. Cut 2002 was an irregular sub-rounded feature, which was very shallow in nature (0.05m). The cut was filled by a single deposit, (2001), a loose mid-greyish brown, clayey silt with moderate amount of CBM, mortar, and modern refuse inclusions. All of the contexts were covered by a thick layer of concrete, associated with the foundations of the latest modern floor level.

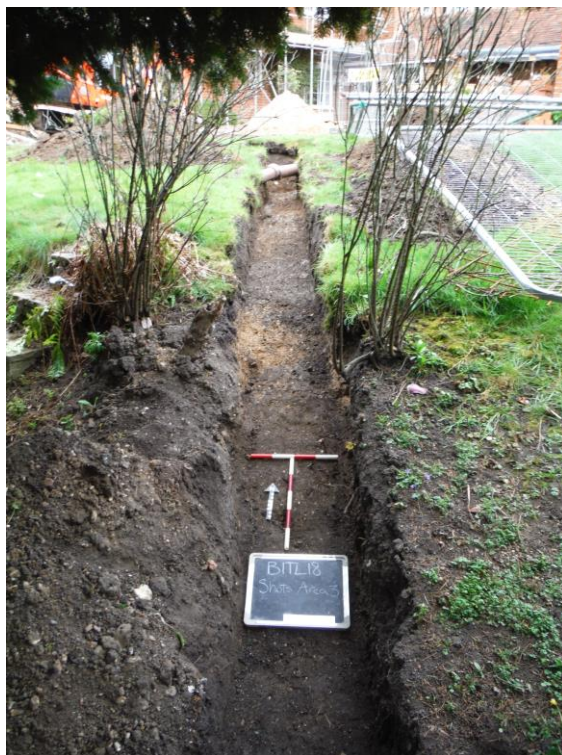
Plate 3: Shot of Area 3 looking north

The earliest deposits found within the confines of Area 3 were layers (3003) and (3007). While both of these deposits were subsoils, possibly associated with the landscaping of the current garden space, they had slightly different composition. Context (3003) was a friable, mid yellowish brown silty clay with occasional chalk flecking, while layer (3007) was a friable, mid-greyish brown silty clay with moderate amounts of small sub-angular stone inclusions. These layers were cut by context 3004. This context was not excavated, and was only minimally exposed by Area 3, and not much was discovered about this feature, though due to its position in the middle of Area 3, it seemed likely that it was associated with the creation of modern garden steps, located in close proximity to this part of Area 3. The context was filled by two visible deposits; (3005), and (3006). The earlier of these two deposits was context (3006), a loose light greyish yellow gravelly sand with frequent amounts of small sub-angular stone inclusions, again possibly associated with the construction of the garden steps mentioned above. Context (3006) was partially overlain by deposit (3005), a friable mid yellowish brown mixed with dark-mid greyish brown silty clay with moderate amounts of charcoal flecking and moderate amounts of small sub-angular stones. This deposit is likely associated with a deliberate backfill of cut 3004, linked to modern landscaping of the garden area.

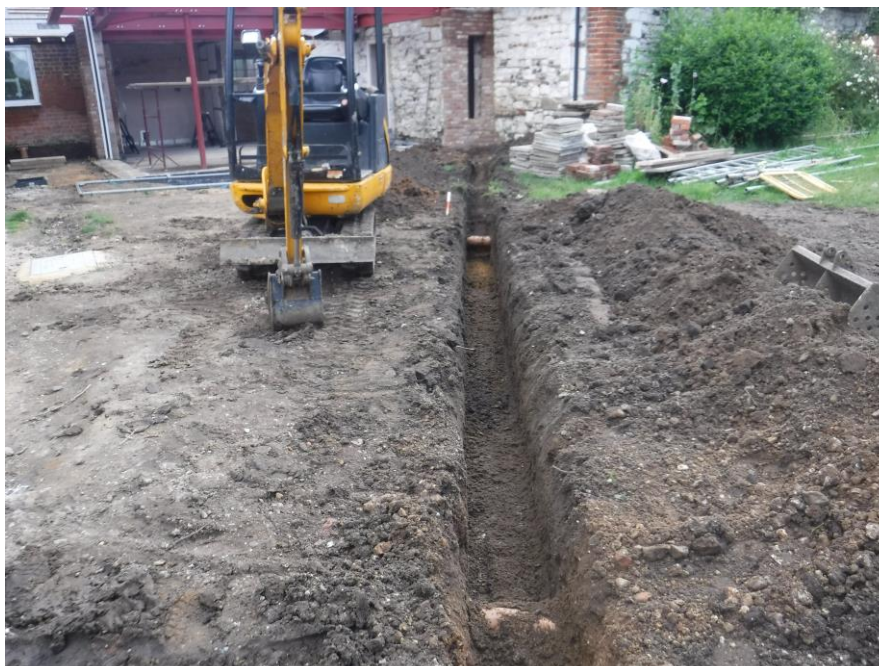
Plate 5: Shot of Area 5 looking east

There were only two deposits found within Area 5; (5001) and (5002). The earliest of these deposits was (5002). This context is likely associated with garden landscaping and probably dates to the modern or late post-medieval period. This context was composed of a friable mid yellowish brown silty clay with moderate amounts of small sub-angular stone and occasional chalk inclusions. Layer (5001) entirely covered this context, and spanned the entirety of Area 5 and beyond. This context was a layer of topsoil associated with the current use of the garden; the deposit was composed of a friable, mid-dark greyish brown clayey silt with moderate amounts of small sub-angular stone inclusions.

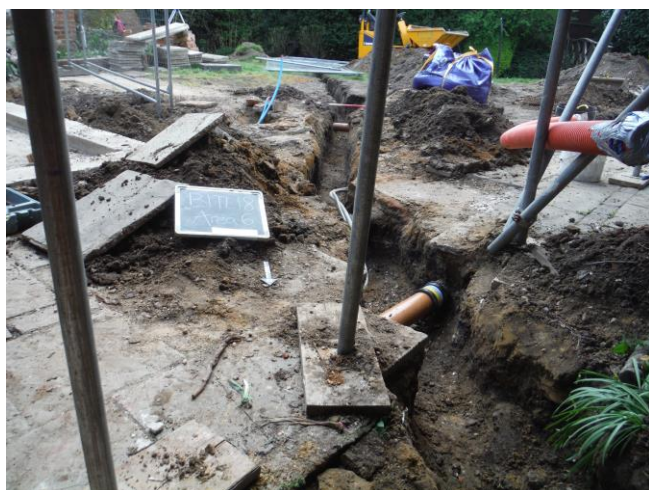
Plate 6: Shot of Area 6 looking south

The earliest deposit identified within Area 6 was a layer of sub-soil (6005). This sub-soil was composed of a friable, mid greyish brown silty clay, with moderate amounts of small sub-angular stones and occasional chalk inclusions. It was cut by the construction cut for the modern

paved area, 6008. Construction cut, 6008, was shaped fairly typically for many modern construction cuts, having vertically sloping regular sides with sharp breaks of slope at the top and base of the feature, and a flat base. The construction cut was filled by three contexts; (6003), (6004), and **6007**. The first of these contexts was deposit (6004), a friable, mid greyish brown silty clay with moderate amounts of small chalk inclusions - this was likely to be a levelling layer associated with the paved surface above. The same can be said of the layer directly above it, (6003), a loose light greyish yellow sand. Lying immediately above this was the current paved surface, **6007**, which was constructed using large grey paving slabs separated by lines of grey bricks arranged in a basket weave bond.

Cutting into the paved surface was the construction cut for a flower bed, 6002, created some time after the paved surface, **6007**. This cut was rectangular in shape with vertically sloping, regular sides with sharp breaks of slope at the top and base of the feature. It was filled by garden soil, (6001) associated with the current use of the ground, i.e. a flower bed. Deposit (6001) was composed of a friable-loose, dark

The remaining context discovered within Area 6 was layer (6006), which is a layer of topsoil. This layer covers subsoil (6005), and butts against the paved surface, **6007**, as well as its associated levelling layers. This layer of topsoil is a friable, mid-dark greyish brown, clayey silt with moderate amounts of small sub-angular stone inclusions.

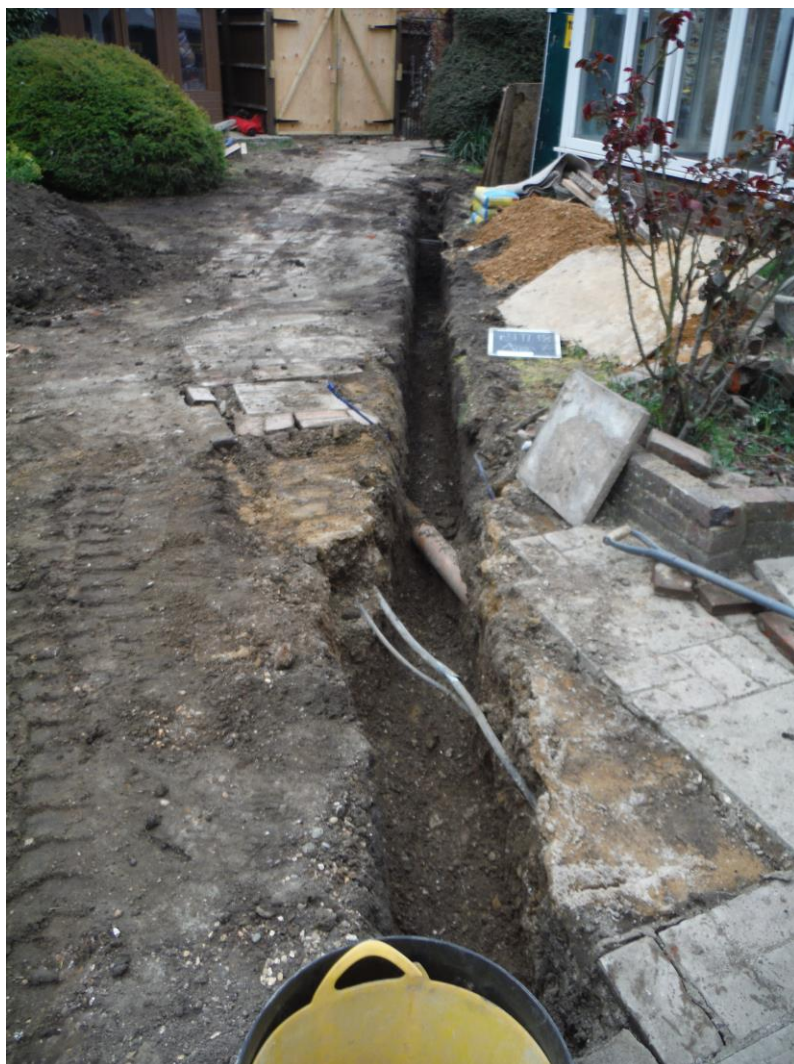
Plate 8: General shot of Area 7 looking southwest

The earliest deposit found within Area 7 was a layer of modern made-ground, (7002). This layer was composed of a friable mid yellowish brown, silty clay with moderate amounts of small sub-angular stone inclusions. It was probably a levelling layer associated with the construction of the paved surface located above this context, or the pool house adjacent to it. This context has a direct stratigraphic link to four contexts; 7003, 7006, 7007, and 7008, all of which are cuts associated with pipelines and other services. While all of these contexts are technically next in the stratigraphic sequence of the site the fills of

The other three service cuts were filled with a single context as well as a modern service; 7006 was filled by deposit (7011), 7007 by (7010), and 7008 by (7009). All of which were overlain by a topsoil and a paved area; (7001) and (7012) which butt against each other. The topsoil, (7001) consisted of a friable mid greyish brown silty clay with occasional small sub-angular stone inclusions. While the paved surface, **7012**, was constructed using large grey paving slabs separated by lines of grey bricks arranged in a basket weave bond.

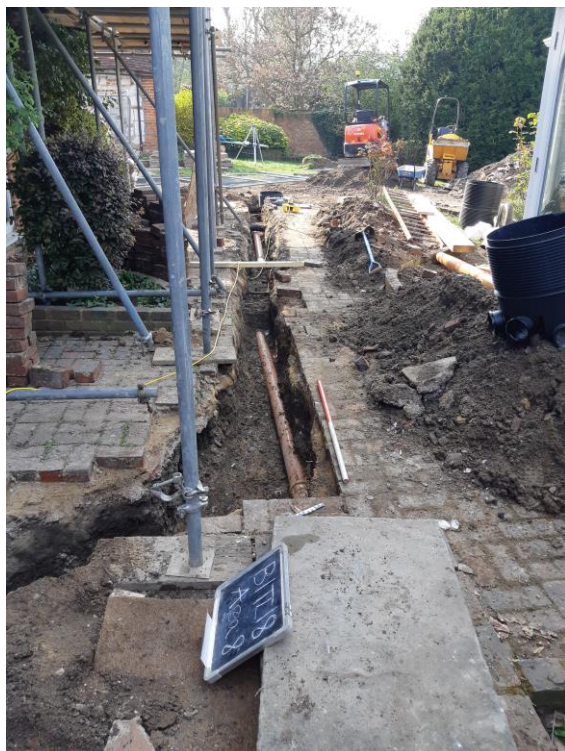
Plate 9: Shot of Area 8 looking southeast

The earliest deposit uncovered in the excavation of Area 8 was context (8004), a layer of made-ground. This layer is composed of a friable, light-mid yellowish brown silty clay with moderate amounts of chalk, charcoal, and small sub-angular stone inclusions. This layer is directly linked with five separate contexts; 8014, 8012, 8005, 8008, 8016. However, just as in Area 7, although each of these contexts is next sequentially on the site matrix, the fills of these cuts indicate that one of them is earlier than the rest, 8005, dates to the early modern or possibly late post-medieval period judging by its fills, **8006**. While the rest of the contexts are judge to be modern in period.

Context 8005 cuts into the layer of made-ground, (8004), and runs E-W across the northern limit of Area 8. Although this cut was not excavated, but only exposed in plan, it was possible to identify two contexts filling the feature; a drain and the backfill associated with the use of this drain; **8006** and (8007). The drain was found to be early modern or possibly late post-medieval in date, and was constructed of red ceramic tiles measuring 120mm by 220mm by 40mm laid in a stack bond. While the backfill of the feature, (8007), was recorded as being friable, mid greyish brown, silty clay with frequent amounts of small sub-angular stone inclusions.

All of these service cuts and their associated fills were covered by a levelling layer which runs across and beyond all the limits of Area 8, (8003). This context was composed of a friable mid blackish brown, silty clay with moderate amounts of small sub-angular inclusions. Sealing this levelling layer was a loose light yellowish grey, sandy cement with frequent amounts of small sub-angular stone inclusions, (8002). And last but by no means least covering and sealing all of these contexts is a paved surface above, constructed using modern grey bricks arranged in a basket weave bond.
