17/01834/FUL - HISTORIC BUILDING RECORD

7 BARTON VILLAGE ROAD, BARTON

OXFORD

FEBRUARY 2020

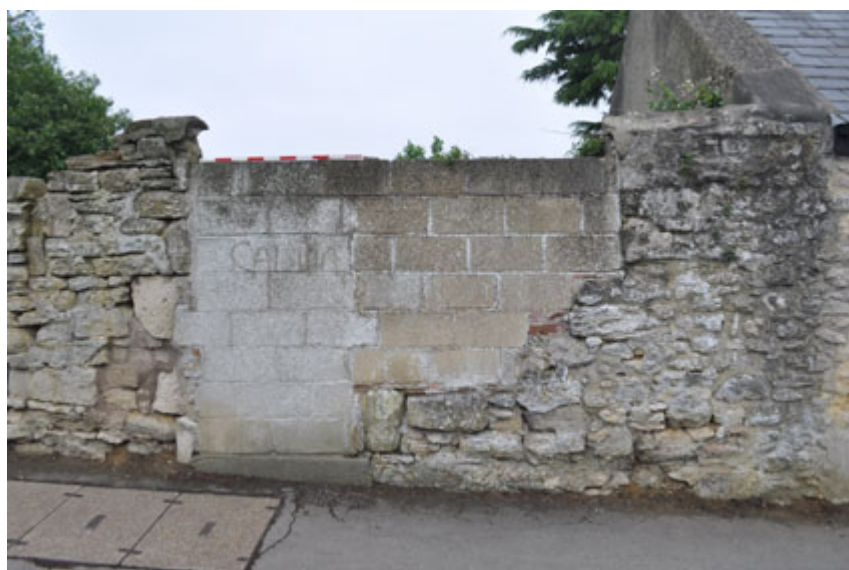
Plate 1: East Face of wall North Part

East Face – North Part

The surviving east boundary wall at its north end is joined to a single storey wing of 7 Barton Village Road, otherwise referred to as Barton Manor (Plate 1, Fig. 2). There is no butt joint between these two parts of walling and it is thus believed that they were once part of the same structure. This first section of limestone wall is a reverse L-shape. On the left hand side, there is a limestone quoin that would have marked the lower part of a door surround. There are a further group of quoins that would have marked the upper part of the wall to the north. These quoins mark the former locations of a door and window that have now been filled in with breeze-blocks. These have been squared in with the use of brick and tile. There is a door step to the south of this stone wall.
