**ENVIRONMENTAL IMPACT ASSESSMENT
(CULTURAL HERITAGE)**

**THE PROPOSED RESERVOIR AND CONSERVATION
AREA, COUGHTON MARSH, ROSS-ON-WYE,
HEREFORDSHIRE**

PART 1 - REPORT

OCTOBER 2007

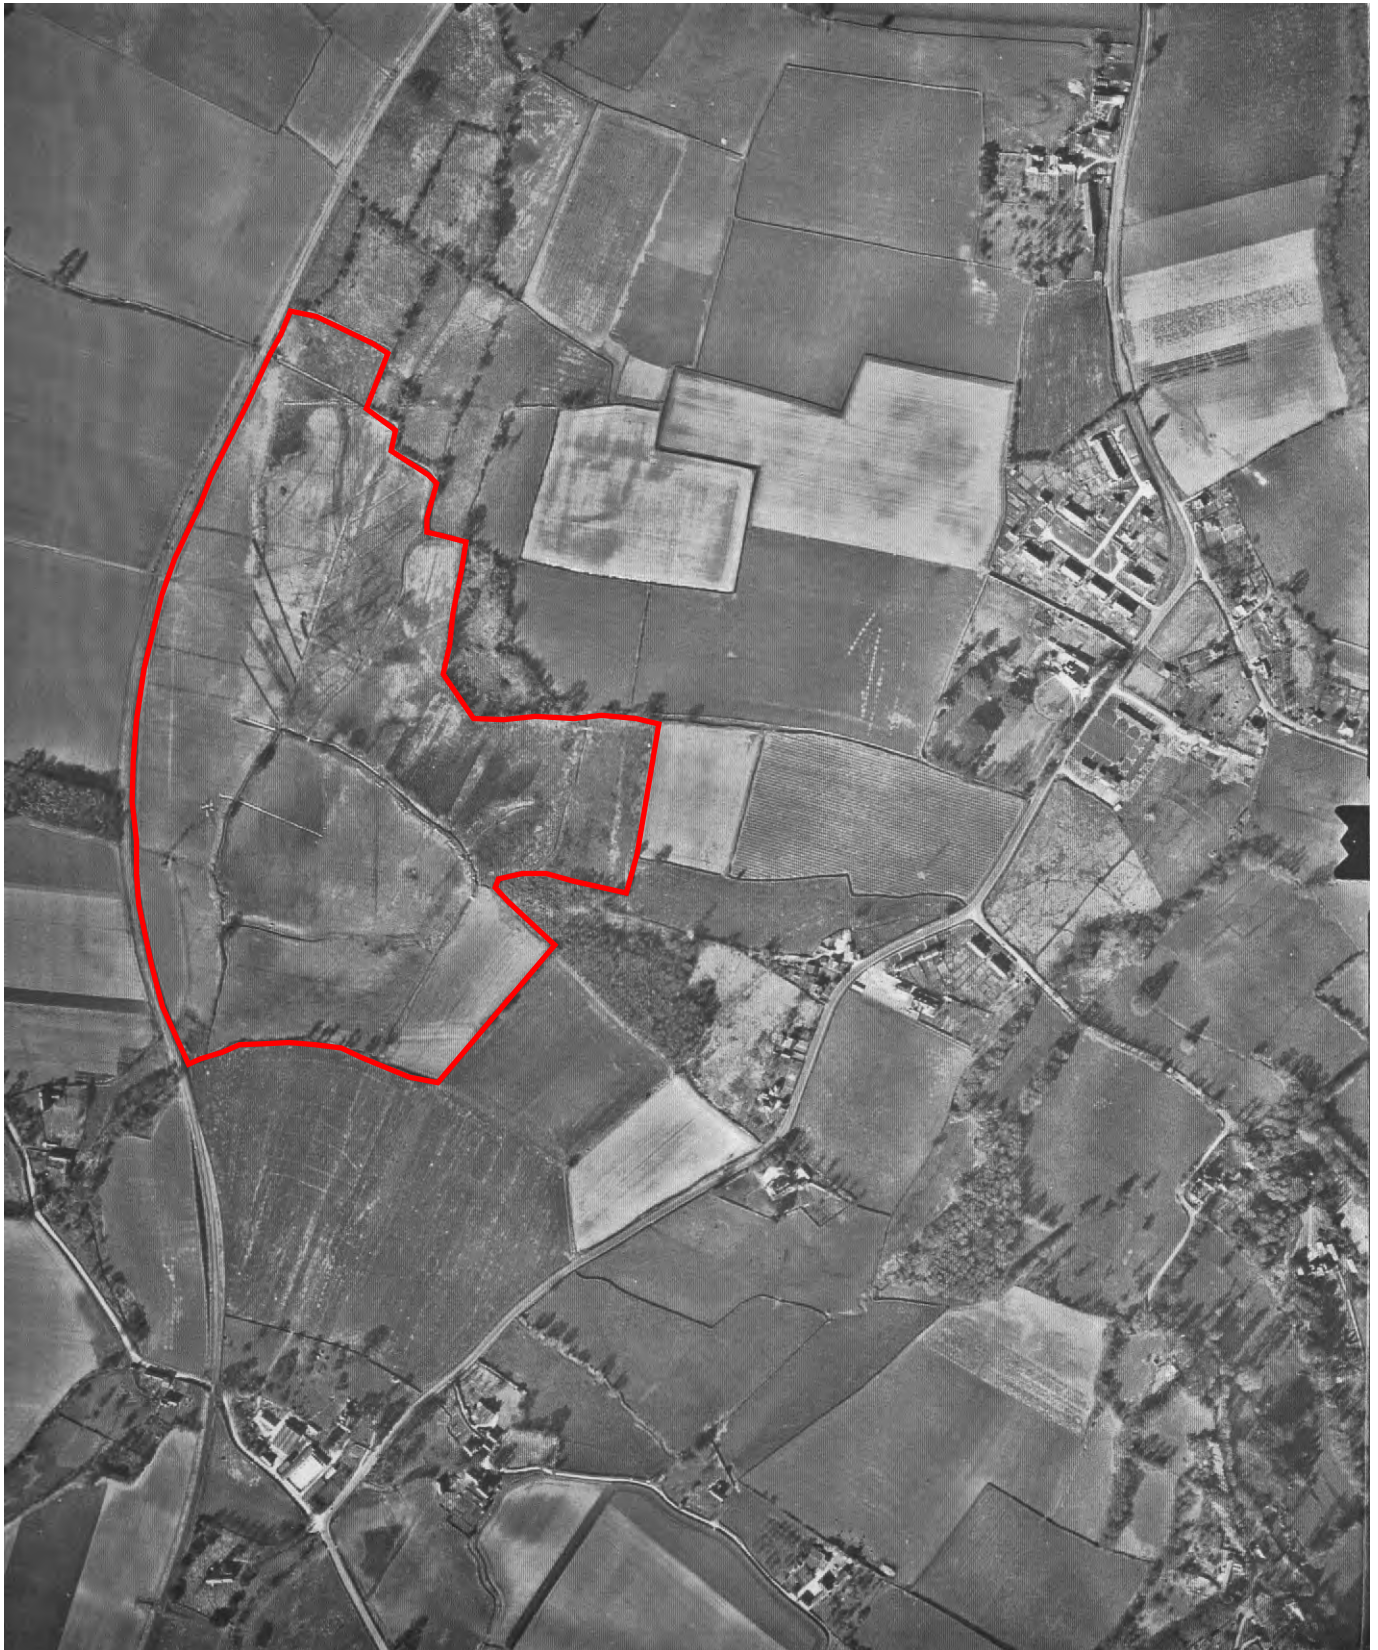
Figure 10. Aerial Photograph - OS 66007-394

Aerial photographs proved inconclusive in identifying any potential archaeological remains in the area. It was noted that the photographs show the area to have a considerable number of land drain in a herring-bone pattern. The fact that they show up on the photographs indicates that they were probably put in place by trenching rather than boring.

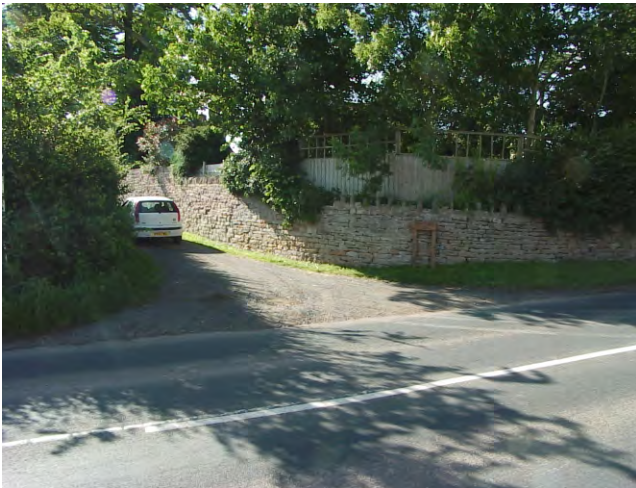
5. Access from B4234

Access to the site is via a dirt track opposite Old Hill Court (figure 27, p7&8) from the tarmac lane that runs north to south from Arbour Hill to Warryfield Farm. This is the access that any plant would be expected to take, although the route may go through Ayles Marsh and Hom Green (figure 28, p11). Alternative access to the site is via a lane opposite Walford House from the B4234 (figure 27, p5&6).

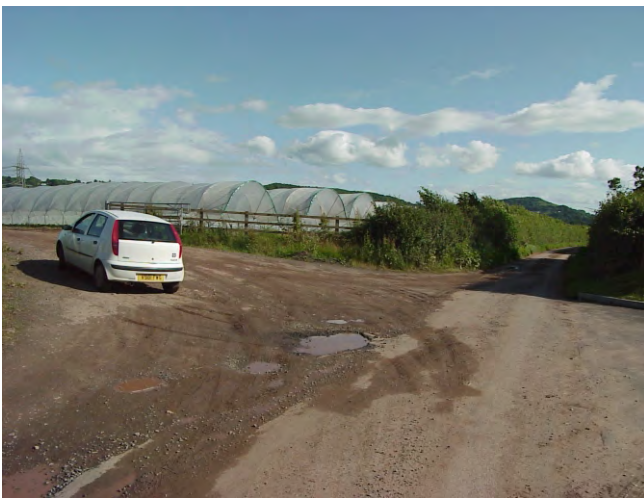
7. Access opposite Old Hill Court

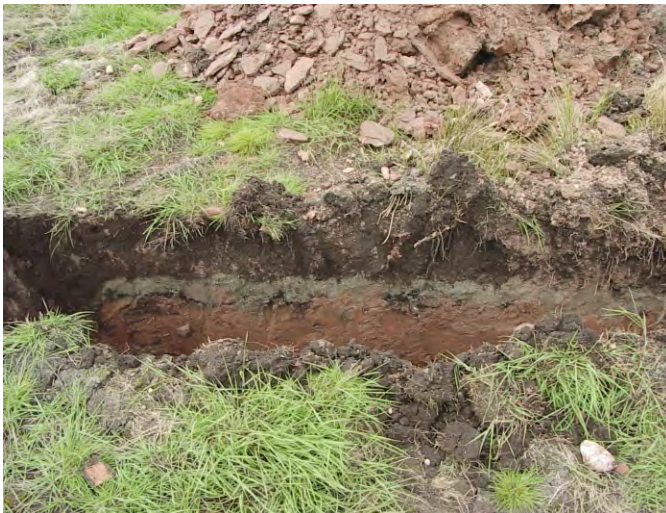
15. Trial Pit 3 - Section

Layer	Layer thickness	Extent	Soil Description	Interpretation
<u>3/01</u>	<u>0.3m</u>	<u>TR</u>	<u>Black Humic LOAM</u>	<u>TOP SOIL</u>
<u>3/02</u>	<u>0.15m</u>	<u>TR</u>	<u>LIGHT GRAY CLAY SAND</u>	<u>SUBSOIL (?)</u>
<u>3/03</u>	<u>0.02m MAX</u>	<u>VERY SPONGY TR.</u>	<u>BLACK POFT</u>	<u>POFT</u>
<u>3/04</u>	<u>0.4m</u>	<u>TR</u>	<u>RED-BROWN SANDY CLAY WITH SOME (5%) STUM.</u>	<u>NATURAL</u>
<u>3/05</u>	<u>0.3m</u>		<u>GRAY SAND AND SILT</u>	<u>NATURAL</u>
<u>3/06</u>	<u>1/4</u>		<u>MOIST-RED SAND CLAY WITH c. 80%+ STUM.</u>	<u>NATURAL</u>

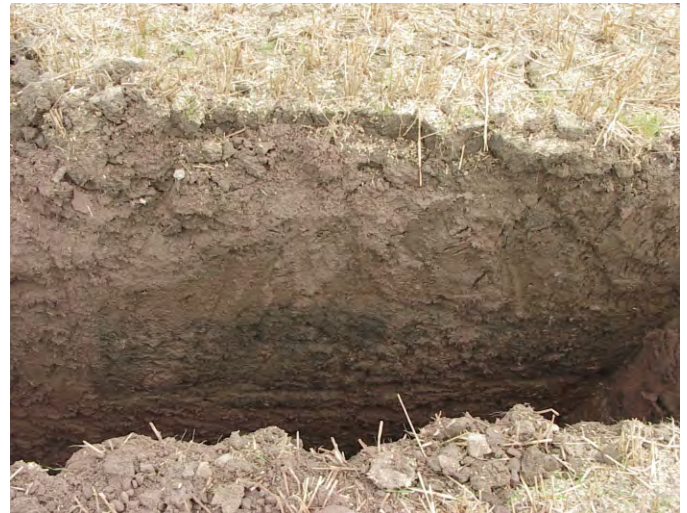
16. Trial Pit 7 - Section
