A watching brief on the fabric of the historic buildings

HALLIDAY'S ANTIQUES

HIGH STREET

DORCHESTER-ON-THAMES

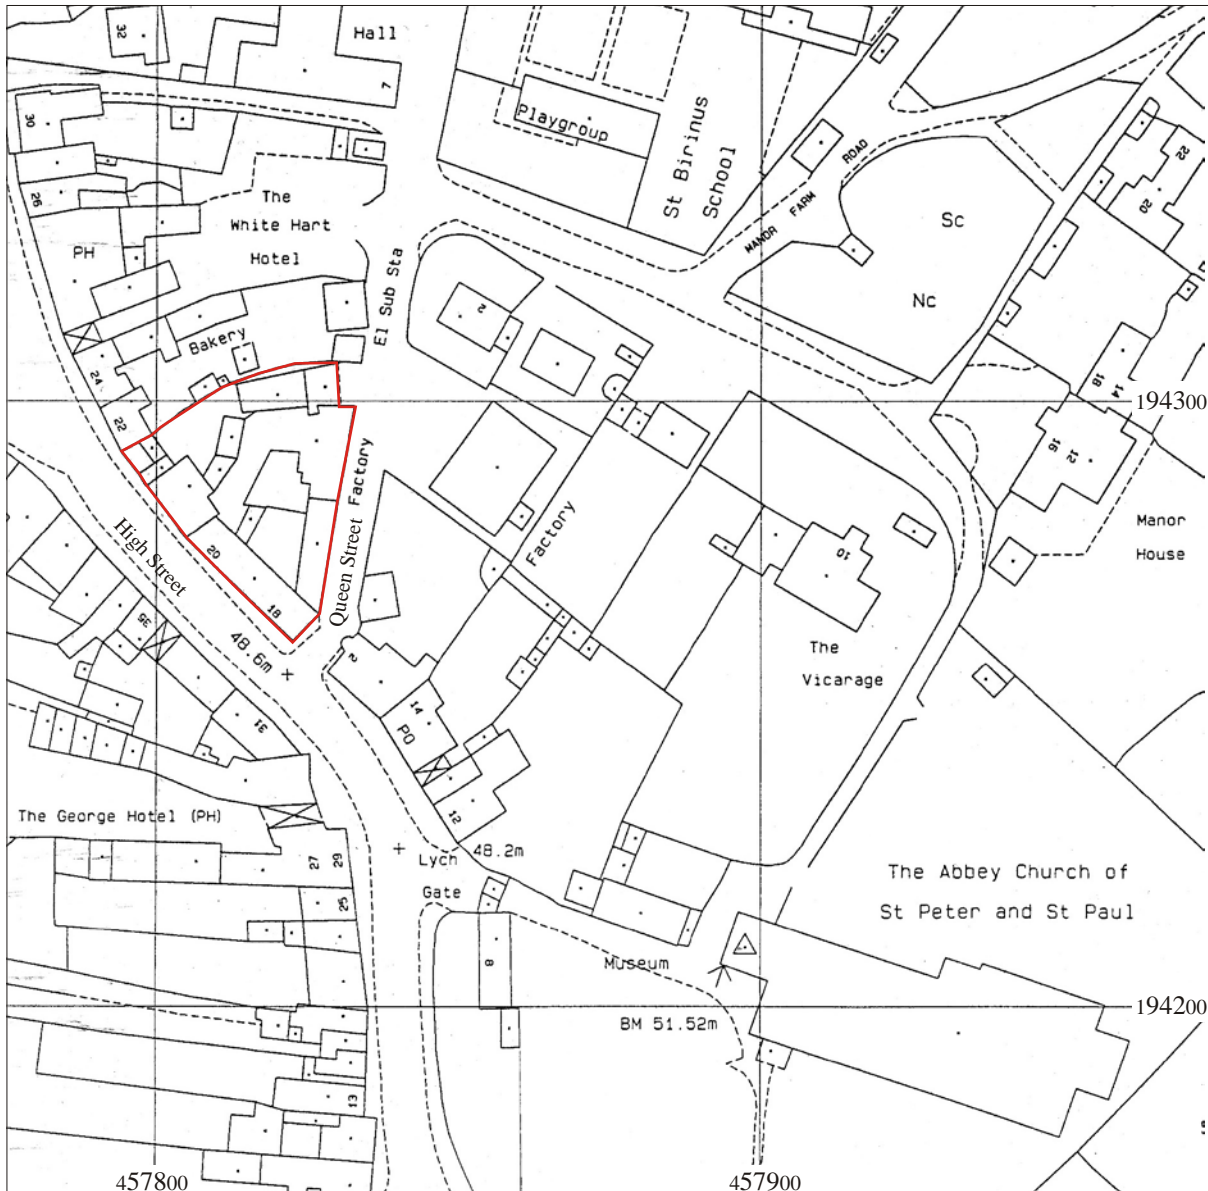
Figure 2: The Site in 1930 (Sales Catalogue Drivers, Jonas & Co)

4.3 The 1930 Sales Catalogue description shows the ground floor layout (Figure 2) of the Missionary College at that date. The cottage, also described in the document, is described as a separate unit, but it is thought that the building had provided additional accommodation for the College.

single storey extension. The location of a staircase is suggested by the ground plan shown on the sales catalogue (Figure 2).

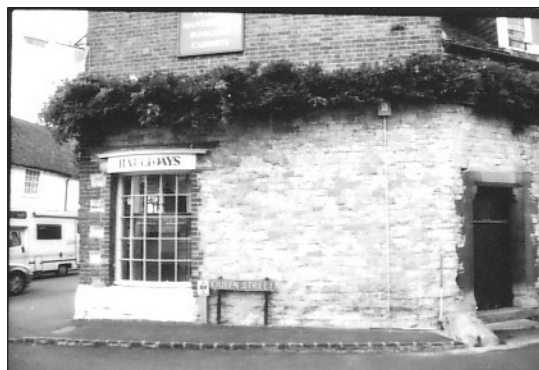
Plate 1: Ground floor clunch construction, first floor of brick. Also shows inserted 20th C. bow window.

The entrance bay also holds a small arched window to the east of the doorway. The arched window is a 20th century addition. The 6 bow windows at ground floor are also a 20th century creation, added by 1961 to replace 18th century sash windows. The doorways between the bow windows were added at the same time. A further bow window was inserted in the gable of the Queen Street range at ground floor level.

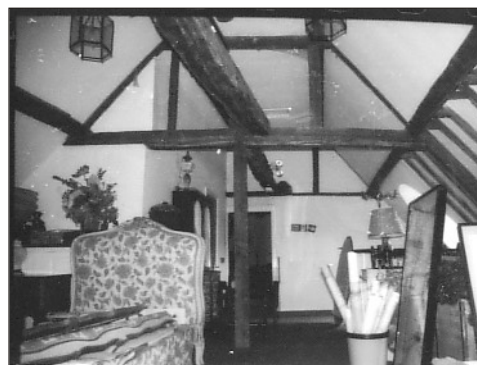
The Roof Structure comprises Queen post trusses (Plate 2). The purlins rest on the truss tie beams and are of considerable length, joined to each other with pegged lap joints. There are short lengths of rafter between purlin and the top of the walls. There are also large central beams extending between the trusses. These beams have empty mortise holes, which may have supported ceiling joists at some point, or are re-used timbers from elsewhere.

Plate 2: Queen Post roof construction

The Queen post truss construction was common in the late 18th and 19th centuries, and it is possible that the roof space was converted for the Missionary College, with the addition of the five dormer windows and the insertion of a 19th century staircase at the eastern end of the range for access from attic to ground floor. The staircase had plain, narrow, square section

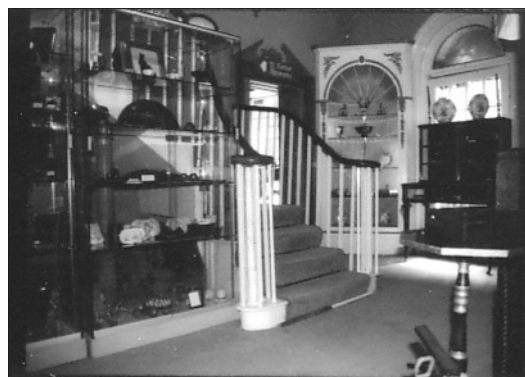
Plate 3: 19th Century Staircase

balusters, clustered at the foot of the staircase to form a cage-type arrangement on the curtail step. The cage had a central carved baluster with a leaf motif. The whole of the staircase was painted white with natural wood treads and risers, currently carpeted (Plate 3).

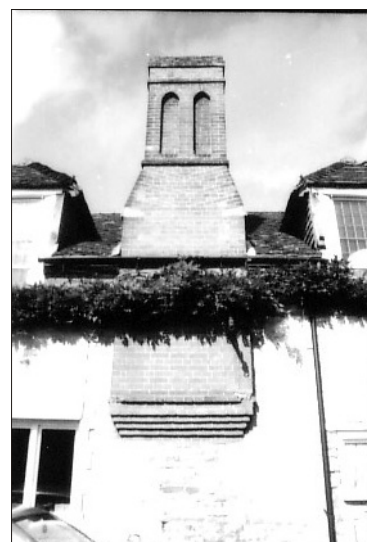
The elaborate corbelled brick chimney stack in the centre of the range has two recessed arches in the upper part, the chimney to the southwest also has arches set into the brick work. These features are typical of the work of Gilbert Scott, and as such were inserted during conversion of the premises to that of the Missionary College (Plate 4).

Plate 4: 19th century chimney

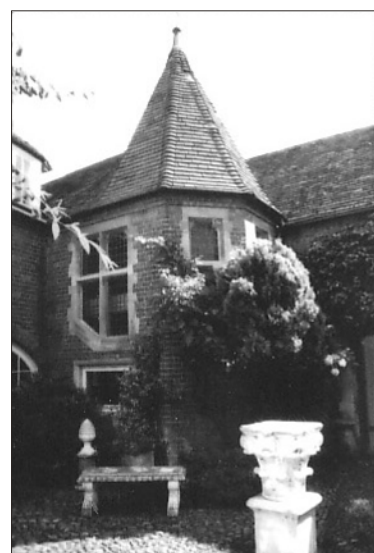
The brick built tower within the courtyard and abutting the Queen Street range and northern extension was part of the 19th century Missionary College construction (Plate 5). The tower was built to house the stair access to the newly converted attics. This stair has since been removed and a floor inserted at attic level to provide further showroom space for the business.

Plate 5: Gilbert Scott architect designed tower

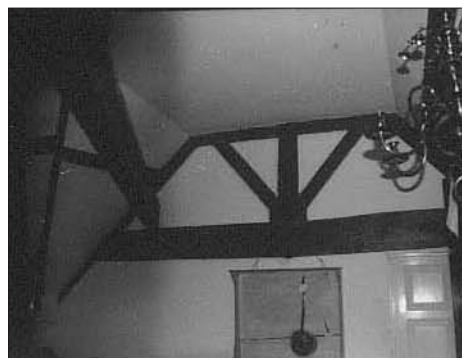
The first floor, or attic of the northern range may have housed the remainder of the thirteen bedrooms and facilities mentioned in the sales catalogue, as the Queen Street attic could not have held that number of bedrooms alone. The current layout is open plan and the roof trusses are exposed. The roof construction is King post truss of 19th century origin (Plate 7), as the building was custom built for the Missionary

Plate 7: King Post roof construction

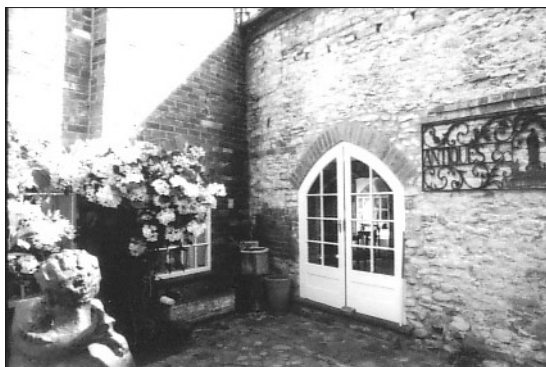
The interior of the central range, at ground floor level was in use as a workshop until conversion to additional showroom space. The western wall has a wide segmental arched doorway, opposite the same in the eastern wall. This western doorway (Plate 8), had been inserted into an existing opening in the stone wall, of considerable size and topped by an oak lintel.

Plate 8: Inserted 19th C. Doorway in stone elevation of Central Range

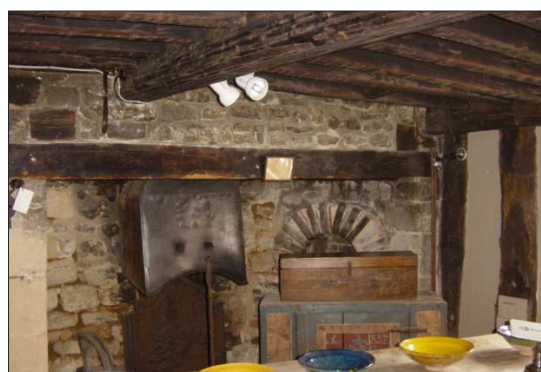
The interior of the earlier room has a low ceiling, and the stone fireplace dominates the room (Plate 9). The fireplace incorporates worked stone possibly taken from the abbey or other ecclesiastical site to be re-used in this location. An arched bread oven has been added to the fireplace, utilising brick and tile. The wide fireplace is surmounted by an oak lintel and the form is suggestive of 16th century origin. The wide floorboards of the upper room are clearly visible supported by oak joists. The joists are chamfered and terminate with chamfer stops clearly visible at both ends of the joists, either side of the main bridging beam. The ceiling of the

Plate 9: Fireplace in Cottage, showing oak lintel

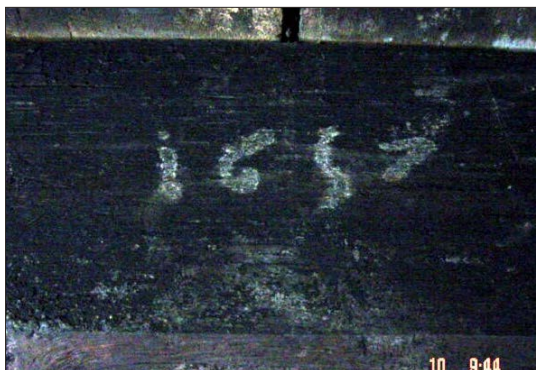
ground floor room had once been finished in lath and plaster: the striped markings left after removal give evidence of this. Graffiti on one of the joists gives the date 1657 (Plate 10). Joists to the rear of the property are of modern origin, within a modern brick built extension.

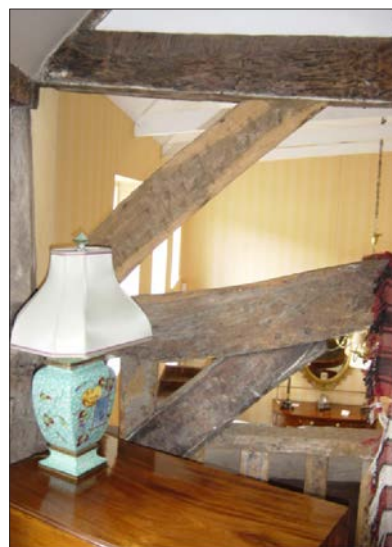
The first floor of the timber building is on a lower level than the adjacent brick building and is accessed by a small stair down into the room. There is evidence of a fireplace in the chimney breast: this however, has been bricked up and the whole whitewashed over. The western end wall of the room has been extensively affected by the addition of a modern extension but the remaining timbers are left exposed. The timbers closest to the High Street frontage are the most intact: with jowel post, arched windbrace and remains of a tie beam. Later studs and a rail had been inserted (Plate 12). The material used to infill these timbers has

Plate 12: The remains of the timber framed west end wall of the cottage

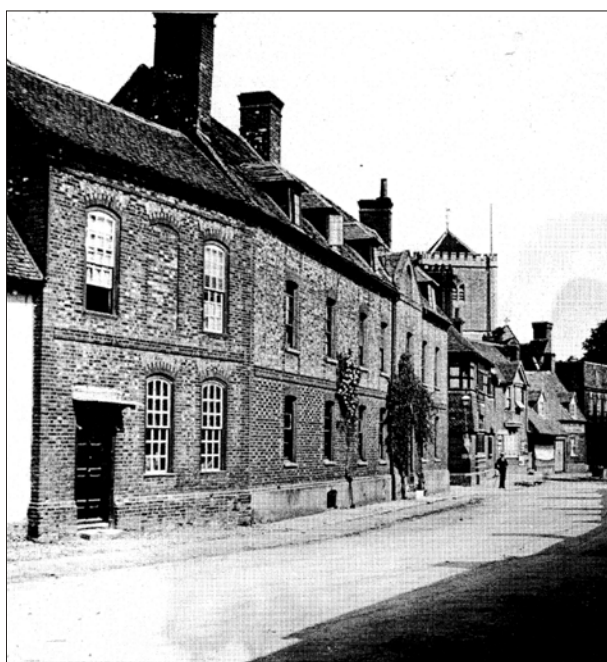
The adjacent three-bay property is brick built with a string course separating ground from first floor. The whole of the façade is now under render. The windows to either side of centre have regency style wrought iron balconies, added to the building in the 20th century. Plate 13 shows the exterior of the building as it was in 1912.

Plate 13: Photograph of the house in 1912

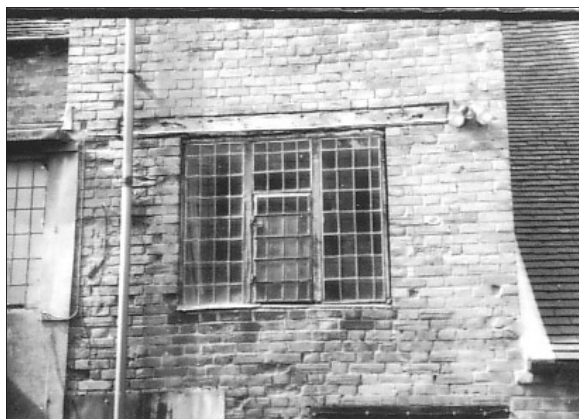
The staircase (described above) has a square case-hung window lighting the stairs (Plate 14). This window has a wooden lintel and small rectangular leaded lights. The window consists of three sections separated by wooden laths. Each section has 24 individual lights of regular size and four smaller rectangular lights at the top. The lower central section, comprising 24 lights is hinged on one side and can be opened. This type of window is difficult to date, but may be of late 17th century origin.

Plate 14: The window on the landing of the 17th century stairway

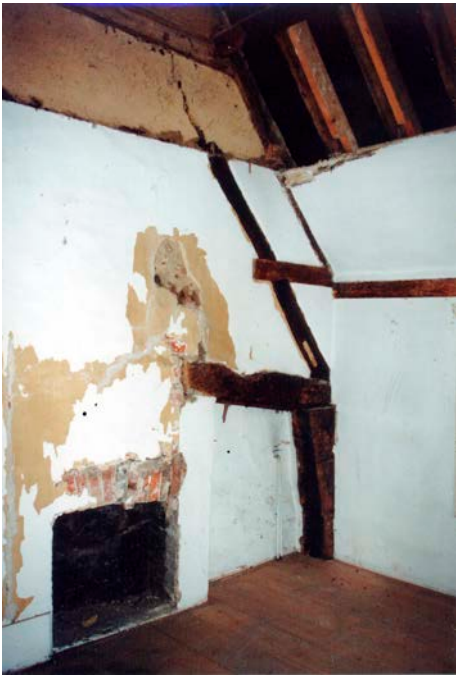
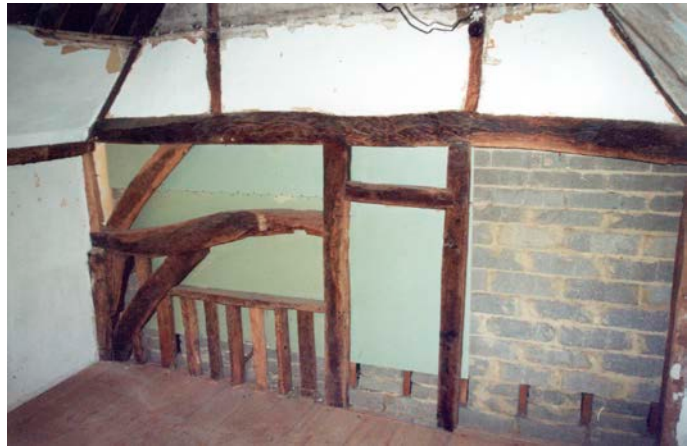
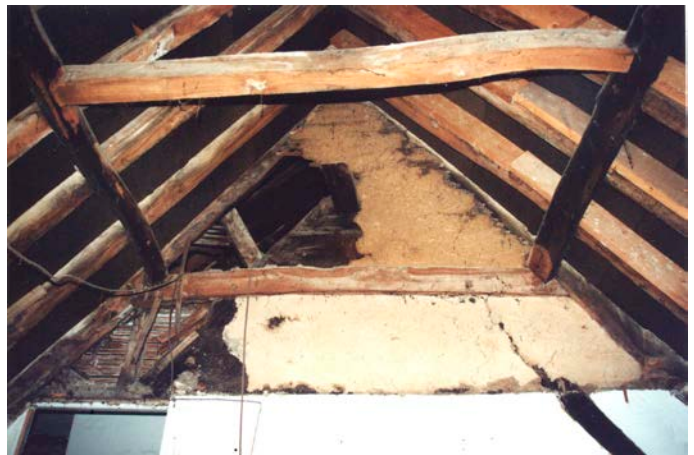
Fig 3 (clockwise)

The Cottage – heightened timber frame (2)
adjoining stack

The Brick House – first floor room, timber frame
at south-east end (5)

The Brick House – staircase wing

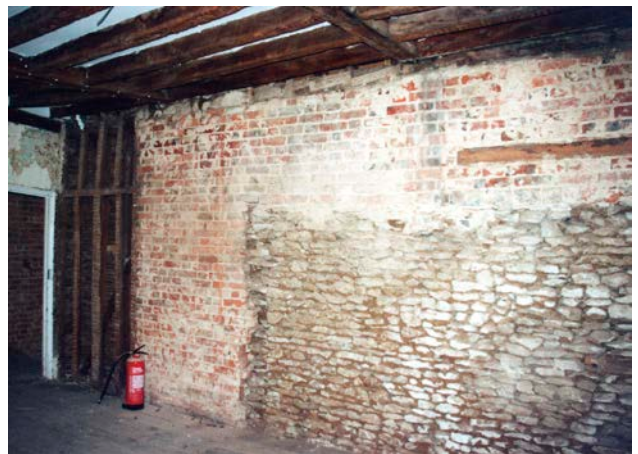
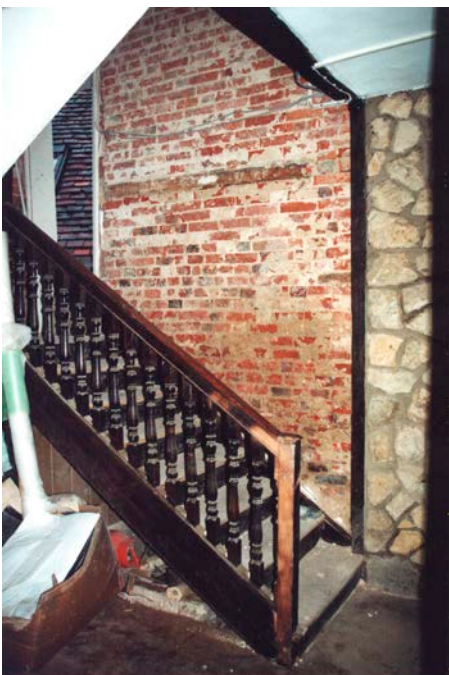
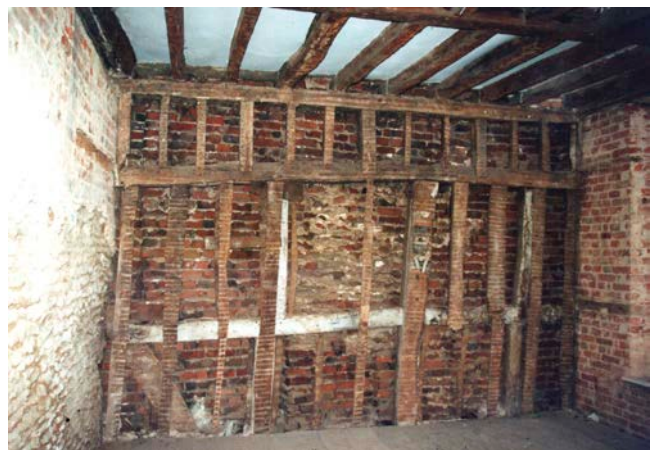
Fig 4
Brick House, first floor - timber frame forming south-east wall (5); surviving wall painting shaded green. Later timbers omitted.

A – painting on post (left)
B – painting on rail (below)

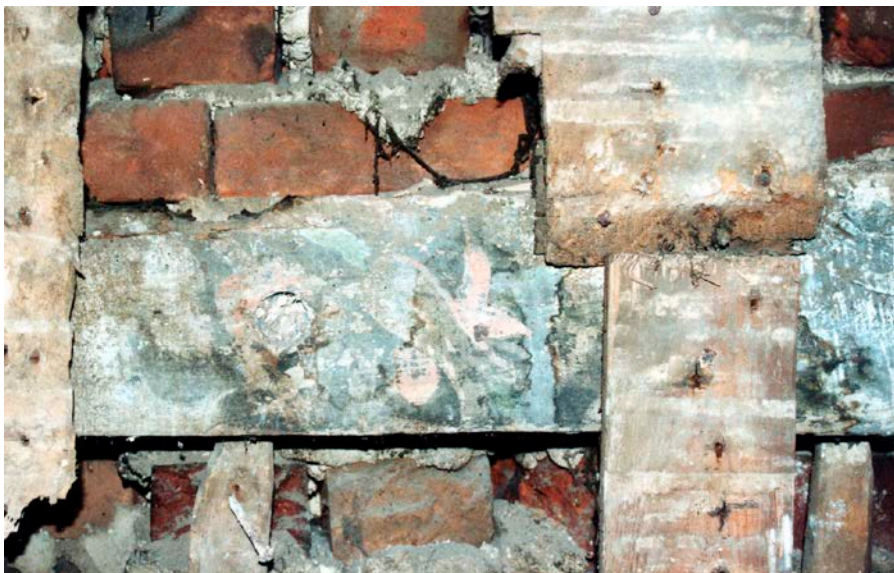
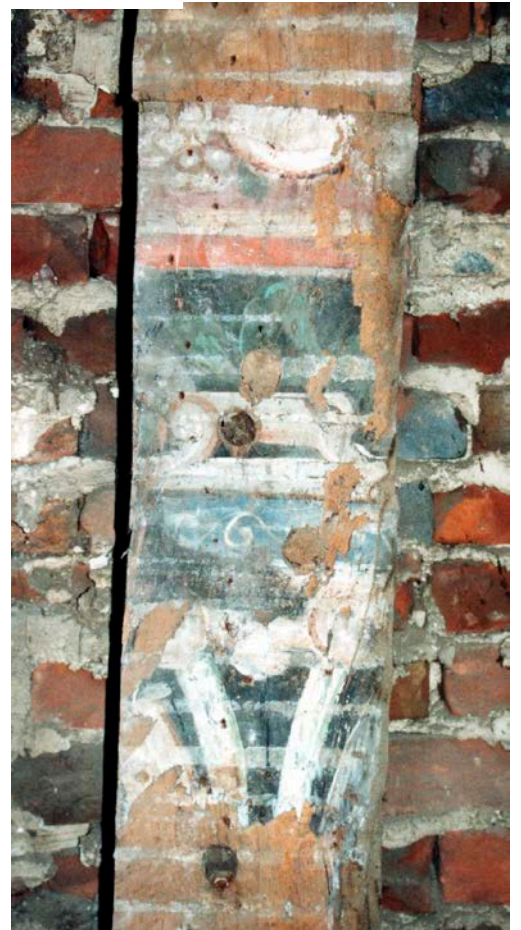
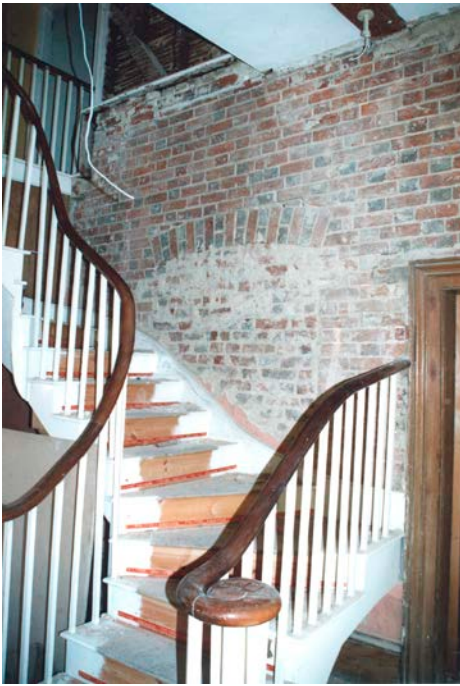
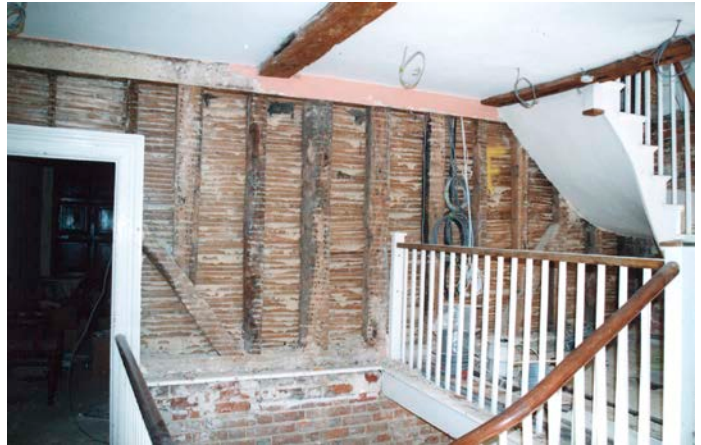
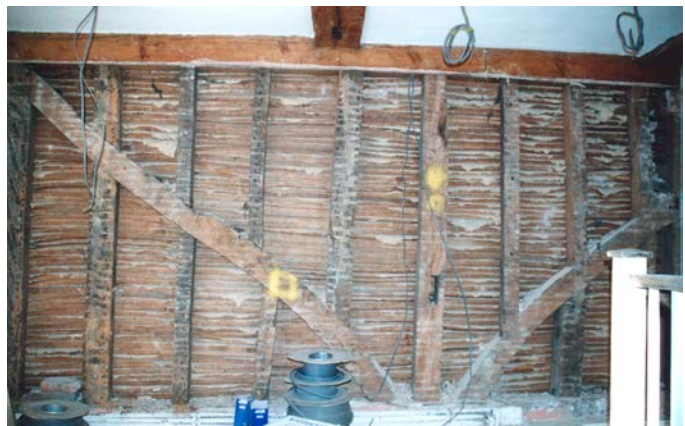
Fig 5 High Street Range
(clockwise)

Blocked window and finished wall face in hall to former covered passage (7)

Former kitchen fireplace in room NW of hall (8)

Partition to passage in room at NW end

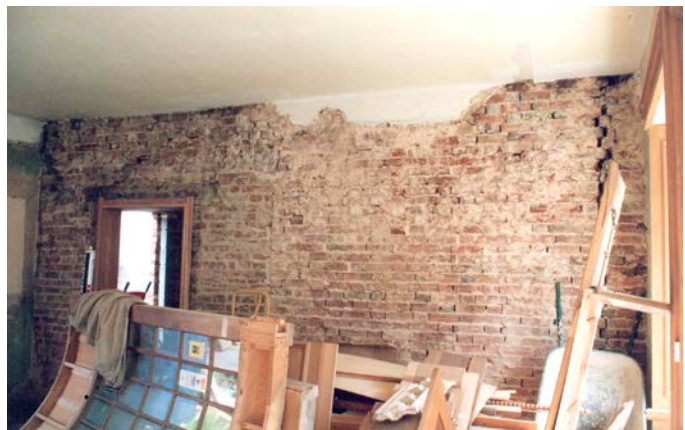
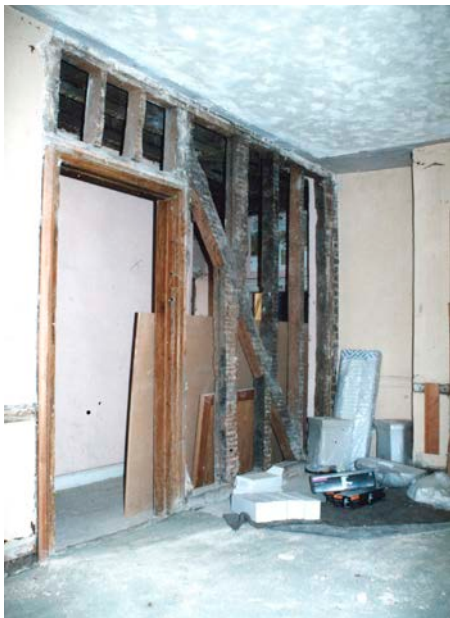
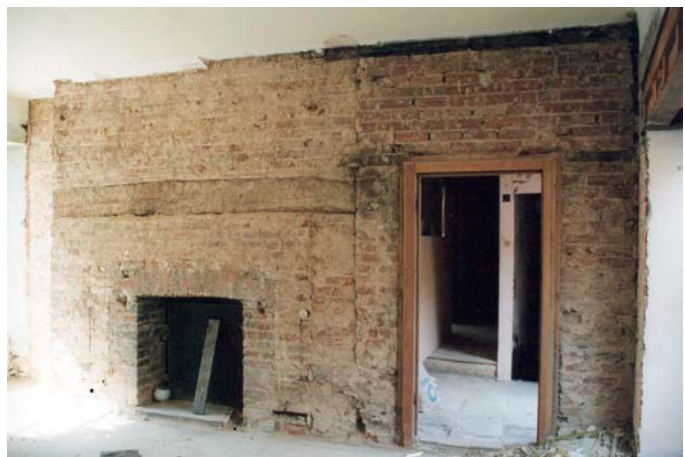
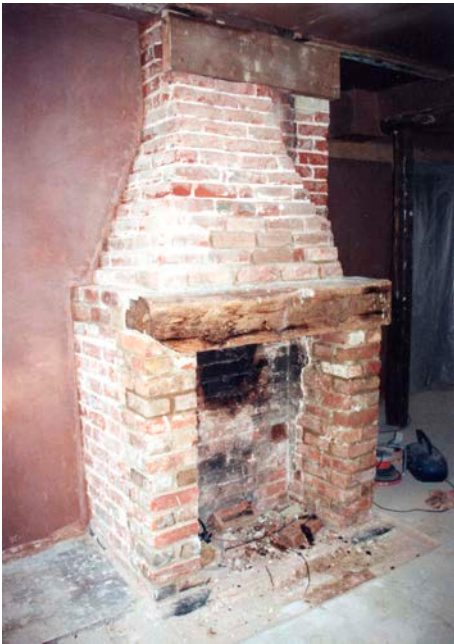
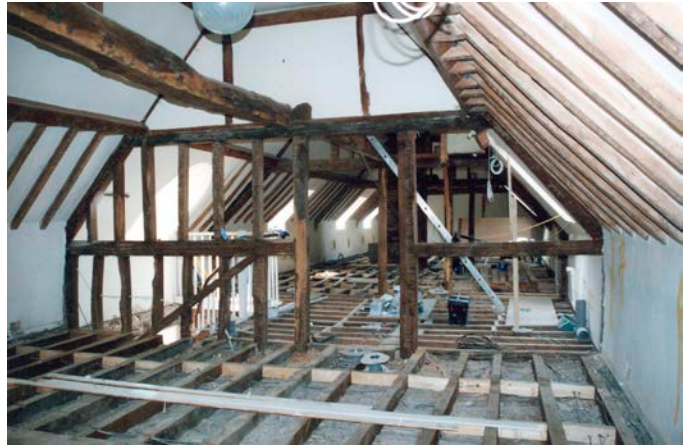
Fig 6 (clockwise)

High Street Range – fireplace in middle first floor room (10)

Central range – first floor roof truss

Central range – ground floor fireplace, south end (16)

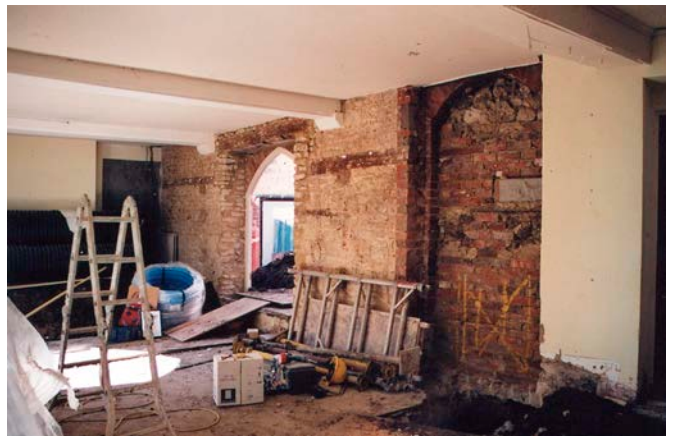
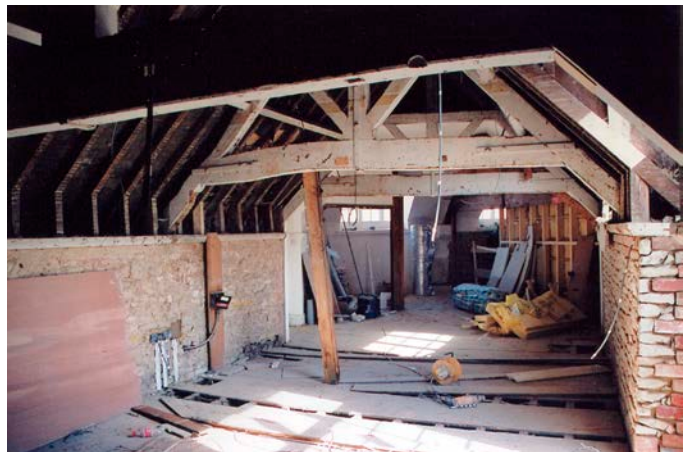
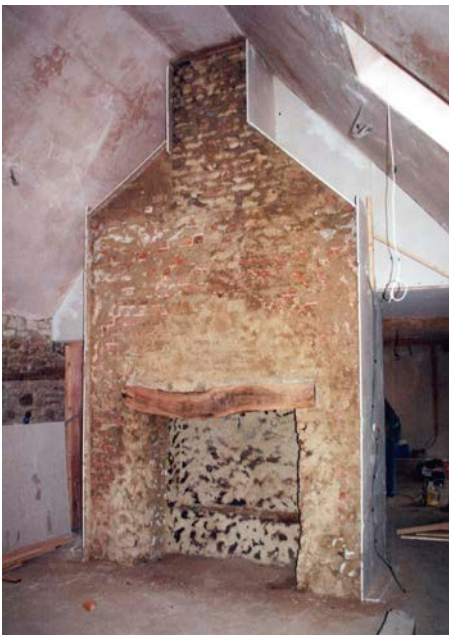
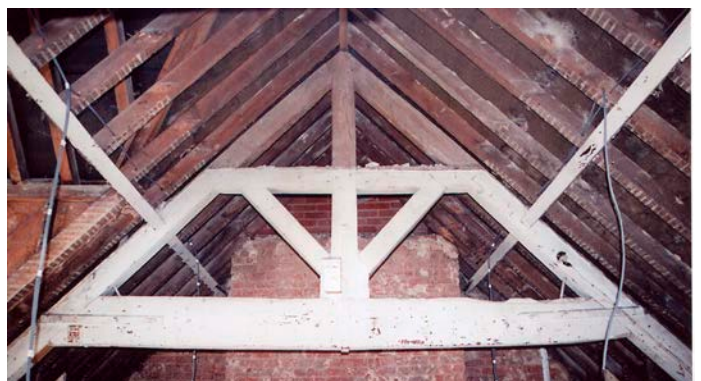
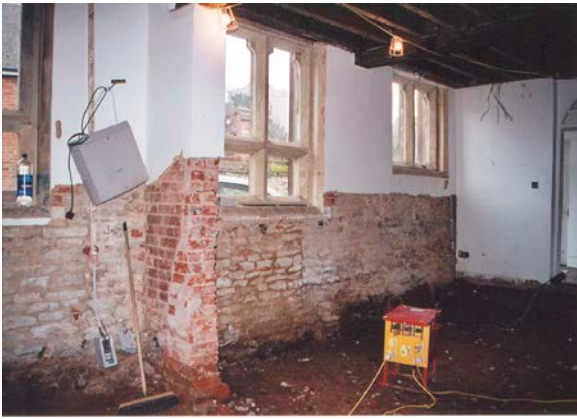
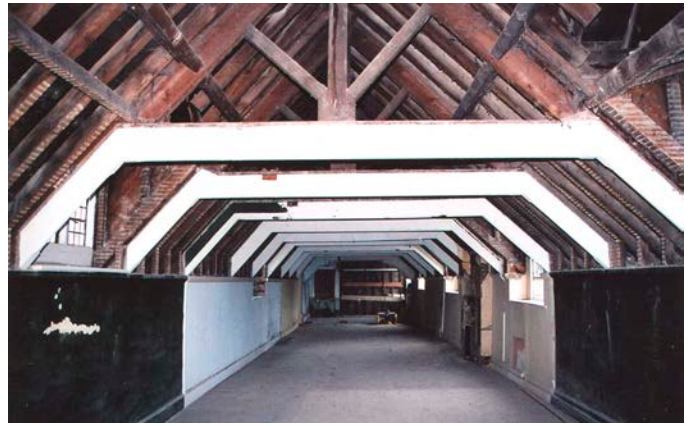
Fig 7 Queen Street & North Ranges
(clockwise)

Ground floor, north end showing blocked opening to street under window (11)

East wall fireplace, first floor (13)

Former stair tower added by Scott

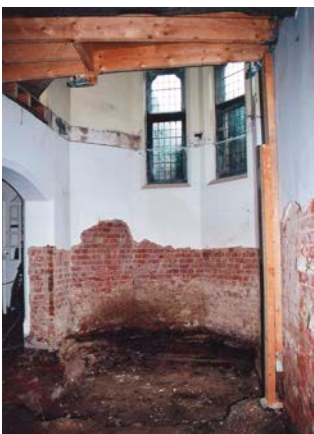
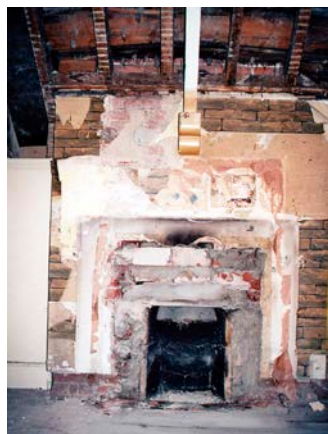
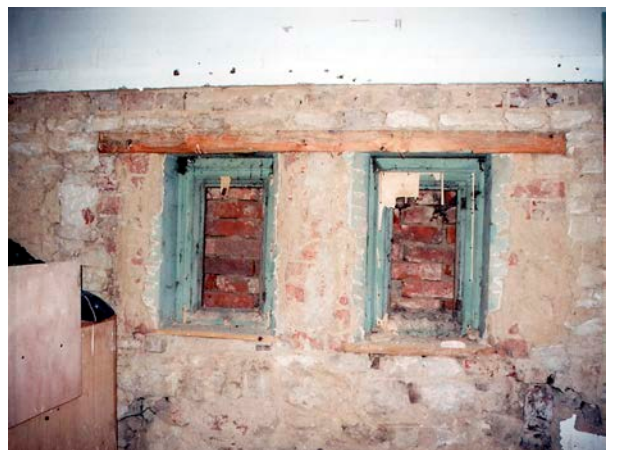
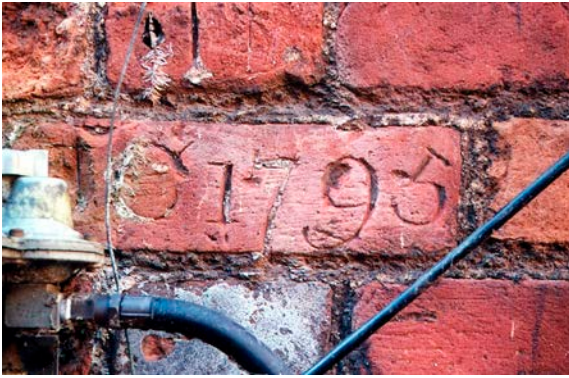
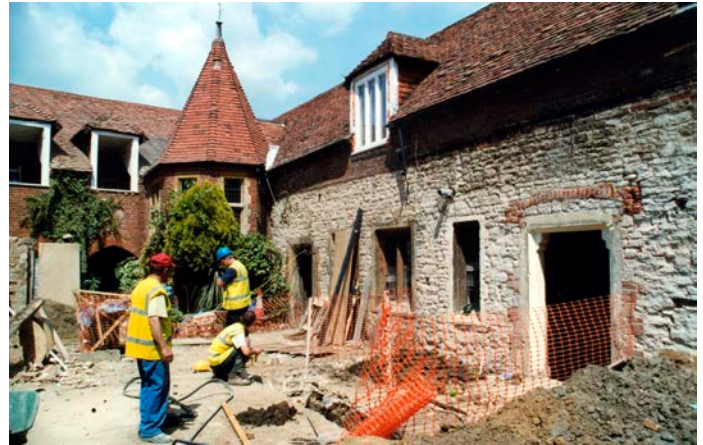
Fig 8 (clockwise)

Brick House – incised brick on exterior of stair tower JC 1795 (3)

Inner court; Central range, south-west wall

Rear wall of High Street range (inside Queen Street range) showing blocked door and previous roofline (14)
