HISTORIC BUILDING RECORDING

19/01133/LBC – ROOM 1:3, STAIR 1, MAIN QUAD,

UNIVERSITY COLLEGE, HIGH STREET,

OXFORD OX1 4BH

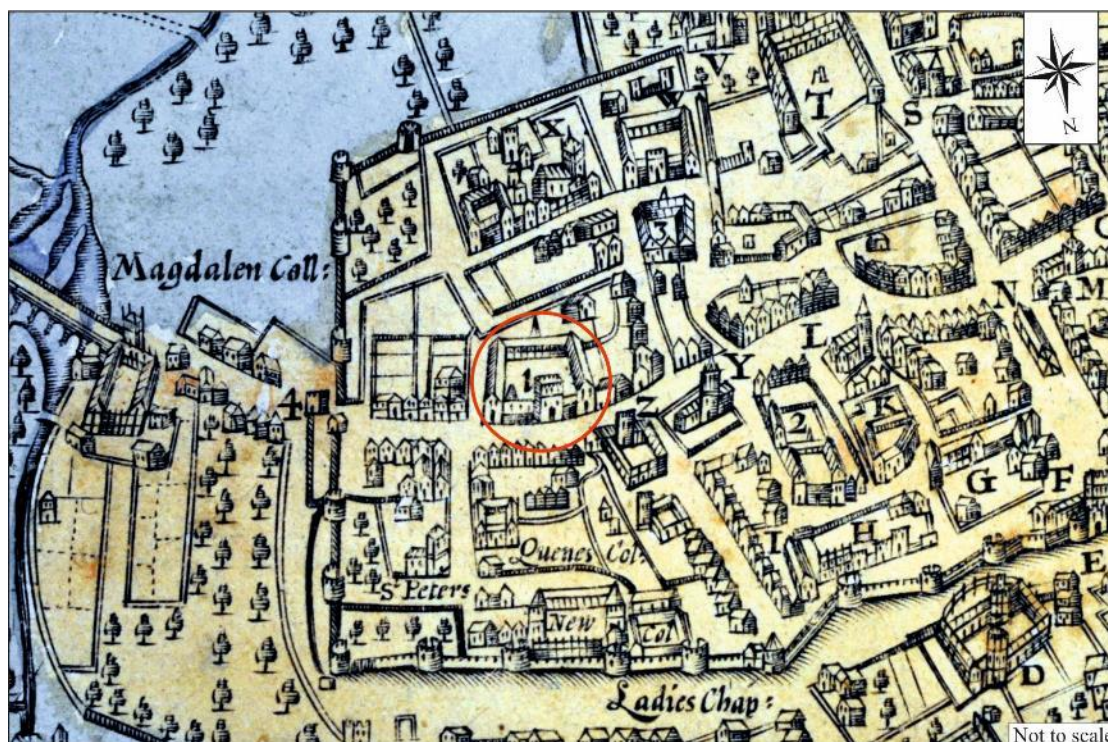
Figure 2: 1605 Map of Oxford showing University College before the new Quad was built (ORO CH XXIII/1a)

University College was founded in 1249 and has the claim of being the oldest college of Oxford (ORO CH XXIII/1a: Fig 2). As University College grew, work began in 1634 to replace its medieval buildings with a new front quadrangle designed by Richard

College records state that the West Quad was completed in 1634, with the East Quad completed after the Civil War in 1677. Historic Maps of 1605 show the original Medieval Quad (ORO CH XXIII/1a: Fig. 2) and later the newly constructed Quad in a late 17th century line engraving (Wellcome Library no. 20828i: Fig. 3). It is likely that the West Quad experienced at least four phases from the 17th-20th century with alterations and refurbishments occurring every one hundred years or so. The most recent occurring in the 1990s.

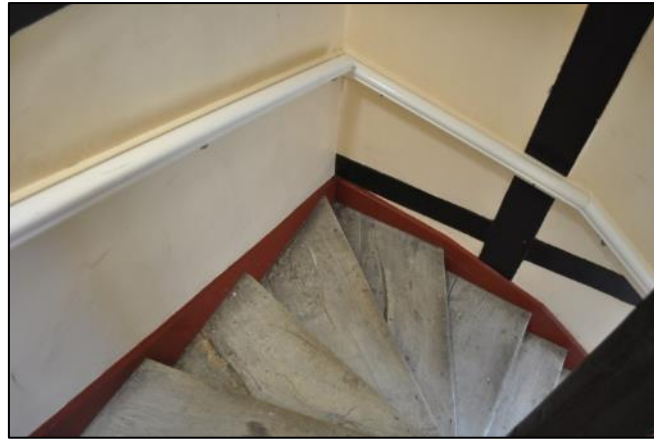
The stairwell is entered on the ground floor through a four-centred arch of a Tudor style. This has a square headed architrave surround. The arch is open and enters a small lobby area, which has a panel door on its north side and access to dogleg stairs is on the east. The stairs are constructed around two large posts that support the treads of the stairs, and between which there are the remains of timber framing (Plate 2-3). The external walls of the stairwell on the north and west sides also contain the remains of timber framing. On the south side, the wall is plastered. On the first floor there is a landing with a panel door on the north side, with moulded surround (Fig 4: E5). In the east wall there are two lancet windows forming a pair, which both have casement windows. The windows contain H-hinges, which are a common feature of most windows here. There are dated by similar pieces to 1674, 1684, and 1698 (Hall and Alcock 1994, 25). The building was constructed 1634 to 1677 (Sherwood and Pevsner 1974, 208). These are fittings that would be appropriate for a mid-17th century date. The dogleg rises again on the west side of the landing to the second floor landing. There is some significant timber framing in the north side wall (Plate 1-2). Above the stairwell is a beam with a chamfer

Plate 2: The Stairwell

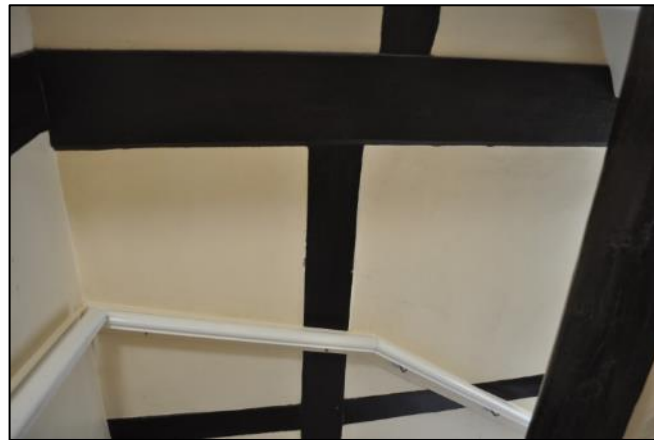
Plate 3: Detail of the timber framing in the stairwell

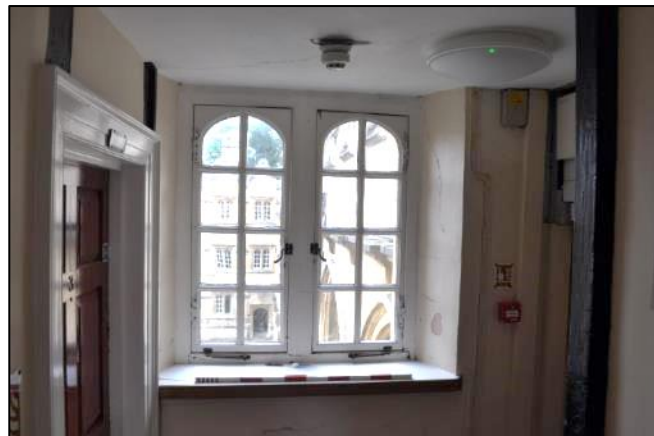
Plate 4: One of the two lancet windows with four-centred arches in corridor

and stop. The second floor landing is of a similar design to that below. In the north wall a four panelled door and in the east wall two lancet windows with four-centred arches (Plate 3). A passageway is located above the stairwell, probably a more recent insertion. The wall on the north side has timber framing. This leads to two rooms that lie to the west of the stairwell. These are rooms with mainly modern fittings. The exception is the window in the west wall of the west room. This contains two lancet windows with

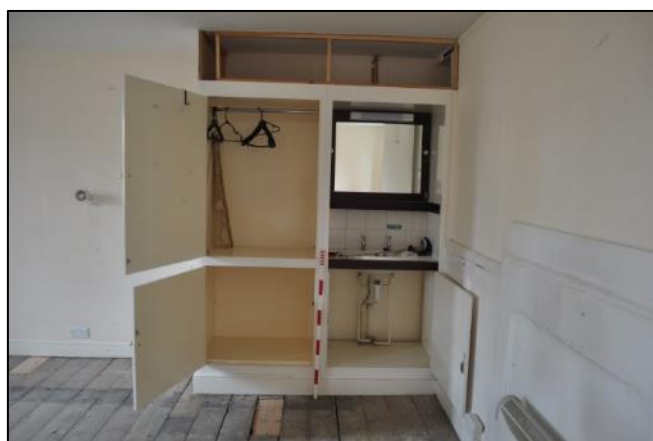
Internally to the Room 1:3 the panel door from the landing was located in the south wall in the east corner. The wall has a moulded skirting. In the southwest corner, there is a modern built-in cupboard (Plate 5 and Fig 4: E3). In the west wall, there is a 17th century fireplace (Plate 6 and Fig 4: E1). To the north there are two lancet windows of a four-centred arch design (Fig 4: E2). These have casement windows that contain 17th century H-hinges. There is an alcove seat below. There is part of a cornice surviving on this wall. The north wall has a skirting board only.

Plate 5: The Cupboard now removed where new door inserted during Watching Brief

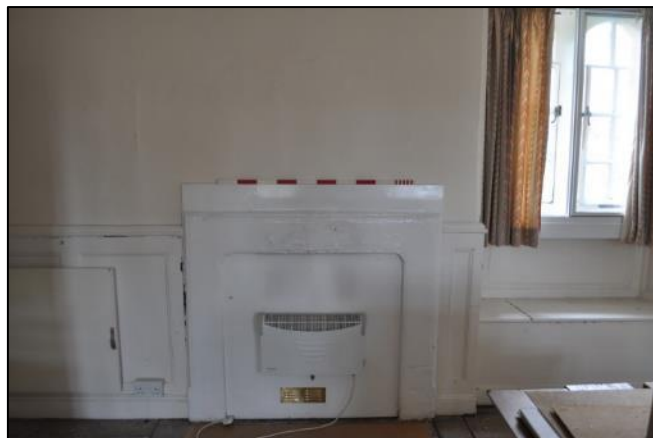
Plate 6: The blocked up fireplace and lancet window

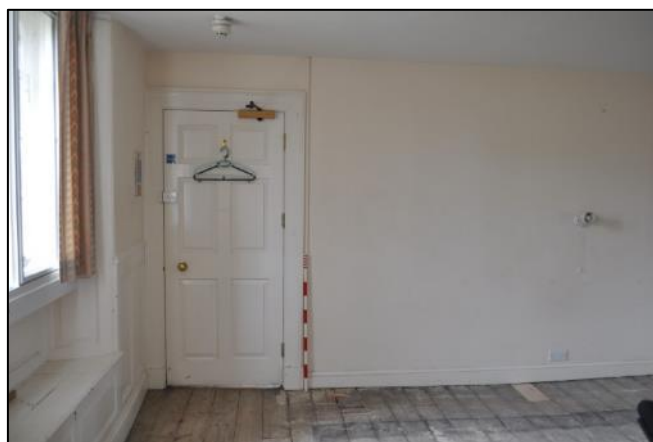
There is a panel door in the east end of the north wall that has a moulded surround (Plate 7). As no timber framing is evident it is not known if this doorway is fitted to the timber frame. It is assumed, based on the style, that this is a probable 18th or 19th century door with a moulded surround. In the east wall there are two sets of double lancet windows, with four-centred arches. These have casement windows with H-hinges of the 17th century. These are both set above alcove seats. There is skirting but no cornice.

Plate 7: The main door, and just visible on the floorboards the remains of a possible earlier wall

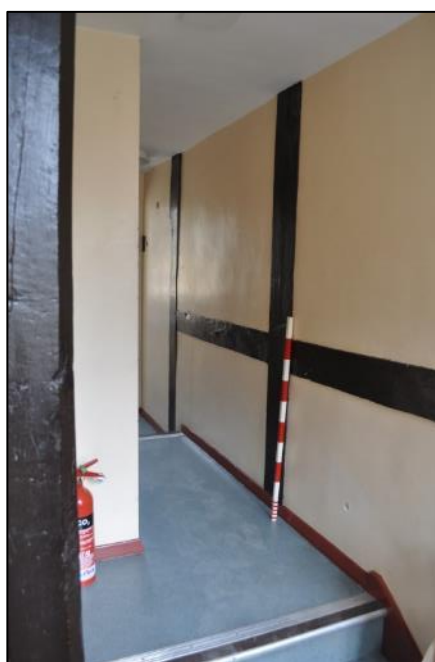
A doorway was opened up measuring 1.78 x 1.92 x 0.15 m (Fig 5-6, Plates 8-15) between the corridor and Room 1:3 in the Western Range of the Main Quad. Removal of the wall panelling revealed that successive layers of paint had been applied onto thick plasterboard (ranging from 0.02 -0.04 m in places) with a modern timber stud framework and cavity wall insulation behind (Plate 10). The works revealed that this section of the wall was likely inserted in the 1990s as it contained plasterboard dating to December 1994. This occurred probably when the (now removed) cupboard and the sink were inserted (see Plate 5). However, the upper portion revealed three original 17th century roof rafters with the remains of lathe lines (now removed, see Plate 10). These were being partially supported by the later studs. It's possible that this was once

Plate 8: Existing Elevation B showing the historic wooden framing in the corridor towards the bathroom

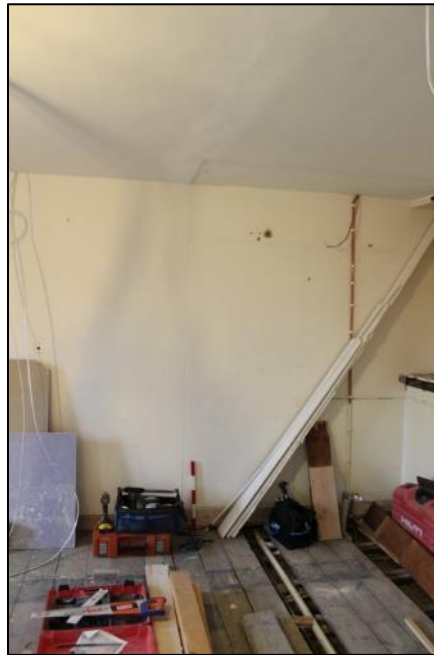
an earlier doorway that was filled in during the 1990s refurbishments. It might have been associated with the removed wall within Room 1:3 (see Fig 4-5 and Plates 5, 7 and 9). Or potentially the earlier door was removed to allow for service pipes to be inserted into the bathroom (Plate 9).

Plate 9: The Location of the Doorway prior to removal in Room 1:3. Note the service pipes under the floorboards. Just visible the dark line of the earlier removed wall

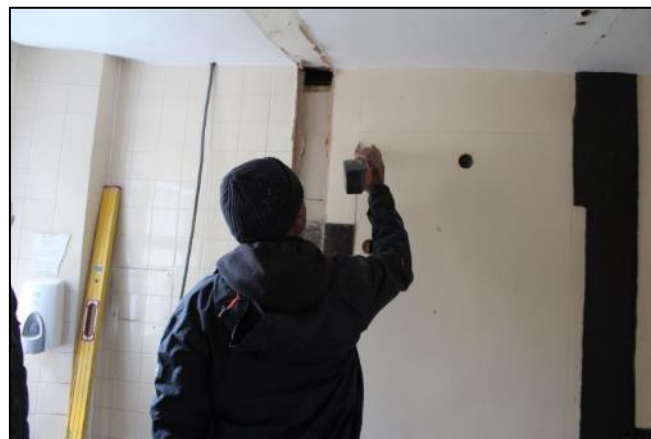
Plate 10: The Location of the Doorway prior to removal

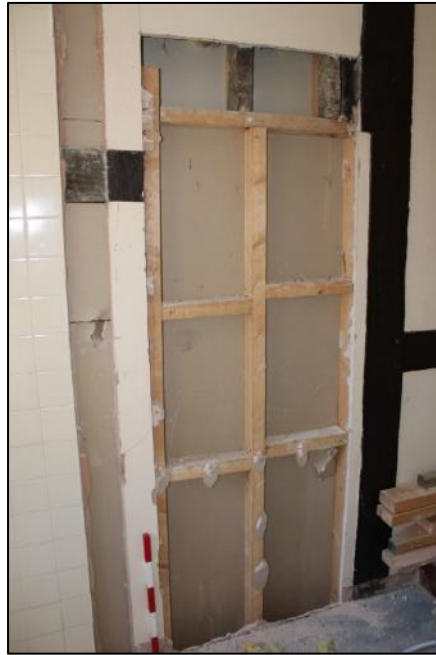
Additionally, the historic 17th century wooden wall frame uprights (noted in the corridor) were further revealed (Plate 11-14).

Plate 11: The Exposed beams below the plasterboard

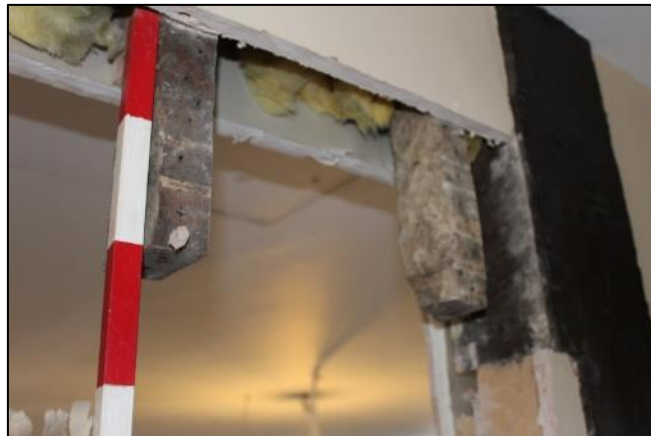
Plate 12: The 17th C rafters *in situ*

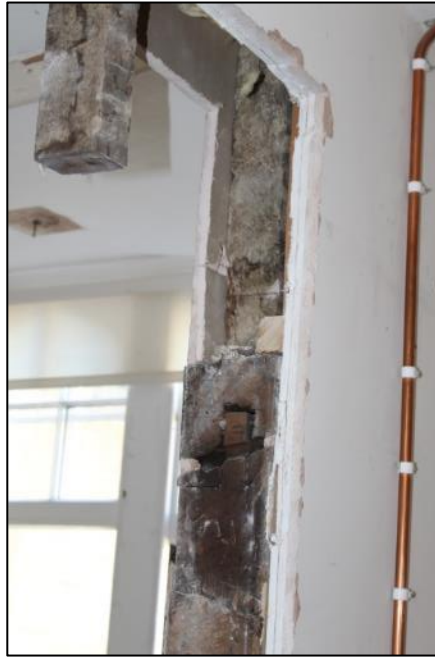
Plate 13: The historic timbers and rafters

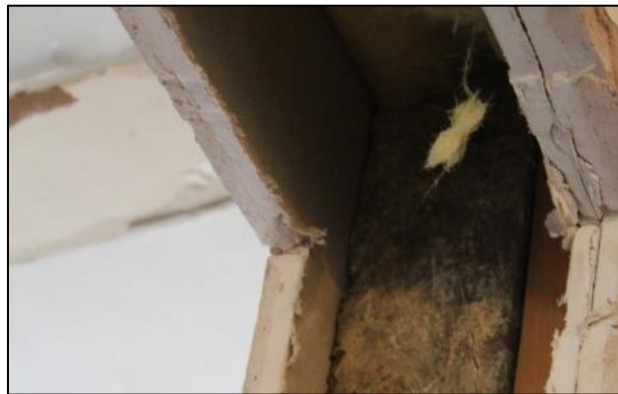
Plate 14: The historic timbers within the thick wall cavity

The proposed works have revealed that the opening of the doorway, in fact, concealed a 1990s era cavity wall rather than historic timbers. Only three historic roof rafters were affected. Therefore the works had only a limited impact.

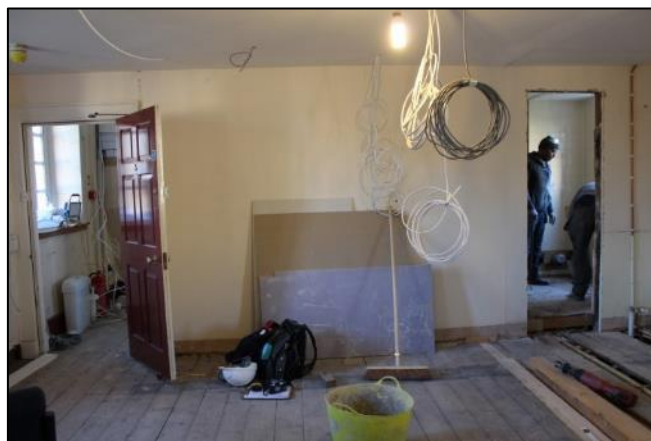
Plate 15: The completed doorway (right)
