JOHN MOORE HERITAGE SERVICES

ARCHAEOLOGICAL WATCHING BRIEF

SEVERN VALLEY RAILWAY, STATION LANE,

BRIDGNORTH, SHROPSHIRE WV16 5DT

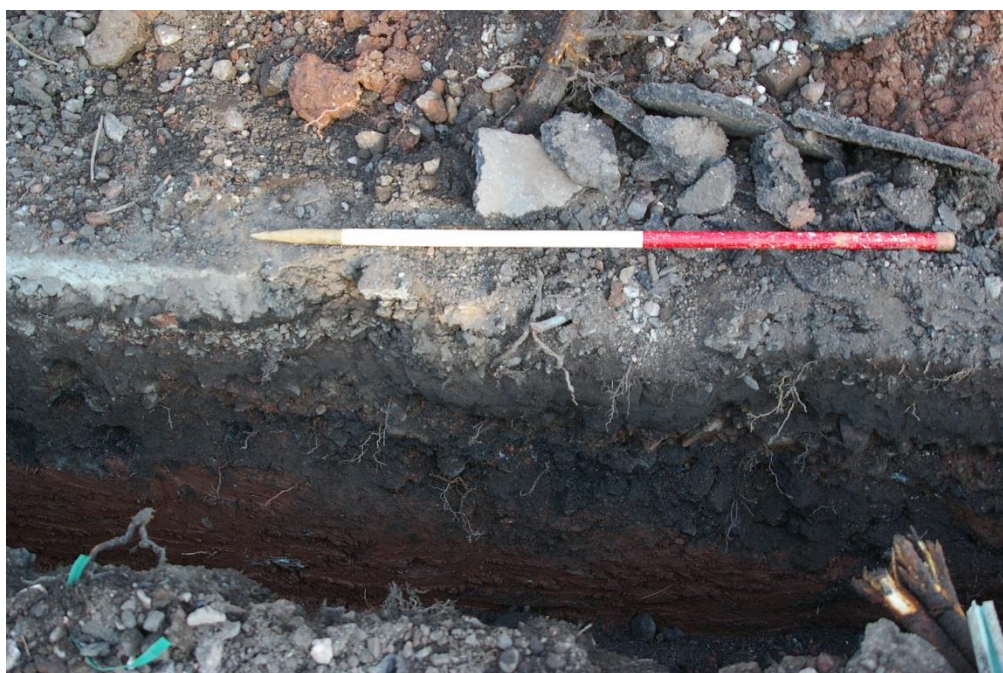
Plate 1. Representative section 1

The deposits encountered within the trench consisted of a 0.1m thick layer of tarmac from the former carpark overlying a 0.6m thick layer of heavily disturbed made ground (01). This layer was a dark grey silty clay with frequent stones and industrial waste that overlay the natural red clay (02). Along the western extent of the trench another layer of made ground was present underlying layer (01), this was a reddish brown silty sand (03). Various disused services were noted across the site that cut through the made ground. No archaeological horizons were present in any of the trenches.

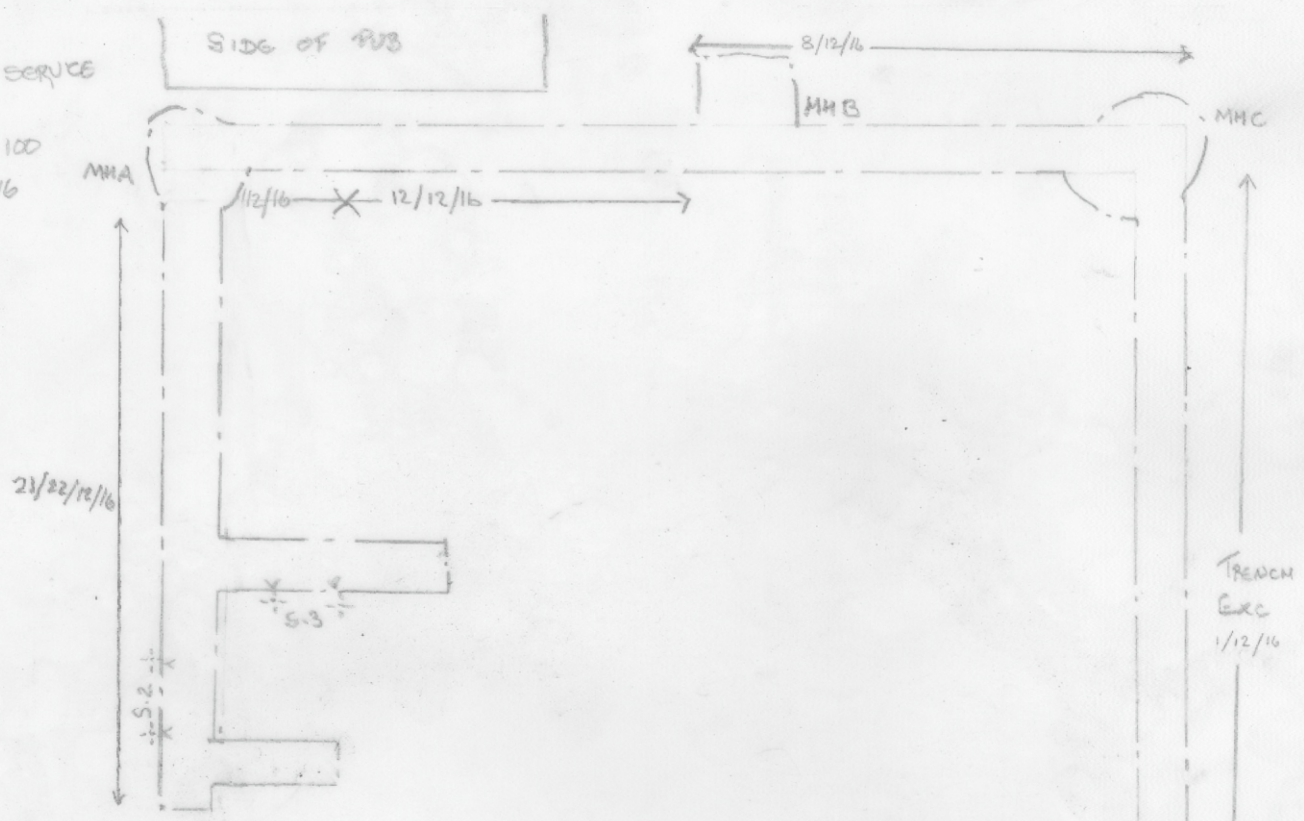
PLAN OF SERVICE TRENCH

SCALE - 1:100
1/12/16

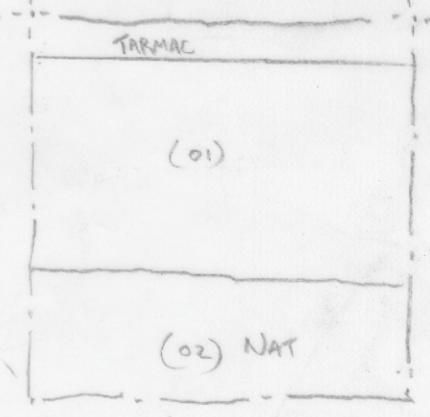
BRSR16
S.1 - REP SEC
SCALE - 1:20
1/12/16

SW FACING
