AN ARCHAEOLOGICAL EVALUATION

CHURCH OF THE HOLY CROSS,

SHIPTON-ON-CHERWELL,

JUNE 2020

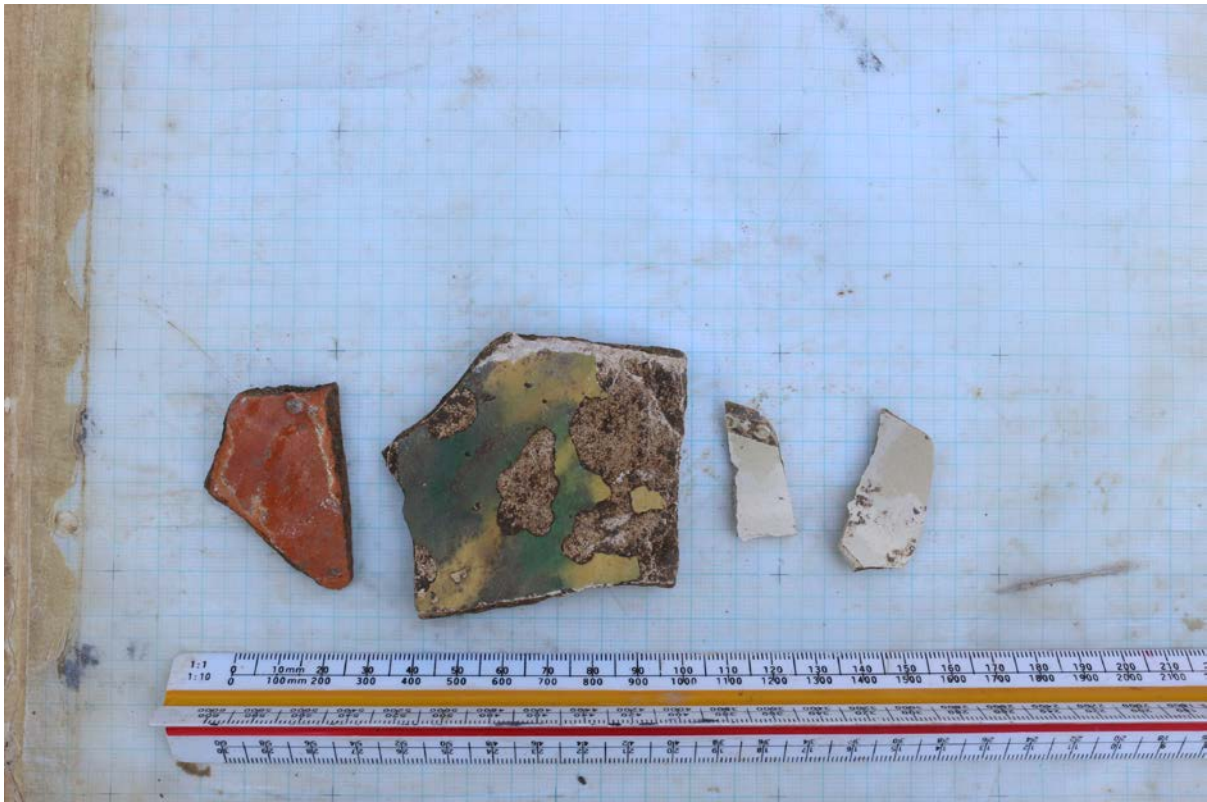
Pottery

Four sherds of pottery of post-medieval to 20th century date were recovered from deposit (1/03) before being reburied prior to reinstatement of the trench. Those positively identified comprised one sherd of Red Earthenware (OXDR) and two sherds of Mass-produced White Earthenware (WHEW).
