ARCHAEOLOGICAL WATCHING BRIEF

4 WHITEHOUSE ROAD, NORTH STOKE.

NOVEMBER 2020

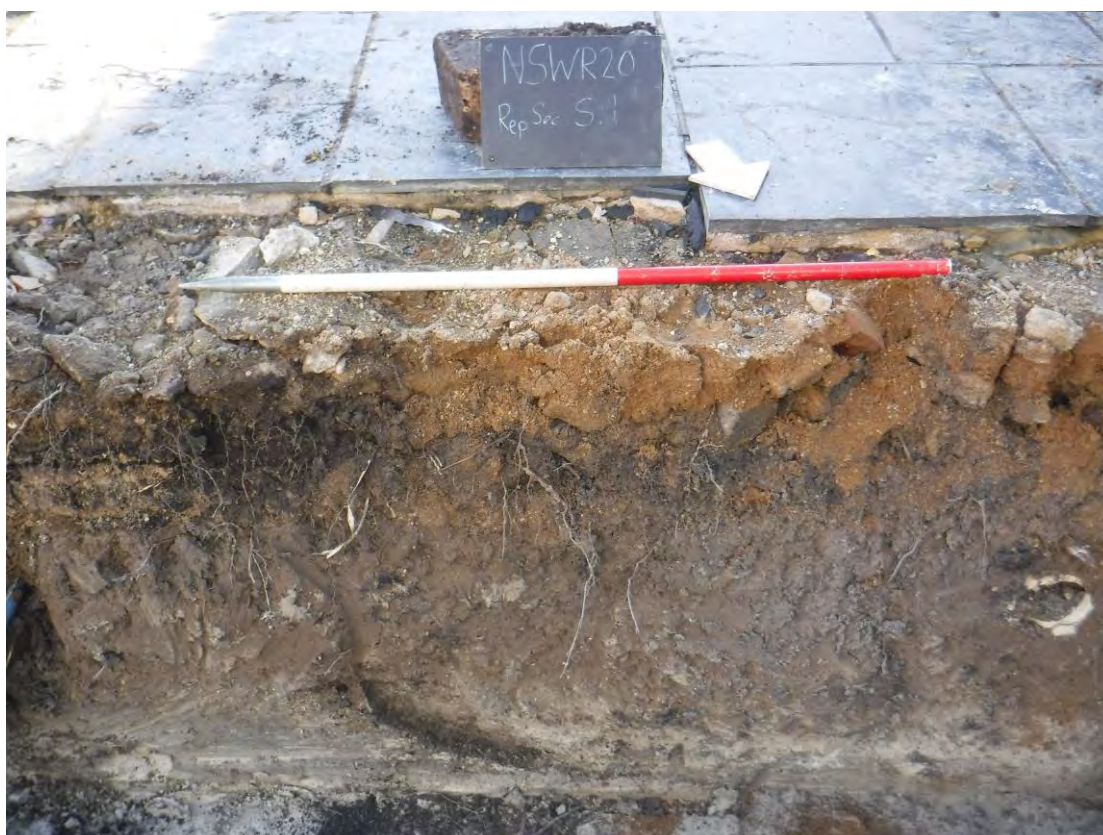
Plate 1: Section 1, looking South/South-West.

The earliest recorded deposit comprised of a firm, light brown, clay mudstone (05) (Figure 2, Plan 3 and Section 2; Plate 1). It measured greater than 2.60m in length, greater than 2.40m in width, and had a thickness of greater than 0.22m at a depth of 1.10m. Deposit (05) was identified as being natural geology, although it was not uncovered throughout the full extent of the groundworks, and was only identified in the south-eastern excavations for the new manhole drain. As those excavations were at a greater depth.

Deposit (03) was a firm, mid-grey sandy-clay deposit that was overlying natural deposit (04) (Figure 2, Plans 1-3 and Sections 1-3; Plates 1 and 2). Deposit (03) contained inclusions of infrequent chalk flecks and rooting. This deposit measured greater than 12m in width and in length, with a thickness varying between 0.50 to 0.59m at a varying depth of 0.15 and 0.30m. Deposit (03) was identified as a subsoil deposit, one that was levelled off during the construction of the later conservatory.

Deposit (02) was a friable, mid-grey mixed with light orangey-brown, sandy-silt with concentrated patches of sand throughout (Figure 2, Plan 1 and Section 1, Plate 1). Deposit (02) was observed overlying the topsoil/garden soil deposit (01) in the south-western corner of the site. This deposit was elsewhere overlying the subsoil (03), and has been associated with the construction of the pre-existing conservatory and garden patio. As a result it has been identified as a made-ground levelling deposit. Deposit (02) measured greater than 2.50m in length and greater than 1.10m in width, it had a thickness of 0.29m.

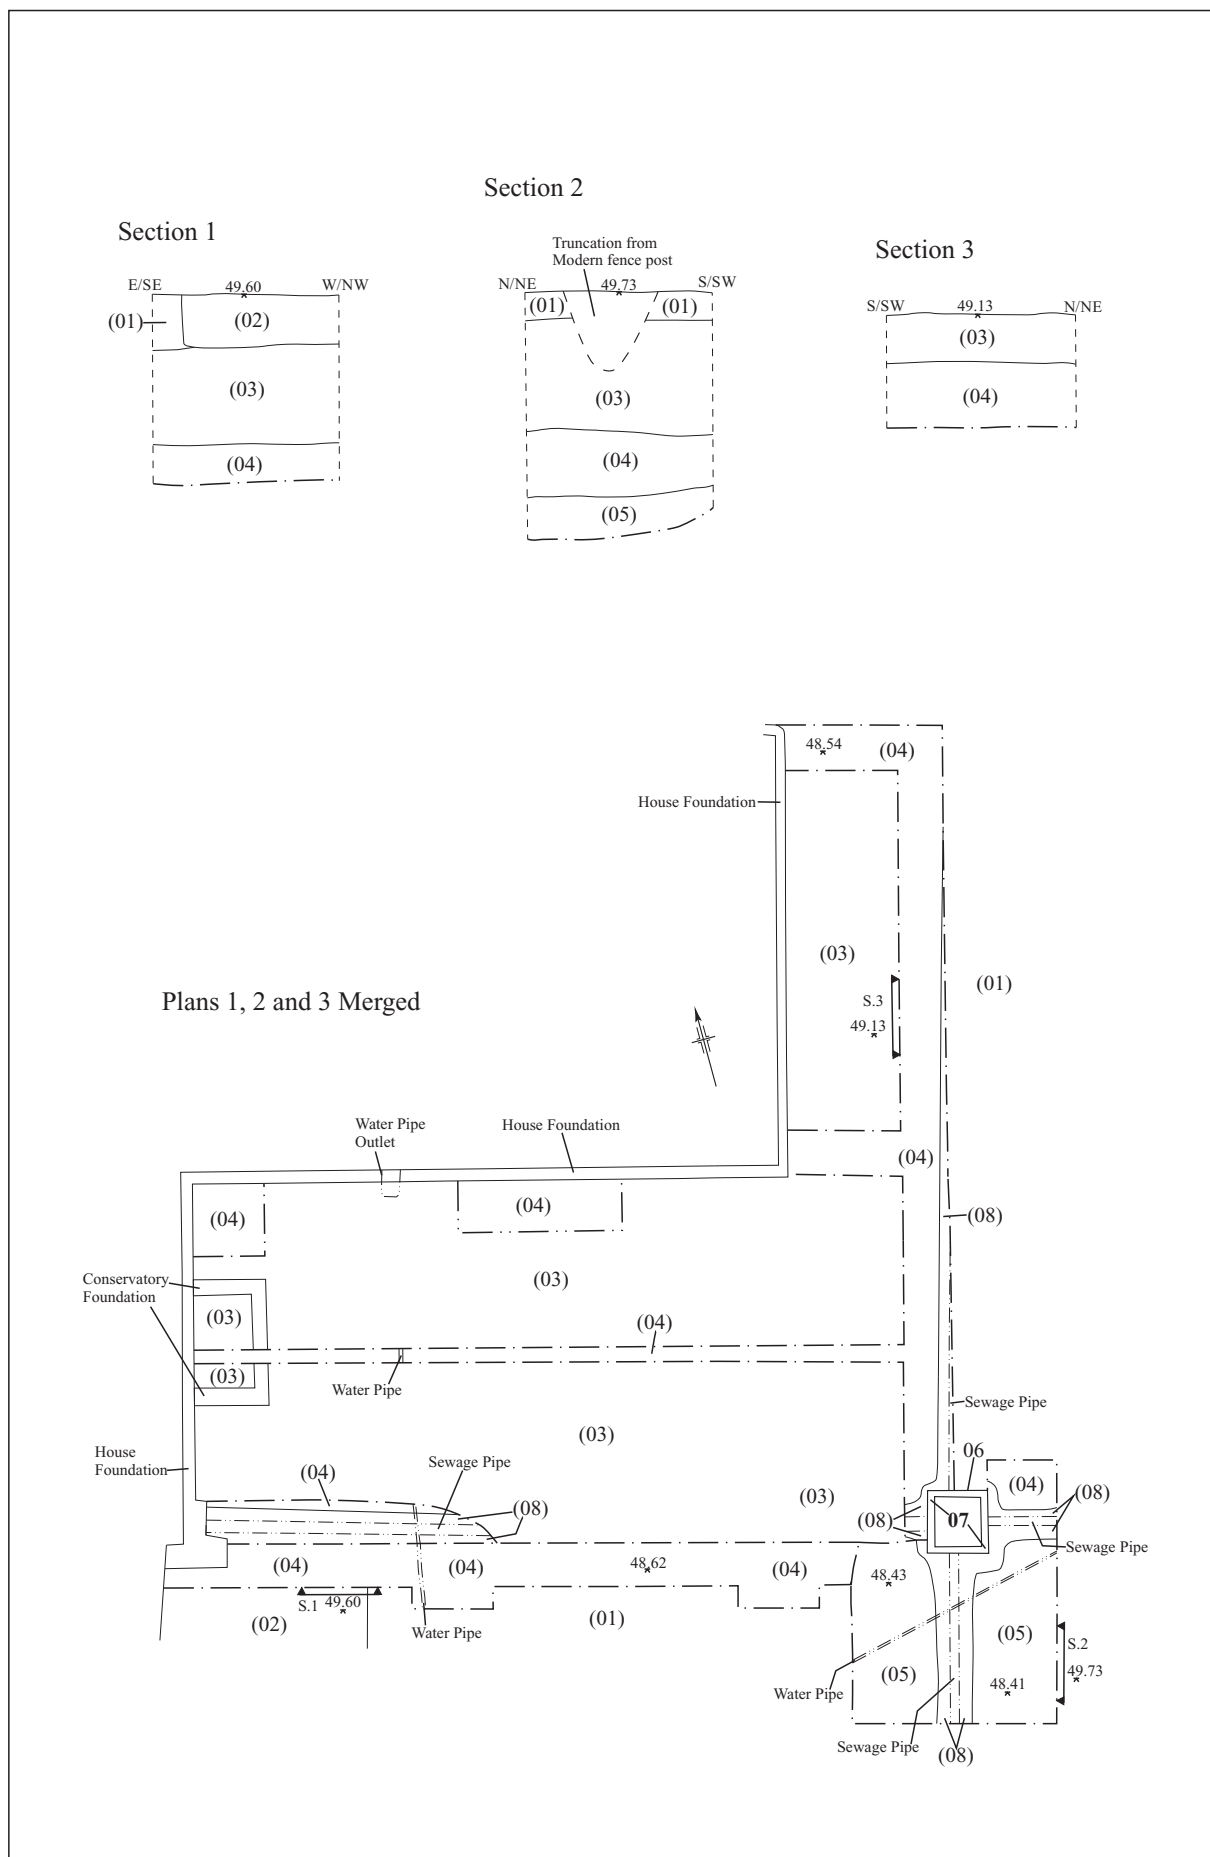
Figure 2: Plan of area with associated Sections.

Overlying natural deposit (05) was a firm, light grey chalky-clay (04). It contained inclusions of infrequent, small to large pieces of chalk. Deposit (04) measured greater than 12m in width and in length, with a varying thickness between 0.20m to 0.35m, at a varying depth of between 0.73 to 0.80m (Figure 2, Plans 1-3 and Sections 1-3; Plates 1 and 2). This deposit was identified as being a natural geology deposit, which was observed throughout the full extent of the excavated foundation trenches.

Overlying deposit (03) was a friable, dark brown-grey clayey-silt (01) (Figure 2, Plans 1-3 and Sections 1 and 2). Deposit (01) contained inclusions of frequent flecks to small sized gravel pieces as well as frequent rooting. It measured greater than 12m in length and in width as well as between 0.15m to 0.30m in thickness. This deposit was identified as the topsoil/garden soil, observed throughout the site.

Truncating deposit (01) was a square-shaped, right-angled cut for a modern and active manhole drain 06 (Figure 2, Plan 2). It had a sharp break-of-slope at the top as well as vertical sides, the base was not exposed. Cut 06 measured 1.20m squared and greater than 1.60m in depth, to allow for the concrete footings. During the groundworks, the

Cut 06 for the manhole drain was initially filled with a shallow layer of concrete (08) to allow for the placement of the sewage pipes and later the brickwork for the drain (Figure 2, Plan 2). The concrete deposit (08) was compact and light brown-grey in colour. The concrete footings measured 0.55m in width, greater than 10m in length and 0.20m in thickness.

Built onto the concrete footing (08) was the square, brick-built structure of the manhole drain **07** (Figure 2, Plan 2). This structure was constructed one course of bricks thick, roughly four courses of bricks wide and more than 11 courses in depth, as the base was not exposed. The individual bricks measured 0.22m by 0.11m by 0.06m. The structure itself measured 0.80m by 0.80m and had a depth of greater than 1.60m.
